Firmware 2.06.3 bug list:

List of bugs/improvement requests

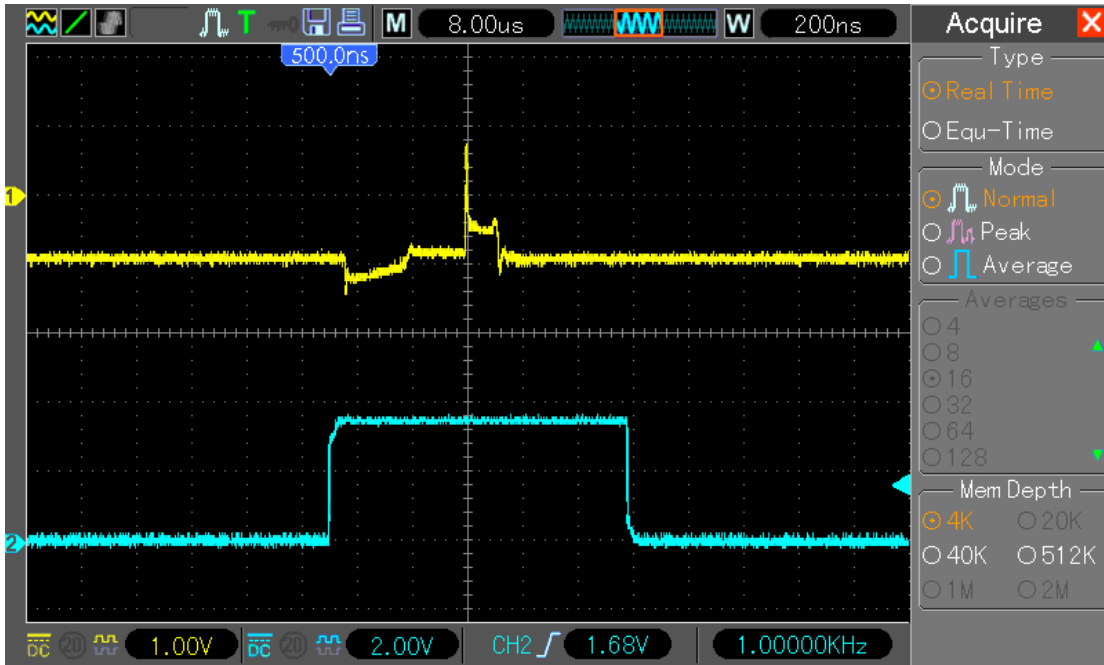
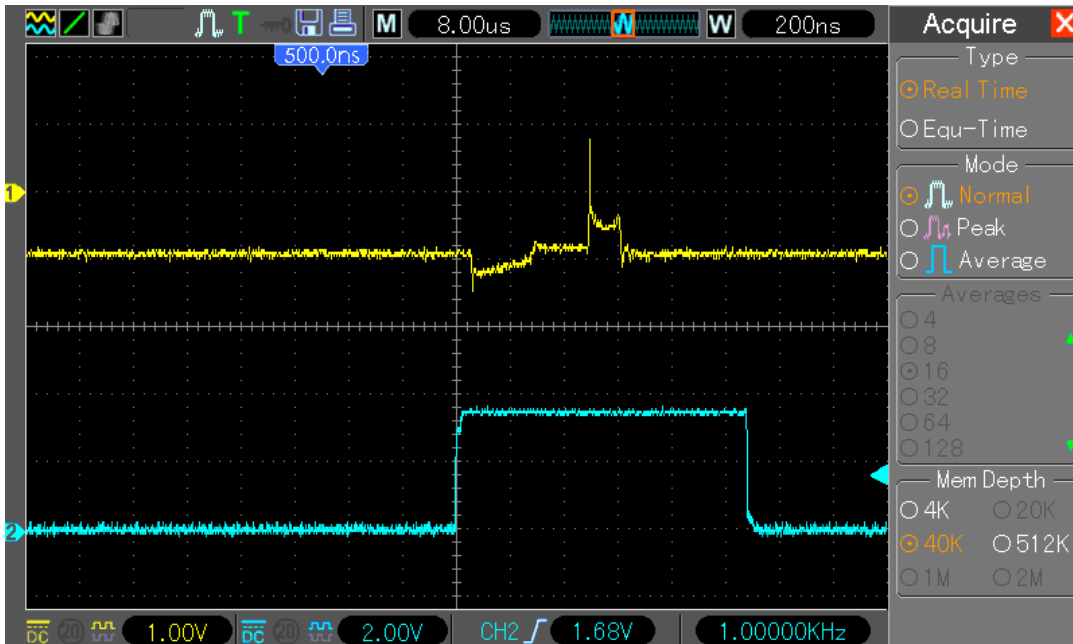
8. In single window, sample memory $\geq 40k$, both channels (ch1, ch2) enabled and time base from 400ns/div up to 2ns/div the position change (fine and coarse) control is not working. Only scale is moving, but not the waveform. See attached picture to understand issue:

with 4k memory when changing position waveform is moving

with 40k and above, when moving changing time base position waveform is NOT moving when in RUN mode (but works in STOP mode)

7. This is improvement proposal and not a bug. It has been removed from to-do as “not important”.
8. This is a very unfortunate bug; possible workaround is to use dual window mode or less memory depth (both with disadvantages)

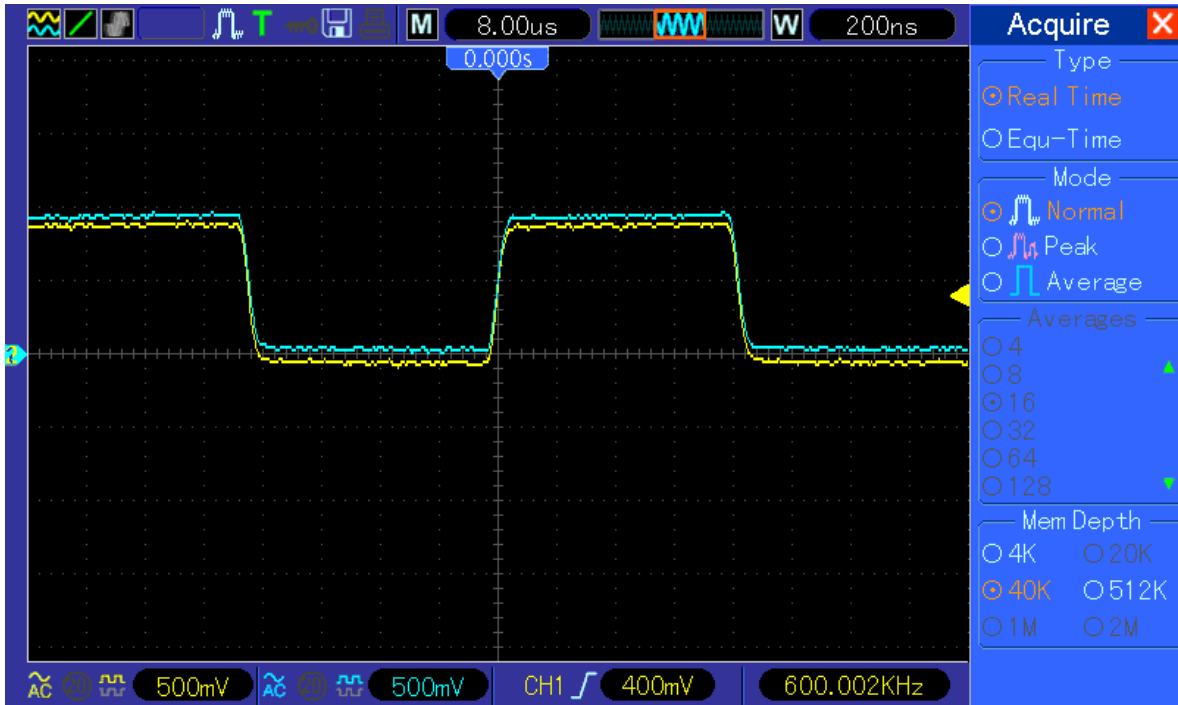
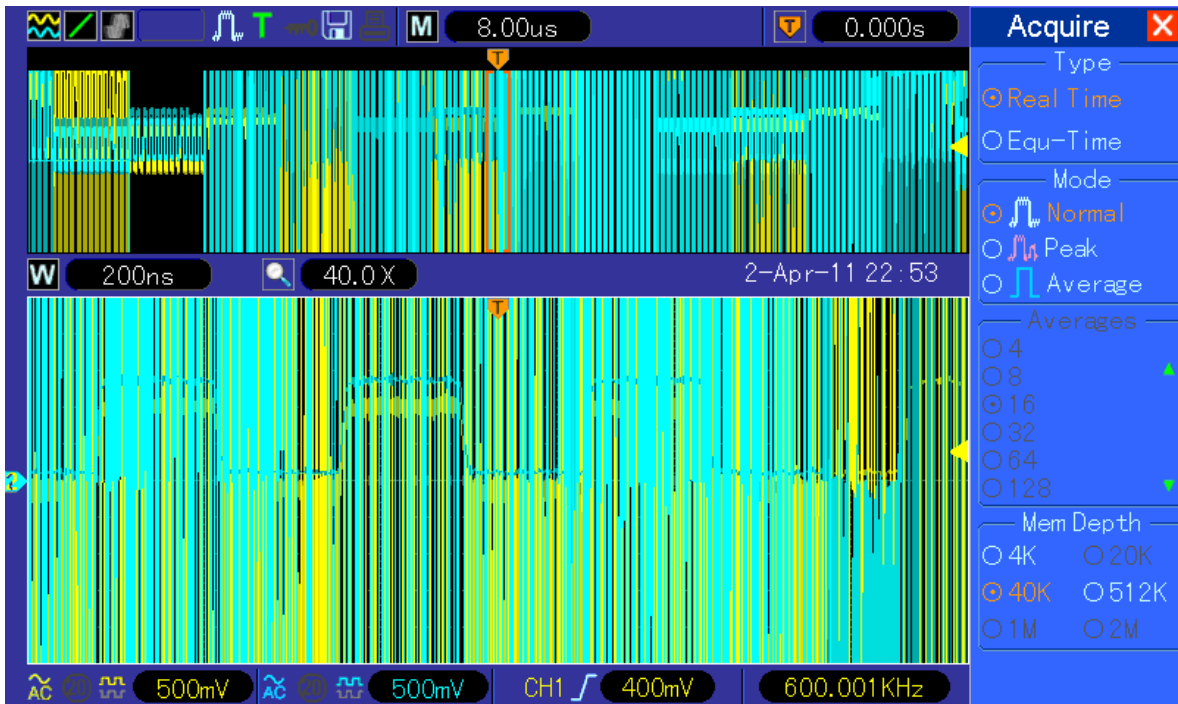
9. In single window mode, sample memory 40k, both channels (ch1, ch2) enabled – while switching to dual window mode artifacts on screen and DSO later crashing and not responding.

Artifacts disappear when changing timebase just after switch to dual window, so just an init error?

Set like on picture

and switch dual window mode to see artifacts like this:

9. ~~Workaround is to change Timebase (just one step forward and back) right after dual window enabled. Note – the main window (top) need to be activated, the bug have something to do with main TB buffer initialization.~~

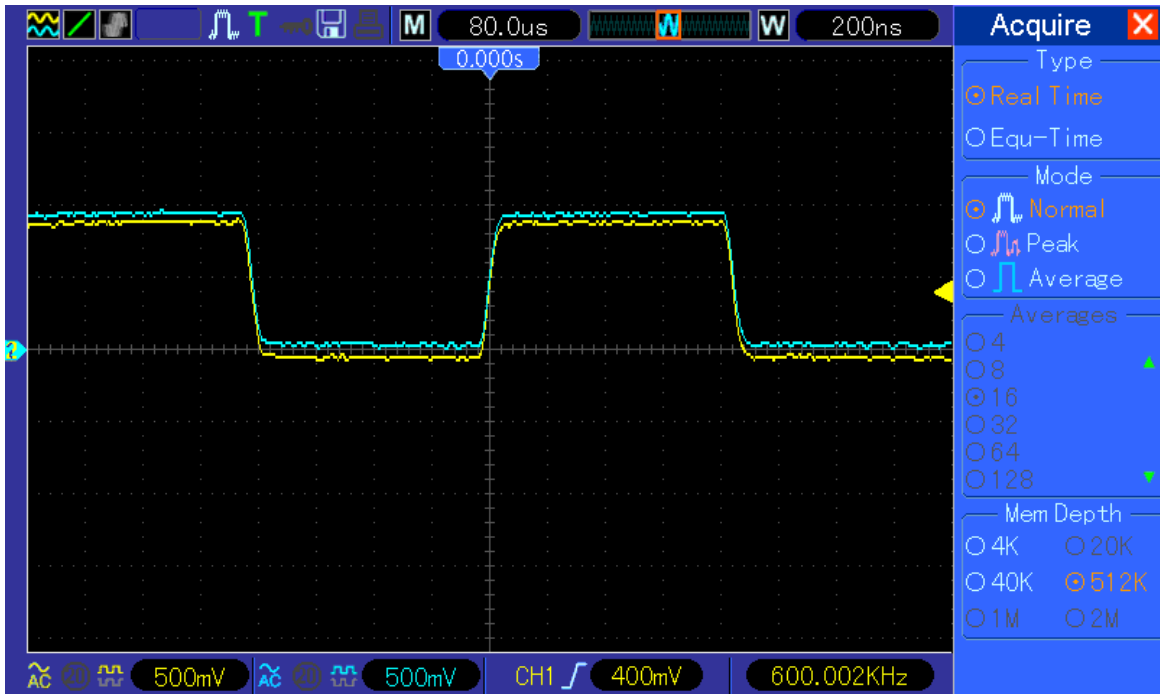
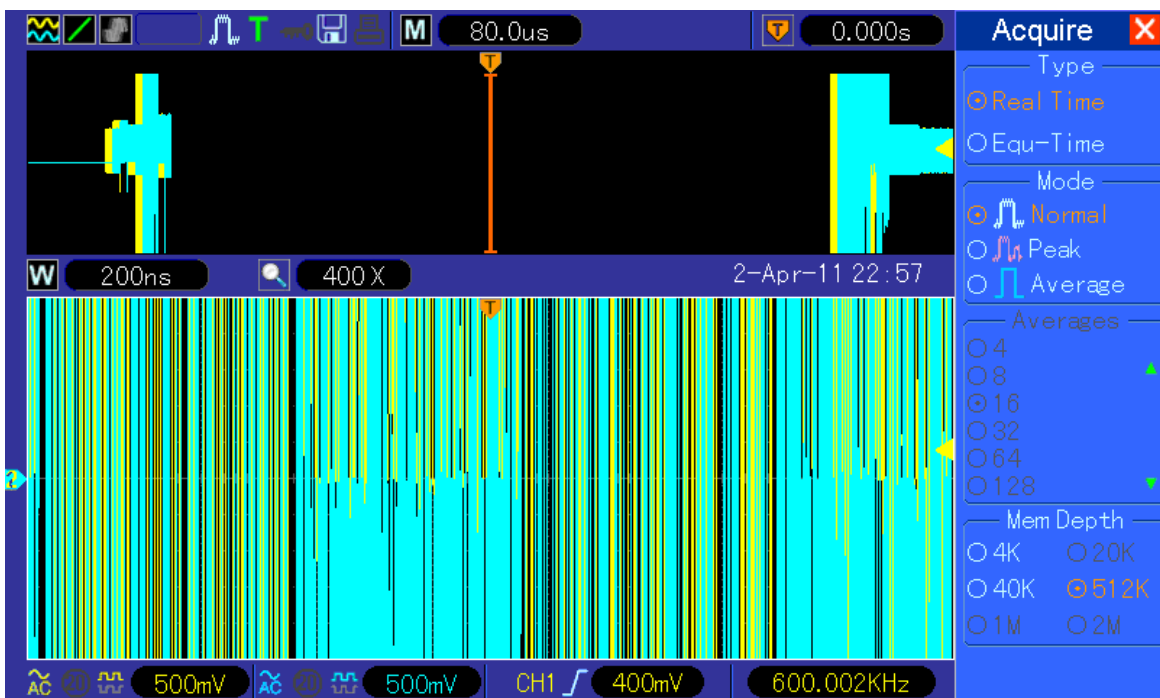
10. In single window mode, sample memory 512k, both channels (ch1, ch2) enabled – when switching to dual window mode artifacts on screen and DSO later crashing and not responding

Artifacts disappear when changing timebase just after switch to dual window, so just an init error?

Set DSO like on picture

and switch dual window mode to see artifacts like this:

10. Workaround is to change Timebase (just one step forward and back) right after dual window enabled. Note — the main window (top) need to be activated, the bug have something to do with main TB buffer initialization.
11. This is improvement proposal and not a bug.
12. Use my firmware (2.06.3_120507.6), I removed that bug.
13. Use DC trigger coupling or “add offset” when you set trigger point. On some other good known DSOs (e.g. Tektronix TDS7xxx) there is exact the same DC-signal/AC-trigger “dependency” (bug) and nobody ever complained about.

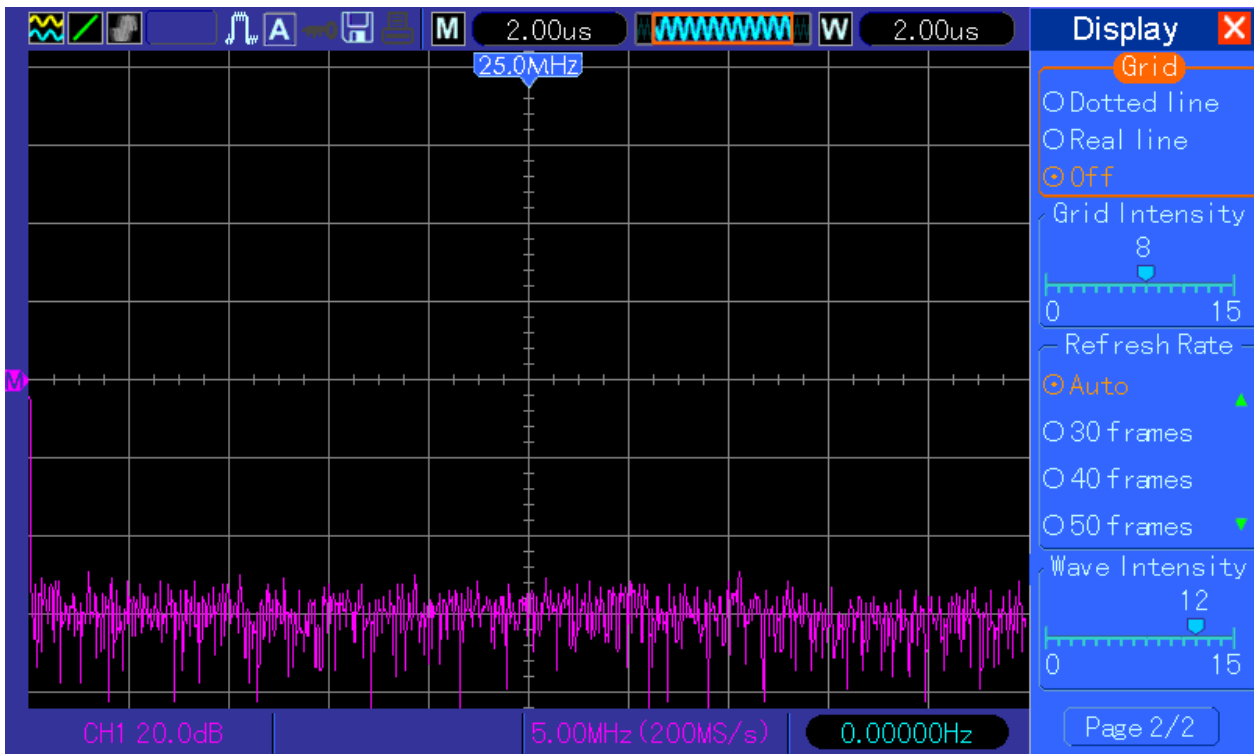
11. In FFT mode the Display -> Grid option is not changing the grid, it is always “real line” and not possible to change to “dotted line” or “off”.

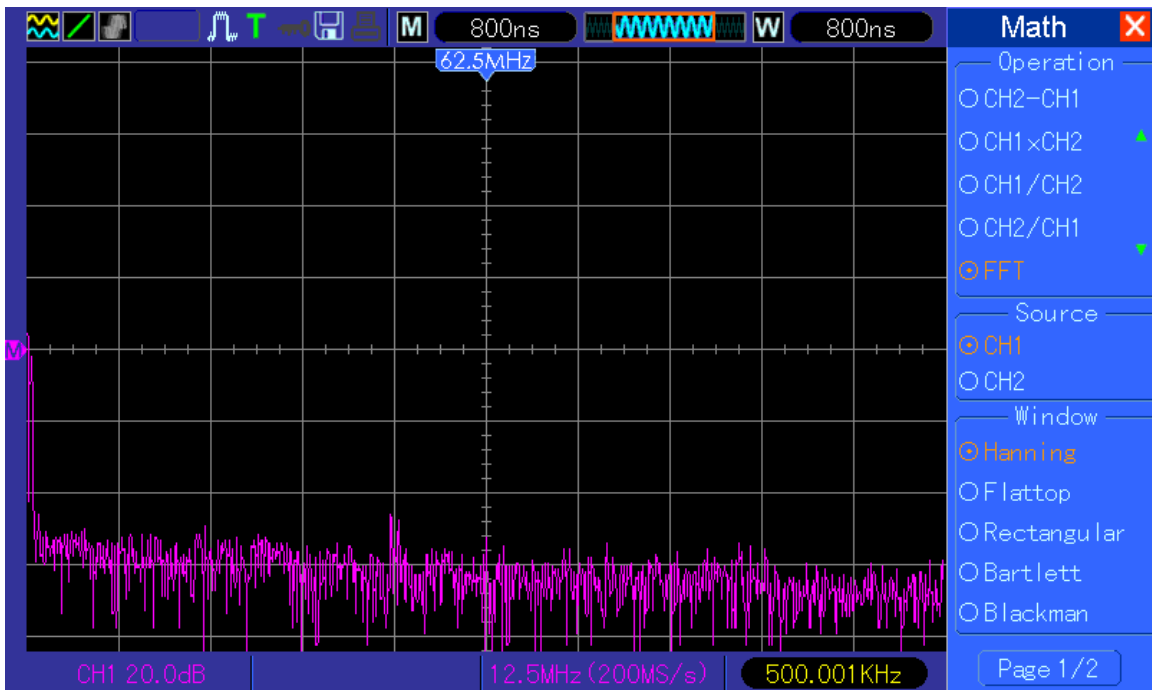
12. In FFT mode “Full span” is higher than Nyquist (sample rate / 2)

Example: 800ns/DIV, sample rate is 200MSs, full span 125MHz. Easy to fix by enabling from 800ns/DIV to 20ns/DIV 1GSs sampling (when 4k memory or FFT enabled)

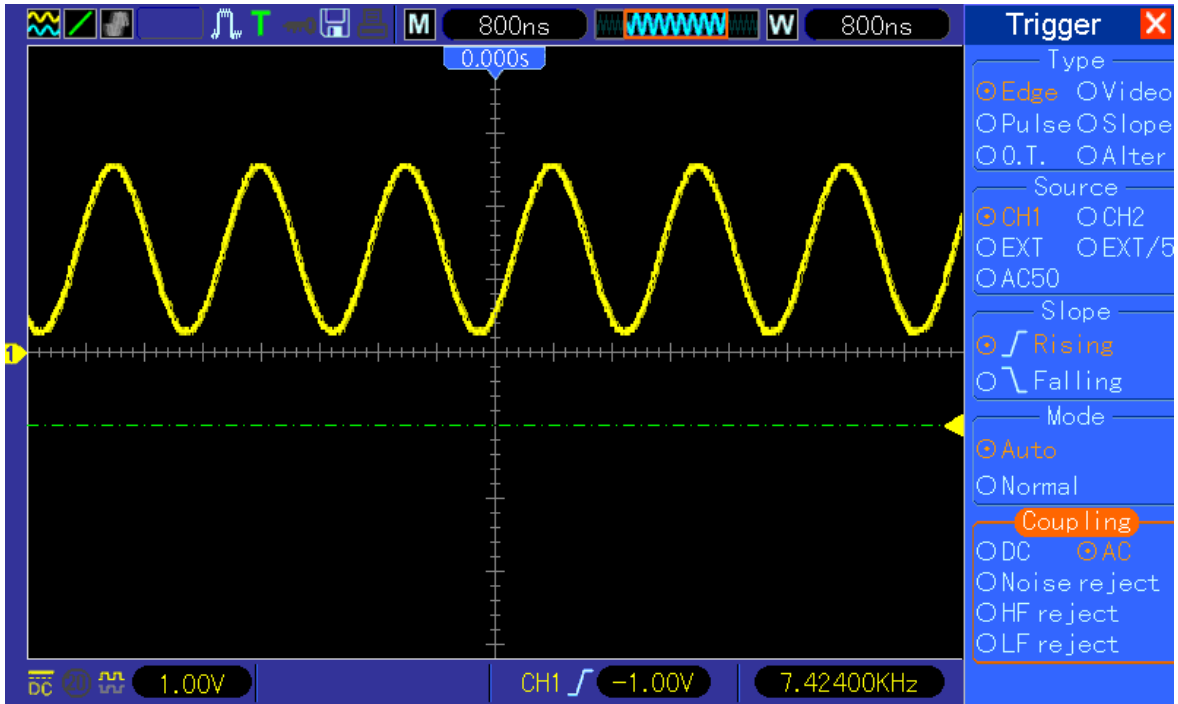
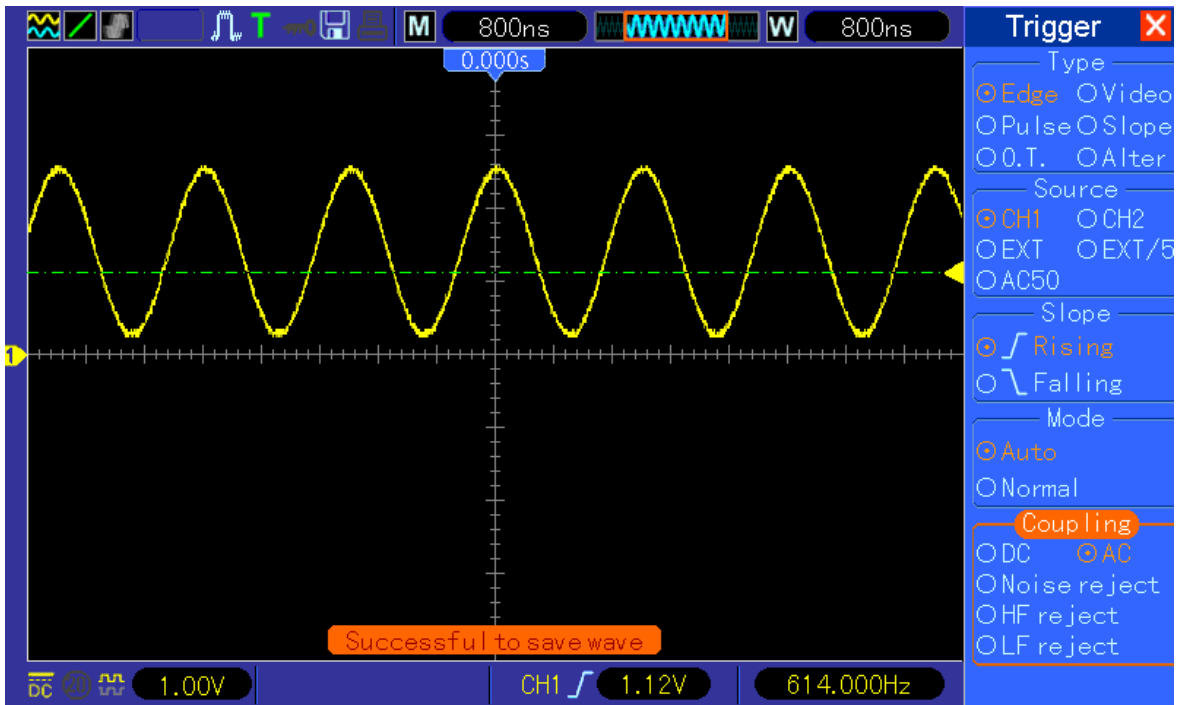
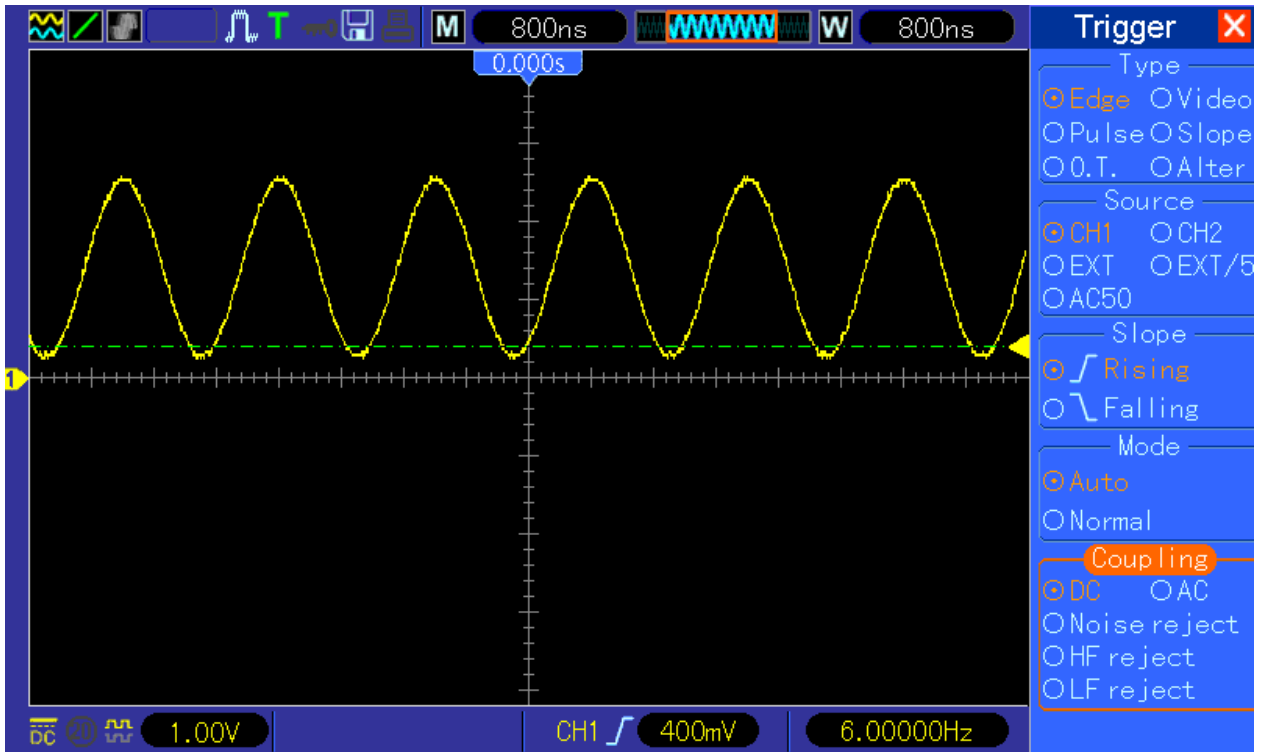
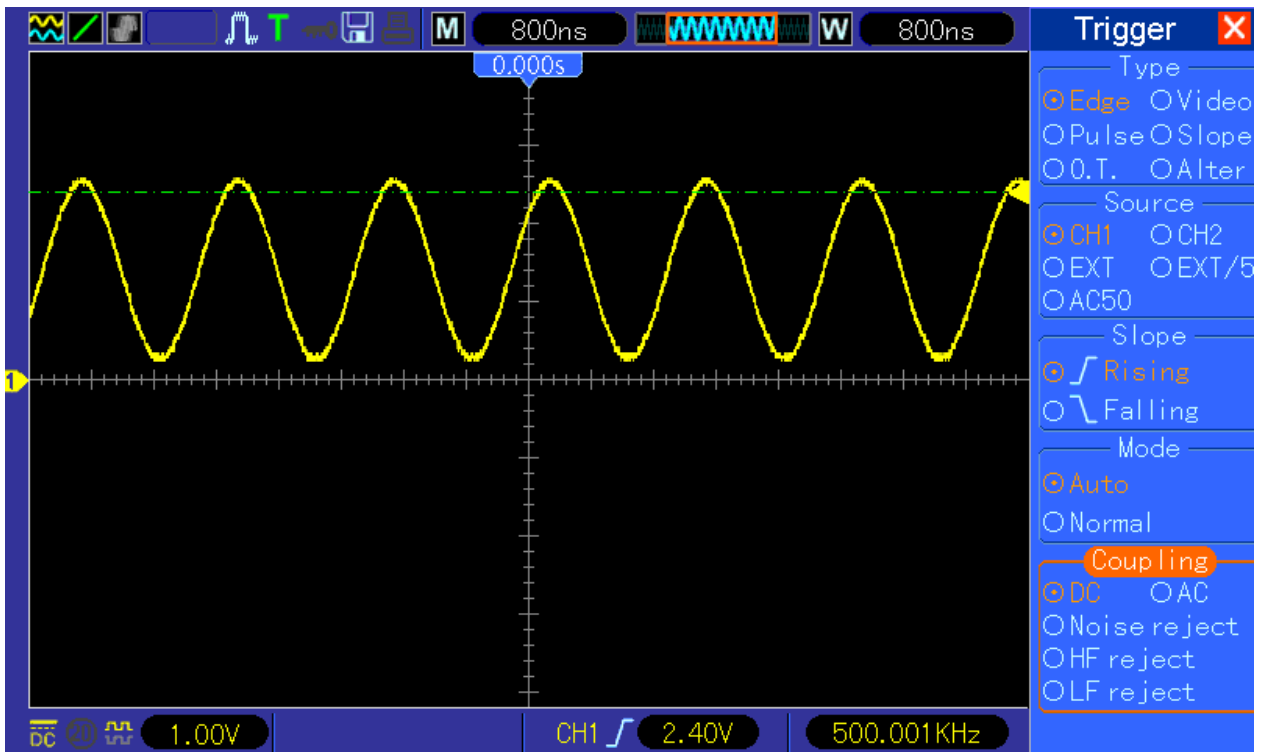
13. AC trigger indicator and line wrong. Set ch1, signal DC coupled, trigger AC coupled. The trigger lowest level below signal :

highest level only mid of signal

But both should look like when trigger coupled in DC mode:

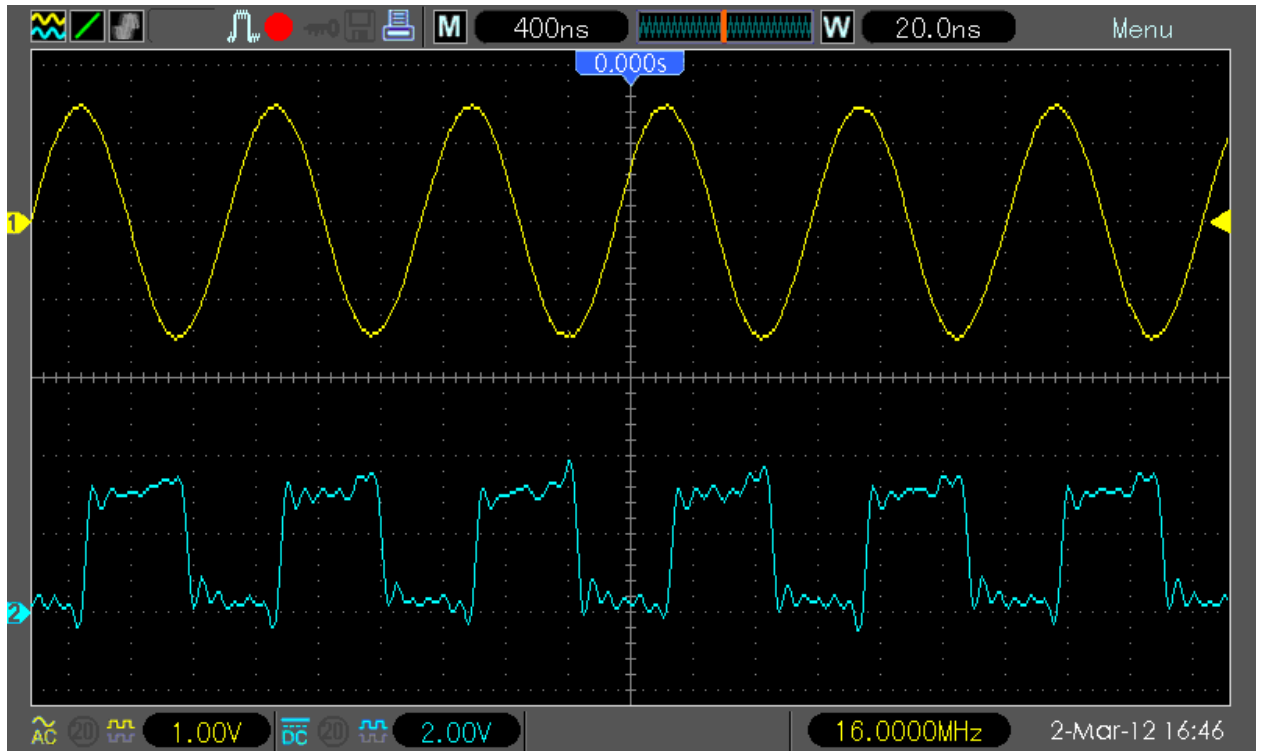
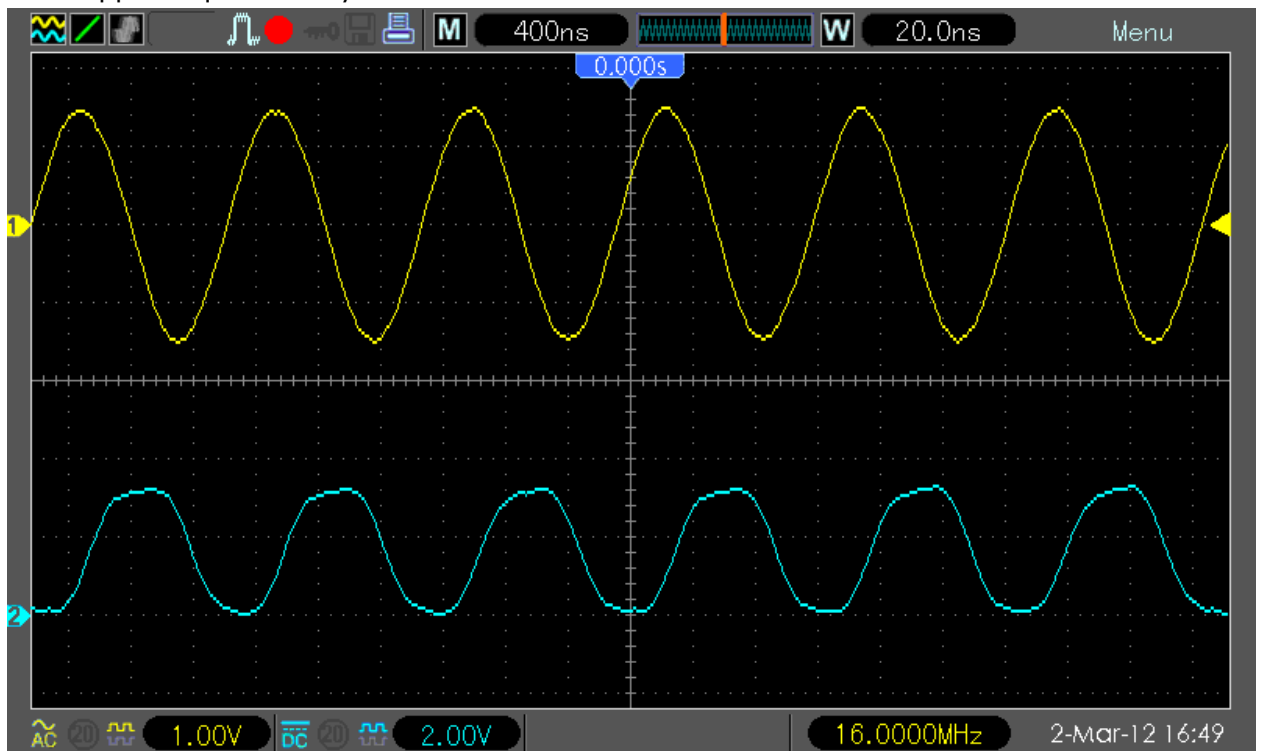
14. Dithering/interpolation filter of waveform too sharp. When enabling both channels (this also occurs in single channel mode and 1GSs, but test signal need to be higher to get same error) and applying for example 16MHz square wave the waveform is switching between proper square:

and crippled square every second:

14. For sure a stupid bug, but since you can see when the signal is “wobbling” you can quick change (when necessary) to single channel to observe the waveform with better resolution and without wobble.
15. Funny bug, but easy to omit since we know it (remember, with higher sample depth there is no issues)
16. This is already fixed, the /dsod (or /dso/app/dsod — this depends on fw/DSO model version) binary is working perfectly as watch dog monitoring potential profile issues.

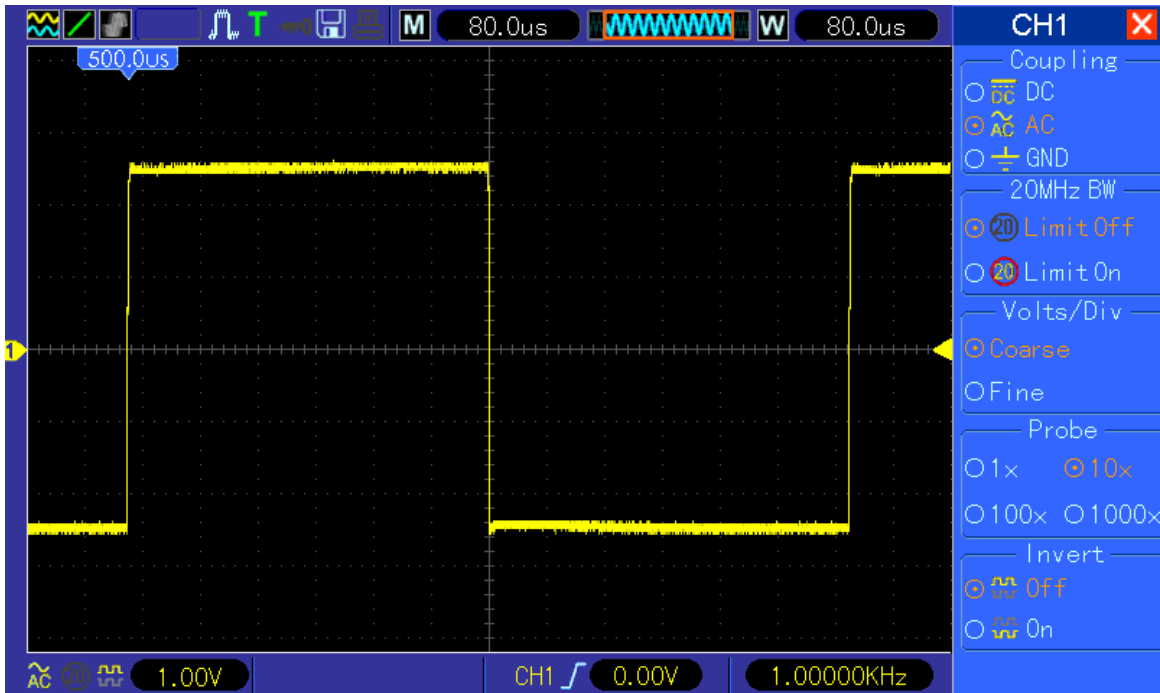
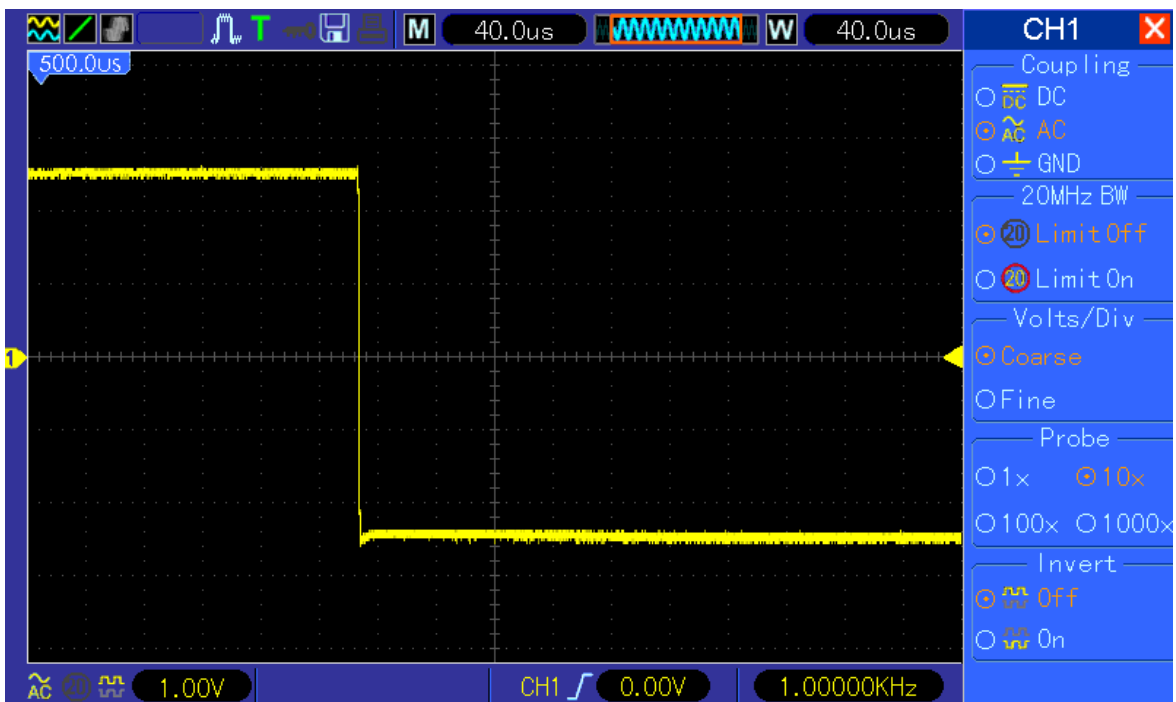
15. Display / Time base scaling strange behavior. When you apply e.g. 1kHz signal, set time base to 80us/DIV and move the waveform to 500us/DIV (bug only in 4/40k memory depth, 512k/1M/2M works fine):

When you now change time base to 40uS/DIV the falling edge (which should be still in the middle of the screen) has been moved to 454uS position (but it should stay on 500uS). The same happens of course with 20uS/DIV.

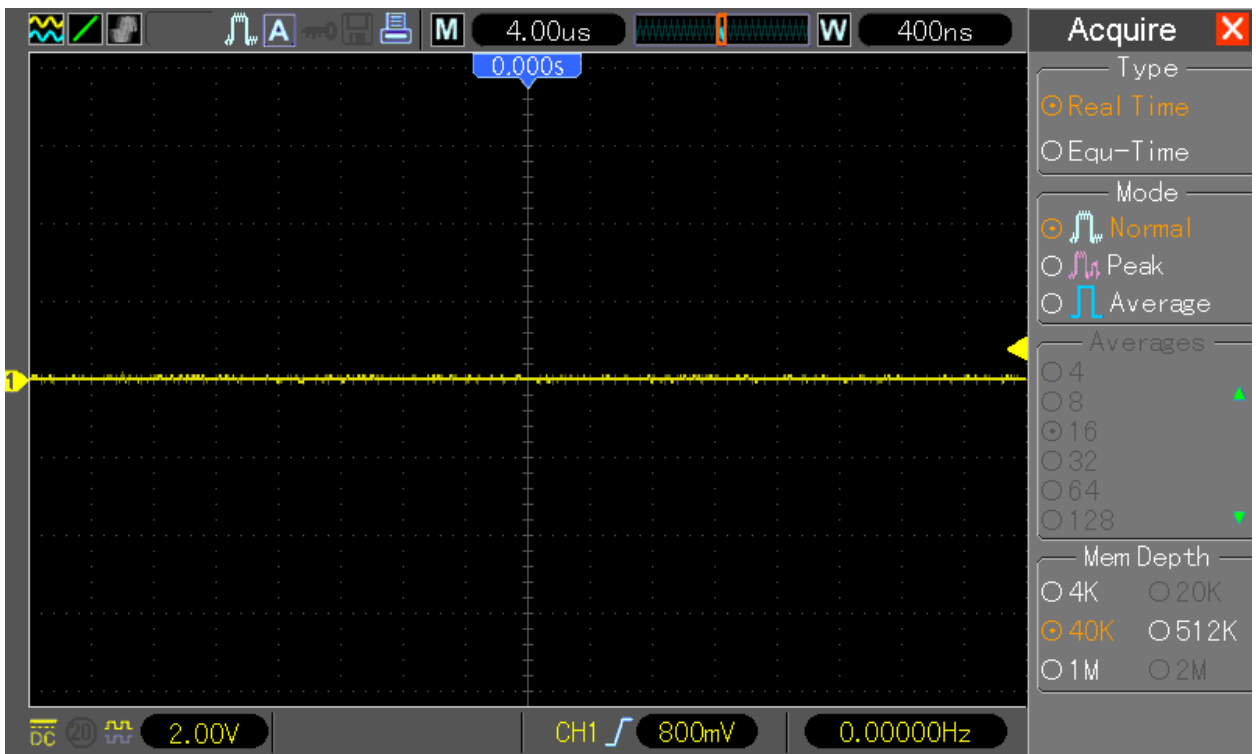
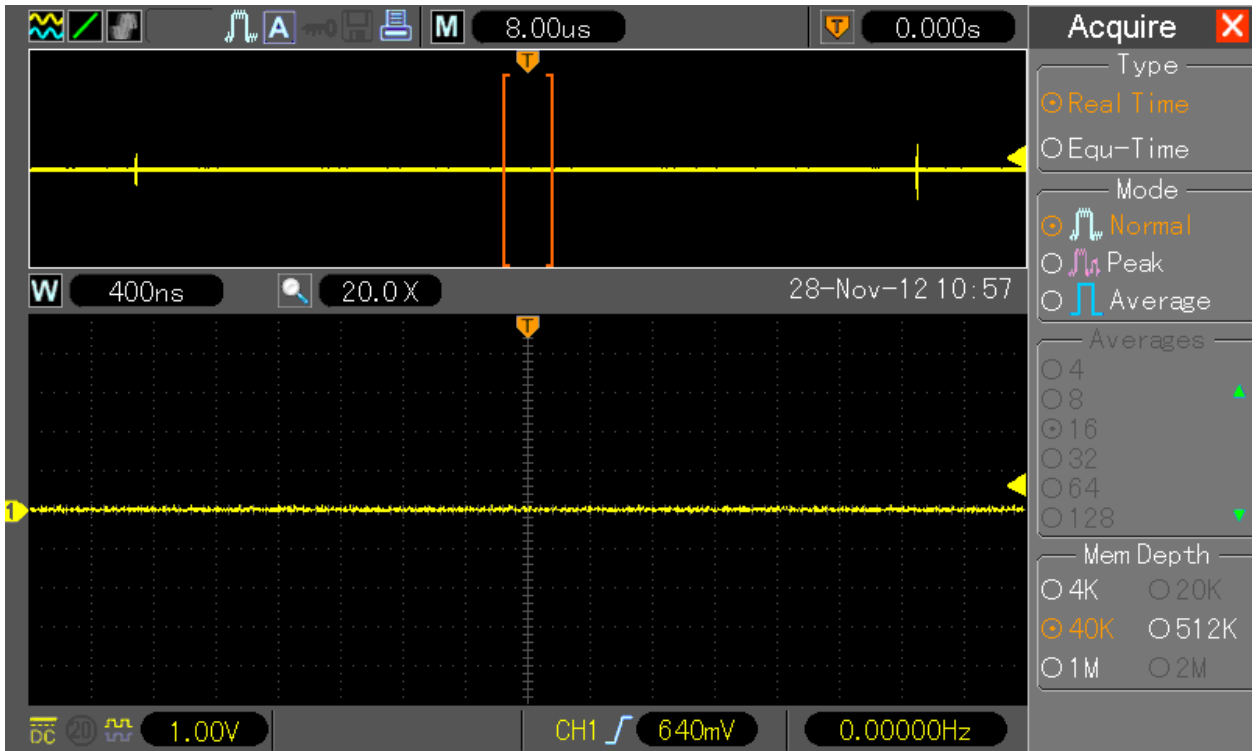
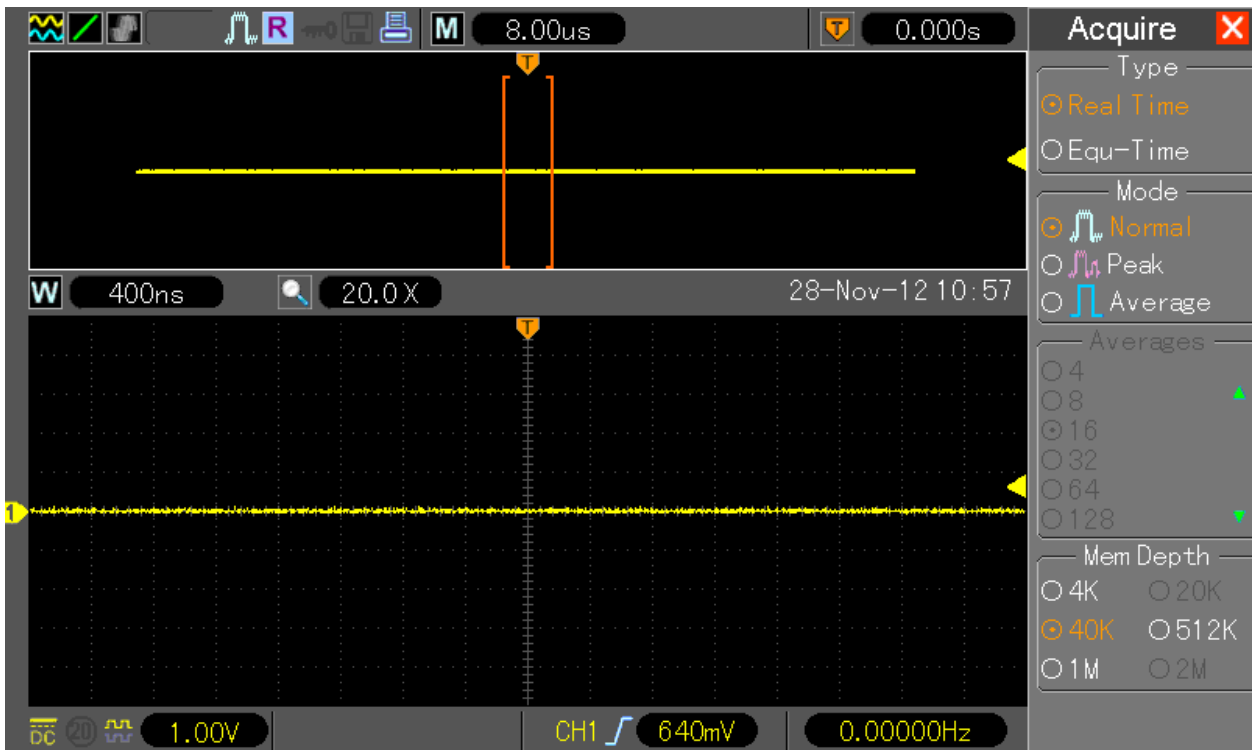
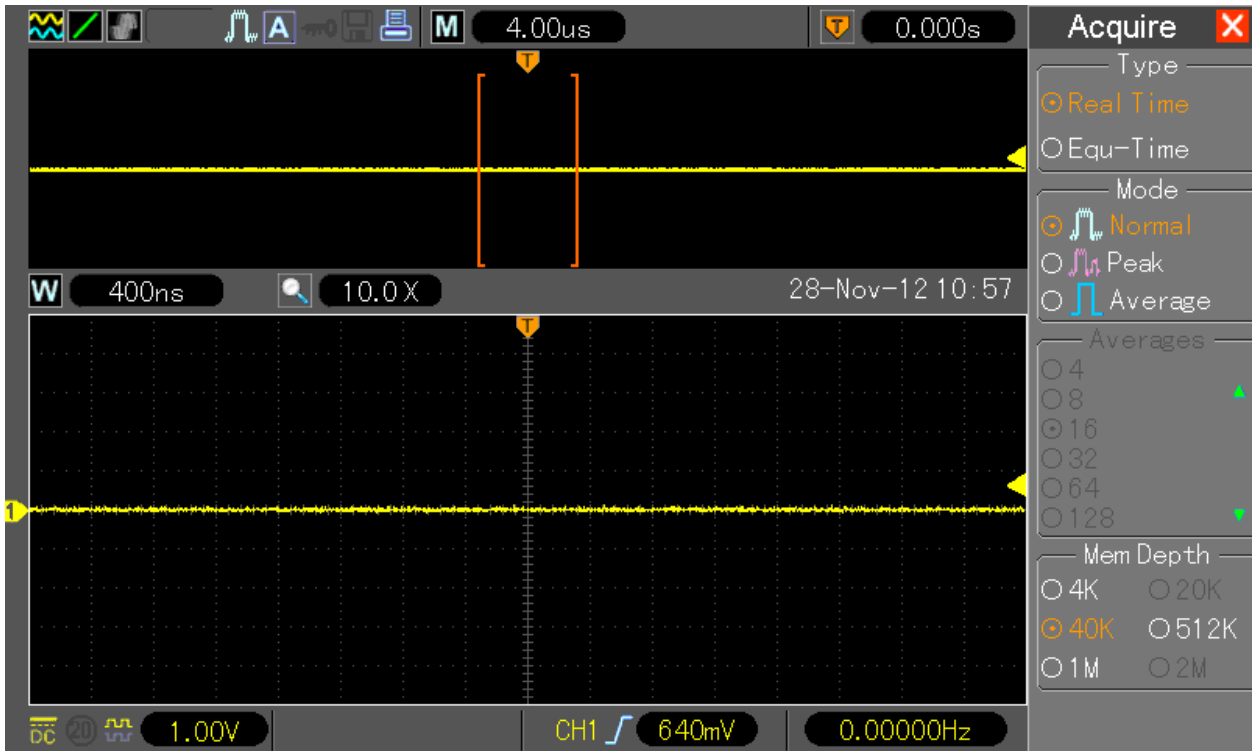
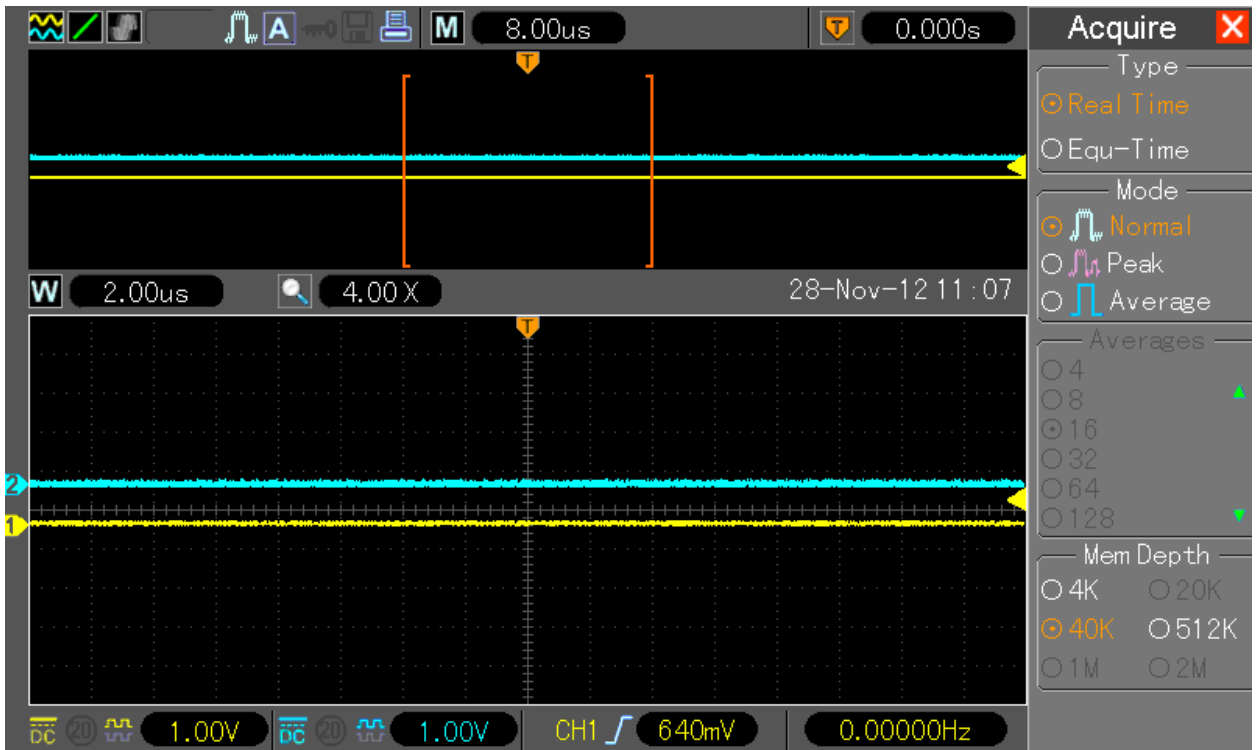
- 26. Main TB not always updating right after dual window enabled. No stability issue at all, scale changing immediately after any control changed. For an interim fw something we can accept as “minor bug”
- 27. While switching from single into dual window mode the main timebase is changing with a wrong factor, e.g. from 200ns/DIV in single into 400ns/DIV in dual window mode. Similar issue in 40k/512k and 1M – in dual window the MTB is twice that high as before in single window mode. Due incorrect timebase the display buffer is showing artifacts on both right and left side of the waveform (end of buffer). Example: CH1 enabled, 40k memory, single window and windows timebase smaller than main timebase, here 400ns/DIV (Main TB is 4us/DIV for 40k)

Now when switching to dual window the Main TB is changing to wrong value (here from 4us/DIV to 8us/DIV – actually it will be always doubled in length) and artifacts from “ned of buffer” right and left in top window are shown:

When the Acquisition could be stopped and restarted or Timebase changed one position forth and back (while Main window is focused) the Main TB and displayed data will be fixed to proper length; no artifacts shown anymore:

With 2 channels enabled this bug **DOES NOT EXIST**, this is because the doubled Main TB value is exactly what it should be for dual channel view:

26. Just ignore it for now; it is interim fw version – for testing only.
27. Switch once focus from minor (bottom window) to major (top window) window by pushing timebase knob down, turn then timebase one position fort and back to get rid of waveform artifacts on left and right side of the waveform.

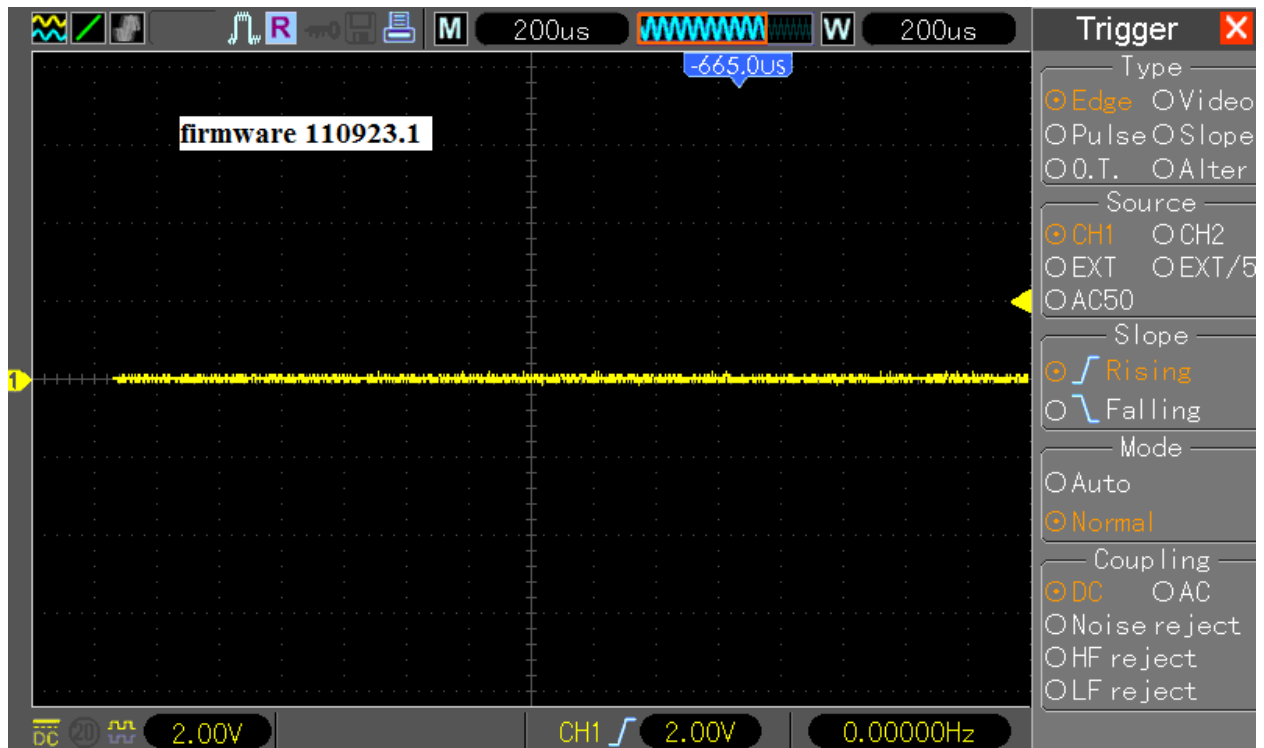
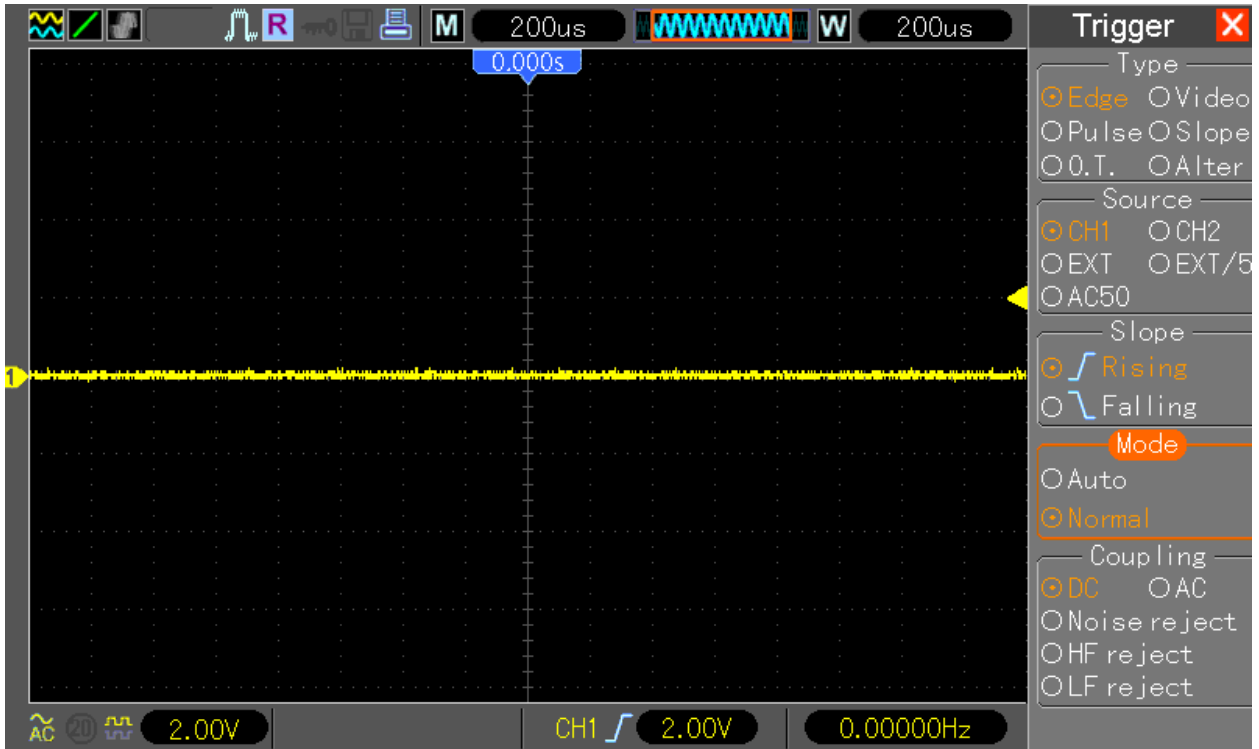
29. Horizontal Position knob not moving display data. Set Trigger to “Normal” – when DSO not triggered the waveform/horizontal screen position cannot be changed. Once triggered it changing rapidly. Another example – set trigger to Single Seq and Auto , while trigger in “R” (ready) mode waveform/horizontal screen position cannot be moved. Again, once triggered it change rapidly. **In firmware 110923.1 this was working! :**

but since few firmware version not anymore working (same condition, Horizontal position knob already turned few times but no move on screen):

Generally, bug 29 and 30 have something to do (in my opinion) with the fact that screen data is dependent on trigger. You can easily see the difference e.g. in cursor, while moving them with no trigger (e.g. normal mode, trigger level above signal level) the cursor is working just fine.

Maybe it would be good idea to remove the trigger event link from screen refresh (why is this linked together anyway? It cannot be necessary for the firmware because older versions never had this bug).
