Firmware 2.06.3 bug list:

List of bugs/improvement requests

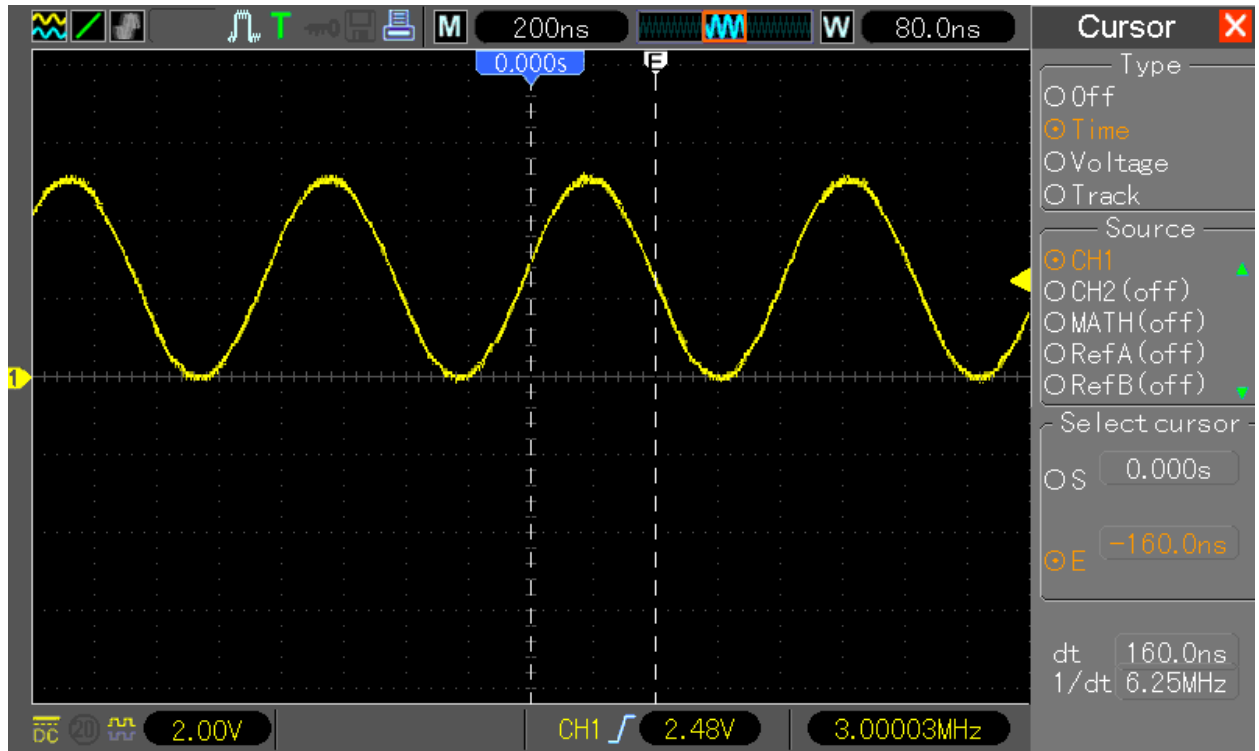
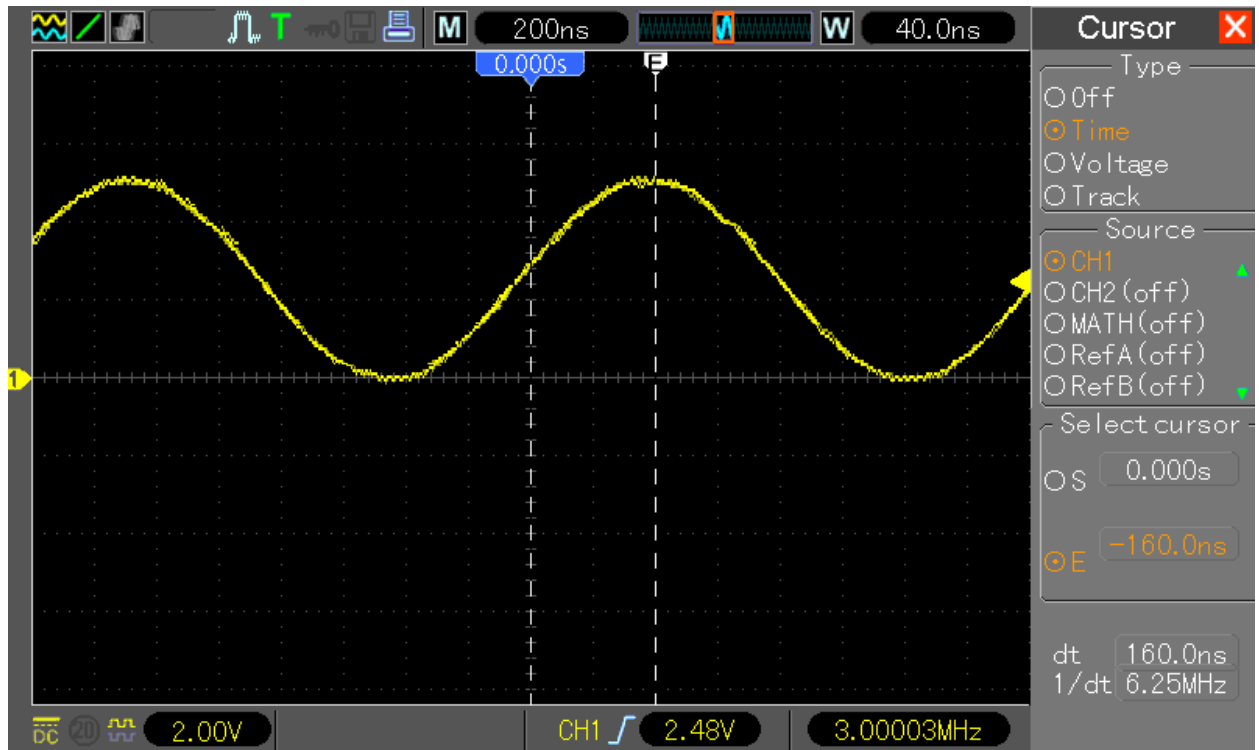
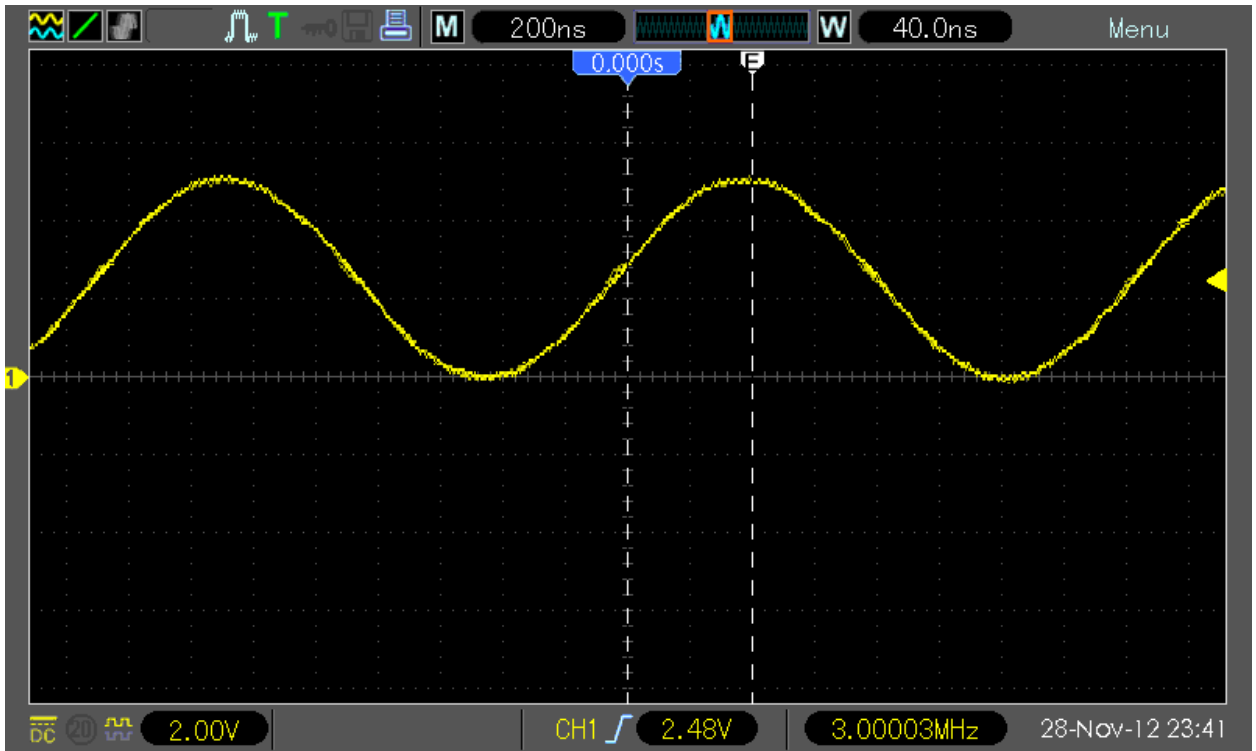
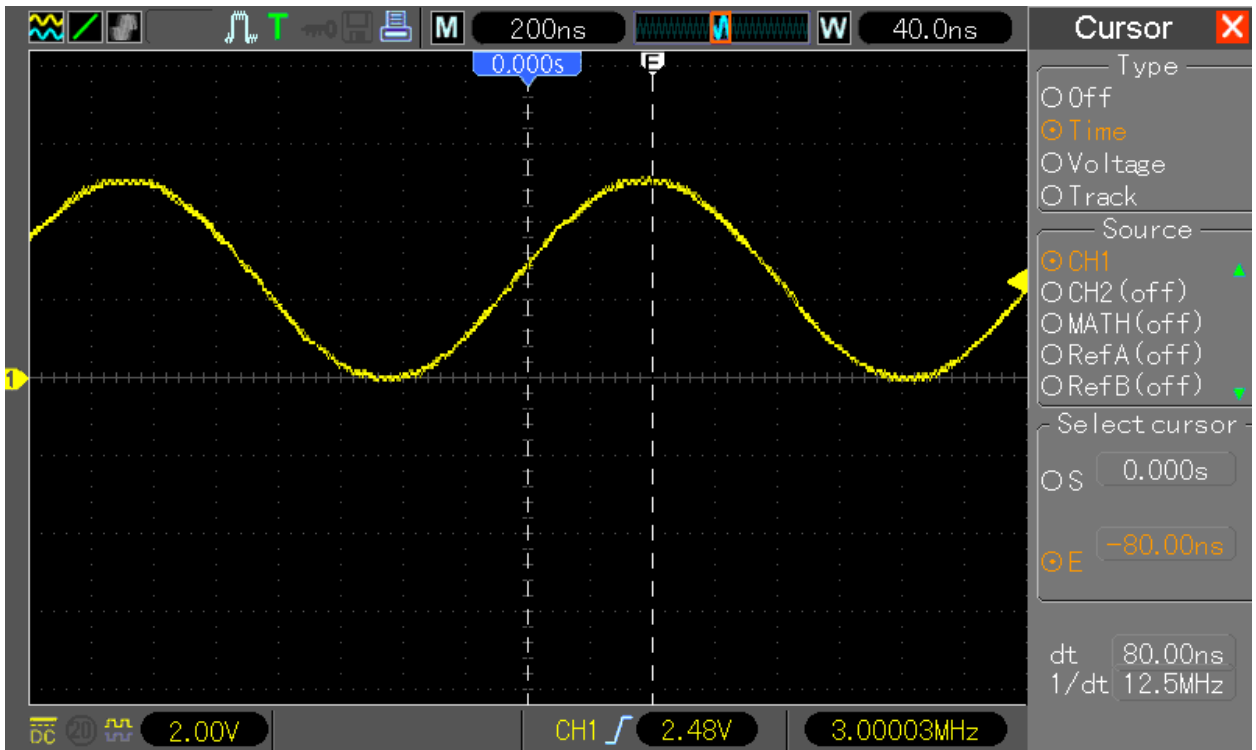
31. In RUN and STOP mode, while changing Timebase the Time Cursor values S and E not refreshing automatically. Any changes to Menu (hide/show with F0), other Knobs (like V0) position or any Buttons (e.g. push Measure button and again Cursor button) is refreshing the S and E values in Menu.

Here example, TB set to 80ns/DIV, cursor S to 0.0ns and E to -160ns:

Then TB changed to 40ns/DIV, but displayed value for E still -160ns:

Now disabling Menu with F0:

and enabling Menu again with F0. The E cursor value is now having proper value (-80ns):

This was working properly the last time in firmware 110923.1
