## Firmware 2.06.3 bug list:

## List of bugs/improvement requests

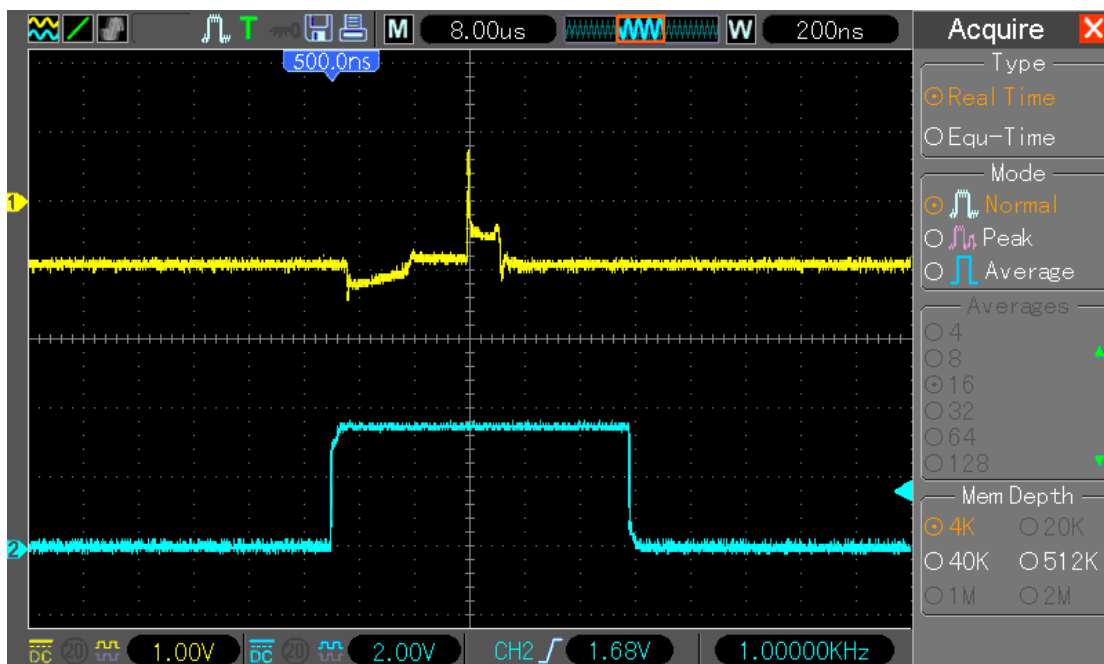
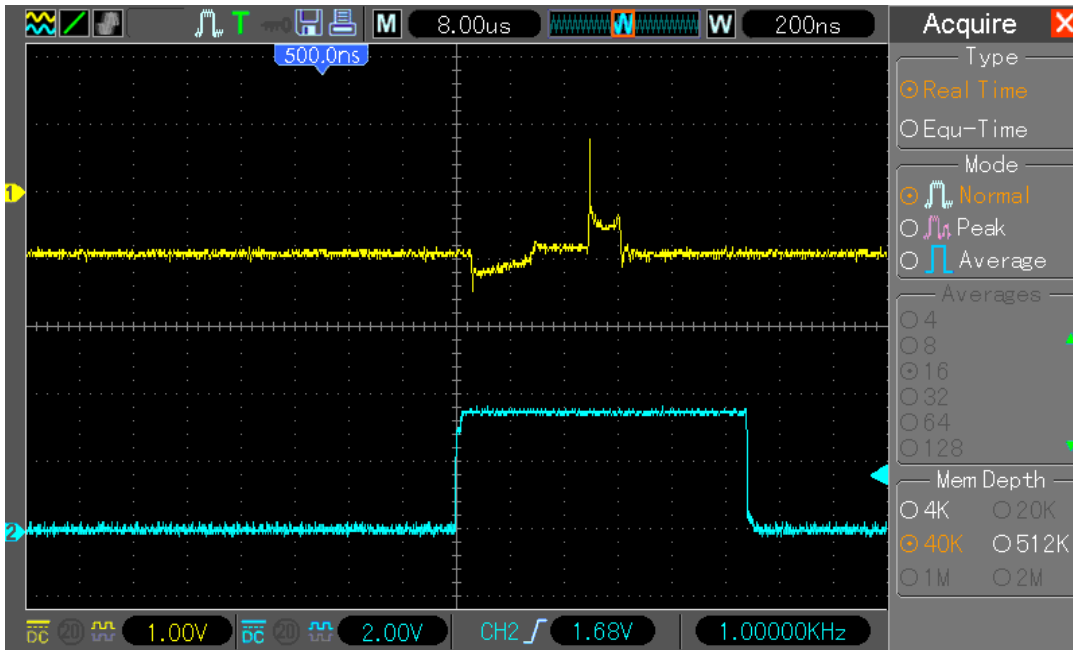
8. In single window, sample memory  $\geq 40k$ , both channels (ch1, ch2) enabled and time base from 400ns/div up to 2ns/div the position change (fine and coarse) control is not working. Only scale is moving, but not the waveform. See attached picture to understand issue:

with 4k memory when changing position waveform is moving

with 40k and above, when moving changing time base position waveform is NOT moving when in RUN mode (but works in STOP mode)

7. This is improvement proposal and not a bug. It has been removed from to-do as “not important”.
8. **This is a very unfortunate bug; possible workaround is to use dual window mode or less memory depth (both with disadvantages)**

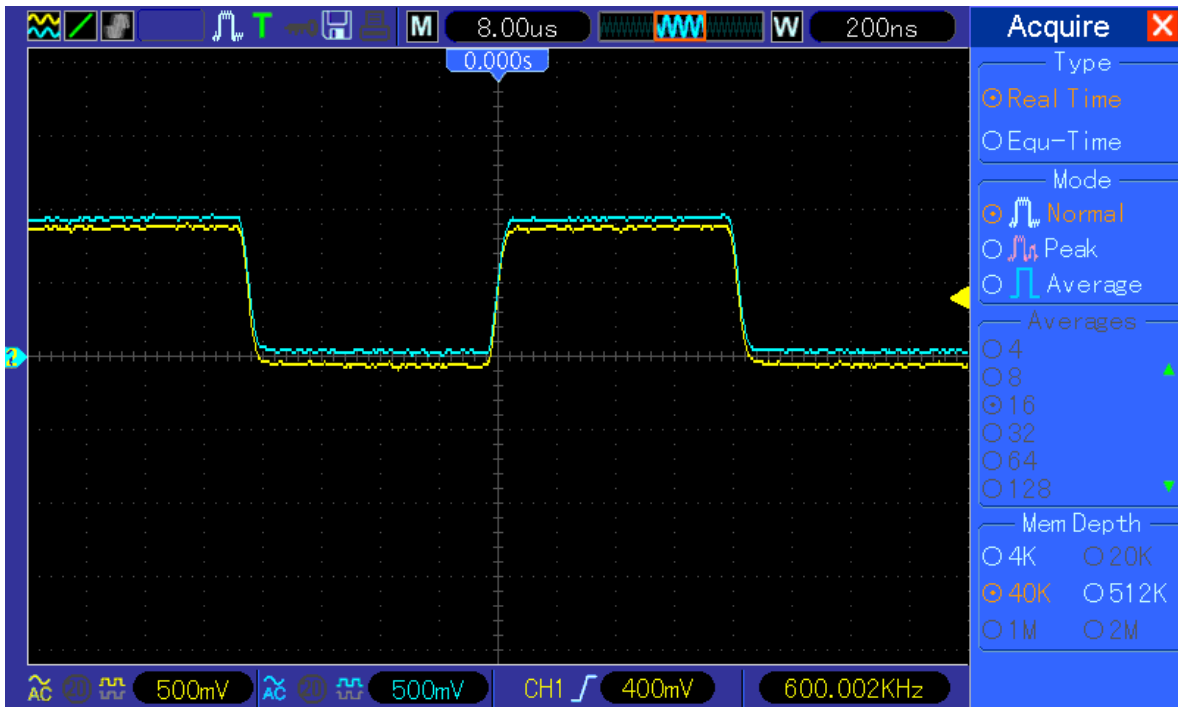
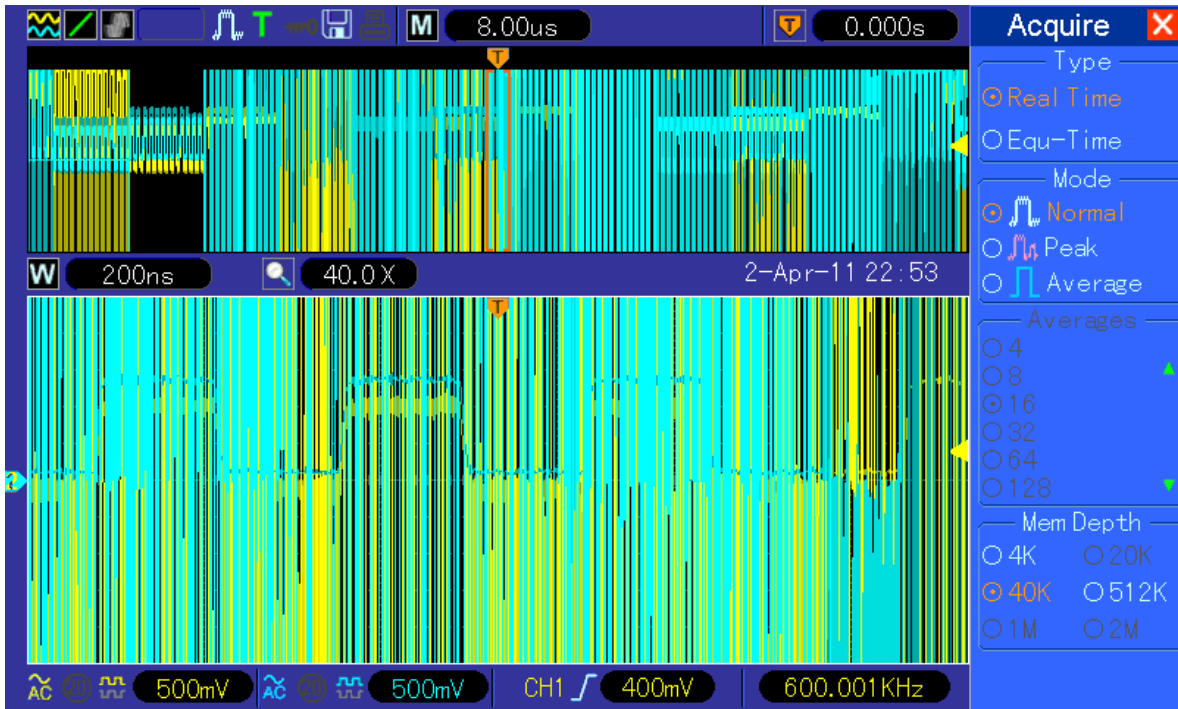
9. In single window mode, sample memory 40k, both channels (ch1, ch2) enabled – while switching to dual window mode artifacts on screen and DSO later crashing and not responding.

**Artifacts disappear when changing timebase just after switch to dual window, so just an init error?**

Set like on picture

and switch dual window mode to see artifacts like this:

9. ~~Workaround is to change Timebase (just one step forward and back) right after dual window enabled. Note – the main window (top) need to be activated, the bug have something to do with main TB buffer initialization.~~

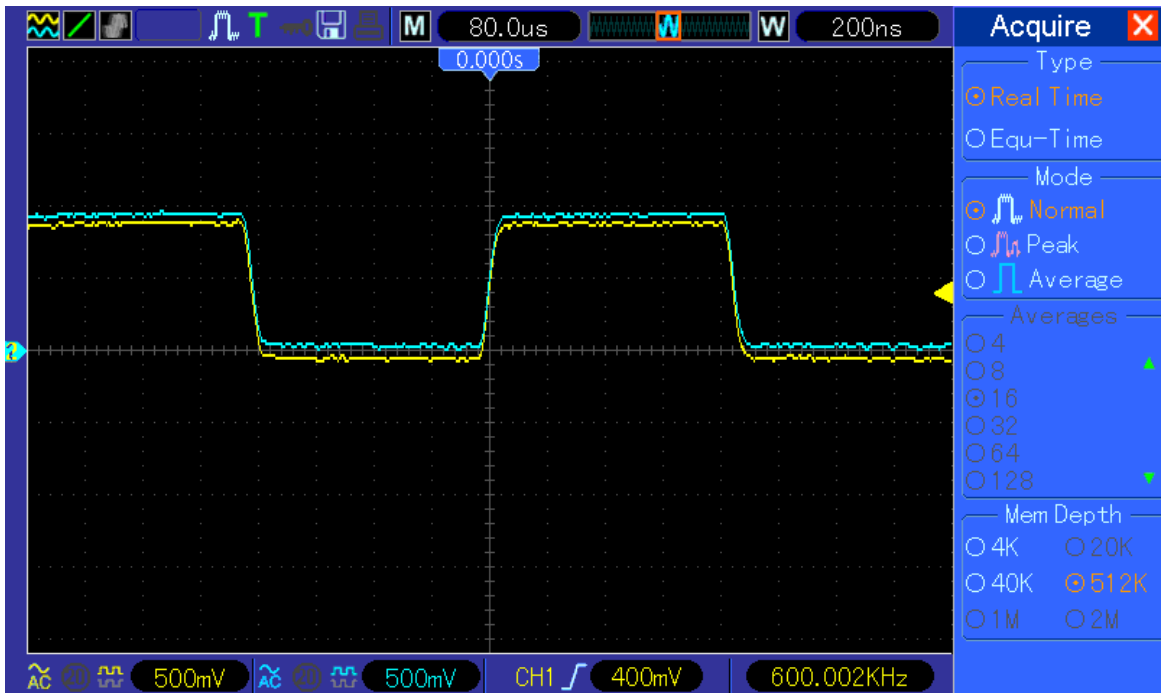
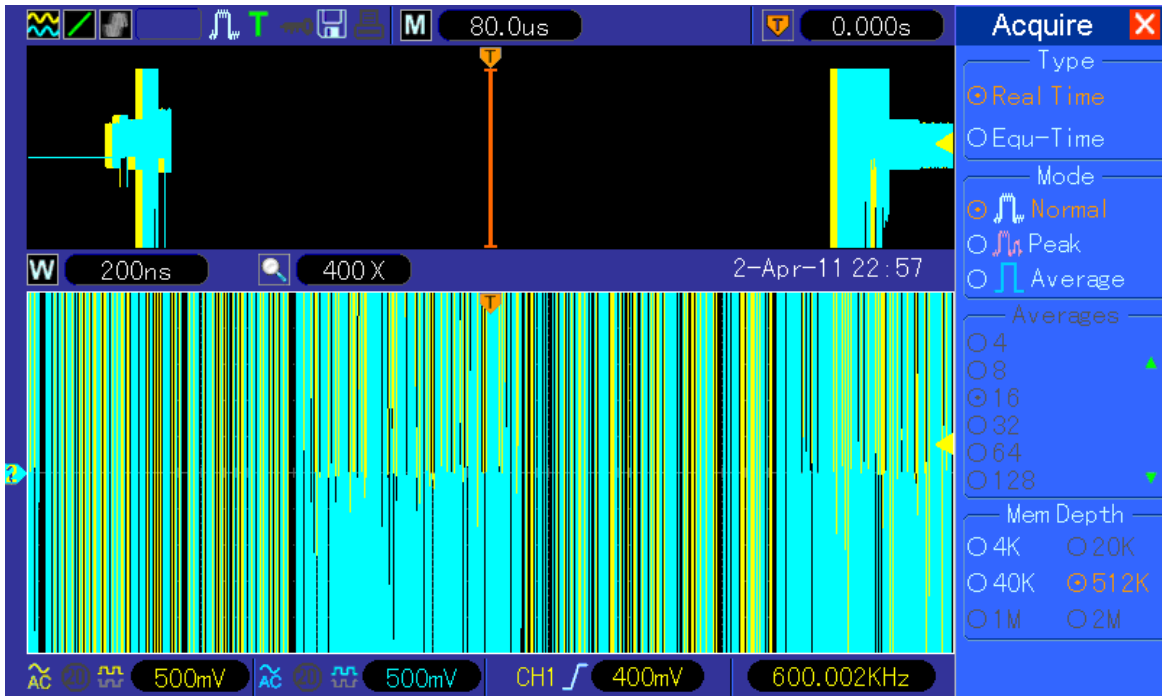
10. In single window mode, sample memory 512k, both channels (ch1, ch2) enabled – when switching to dual window mode artifacts on screen and DSO later crashing and not responding

**Artifacts disappear when changing timebase just after switch to dual window, so just an init error?**

Set DSO like on picture

and switch dual window mode to see artifacts like this:

10. Workaround is to change Timebase (just one step forward and back) right after dual window enabled. Note — the main window (top) need to be activated, the bug have something to do with main TB buffer initialization.
11. This is improvement proposal and not a bug.
12. Use my firmware (2.06.3\_120507.6), I removed that bug.
13. Use DC trigger coupling or “add offset” when you set trigger point. On some other good known DSOs (e.g. Tektronix TDS7xxx) there is exact the same DC-signal/AC-trigger “dependency” (bug) and nobody ever complained about.

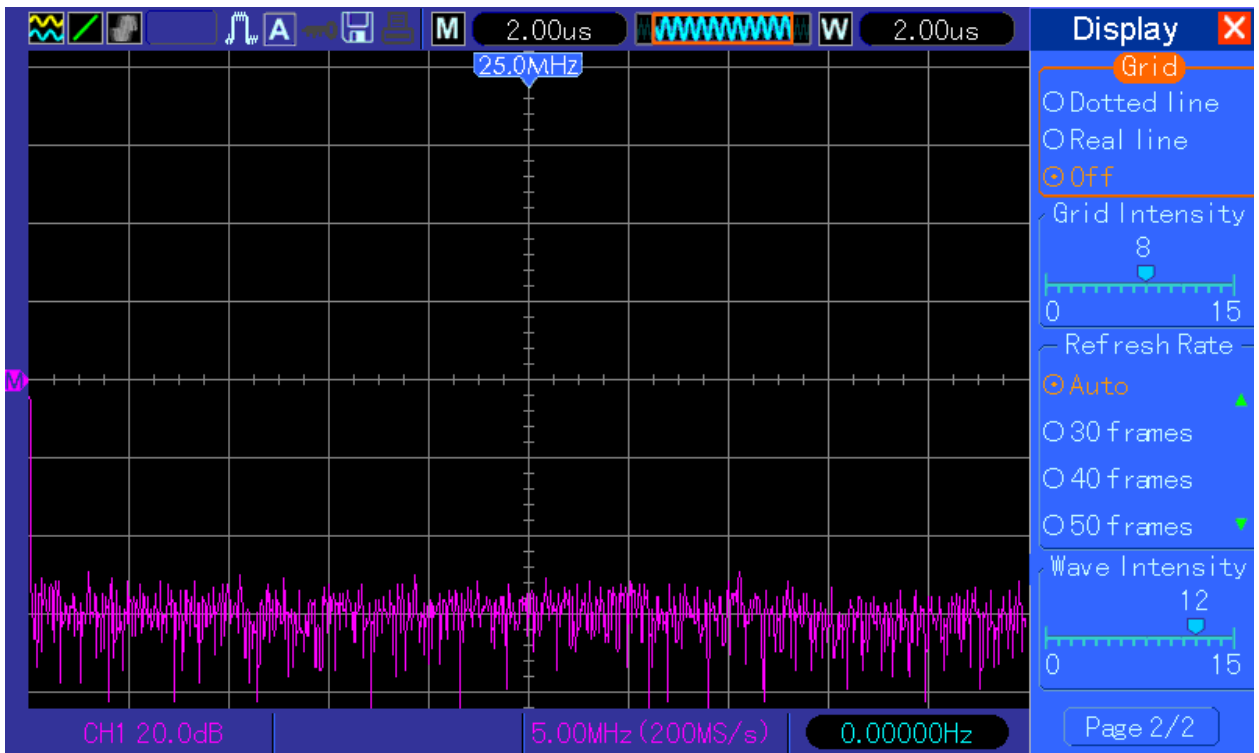
11. In FFT mode the Display -> Grid option is not changing the grid, it is always “real line” and not possible to change to “dotted line” or “off”.

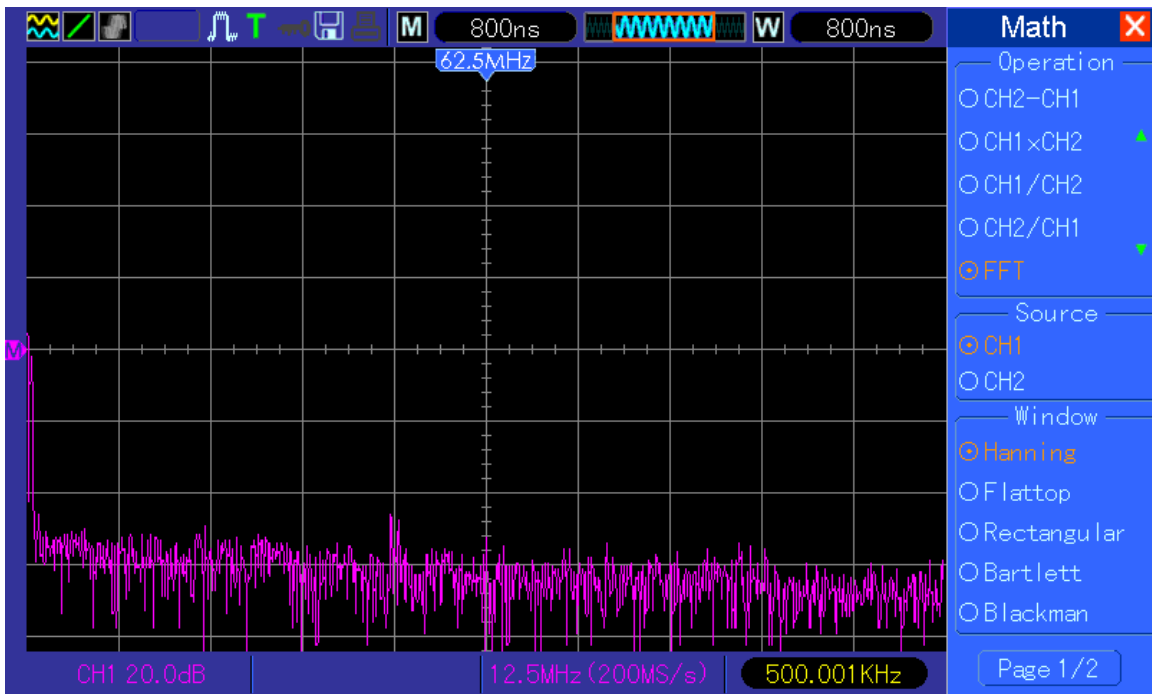
12. In FFT mode “Full span” is higher than Nyquist (sample rate / 2 )  
 Example: 800ns/DIV, sample rate is 200MSs, full span 125MHz. Easy to fix by enabling from

800ns/DIV to 20ns/DIV 1GSs sampling (when 4k memory or FFT enabled)

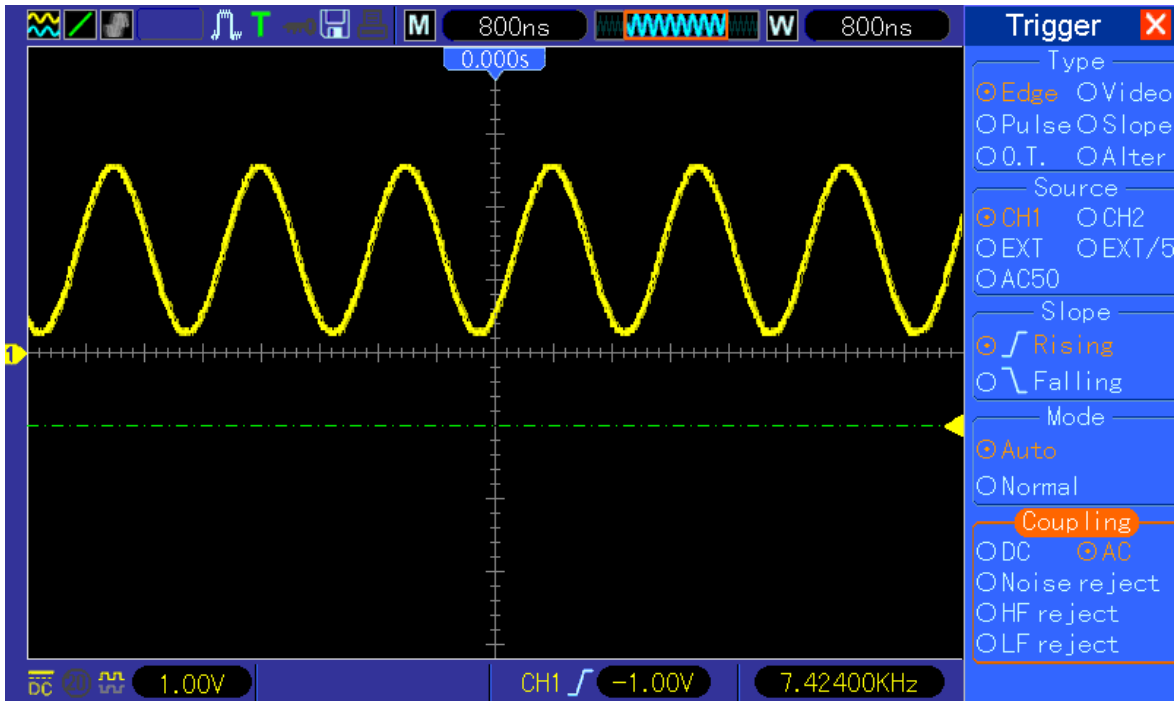
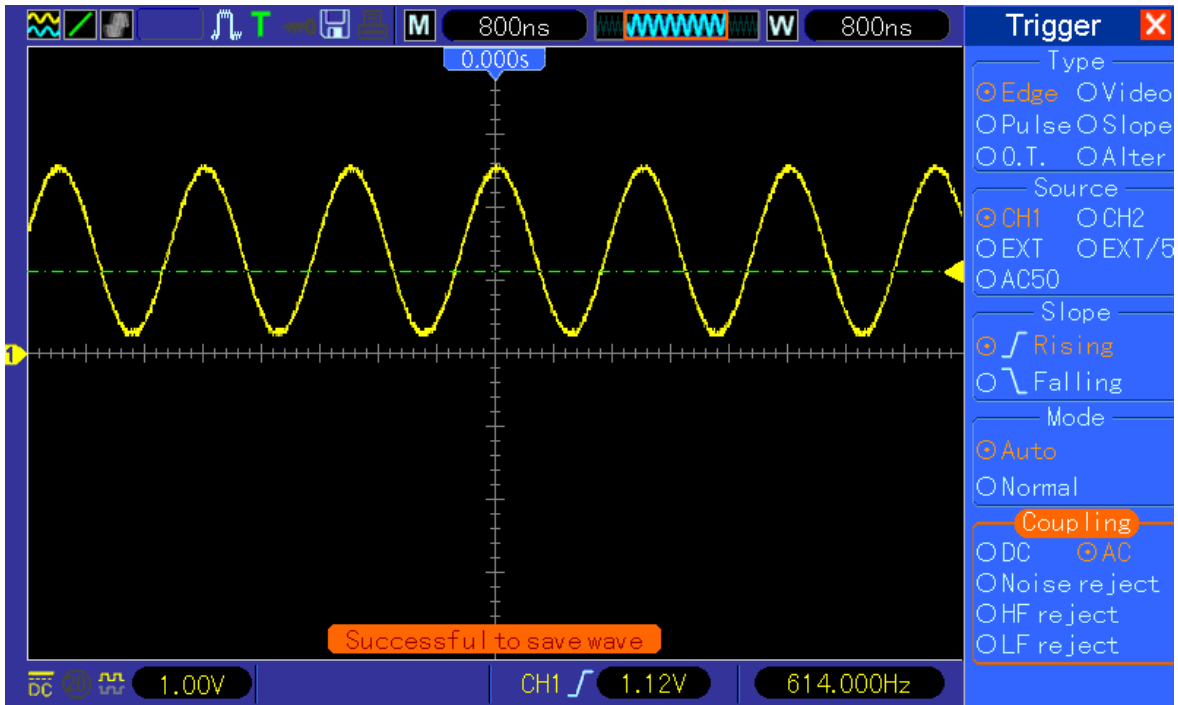
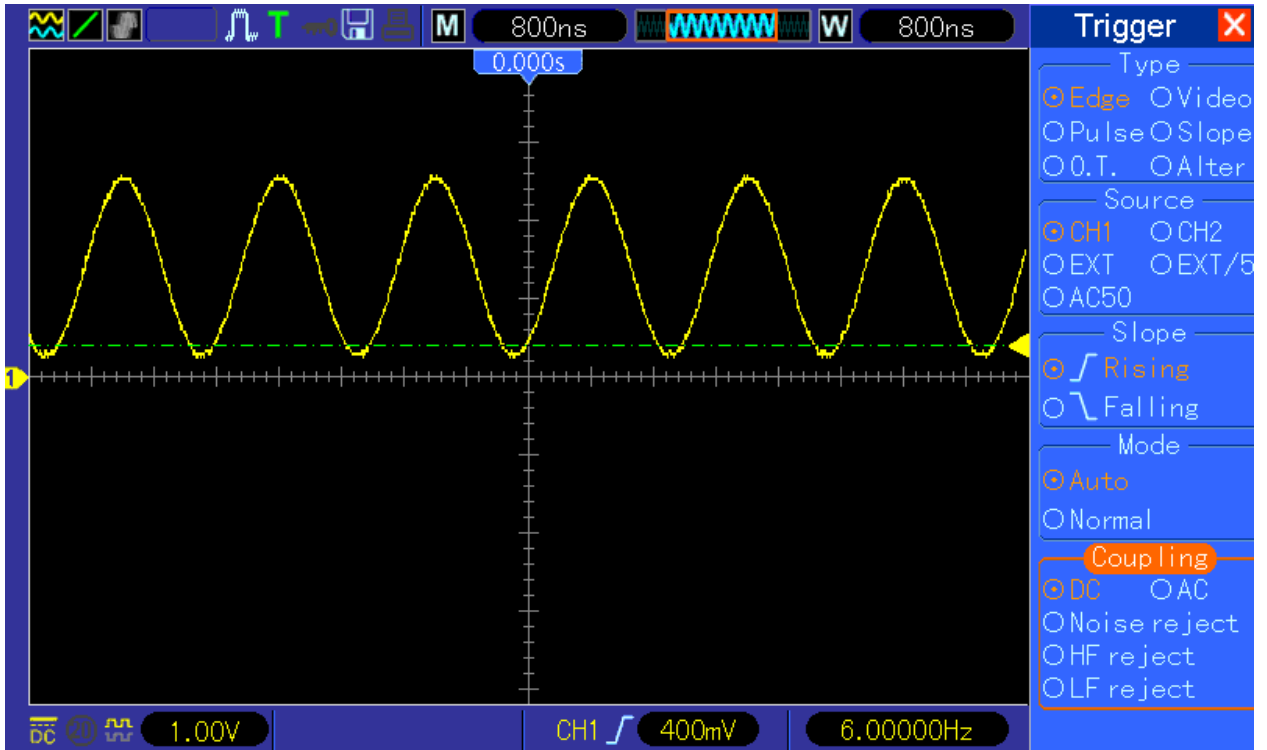
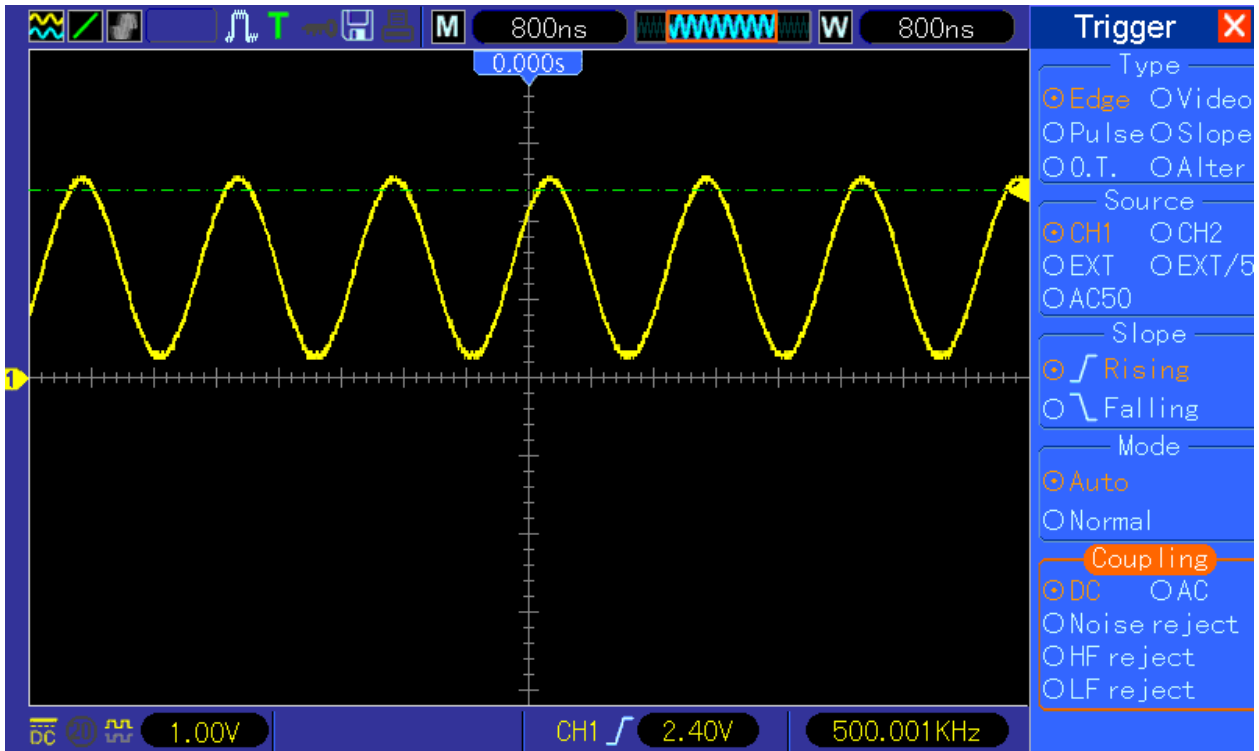
13. AC trigger indicator and line wrong. Set ch1, signal DC coupled, trigger AC coupled. The trigger lowest level below signal :

highest level only mid of signal

But both should look like when trigger coupled in DC mode:

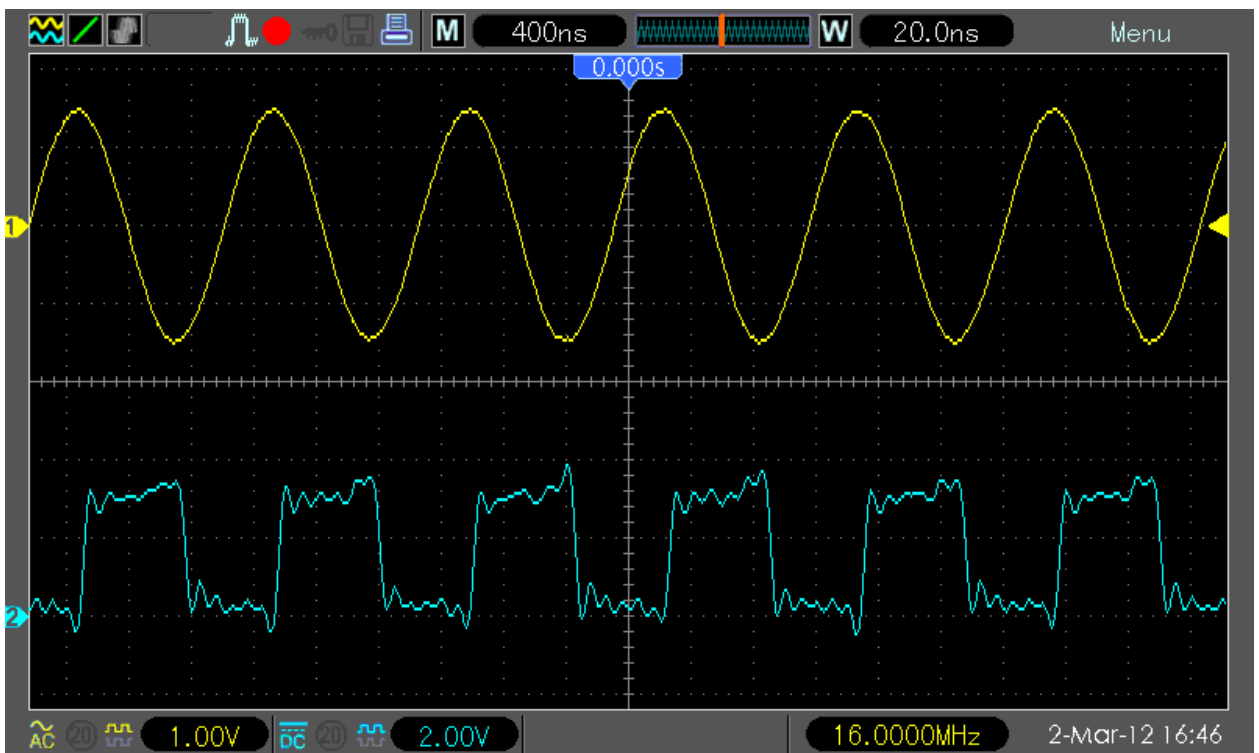
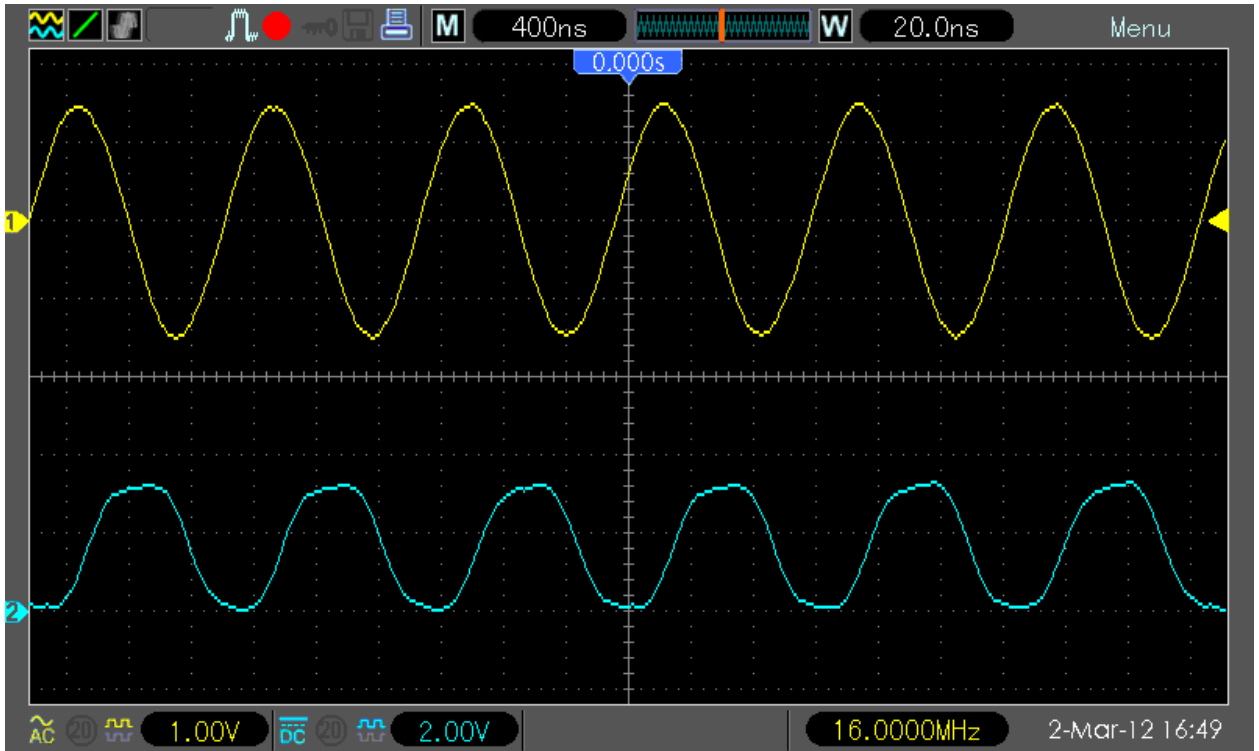
14. Dithering/interpolation filter of waveform too sharp. When enabling both channels (this also occurs in single channel mode and 1GSs, but test signal need to be higher to get same error) and applying for example 16MHz square wave the waveform is switching between proper square:

and crippled square every second:

14. For sure a stupid bug, but since you can see when the signal is “wobbling” you can quick change (when necessary) to single channel to observe the waveform with better resolution and without wobble.
15. Funny bug, but easy to omit since we know it (remember, with higher sample depth there is no issues)
16. This is already fixed, the /dsod (or /dso/app/dsod — this depends on fw/DSO model version) binary is working perfectly as watch dog monitoring potential profile issues.

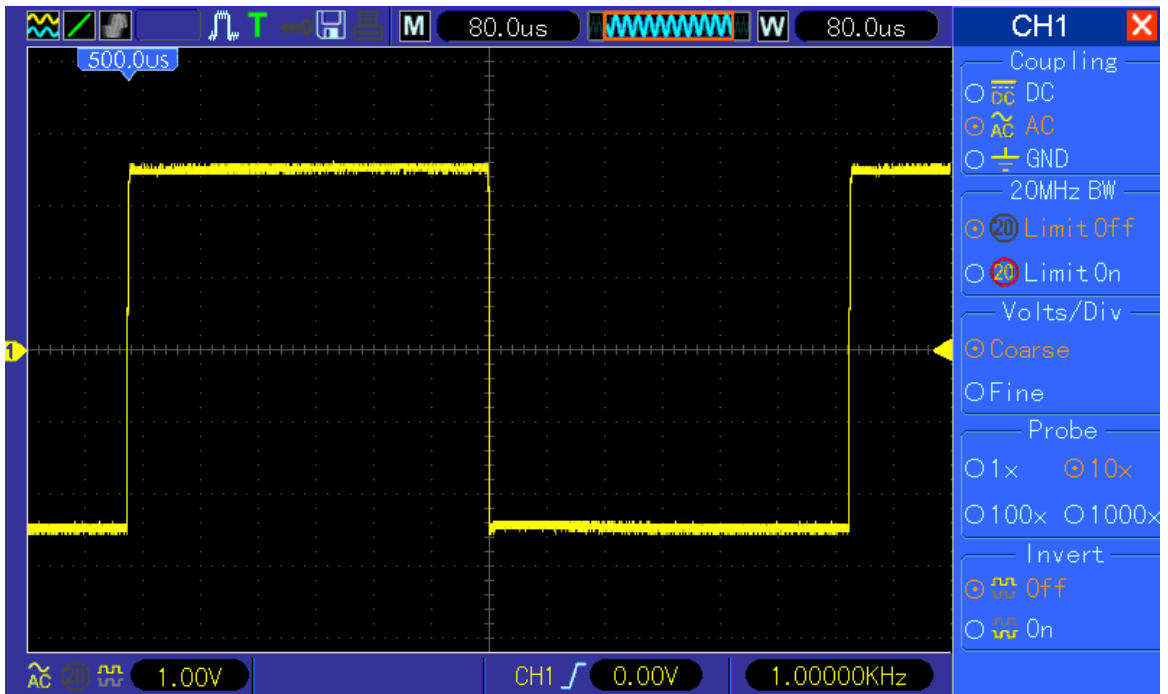
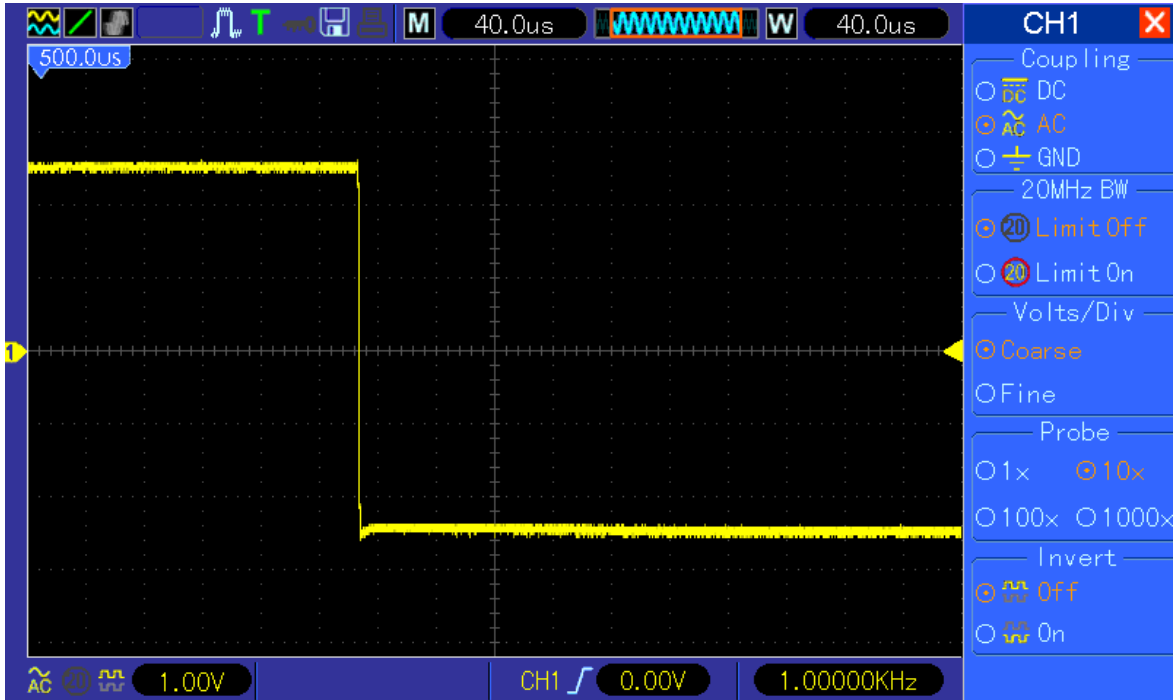
15. Display / Time base scaling strange behavior. When you apply e.g. 1kHz signal, set time base to 80us/DIV and move the waveform to 500us/DIV (bug only in 4/40k memory depth, 512k/1M/2M works fine):

When you now change time base to 40uS/DIV the falling edge (which should be still in the middle of the screen) has been moved to 454uS position (but it should stay on 500uS). The same happens of course with 20uS/DIV.

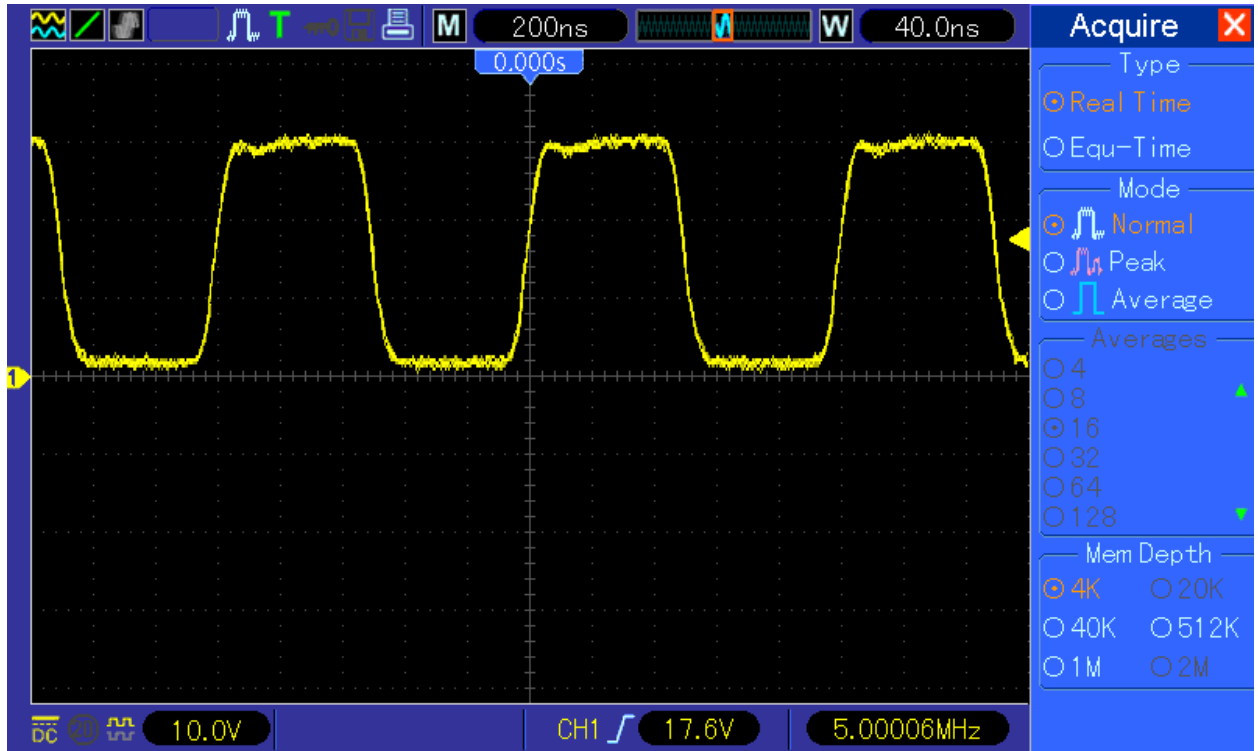
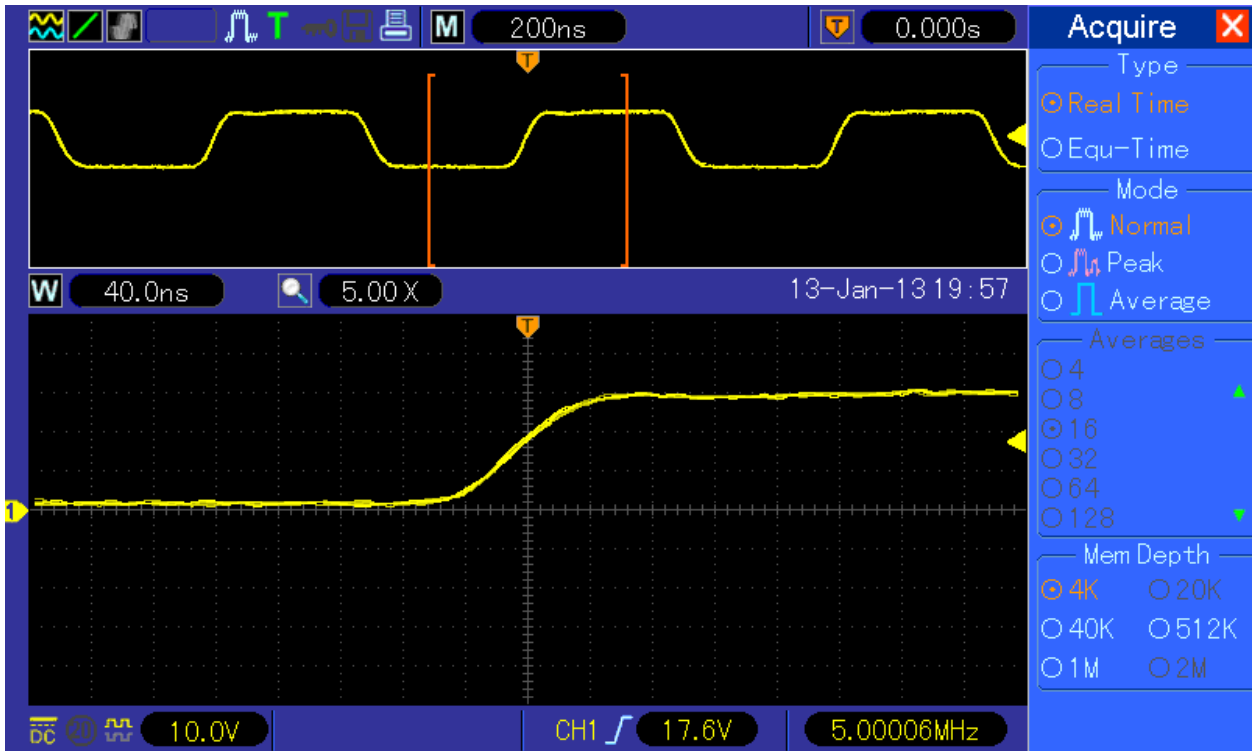
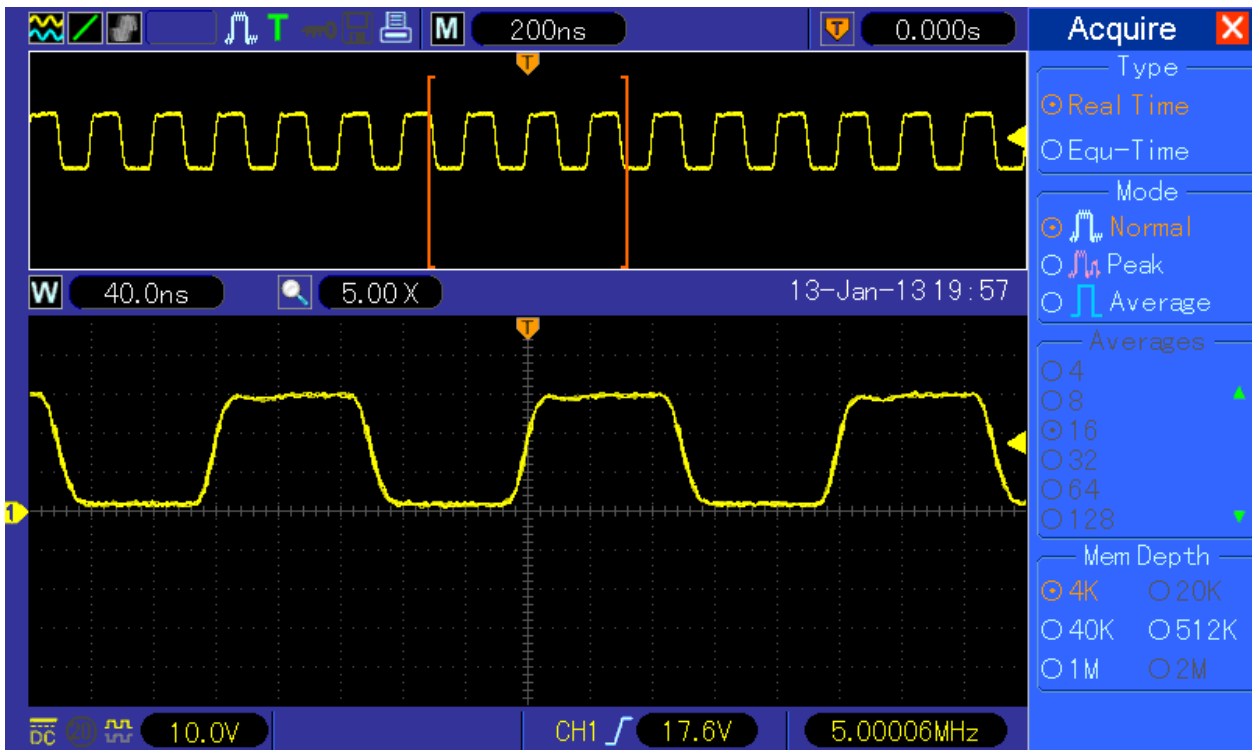
26. While switching to Dual Window (F7) , if  $WTB < MTB$ , the MTB displayed value is not always set properly. **Up to fw 120423.0 it was working properly, in 120808.0 and 121027.0 the MTB scale changed in a completely wrong way (see bug 27), in fw 121208.3 following behavior:**

This seems to be only issue when  $MTB < WTB$ , with  $MTB=WTB$  it does works properly.

Example1: 4k depth, 5MHz signal, 40ns/DIV WTB

now when we change with F7 to dual window the top window is showing wrong scaled waveform, the resulting bottom zoom window showing as well wrong :

when we turn now the Timebase knob one position “up” (200ns/DIV is actually to max “up” position for MTB by 4k depth, but by turning the knob firmware is updating windows) the waveform in top and bottom window is properly scaled:

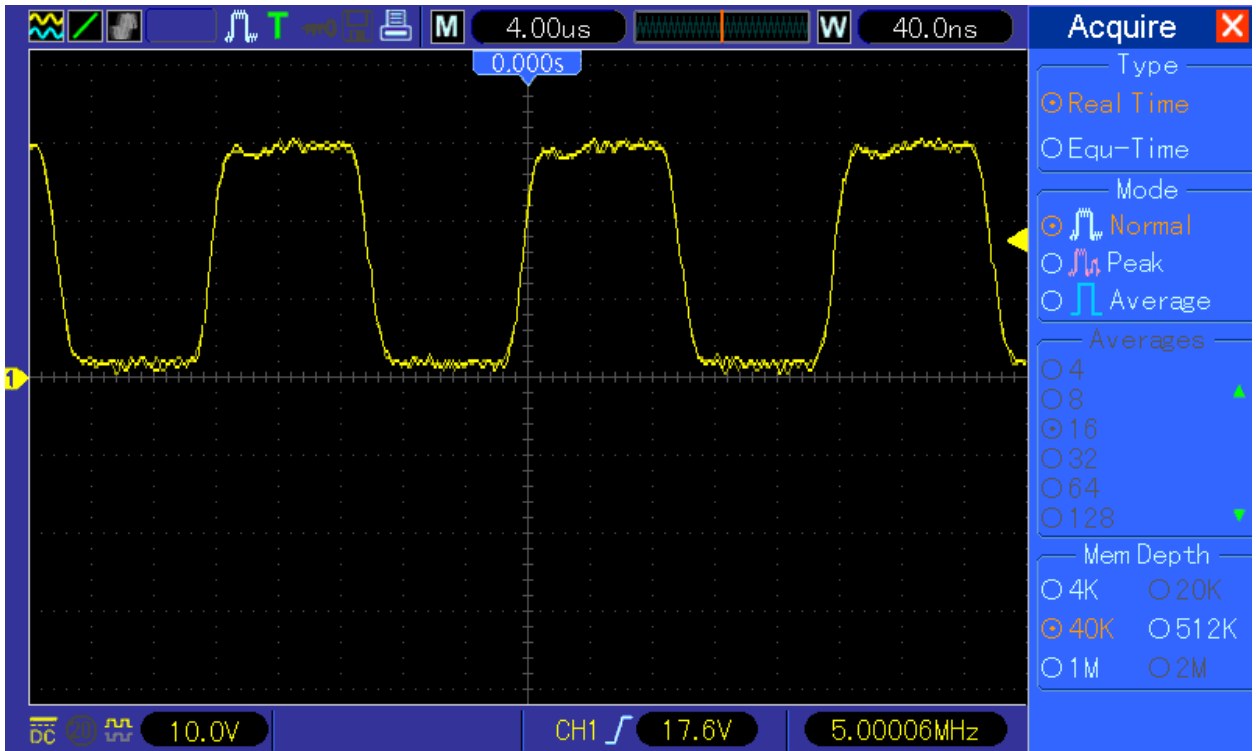
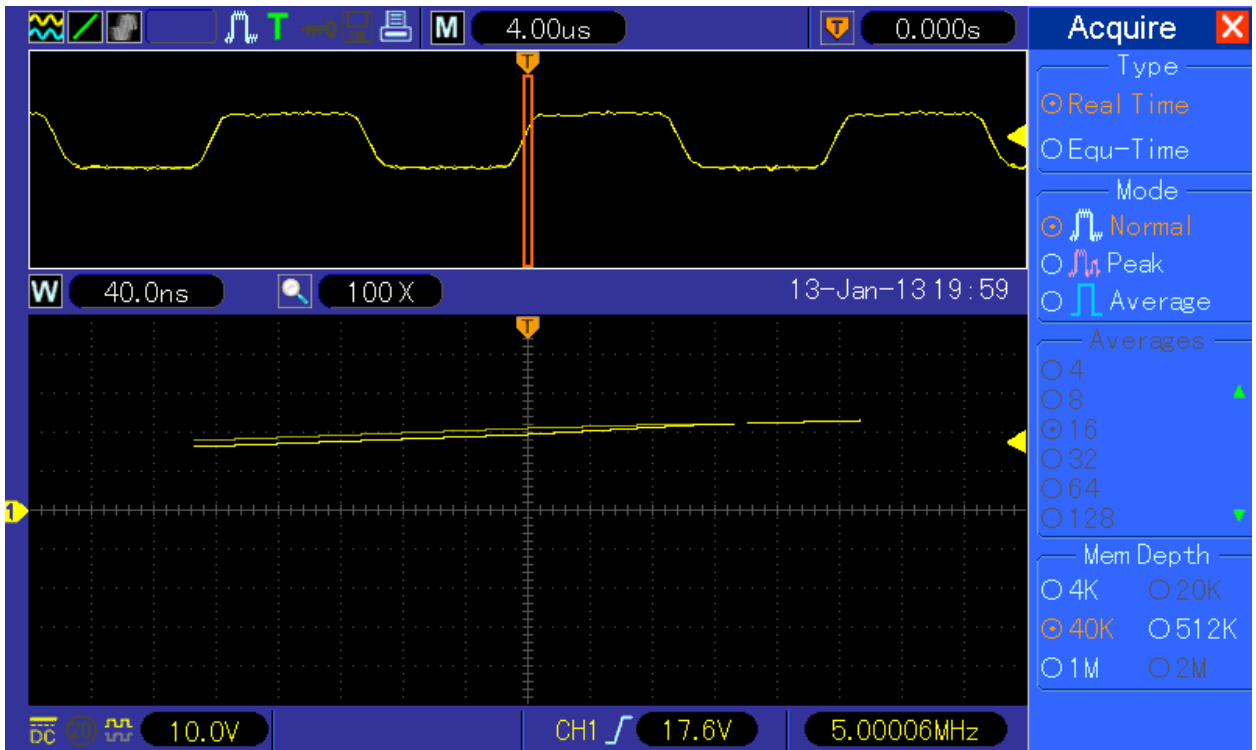
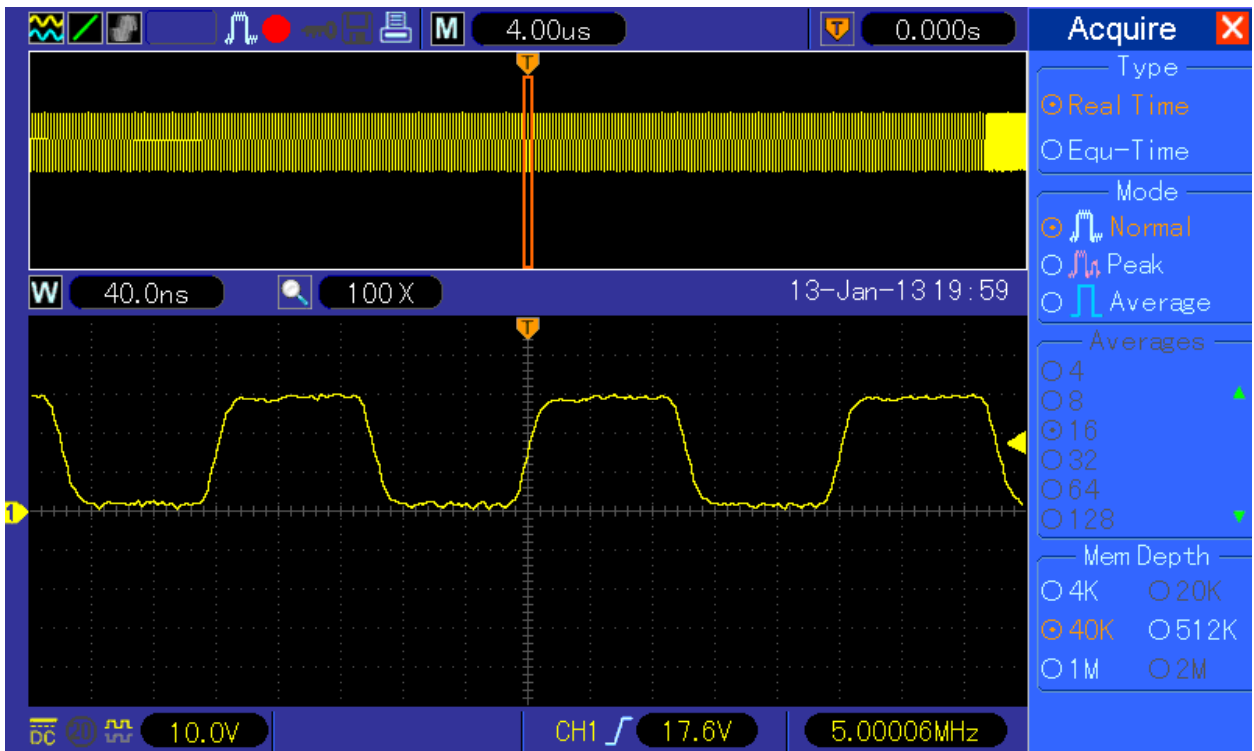
Example2 : 40k depth, 5MHz signal, 40ns/DIV WTB

now when we change with F7 to dual window the top window is showing wrong scaled waveform, the resulting bottom zoom window showing as well wrong :

when we turn now the Timebase knob one position "up" (4us/DIV is actually to max "up" position for MTB by 40k depth, but by turning the knob firmware is updating windows) the

waveform in top and bottom window is properly scaled:
