## Firmware 2.06.3 bug list:

## List of bugs/improvement requests

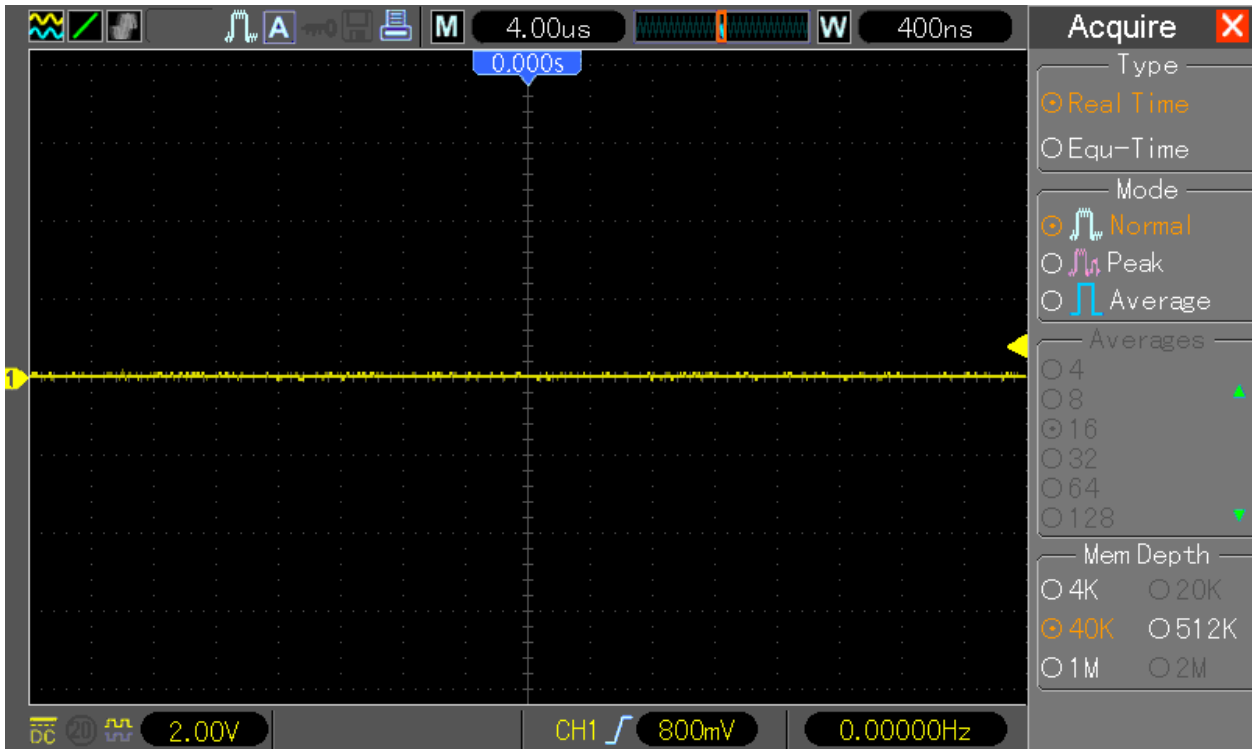
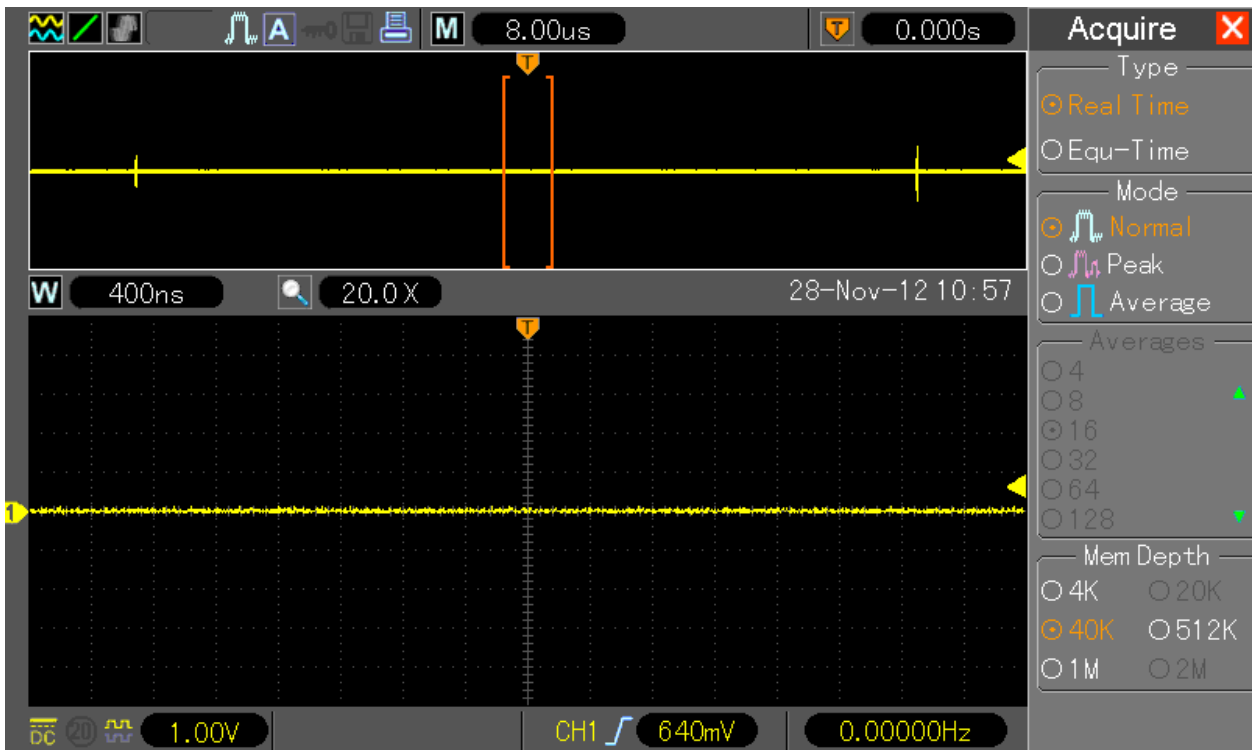
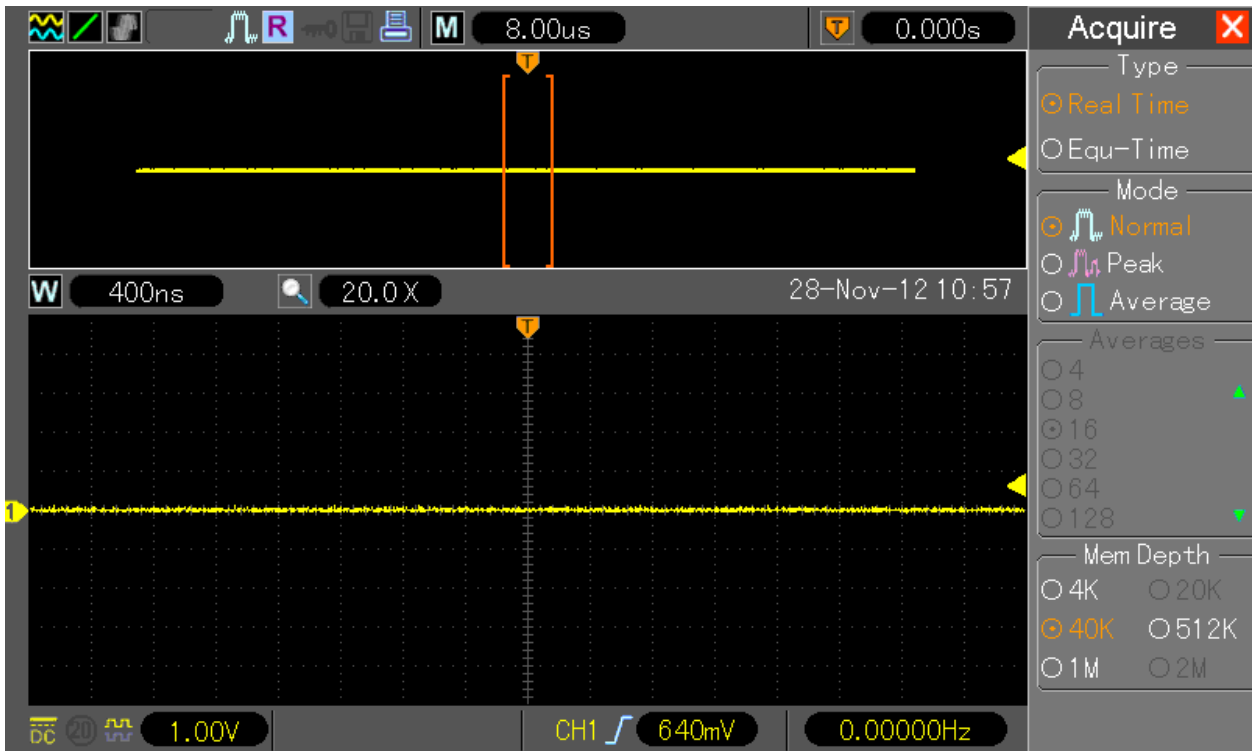
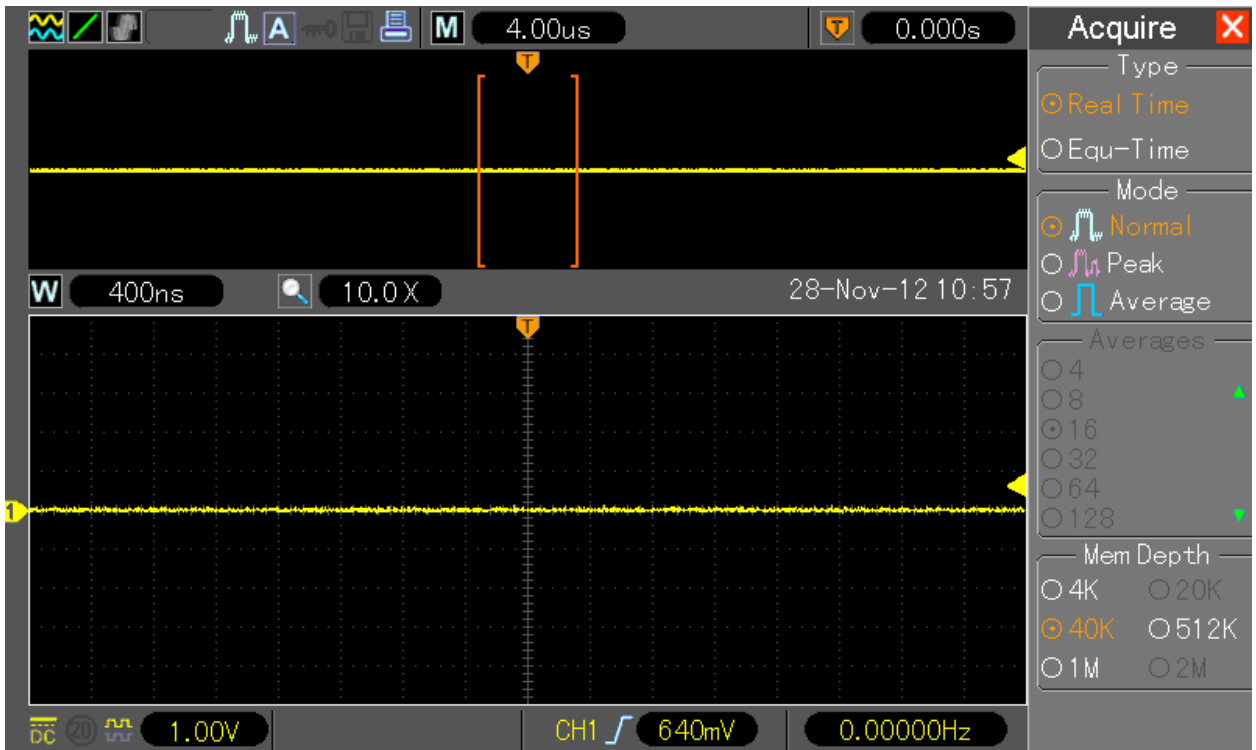
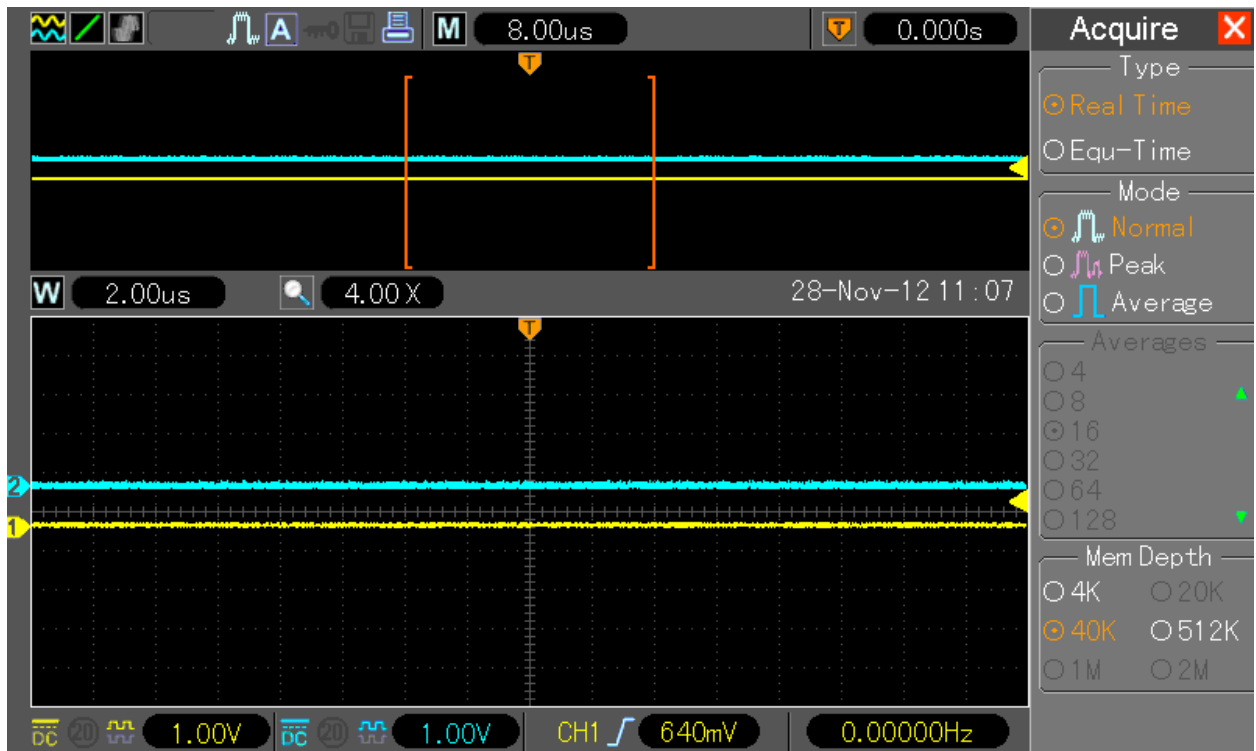
27. While switching from single into dual window mode the main timebase is changing with a wrong factor, e.g. from 200ns/DIV in single into 400ns/DIV in dual window mode. Similar issue in 40k/512k and 1M – in dual window the MTB is twice that high as before in single window mode. Due incorrect timebase the display buffer is showing artifacts on both right and left side of the waveform (end of buffer). Example: CH1 enabled, 40k memory, single window and windows timebase smaller than main timebase, here 400ns/DIV (Main TB is 4us/DIV for 40k)

Now when switching to dual window the Main TB is changing to wrong value (here from 4us/DIV to 8us/DIV – actually it will be always doubled in length) and artifacts from “end of buffer” right and left in top window are shown:

When the Acquisition would be stopped and restarted or Timebase changed one position forth

and back (while Main window is focused) the Main TB and displayed data will be fixed to proper length; no artifacts shown anymore:

With 2 channels enabled this bug **DOES NOT EXIST**, this is because the doubled Main TB value is exactly what it should be for dual channel view:

26. ~~Just ignore it for now; it is interim fw version — for testing only.~~ This is no in production firmware as well, very annoying bug.
27. Switch once focus from minor (bottom window) to major (top window) window by pushing timebase knob down, turn then timebase one position fort and back to get rid of waveform artifacts on left and right side of the waveform.

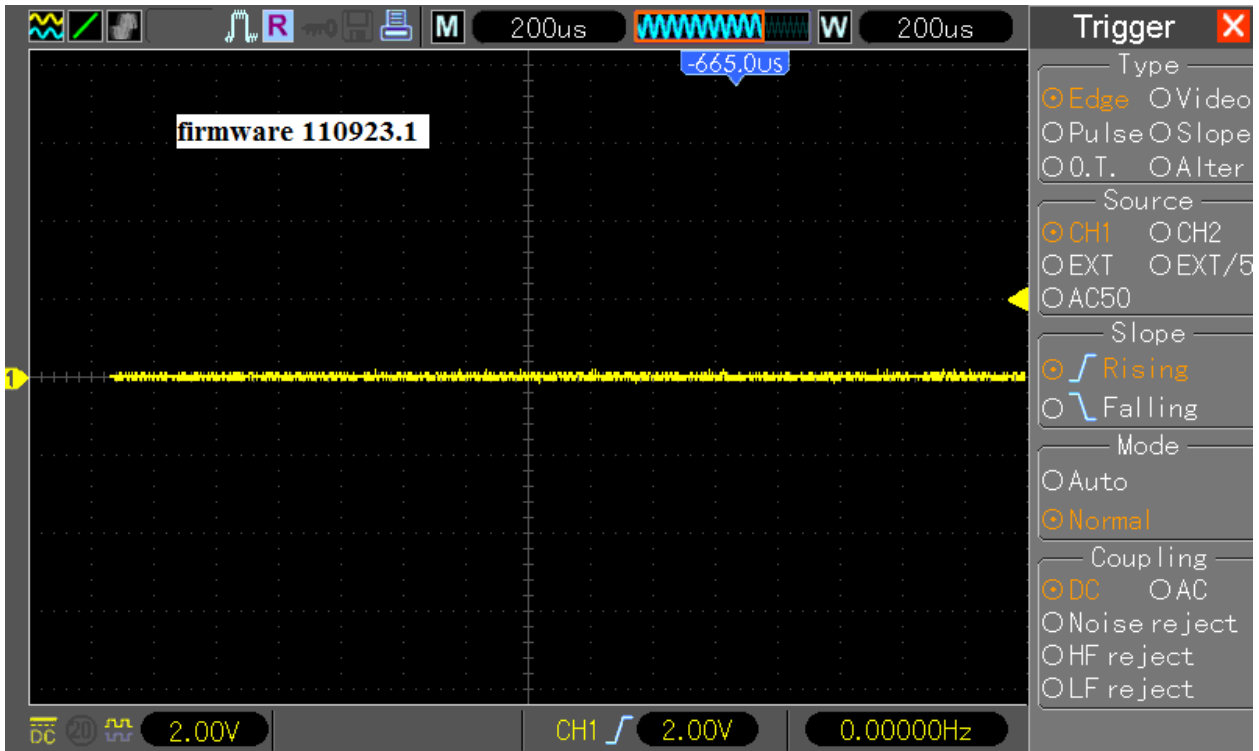
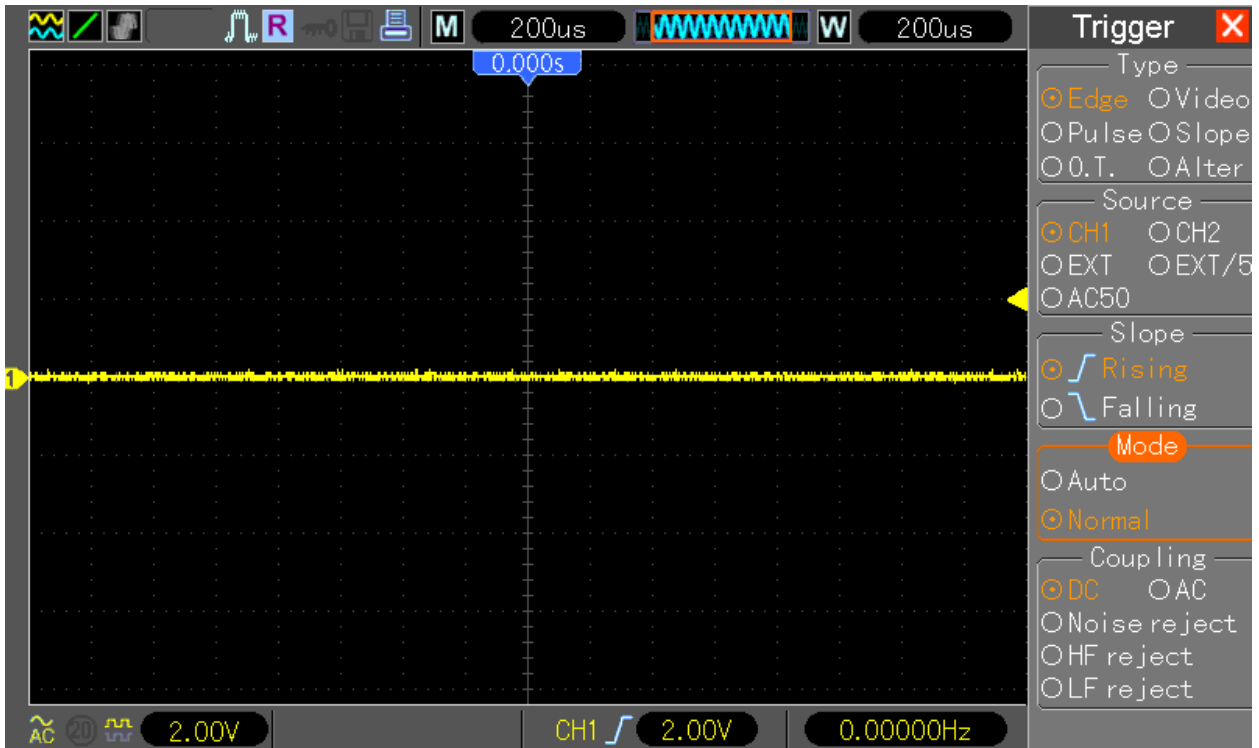
29. Horizontal Position knob not moving display data. Set Trigger to “Normal” – when DSO not triggered the waveform/horizontal screen position cannot be changed. Once triggered it changing rapidly. Another example – set trigger to Single Seq and Auto , while trigger in “R” (ready) mode waveform/horizontal screen position cannot be moved. Again, once triggered it change rapidly. **In firmware 110923.1 this was working! :**

but since few firmware version not anymore working (same condition, Horizontal position knob already turned few times but no move on screen):

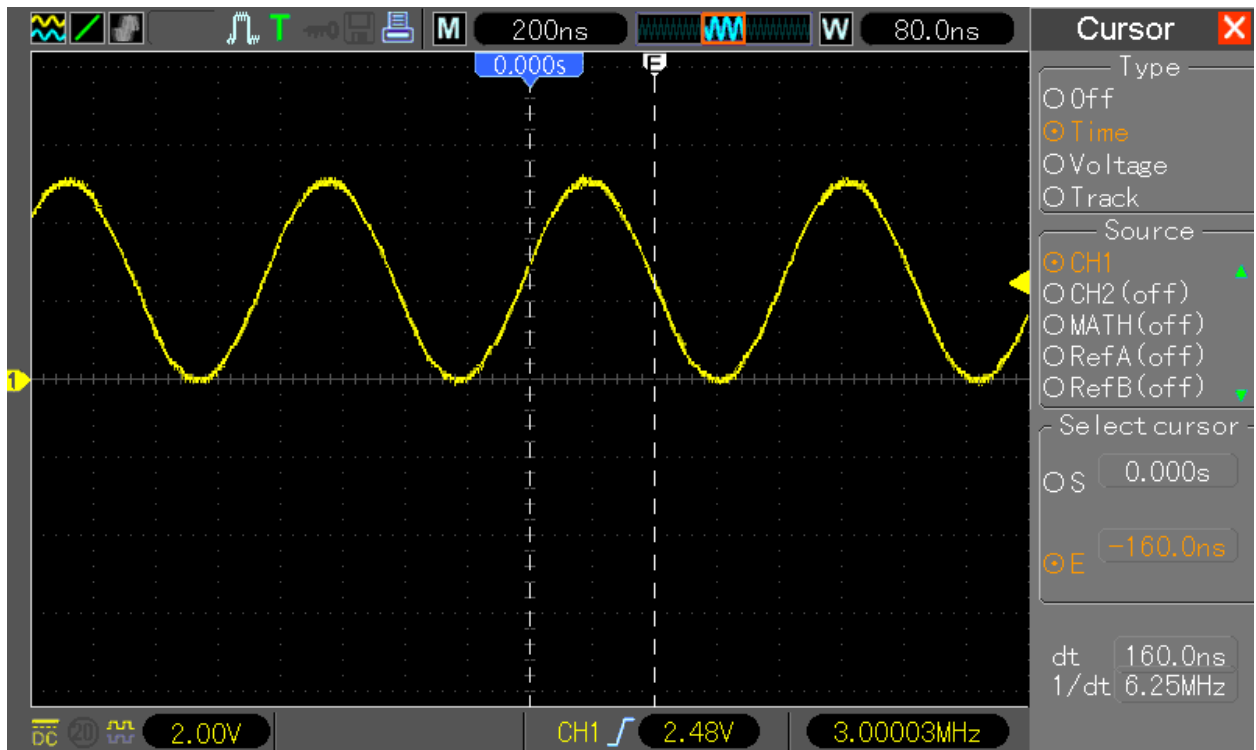
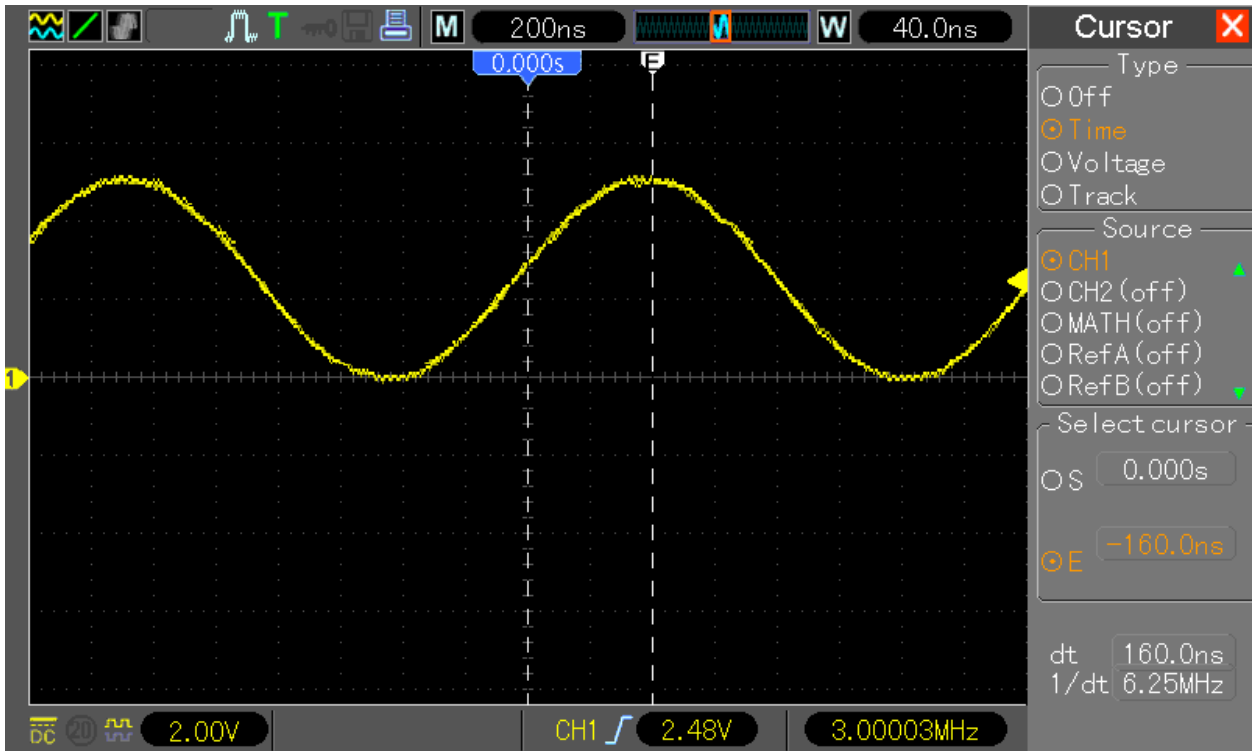
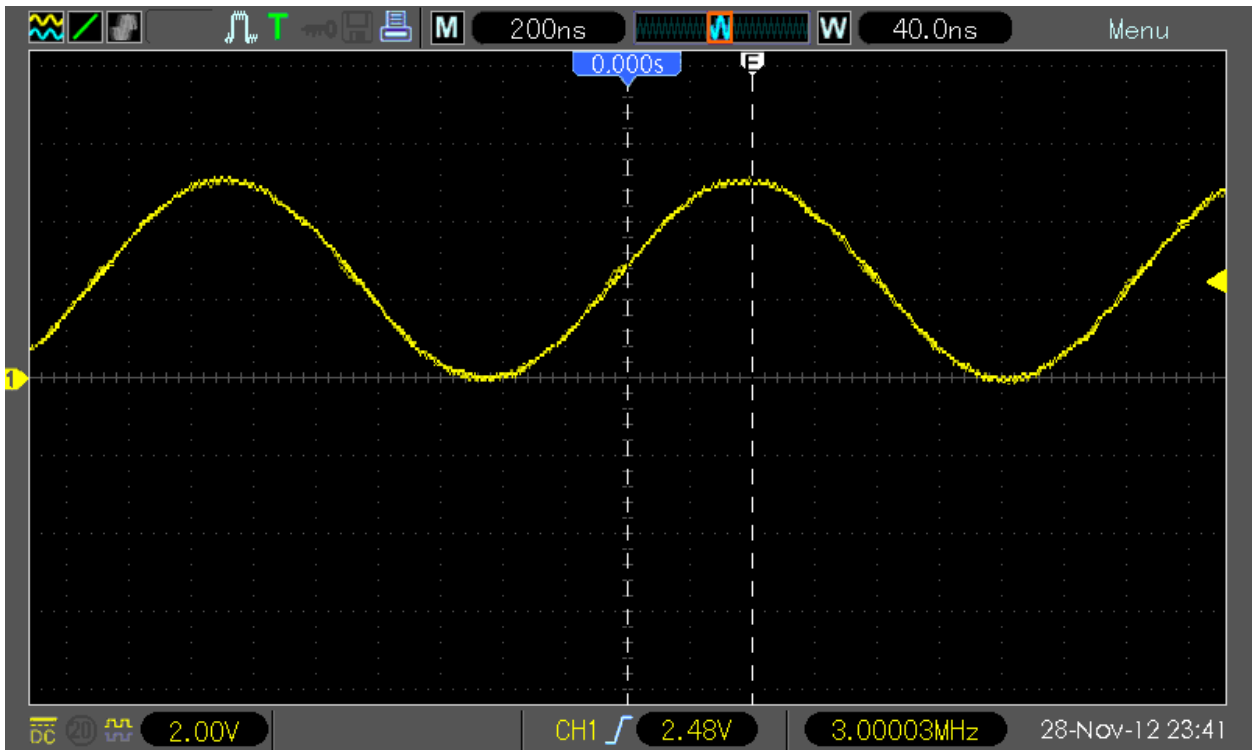
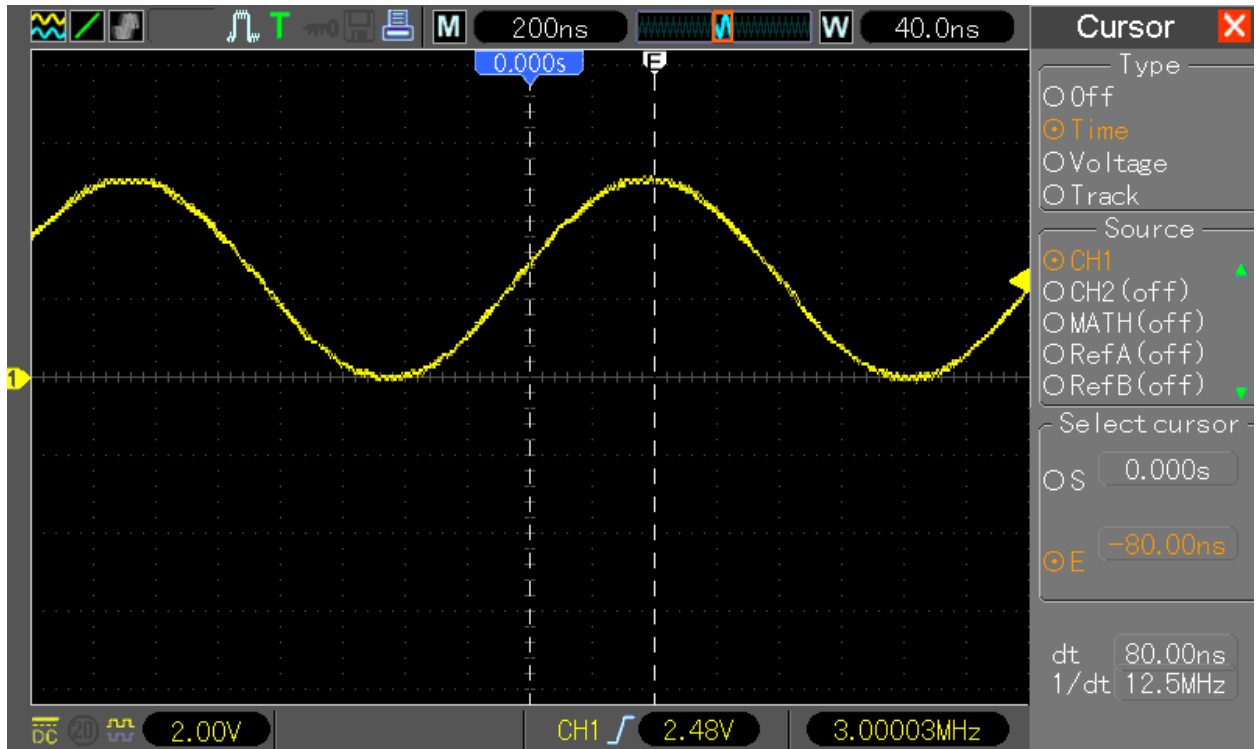
31. In RUN and STOP mode, while changing Timebase the Time Cursor values S and E not refreshing automatically. Any changes to Menu (hide/show with F0), other Knobs (like V0) position or any Buttons (e.g. push Measure button and again Cursor button) is refreshing the S and E values in Menu.

Here example, TB set to 80ns/DIV, cursor S to 0.0ns and E to -160ns:

Then TB changed to 40ns/DIV, but displayed value for E still -160ns:

Now disabling Menu with F0:

and enabling Menu again with F0. The E cursor value is now having proper value (-80ns):

This was working properly the last time in firmware 110923.1

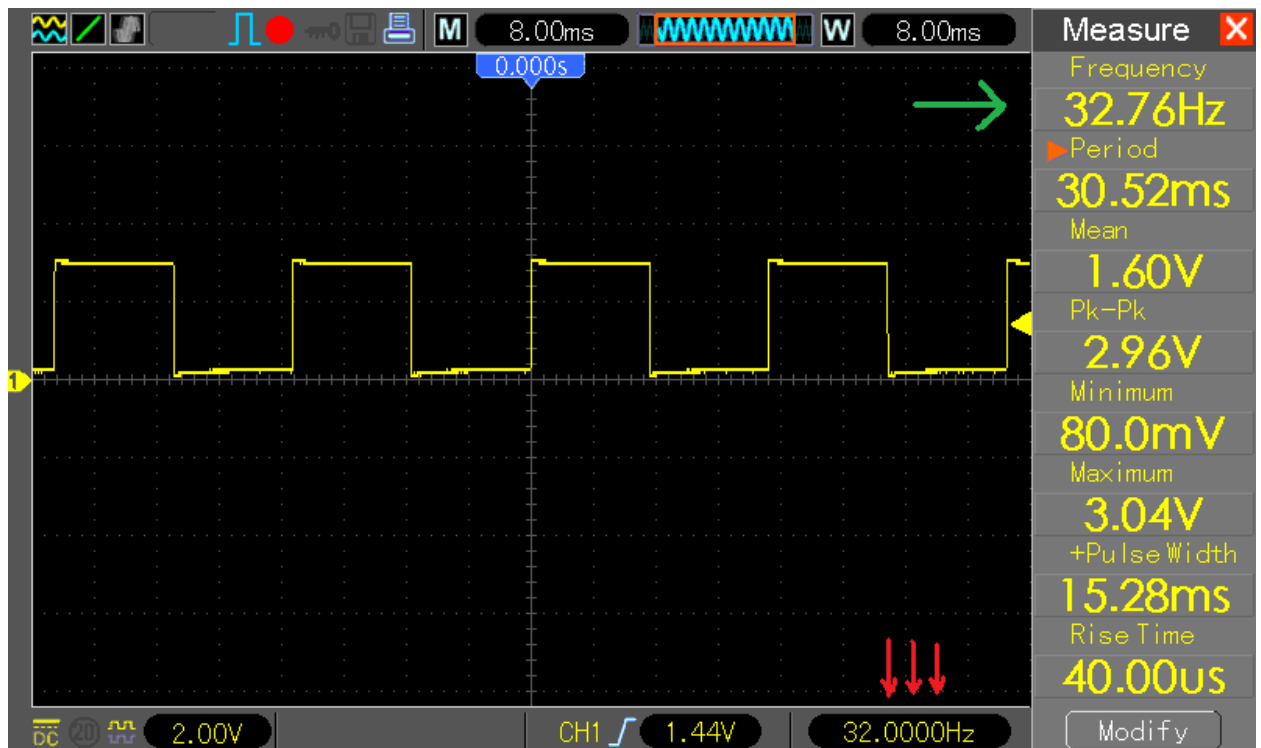
36. If possible change the Frequency Counter to display in mHz resolution when counter value between 1Hz and 99.999kHz (99999Hz). If not possible change displayed value to cut (trailing) zeros, when there is no mHz no need to see zeros instead (e.g 10Hz should be shows as 10Hz and not 10.0000Hz). This might be sometimes very confusing for the user, imagine e.g. frequency of 32.768Hz – the counter will show 32.000Hz (and Wave measure 32.76Hz).

36. Not a bug, but who need to see trailing zeros?
37. Turn Timebase knob one position forth and back.
38. This is funny bug, isn't?
39. Turn Timebase knob one position forth and back, in most cases the Sampling Rate within FFT will be then updated to proper value.
40. ~~Ensure that no more than 10 file on the Flash Drive.~~

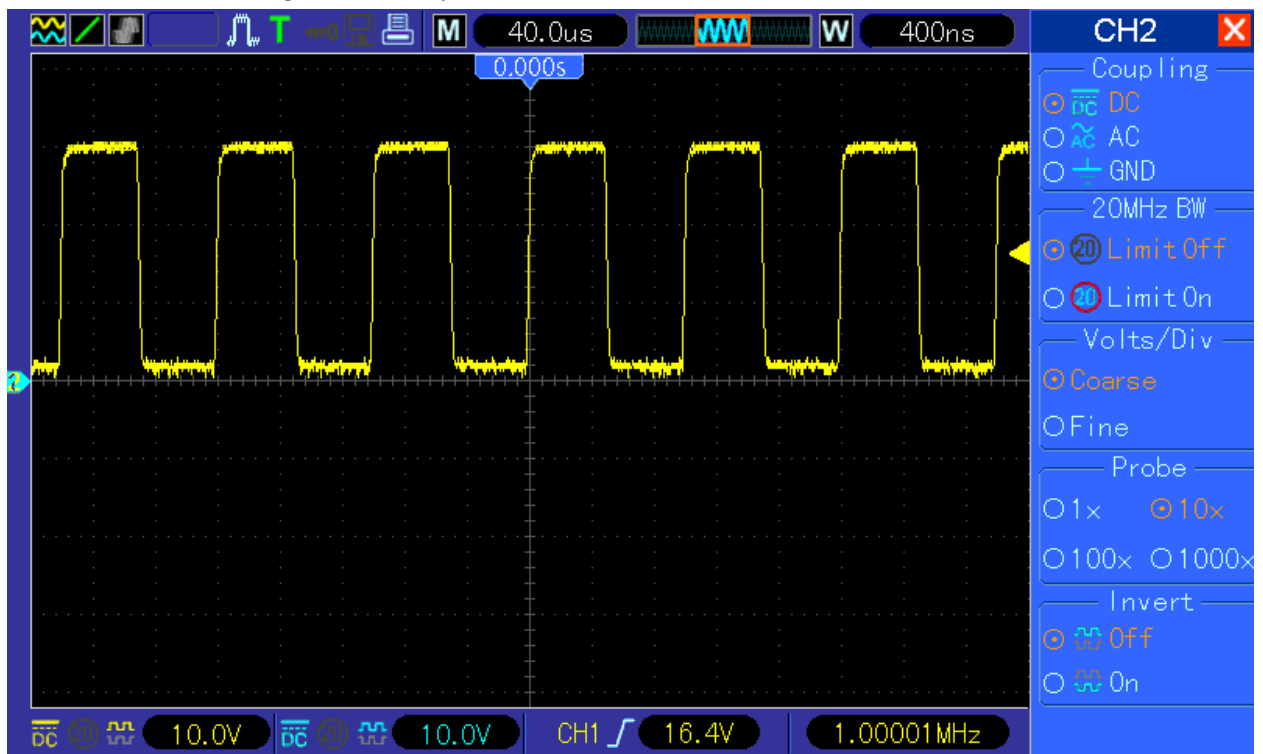
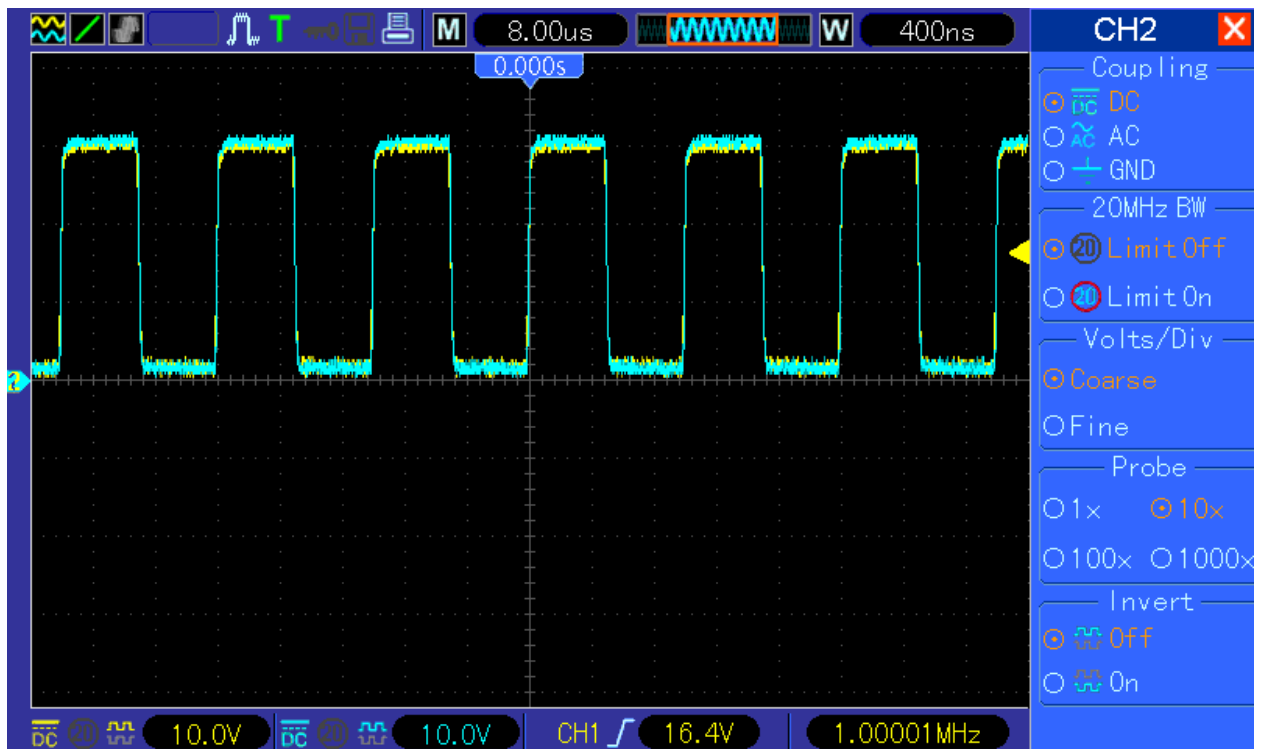
37. With Long Memory enabled (40k, 512k, 1M, 2M?) when the WTB is 400ns/DIV (and lower, up to 2ns/DIV) when enabling second channel the indicator in status line will be already displayed but the waveform is missing. Additionally the CH2 LED is off :

But after changing Timebase (or wave position) one position forth and back the second channel waveform will get displayed and LED gets on :

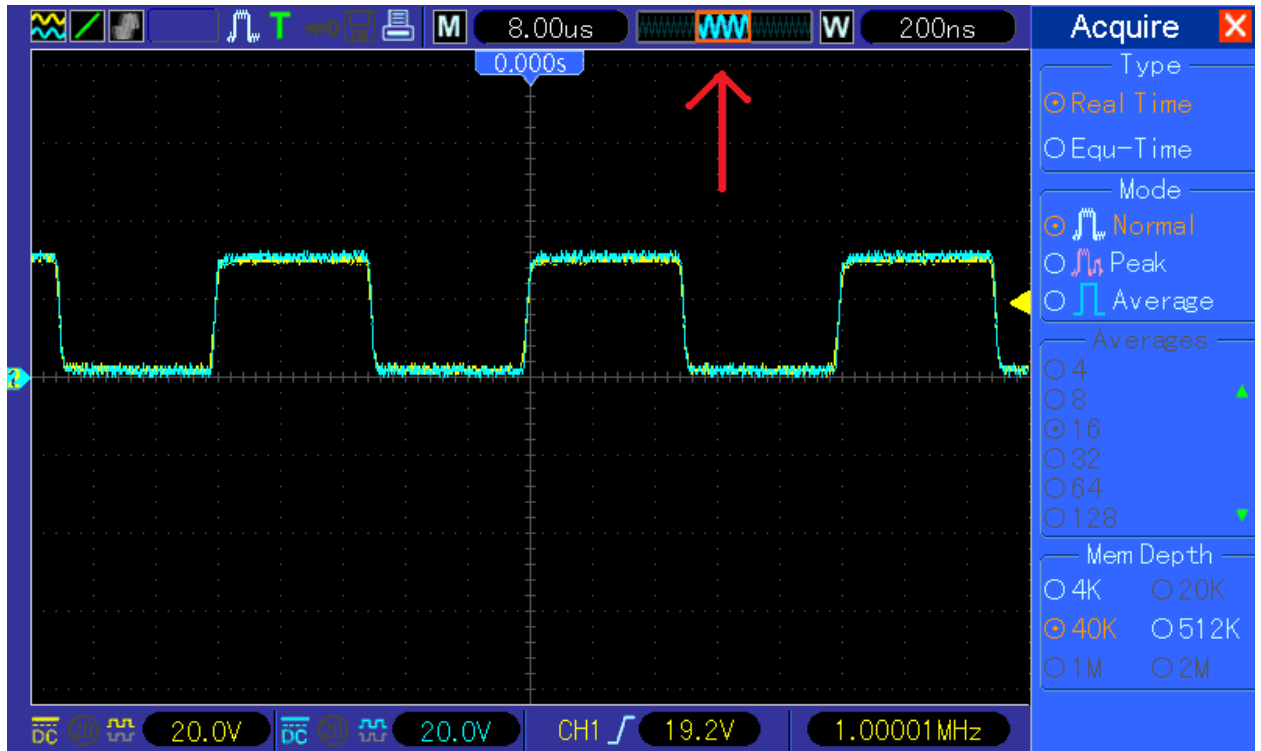
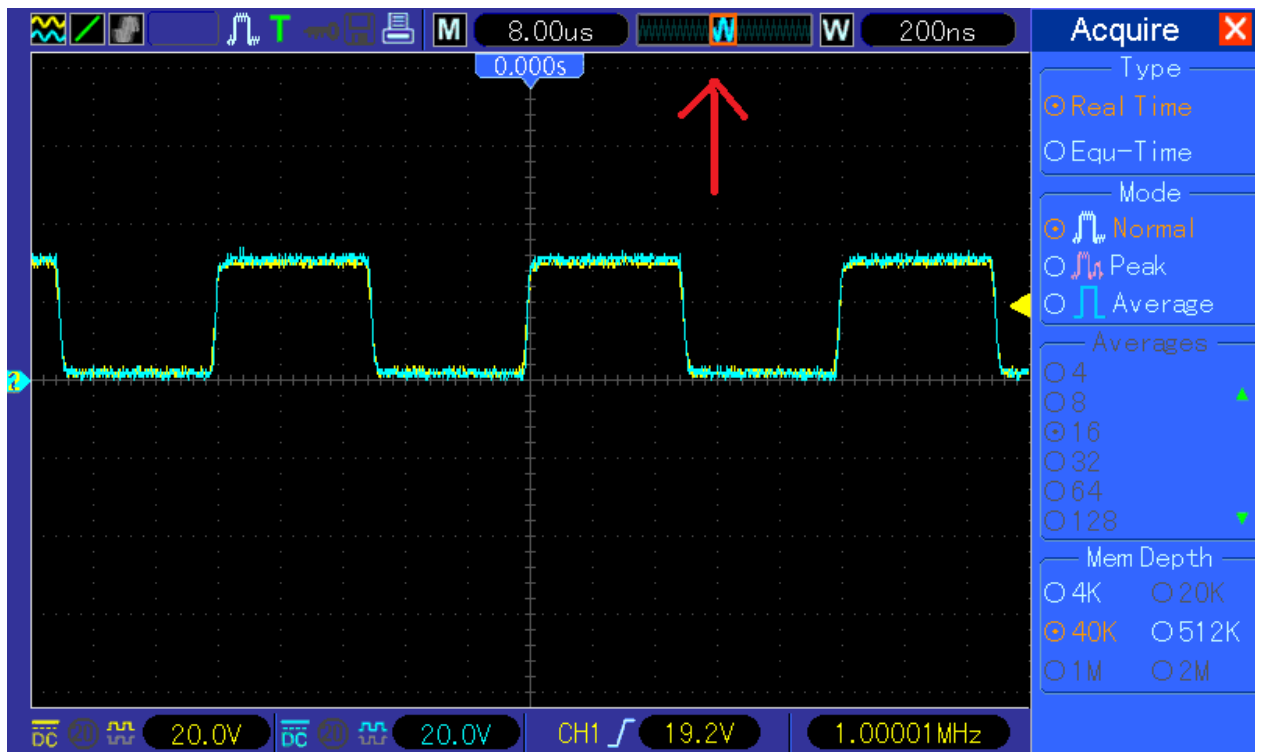
38. MTB Area indicator is blinking! Select 40k depth (or 512k), enable both channels set WTB to 400ns/DIV or 200ns/DIV and watch the area blinking :

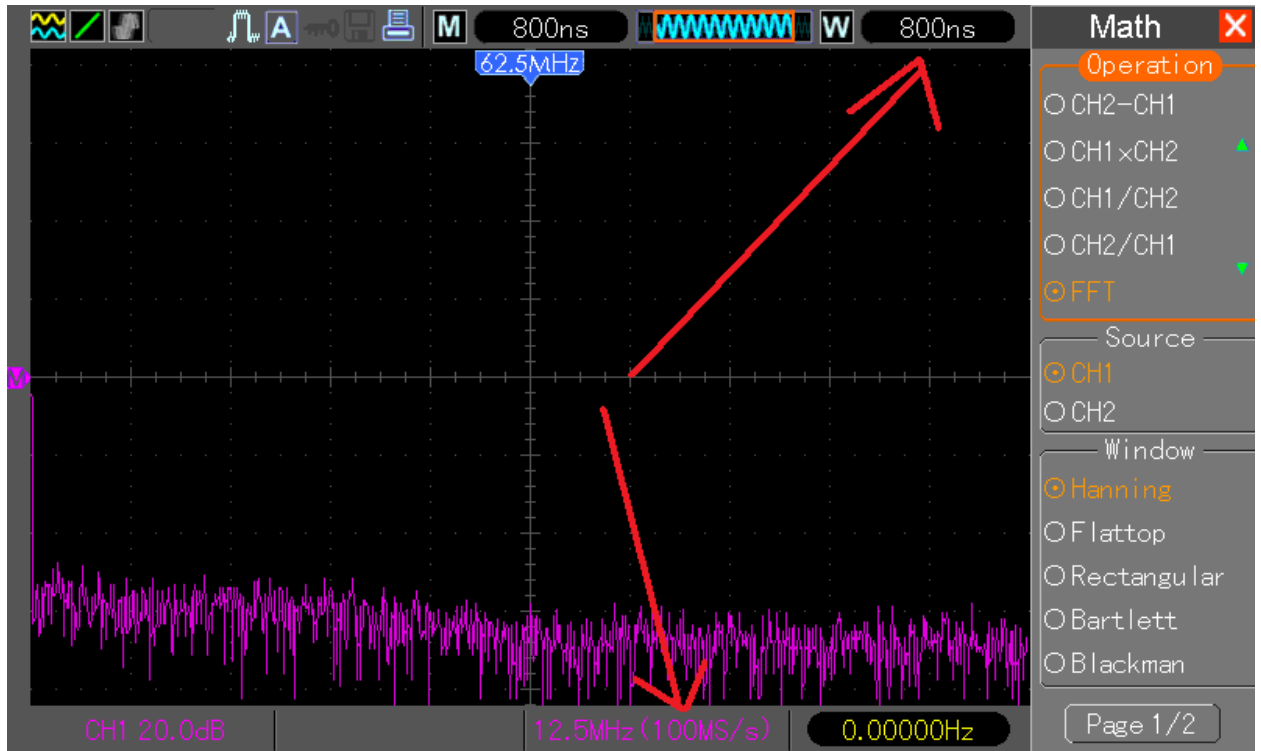
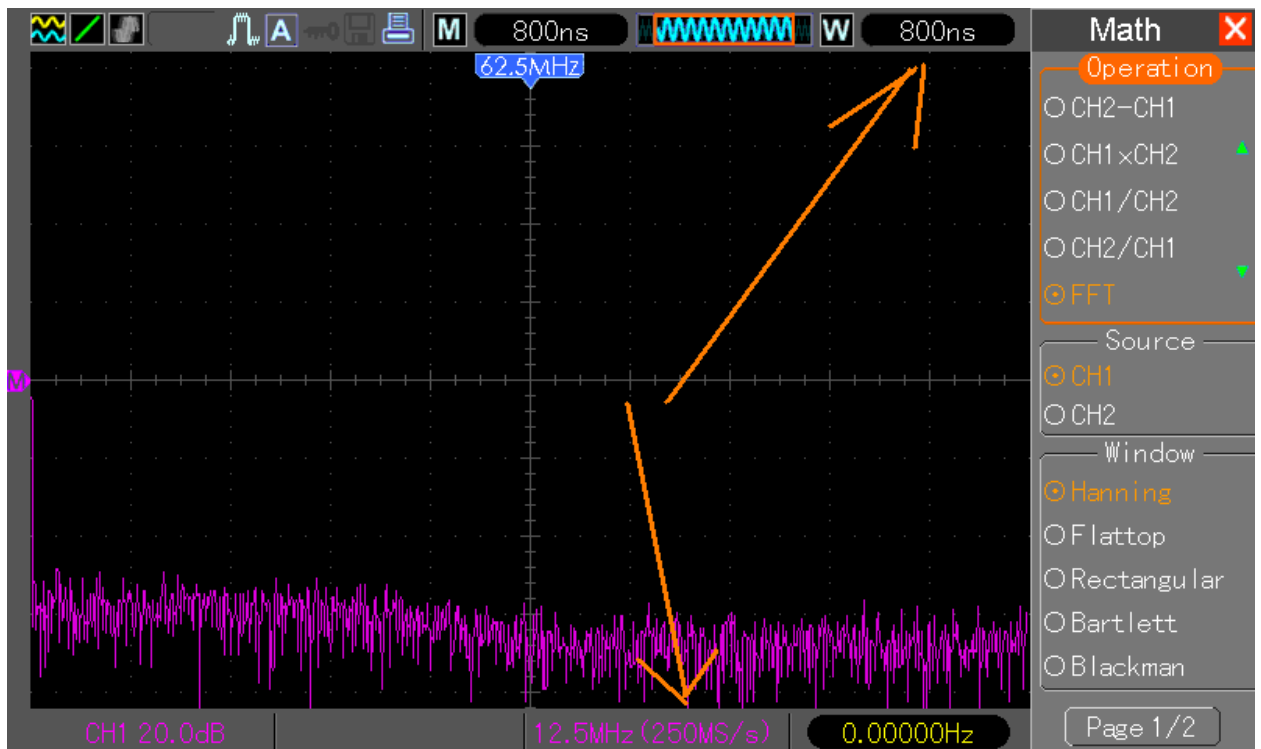
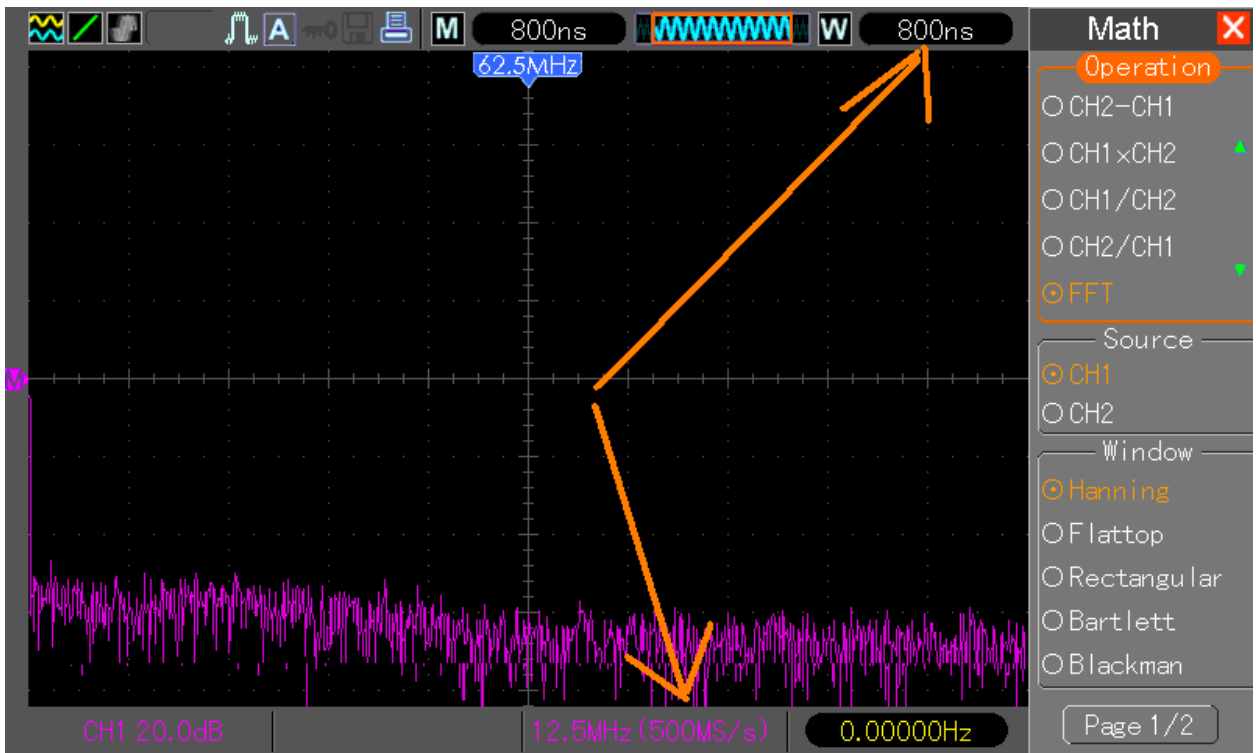
39. Within FFT the information in status bar is not always showing the proper sampling rate, sometimes even jumping from proper to bad value. As the FFT cursor is taking in count the sampling rate, the measure value might be not correct. Example random values in 800ns/DIV FFT , here 100MS/s

then 250MS/s (but still 800ns/DIV)

and here 500MS/s (but still 800ns/DIV)

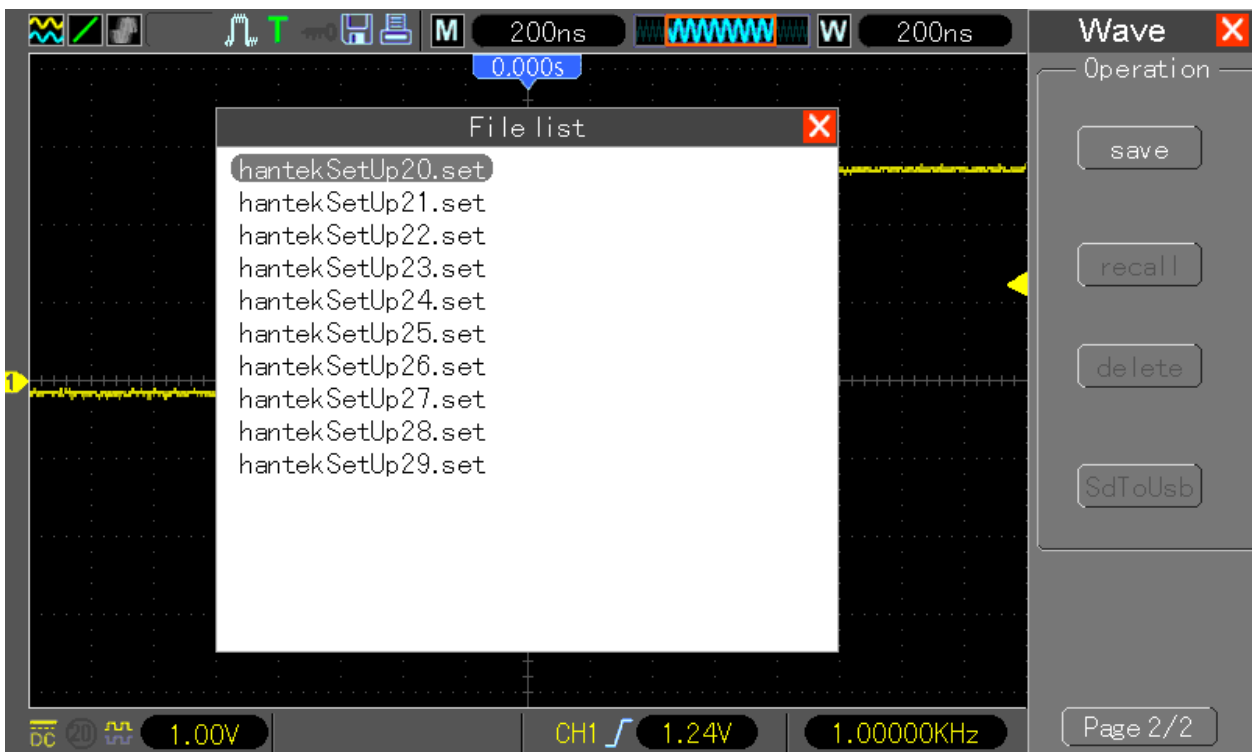
40. Flash Drive directory listing (in CSV Save/Recall and DSO Setup Save/Recall menus) is showing maximum 10 files. Additionally no option to scroll over the directory to choose other than one of the listed 10 files
