## Firmware 2.06.3 bug list:

## List of bugs/improvement requests

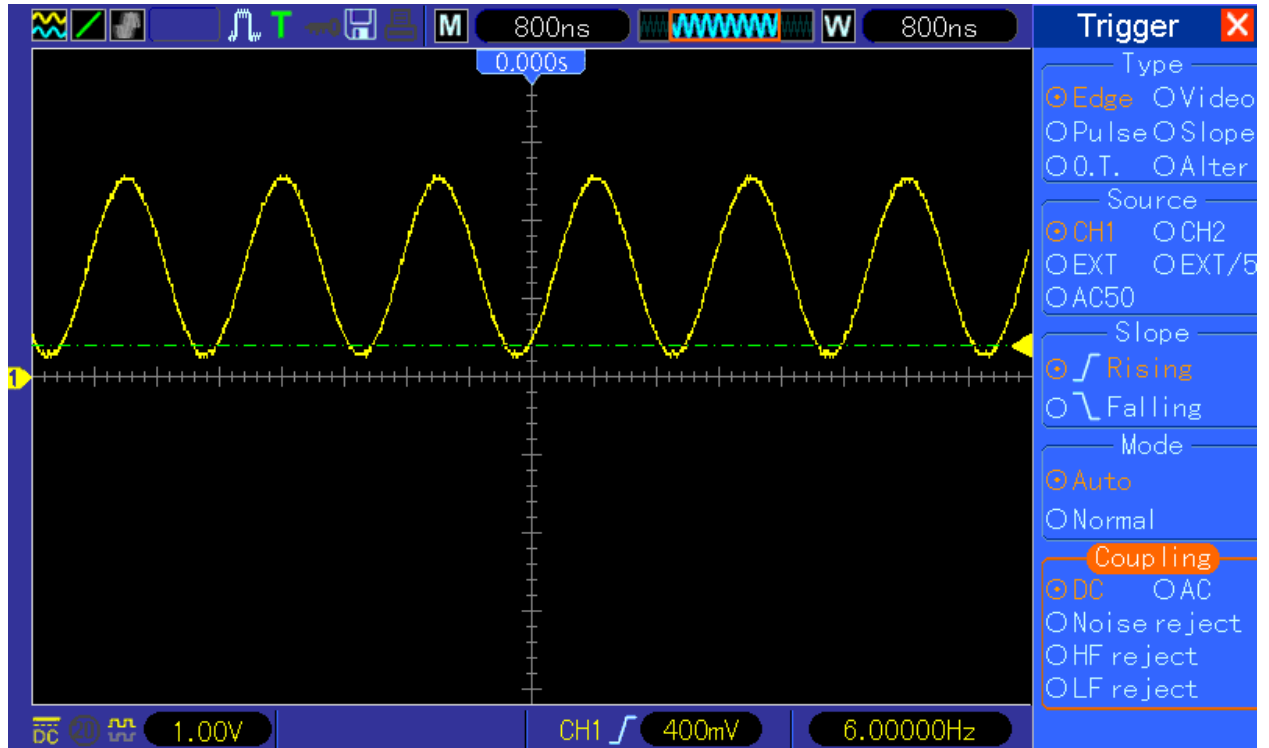
13. AC trigger indicator and line wrong. Set ch1, signal DC coupled, trigger AC coupled. The trigger lowest level below signal :

highest level only mid of signal

But both should look like when trigger coupled in DC mode:

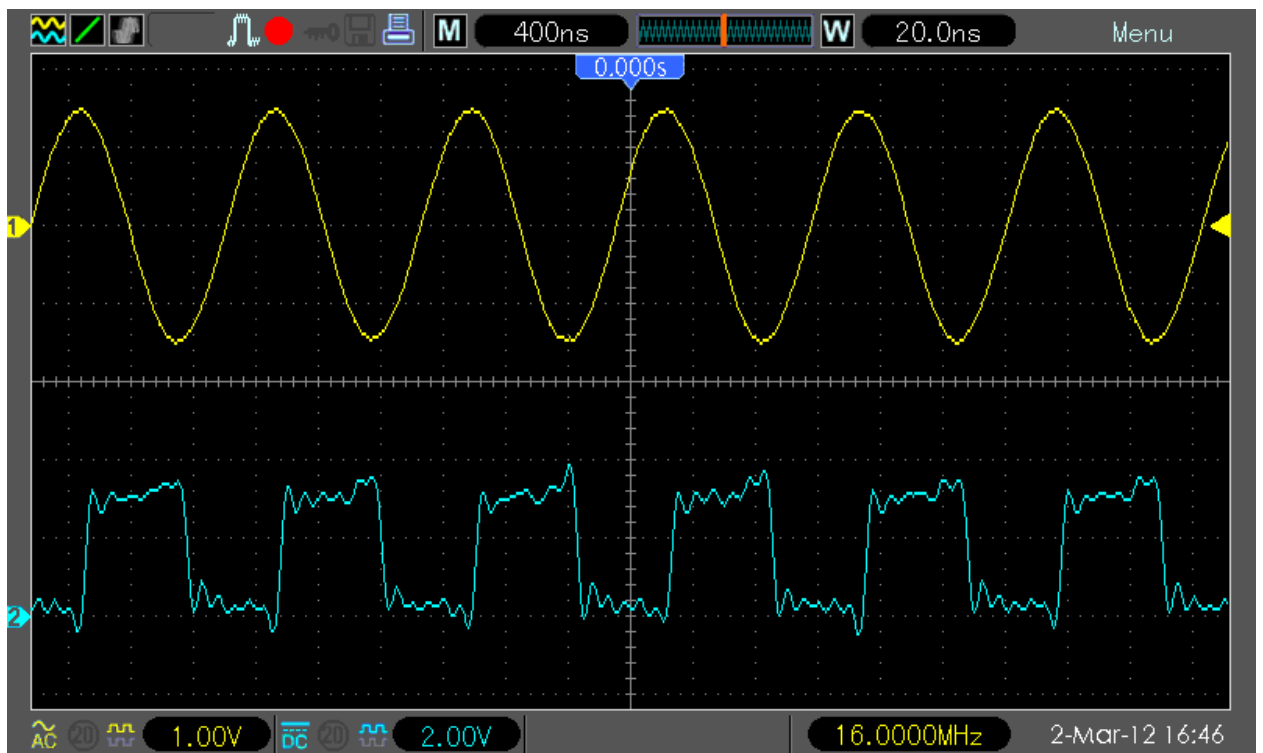
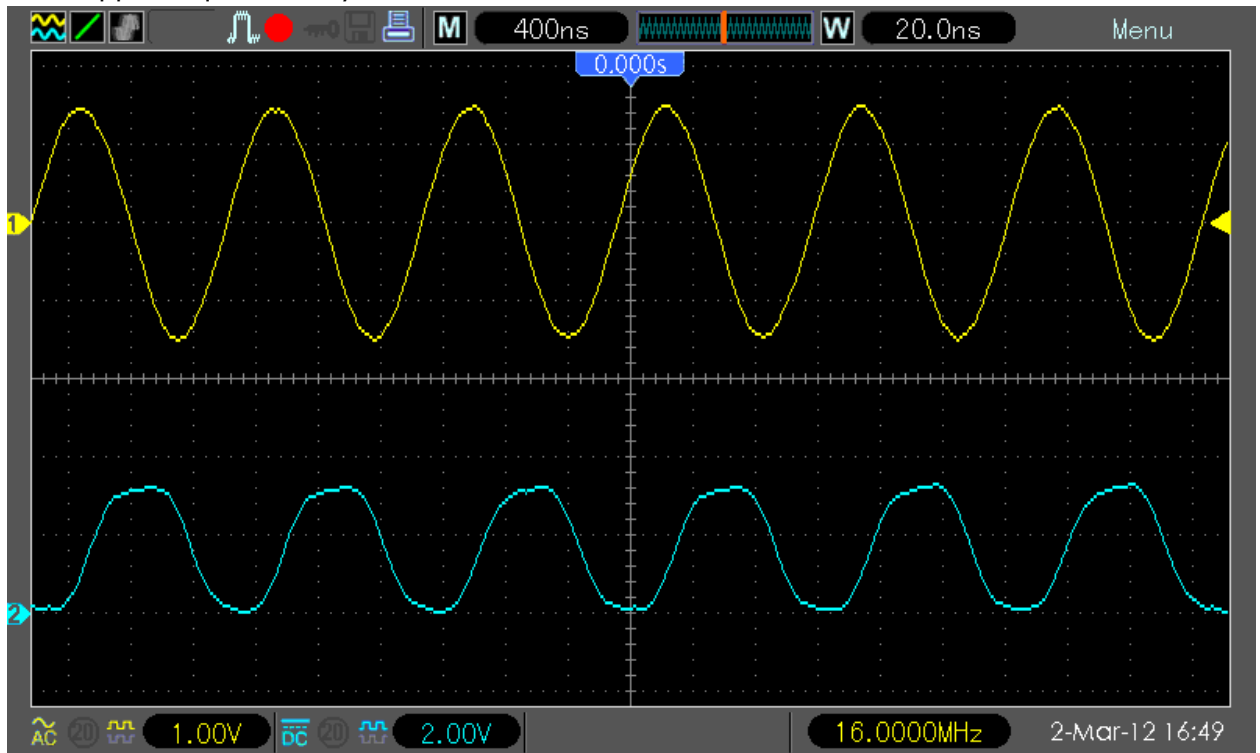
14. Dithering/interpolation filter of waveform too sharp. When enabling both channels (this also occurs in single channel mode and 1GSs, but test signal need to be higher to get same error) and applying for example 16MHz square wave the waveform is switching between proper square:

and crippled square every second:

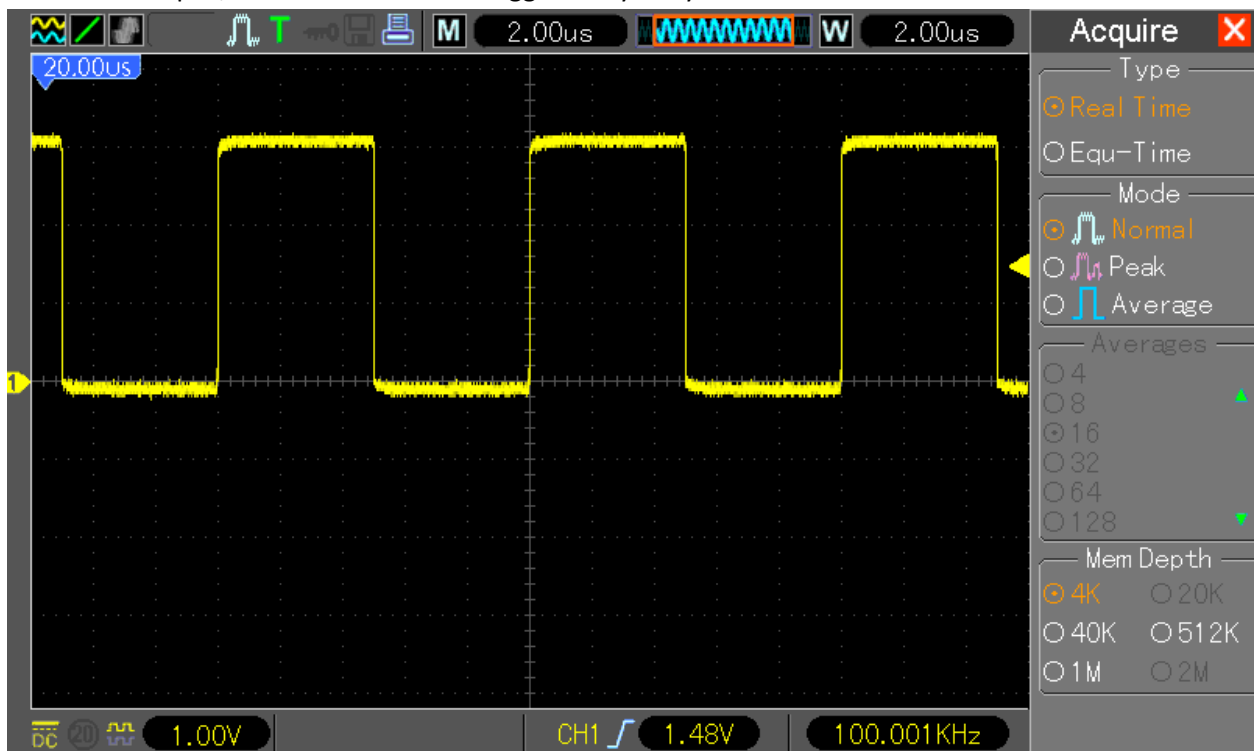
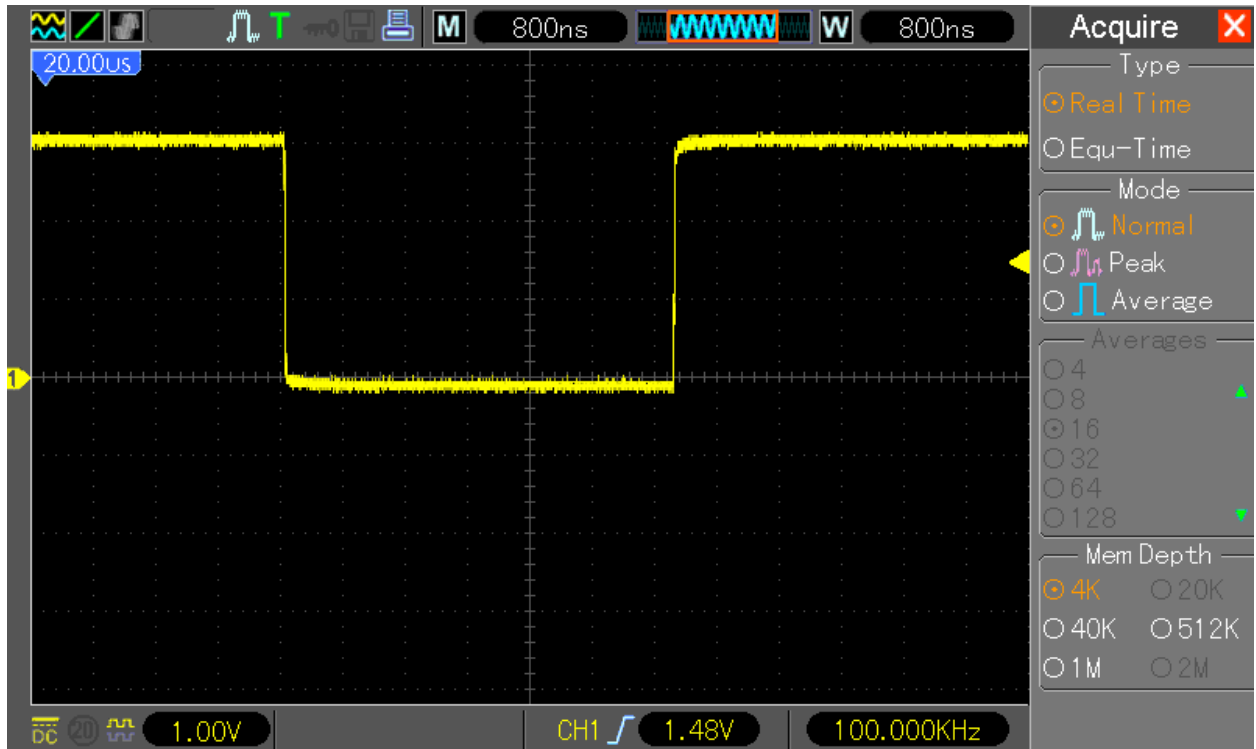
Another example , waveform moved to trigger delayed by 20us:

when zoomed it is not ok, it is off by 1.8us already!

in principle in 4k, 40k and 512k everywhere same error, move waveform by more that MTB, do zoom and it is not ok anymore.

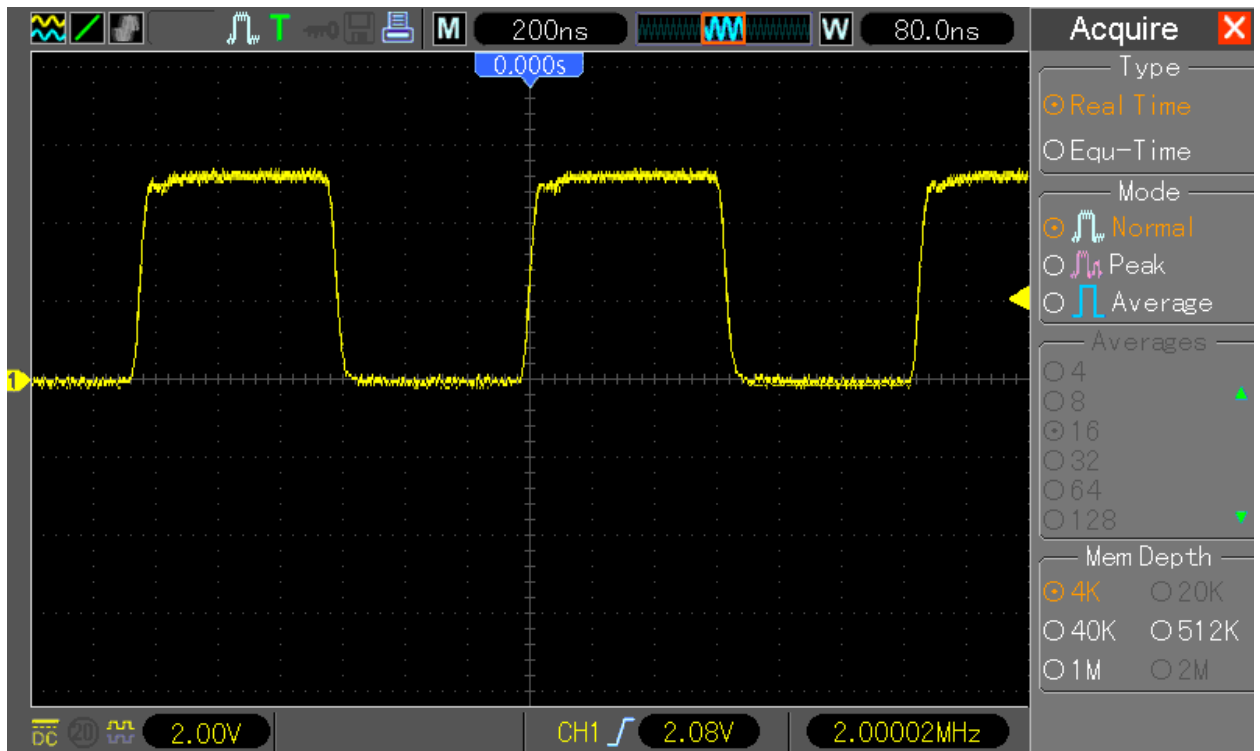
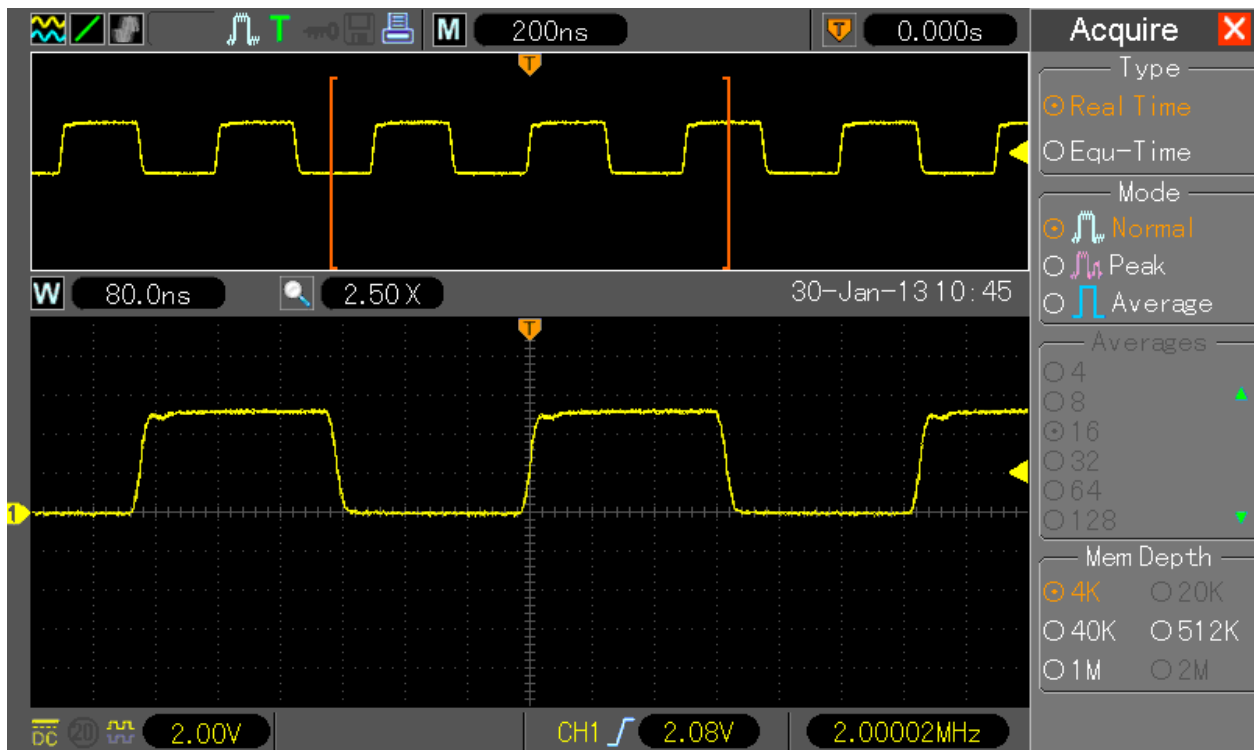
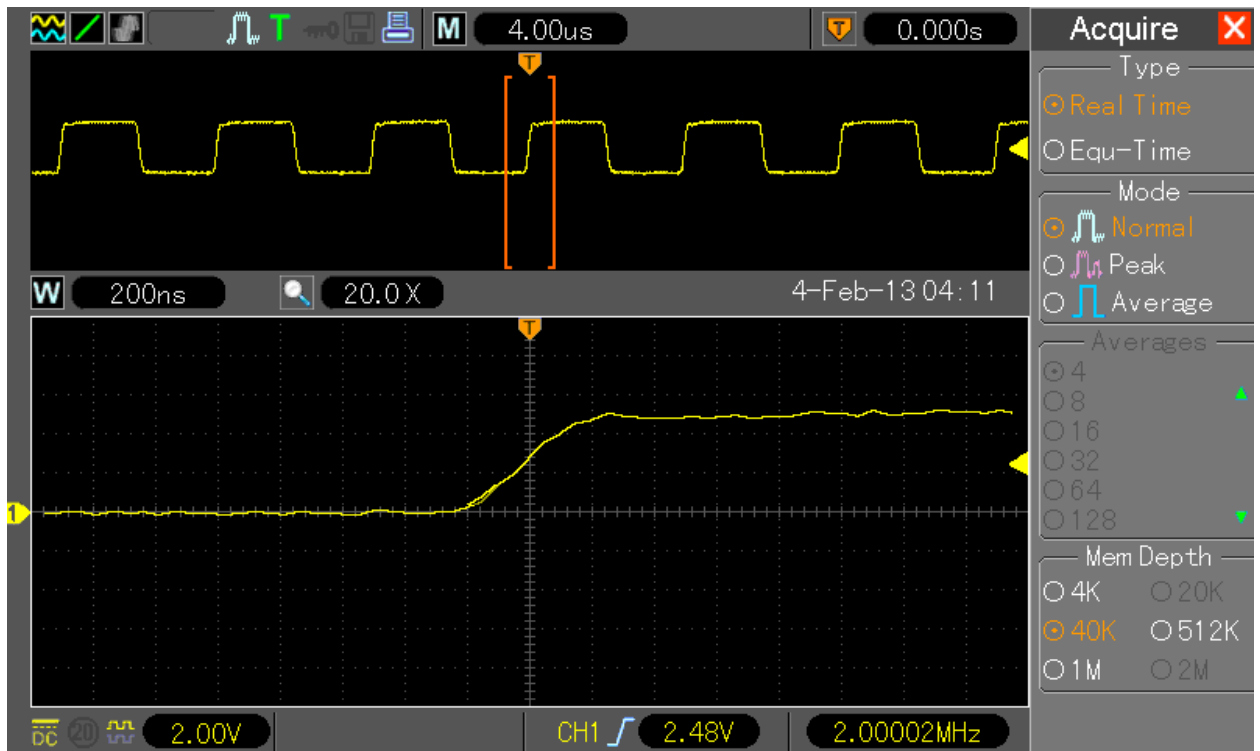
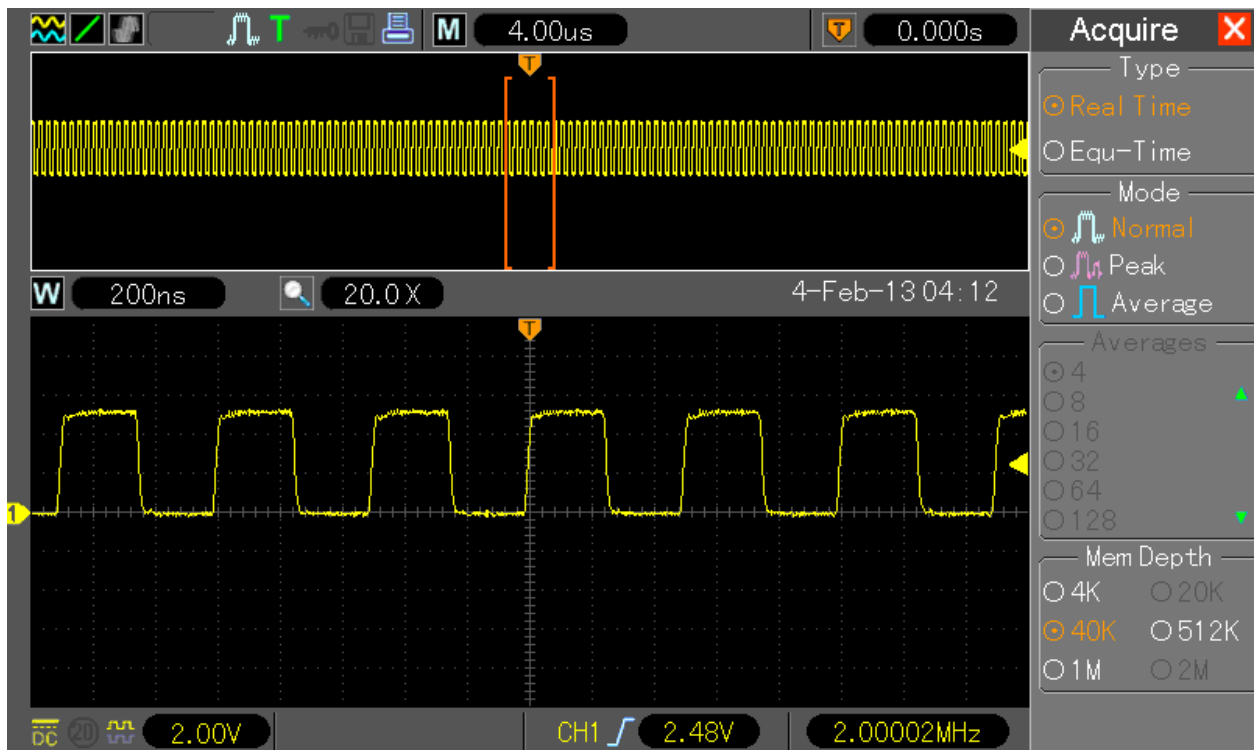
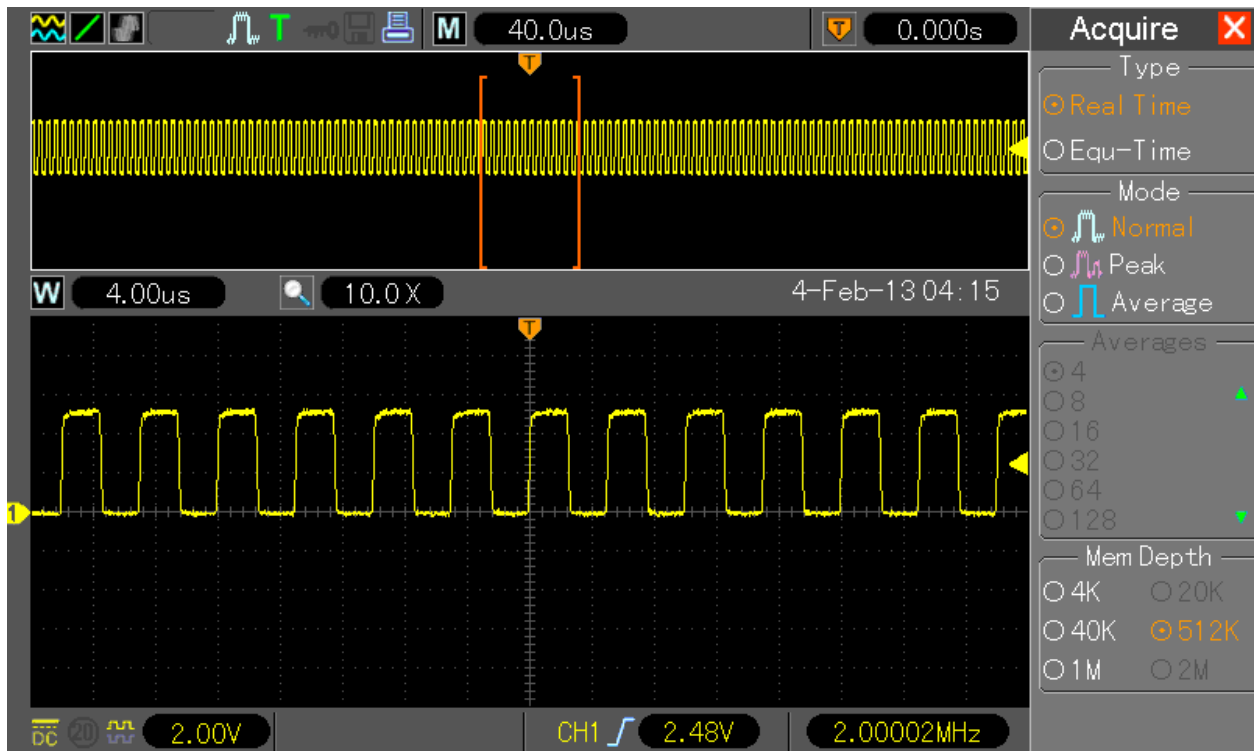
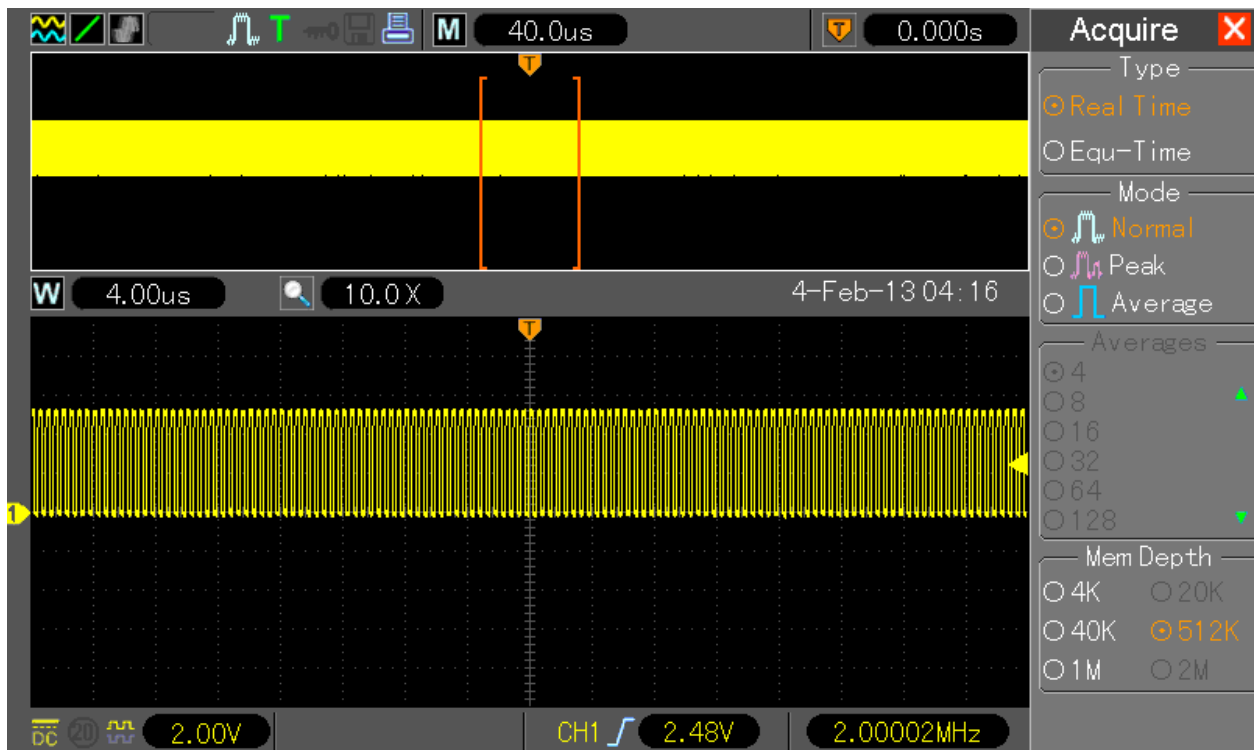
**Update 130202.0 – when switching from single into dual window scaling works. But still there is another one kind of this bug:**

You should see now 2.5 period on screen like here:

Now press F7 to enable dual window. The top MTB window show 6.5 periods and bottom window WTB shows 2.5 periods, which is what it should be:

Now change memory depth to 40k, top window is having still 6.5 periods, this is **wrong**

Switch now focus to top window and turn timebase one position up, the display will be now refreshed to **proper values**:

the same error is there if you change to 512k (and 1M exact same error), push now F5 to change to 512k, picture looks like

Switch now focus to top window and turn timebase one position up, the display will be refreshed to **proper** values:

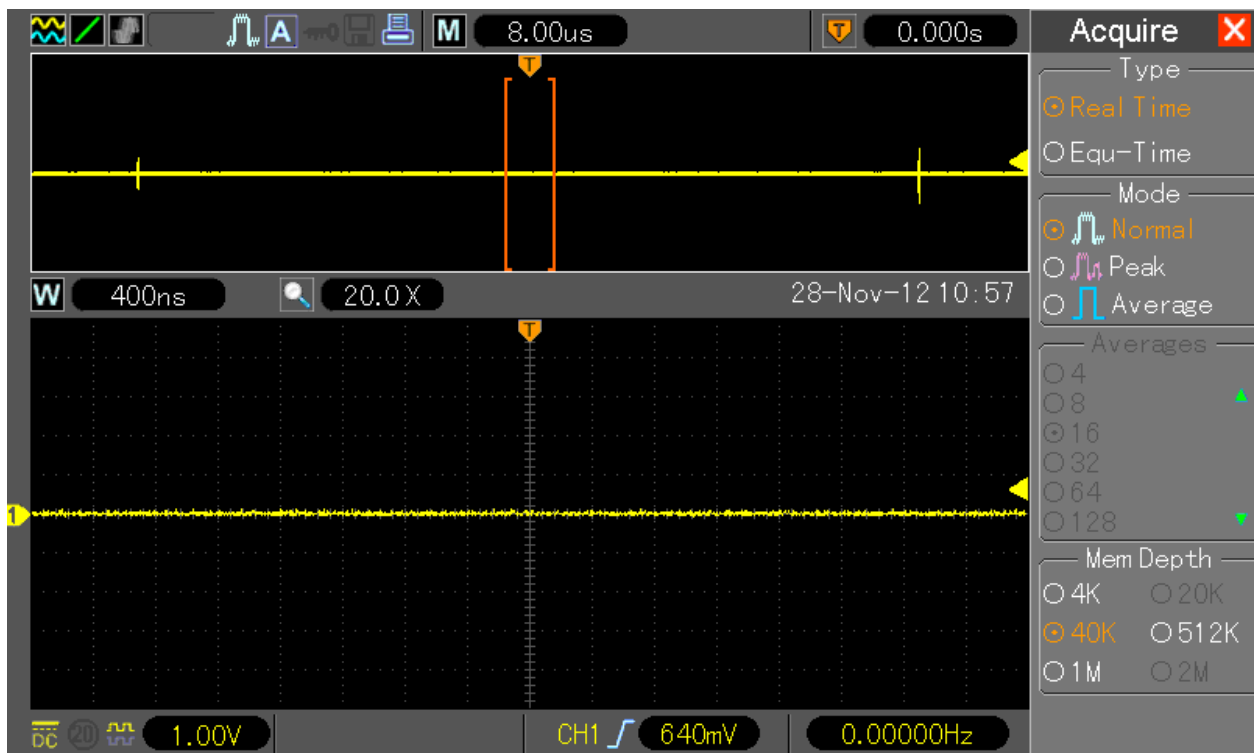
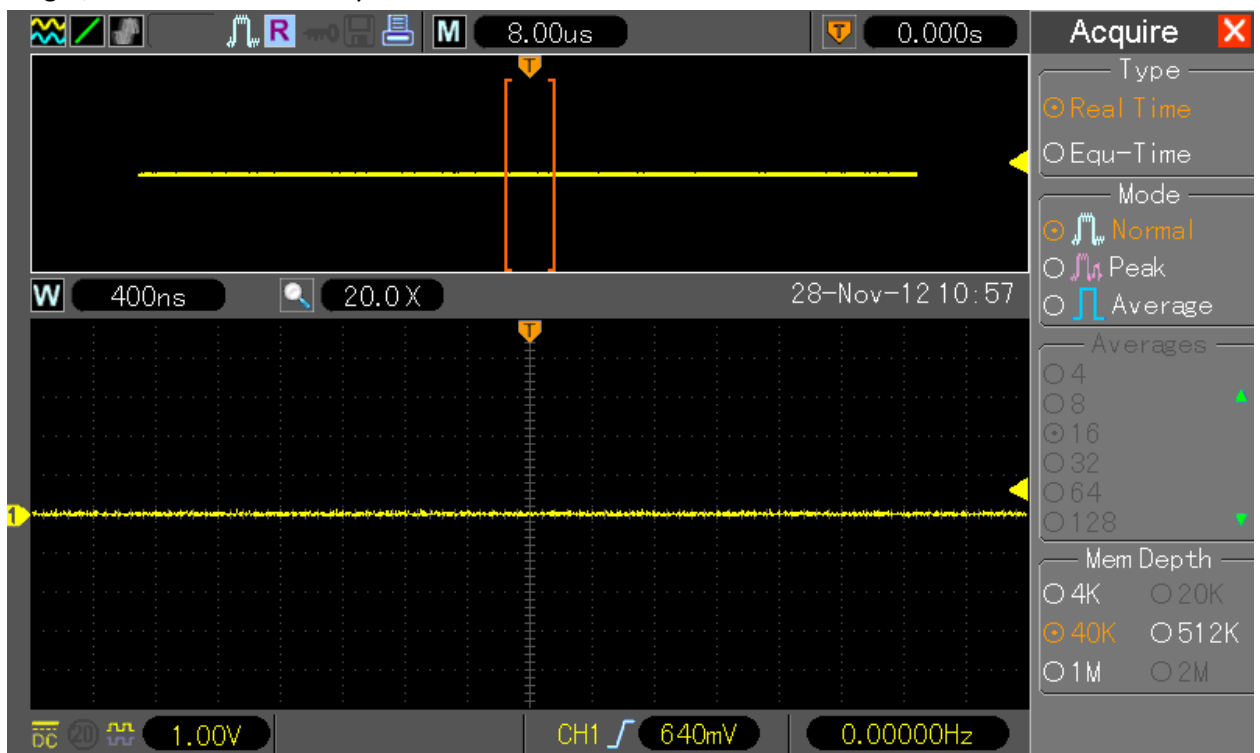
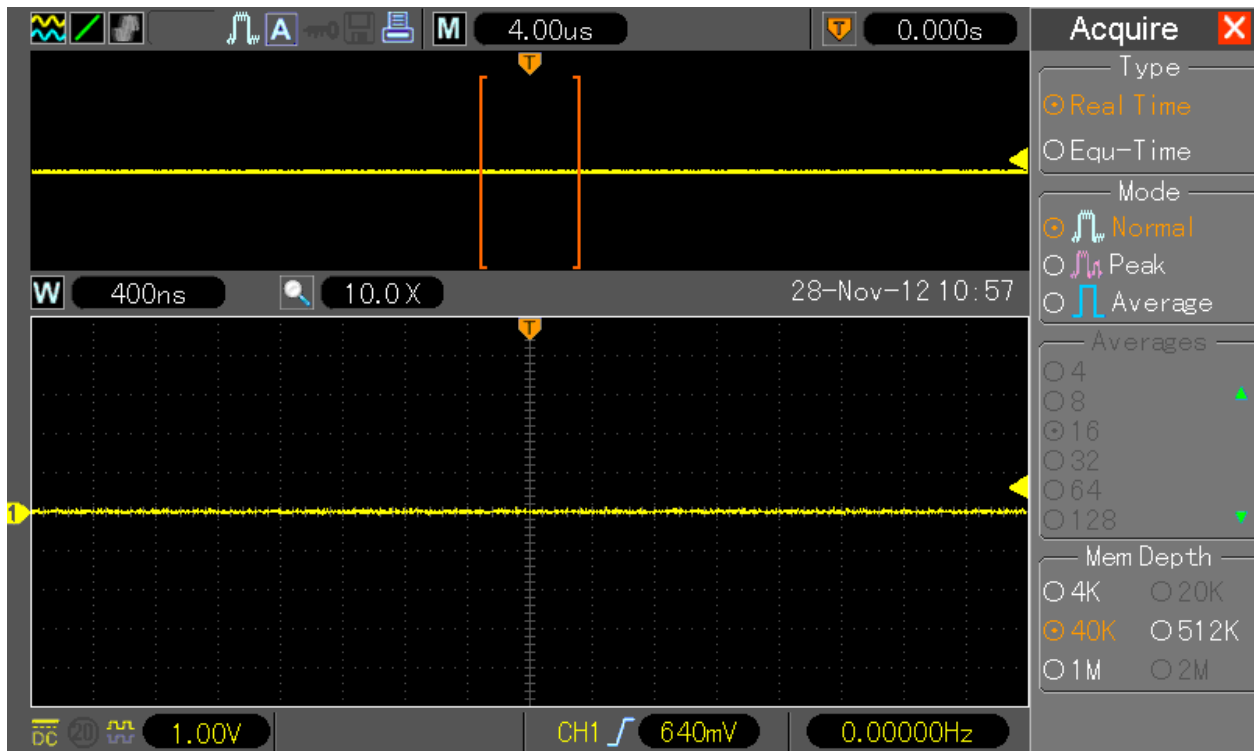
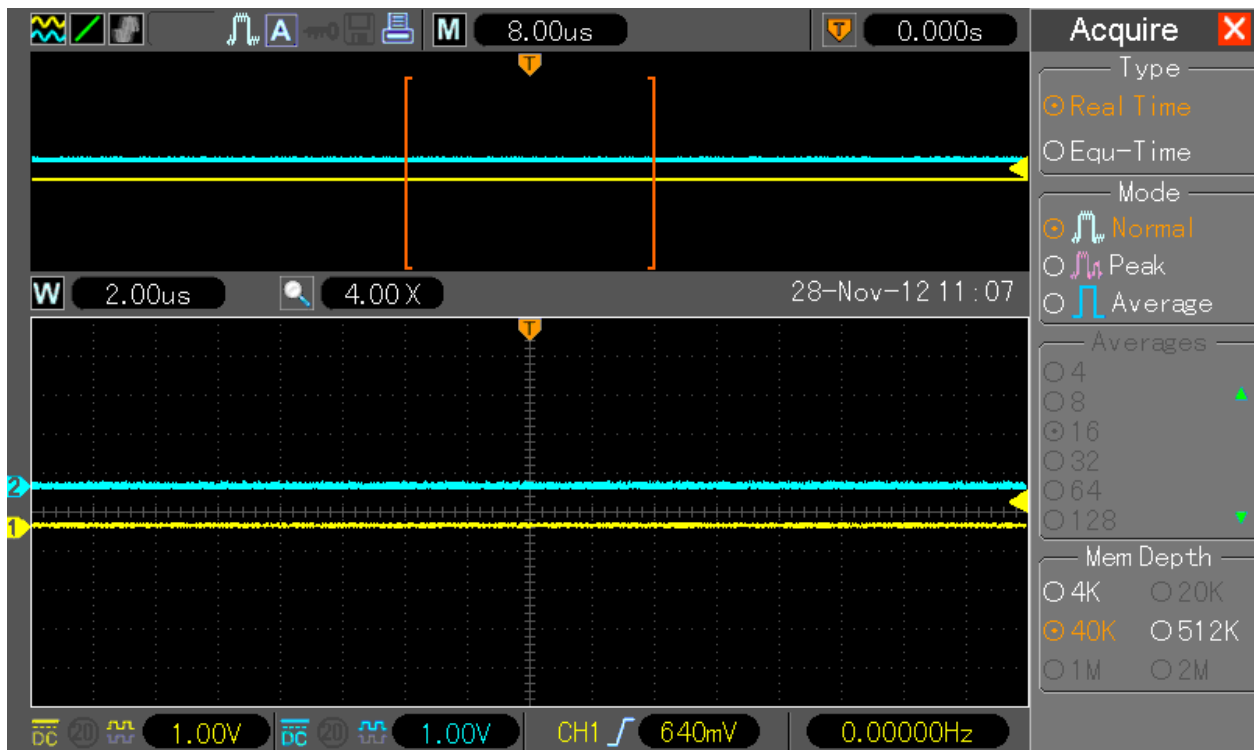
27. While switching from single into dual window mode the main timebase is changing with a wrong factor, e.g. from 200ns/DIV in single into 400ns/DIV in dual window mode. Similar issue in 40k/512k and 1M – in dual window the MTB is twice that high as before in single window mode. Due incorrect timebase the display buffer is showing artifacts on both right and left side of the waveform (end of buffer). Example: CH1 enabled, 40k memory, single window and windows timebase smaller than main timebase, here 400ns/DIV (Main TB is 4us/DIV for 40k)

Now when switching to dual window the Main TB is changing to wrong value (here from 4us/DIV to 8us/DIV – actually it will be always doubled in length) and artifacts from “end of buffer” right and left in top window are shown:

When the Acquisition would be stopped and restarted or Timebase changed one position forth and back (while Main window is focused) the Main TB and displayed data will be fixed to proper length; no artifacts shown anymore:

With 2 channels enabled this bug **DOES NOT EXIST**, this is because the doubled Main TB value is exactly what it should be for dual channel view:

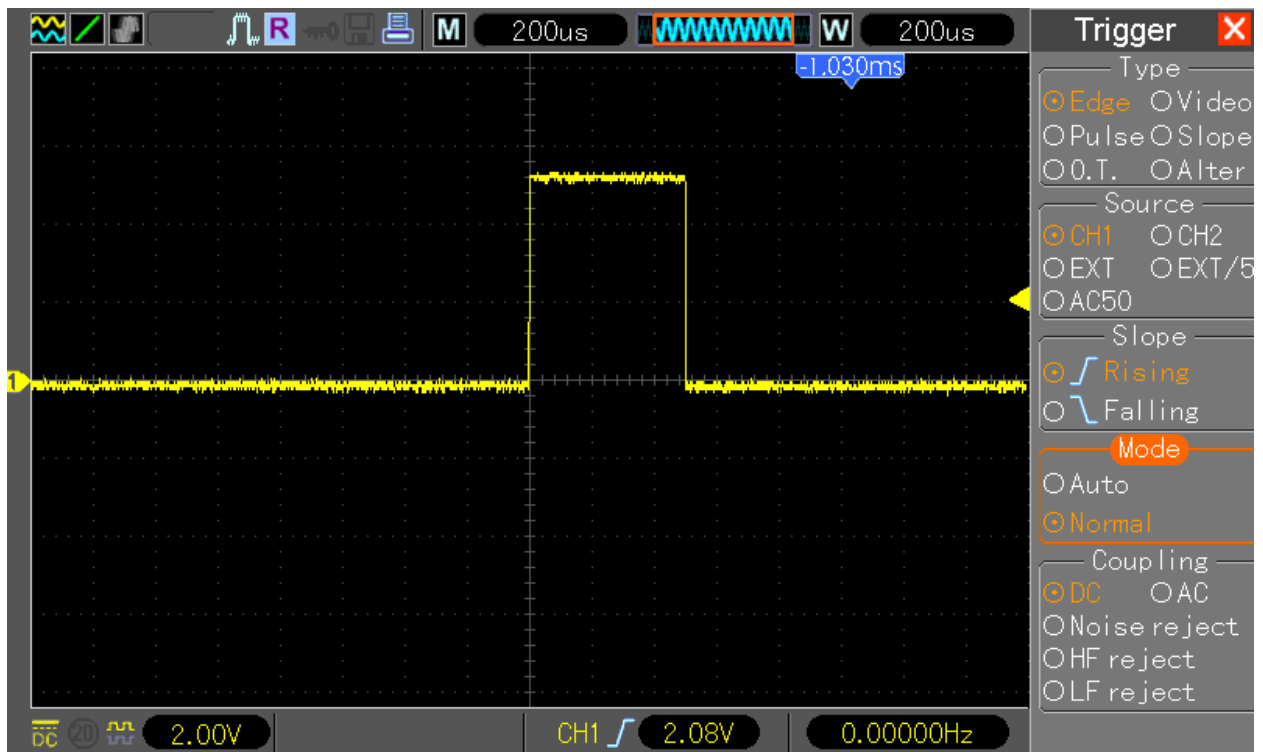
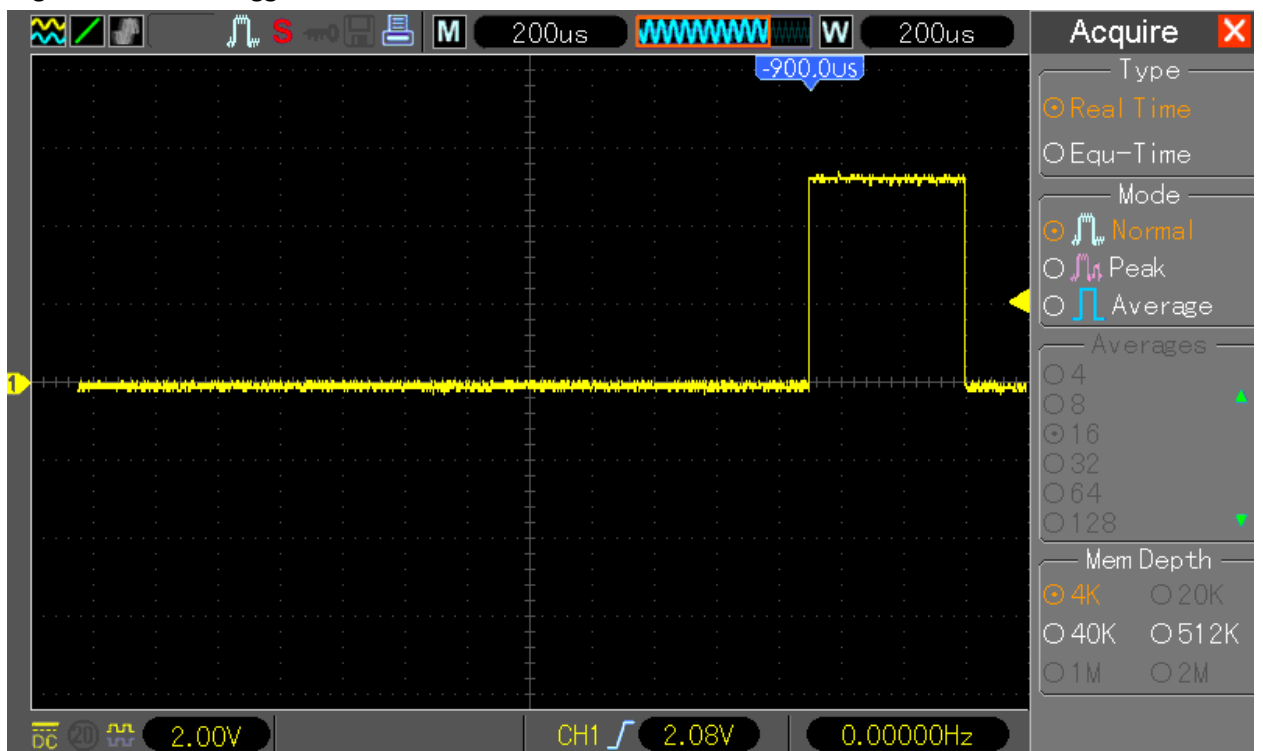
Now when you turn the Horizontal position knob to left or right to change the position, the blue trigger indicator is changing as expected, but the already captured waveform is not moving (which is a bug, it make sense to be able to move already captured waveform while waiting for next trigger event. )

However, when working with acquisition in “Single shot” mode the waveform can be moved together with the trigger indicator :

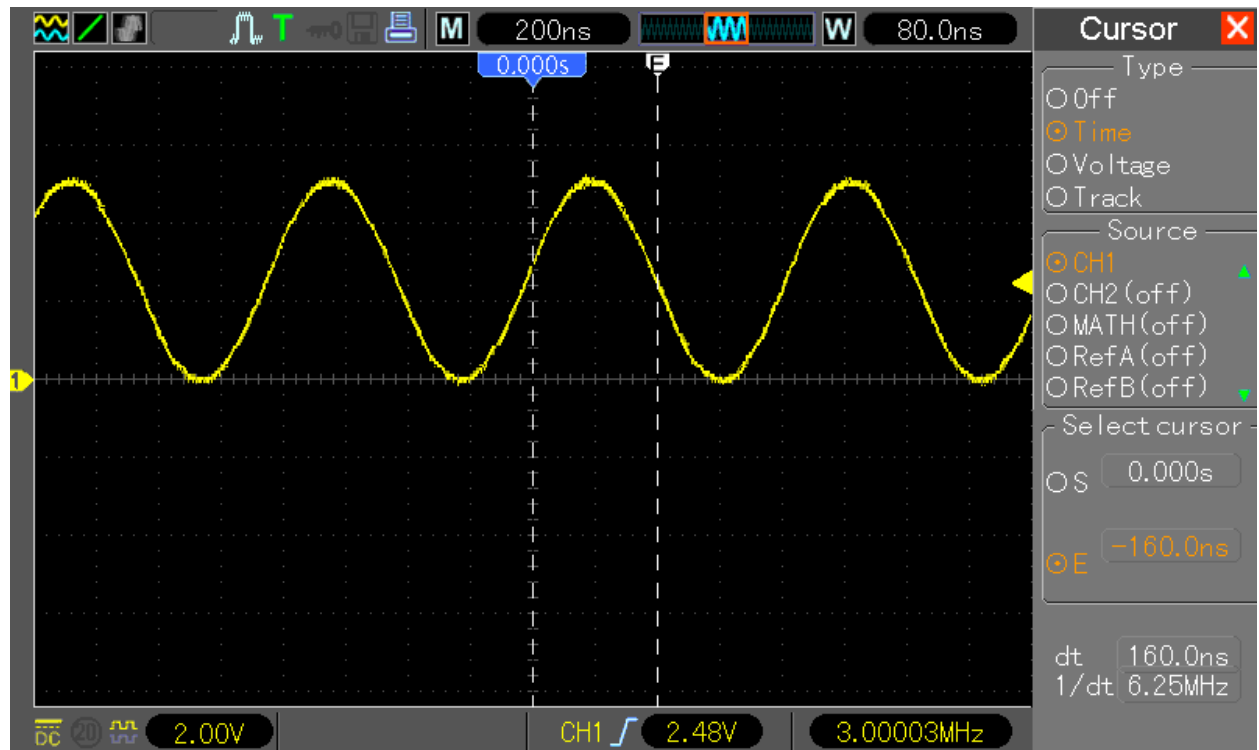
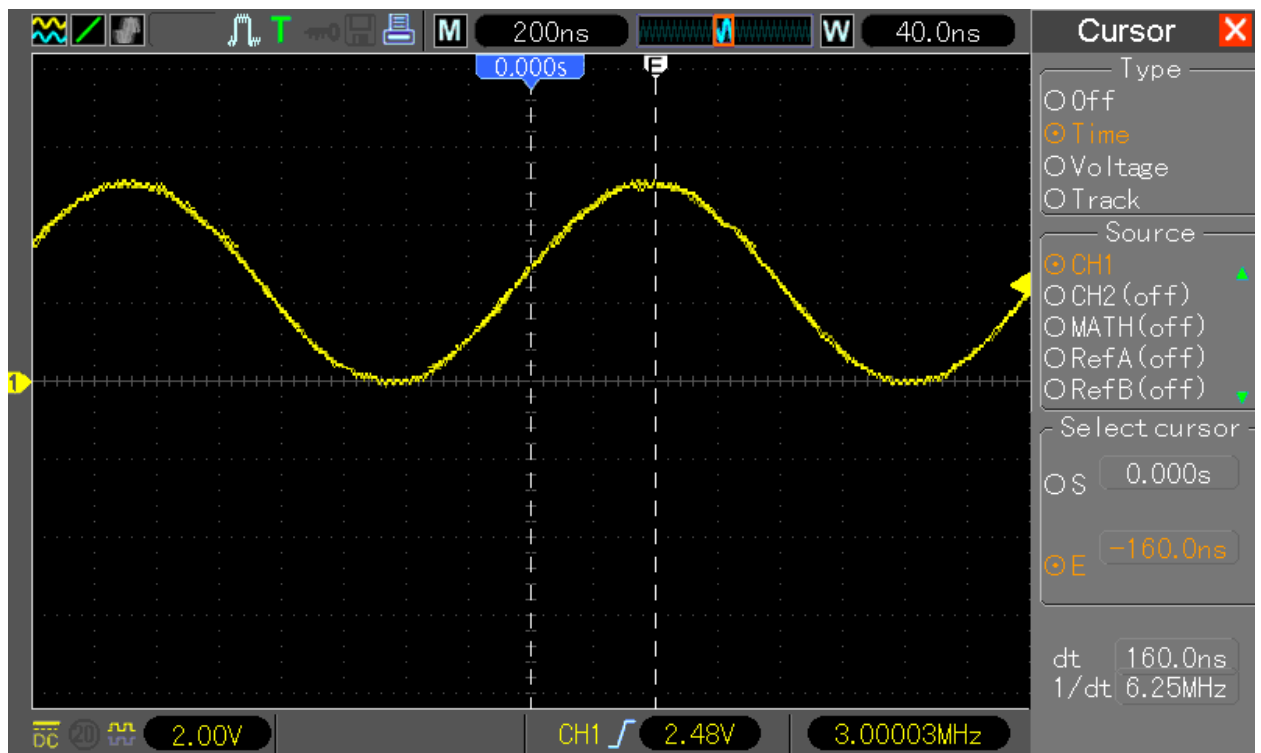
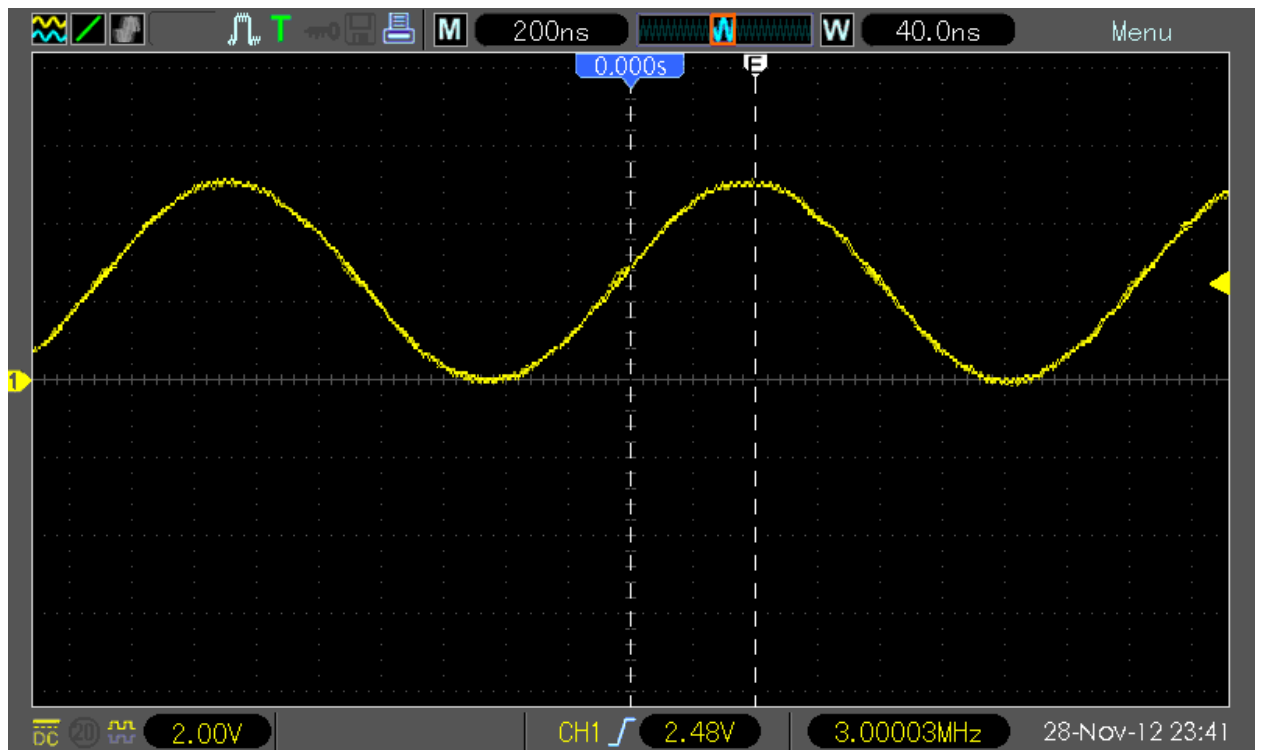
31. In RUN and STOP mode, while changing Timebase the Time Cursor values S and E not refreshing automatically. Any changes to Menu (hide/show with F0), other Knobs (like V0) position or any Buttons (e.g. push Measure button and again Cursor button) is refreshing the S and E values in Menu.

Here example, TB set to 80ns/DIV, cursor S to 0.0ns and E to -160ns:

Then TB changed to 40ns/DIV, but displayed value for E still -160ns:

Now disabling Menu with F0:

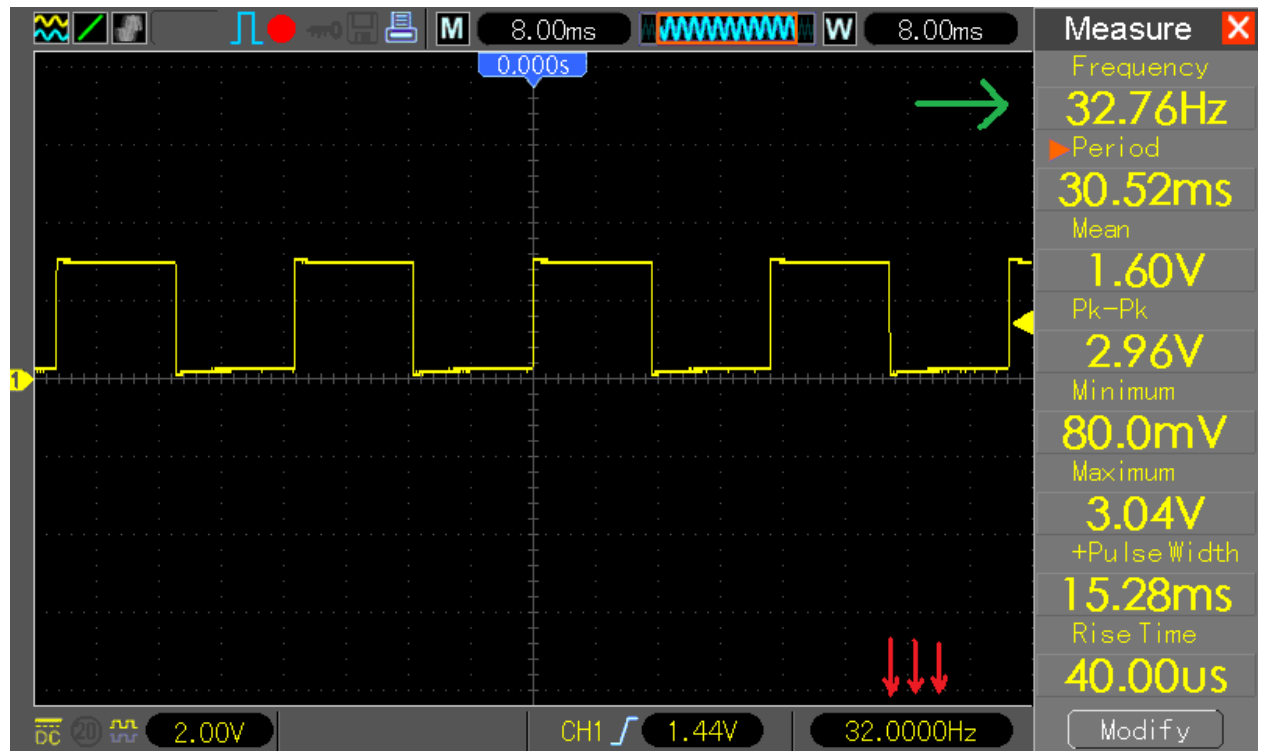
frequency of 32.768Hz – the counter will show 32.000Hz (and Wave measure 32.76Hz).

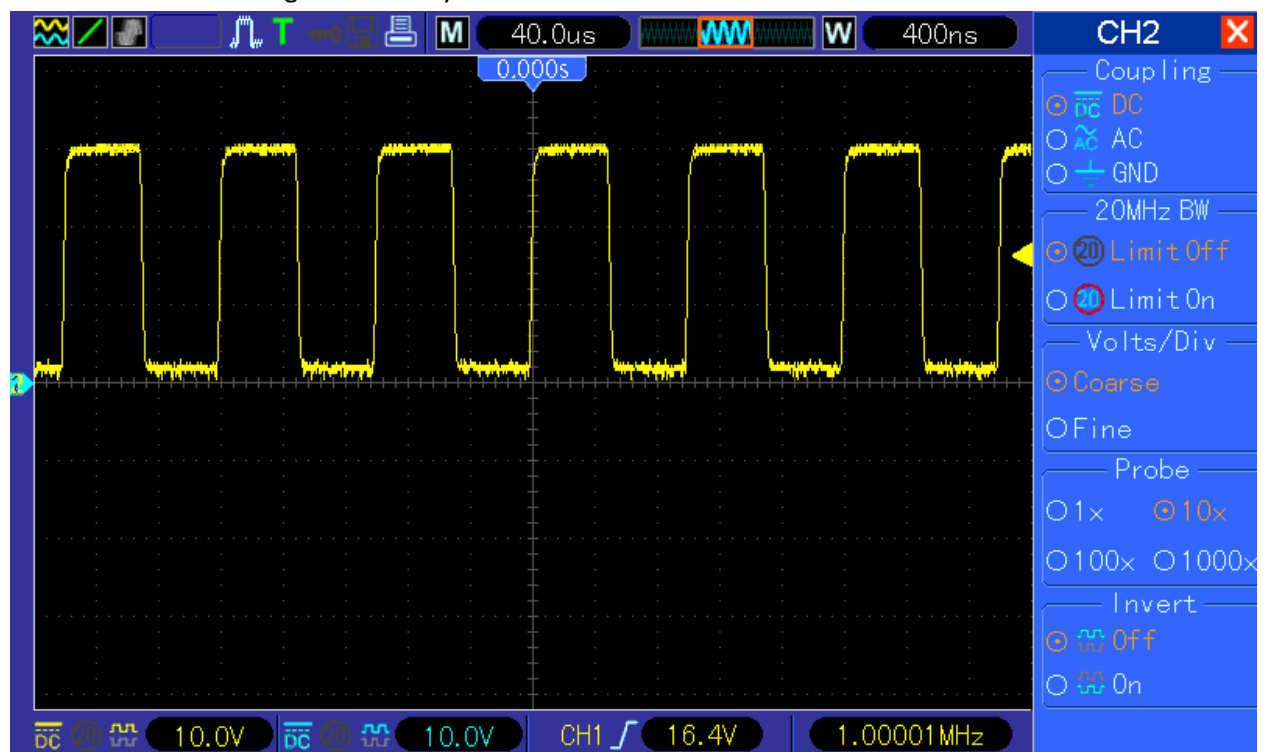
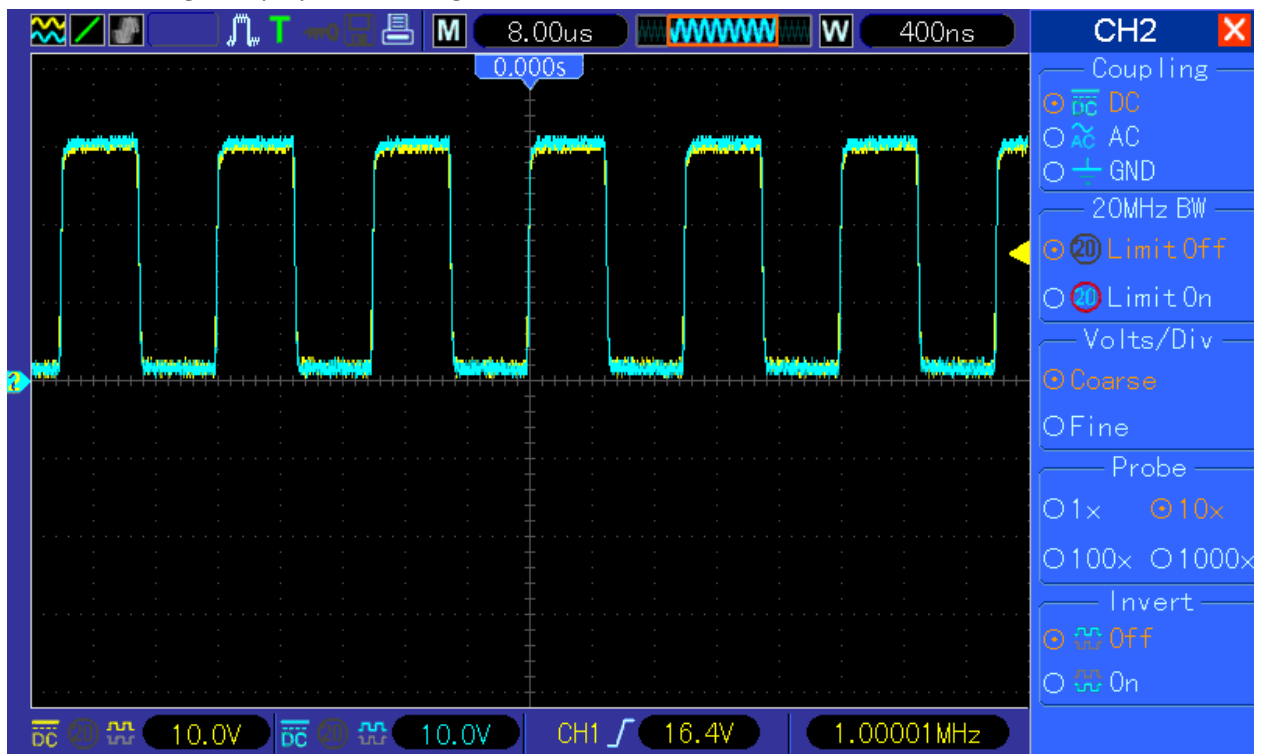
37. With Long Memory enabled (40k, 512k, 1M, 2M?) when the WTB is 400ns/DIV (and lower, up to 2ns/DIV) when enabling second channel the indicator in status line will be already displayed but the waveform is missing. Additionally the CH2 LED is off :

But after changing Timebase (or wave position) one position forth and back the second channel waveform will get displayed and LED gets on :
