## Firmware 2.06.3 bug list:

## List of bugs/improvement requests

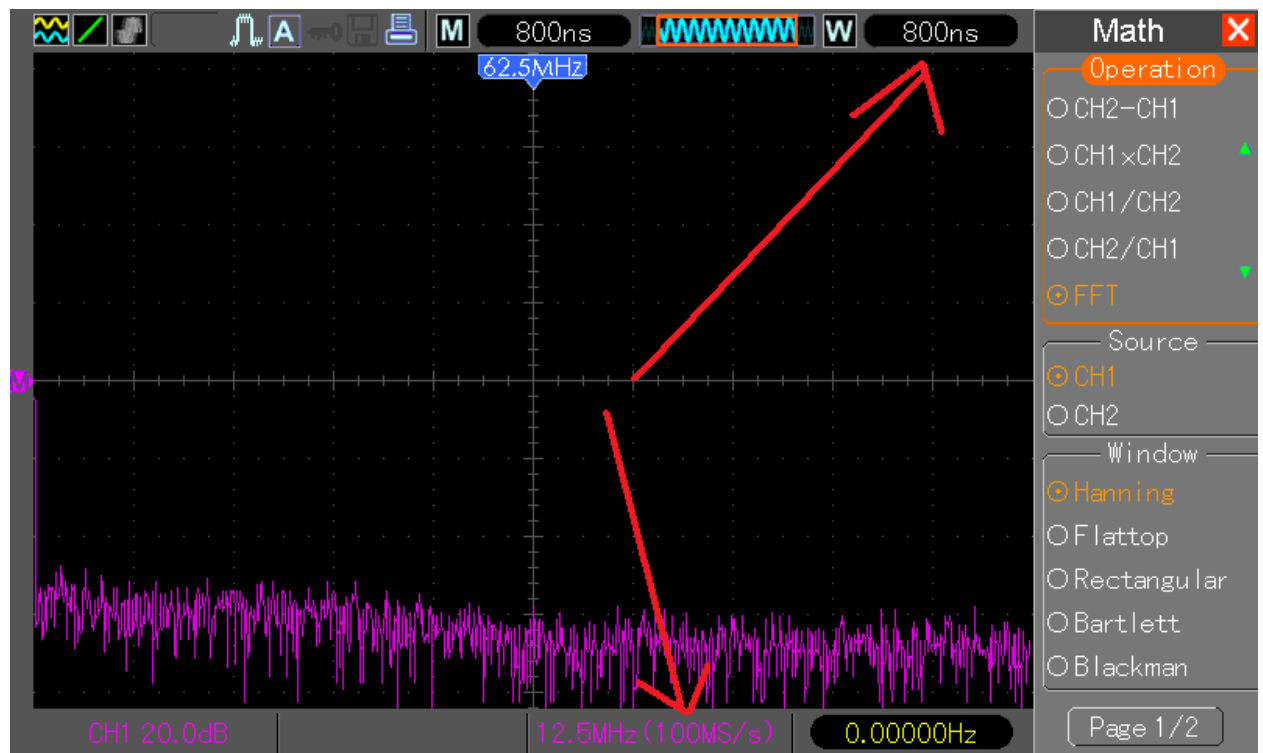
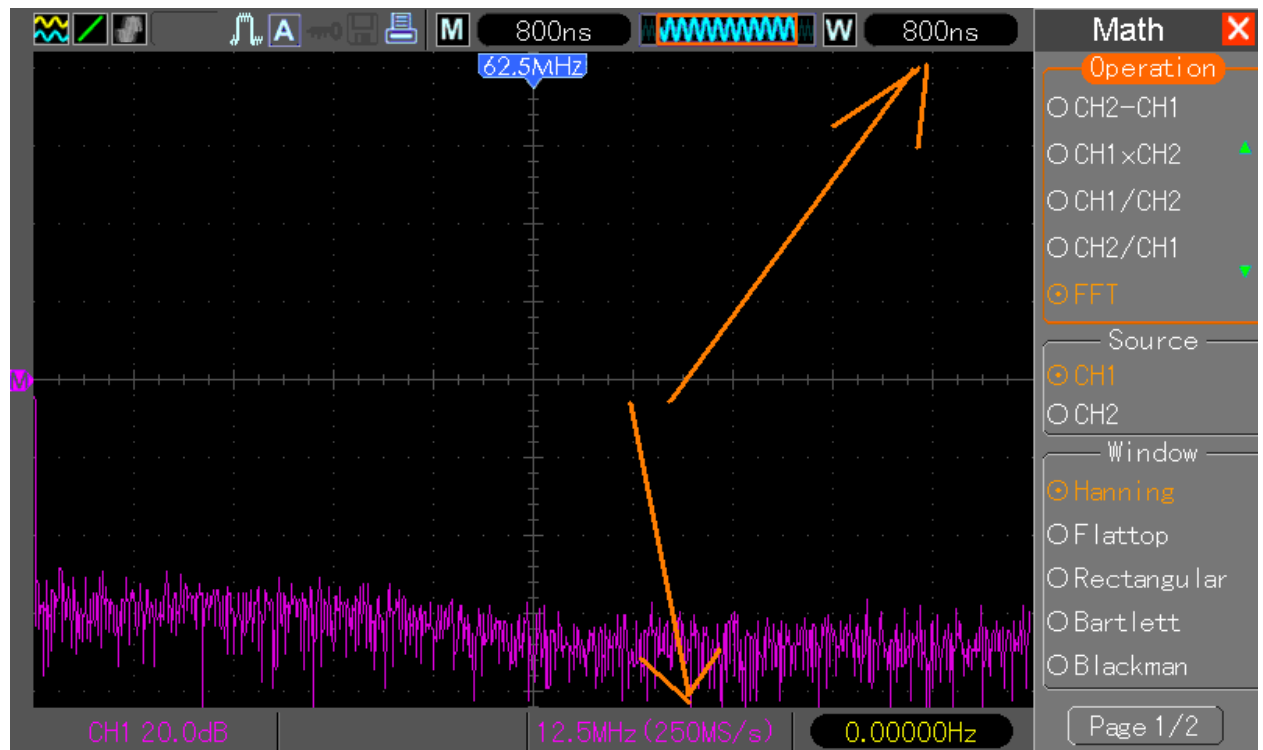
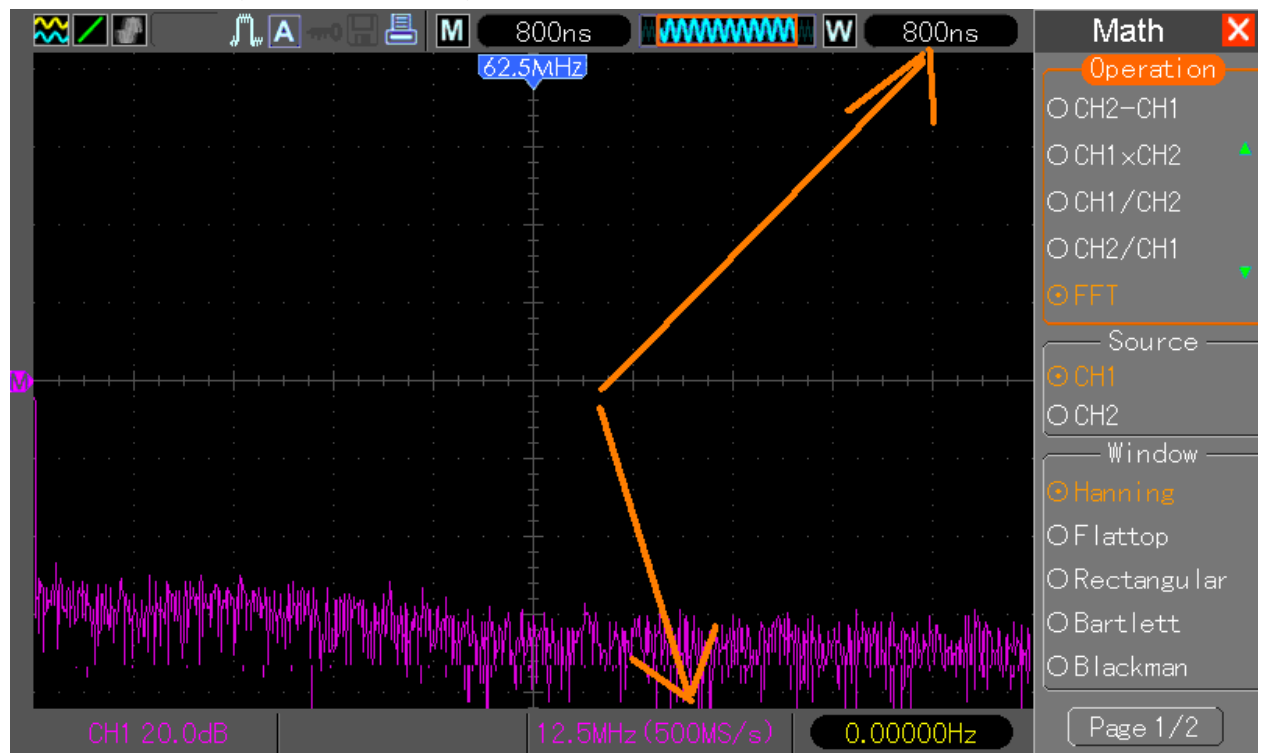
39. Within FFT the information in status bar is not always showing the proper sampling rate, sometimes even jumping from proper to bad value. As the FFT cursor is taking in count the sampling rate, the measure value might be not correct. Example random values in 800ns/DIV

FFT , here 100MS/s

then 250MS/s (but still 800ns/DIV)

and here 500MS/s (but still 800ns/DIV)

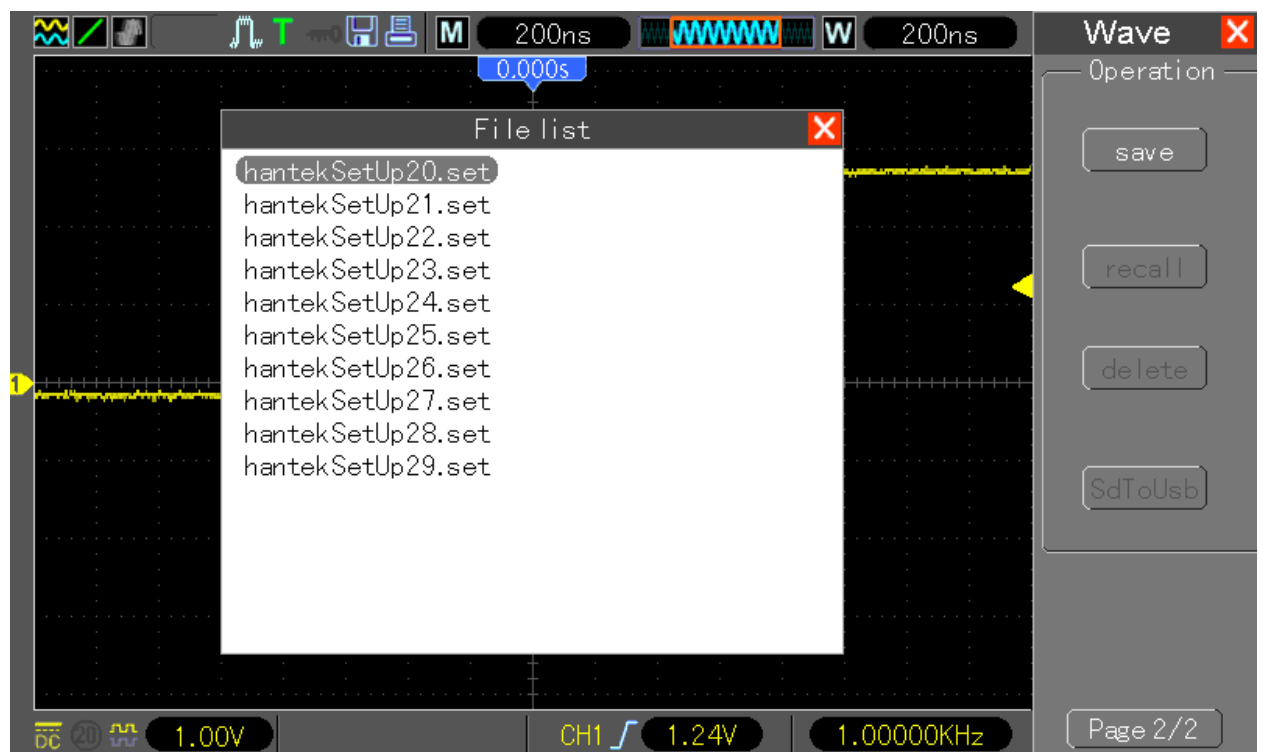
40. Flash Drive directory listing (in CSV Save/Recall and DSO Setup Save/Recall menus) is showing maximum 10 files. Additionally no option to scroll over the directory to choose other than one of the listed 10 files

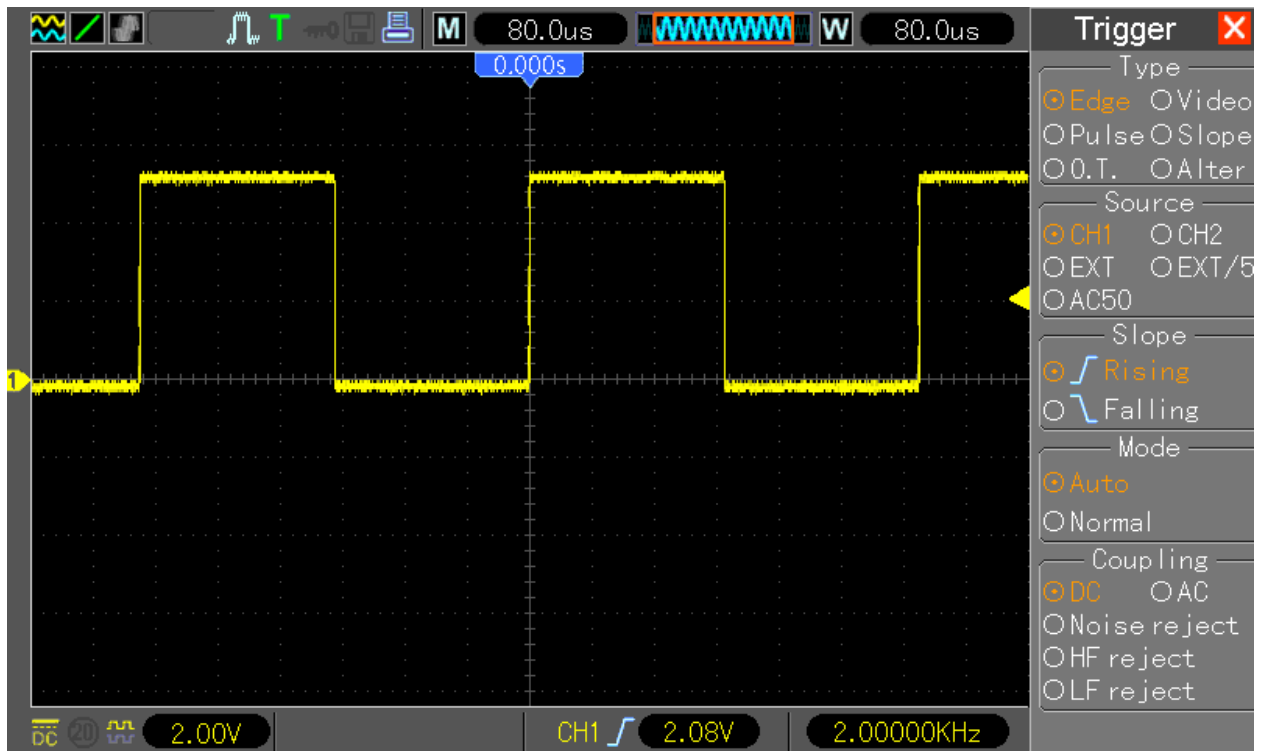
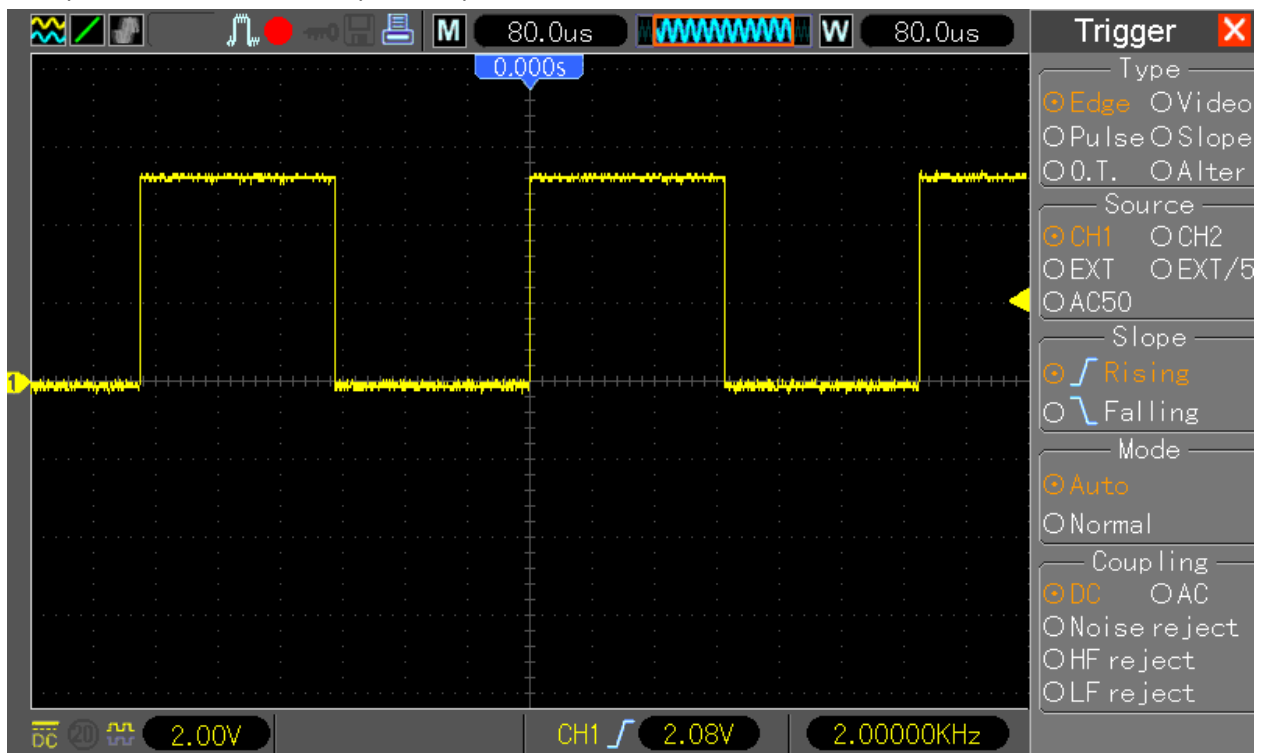
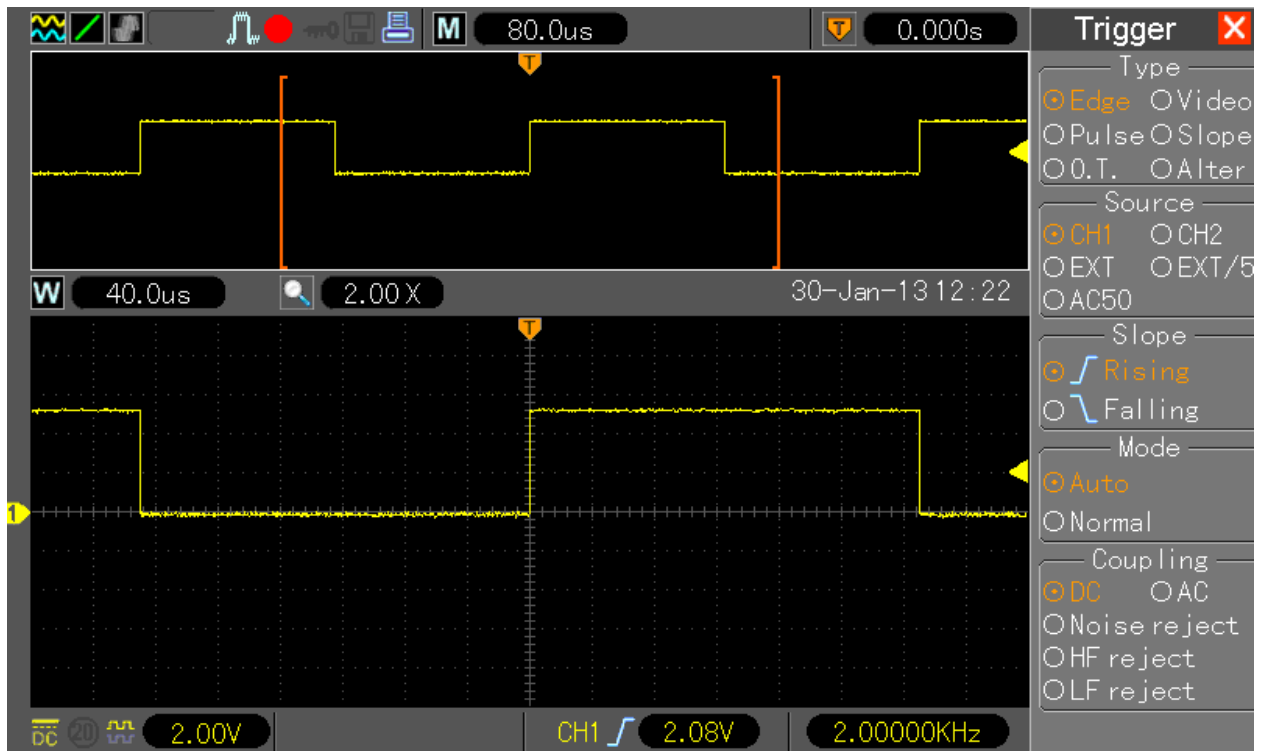
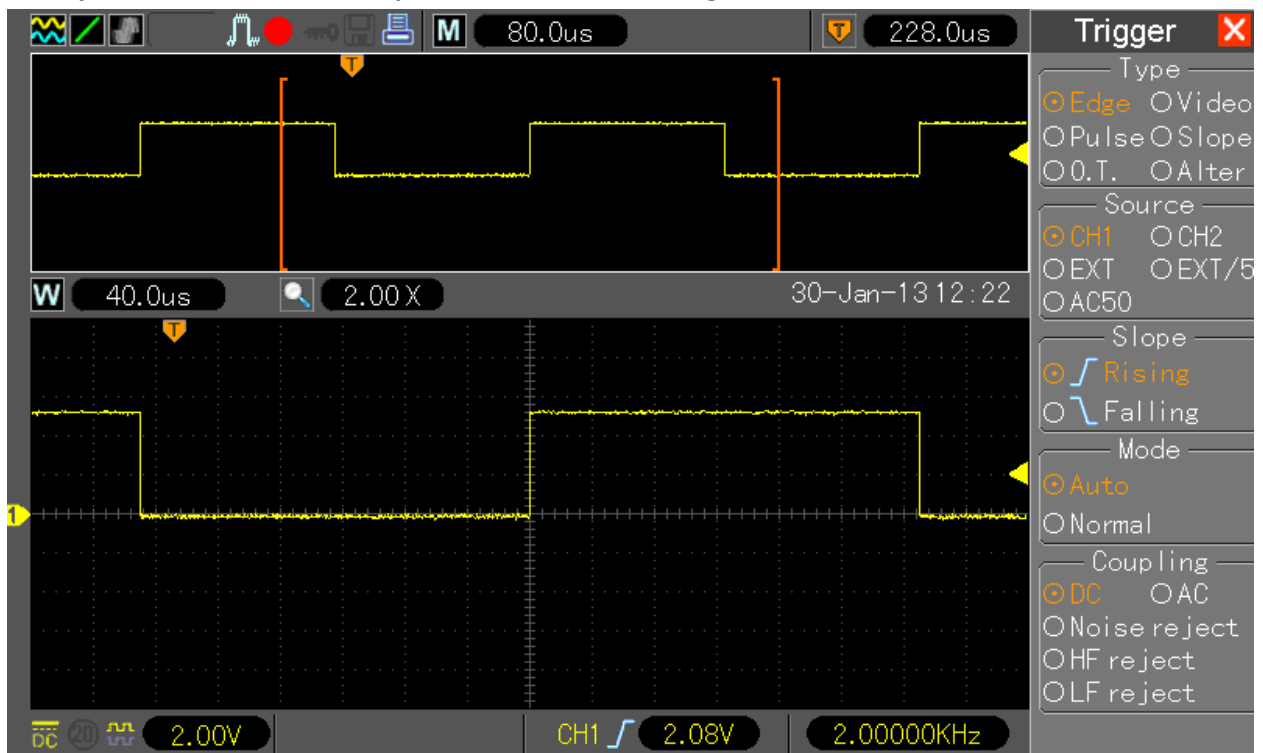
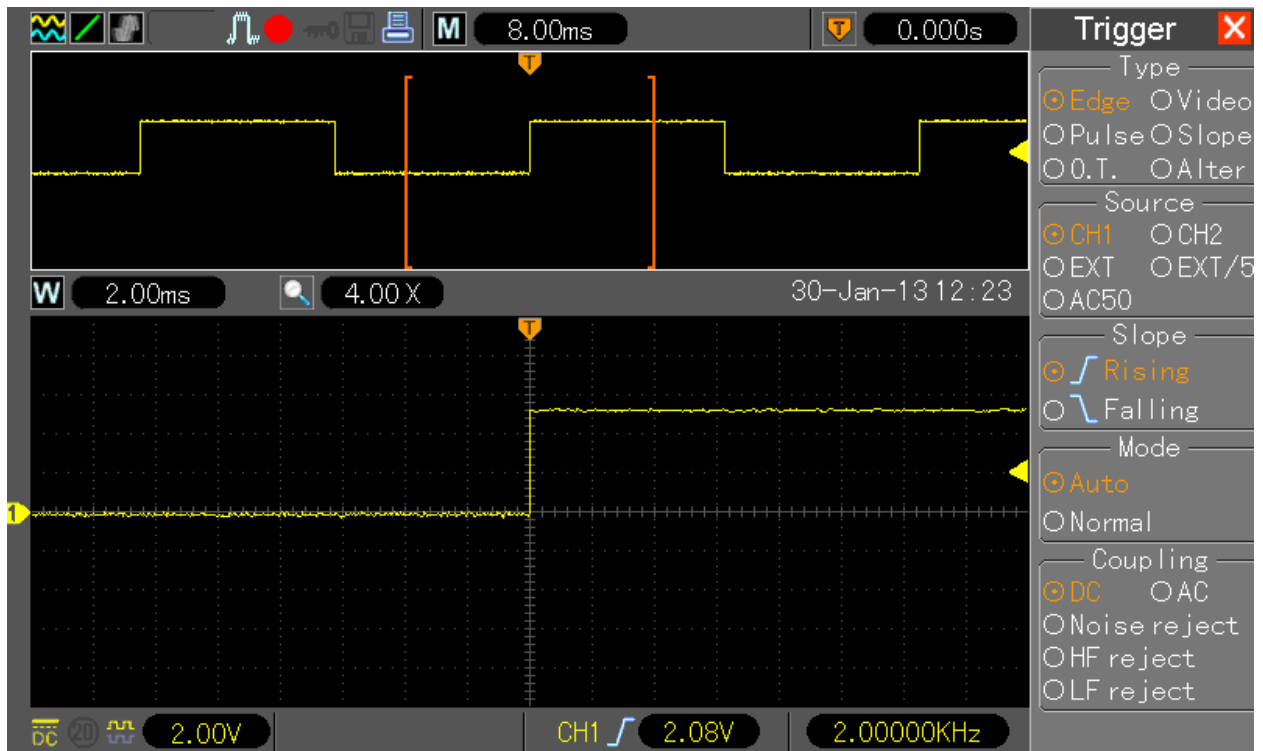
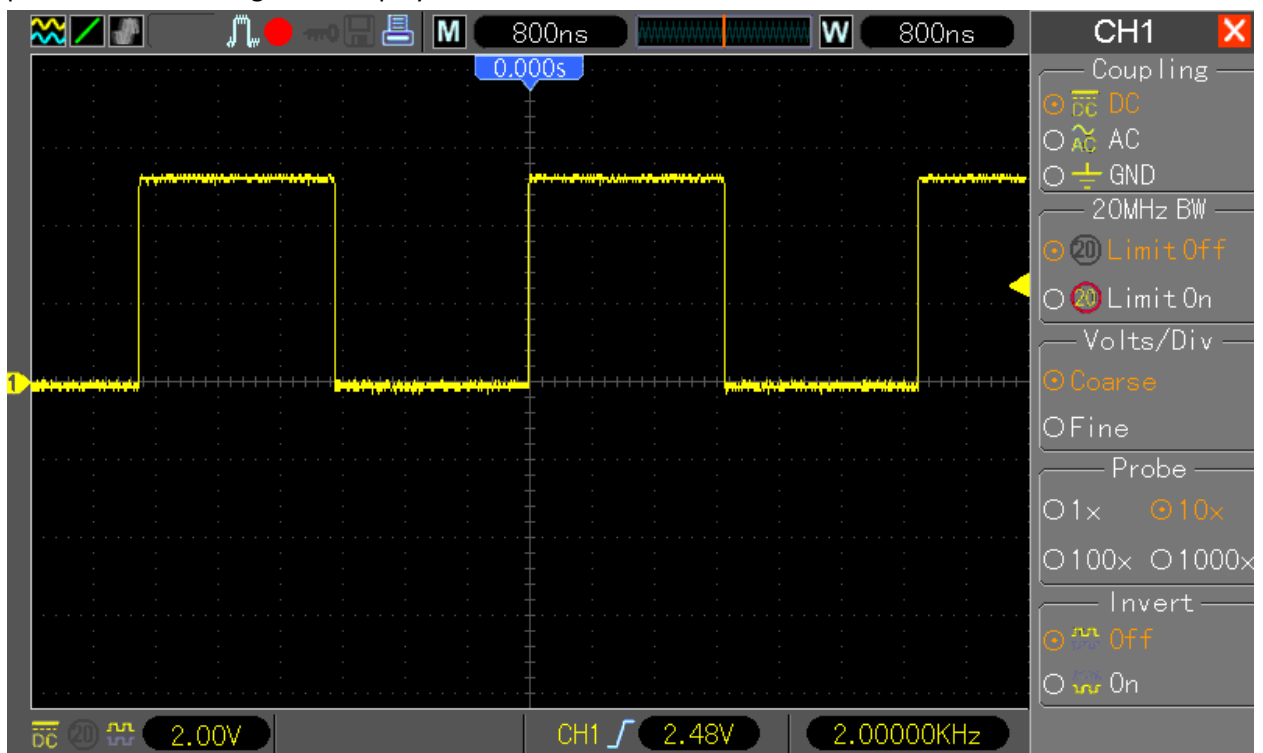
41. **This bug was already there in 2011, then it has been fixed. Now it's again there. This is one of the DSO basic functions; this bug is really annoying and need to be fixed FIRST.**  
 Apply any test signal, push "STOP" button to stop the Acquisition, e.g.:  
 now change to Dual Window by pushing F7, the Waveform disappeared from the Screen!!!:  
**UPDATED: In fw 130130, the waveform is not disappearing from window anymore, but is not usable at all, it can not be moved or zoomed, because it does not change on screen).**  
**UPDATED: In fw 130131, the waveform is not disappearing from window anymore; it can be moved and/or zoomed as well. However two small issues still there:**

The DSO should display 2.5 periods of the waveform:

now push "RUN/STOP" to stop the acquisition:

and push F7 to switch into dual window, the waveform seems to be, top window displaying properly 2.5 periods:

but try now to move horizontal position: wave not moving:

or try to change in MTB window (top window) the timebase, look on my picture, already 8ms/DIV but still only 2.5 periods displayed, so nothing refreshed on display:

or try to push again F7 to go back to single window mode, the waveform will be there but it can not be moved not changed by tuning timeabse knob, look on my picture, 800ns/DIV but still 2.5 periods from 1kHz signal on display:

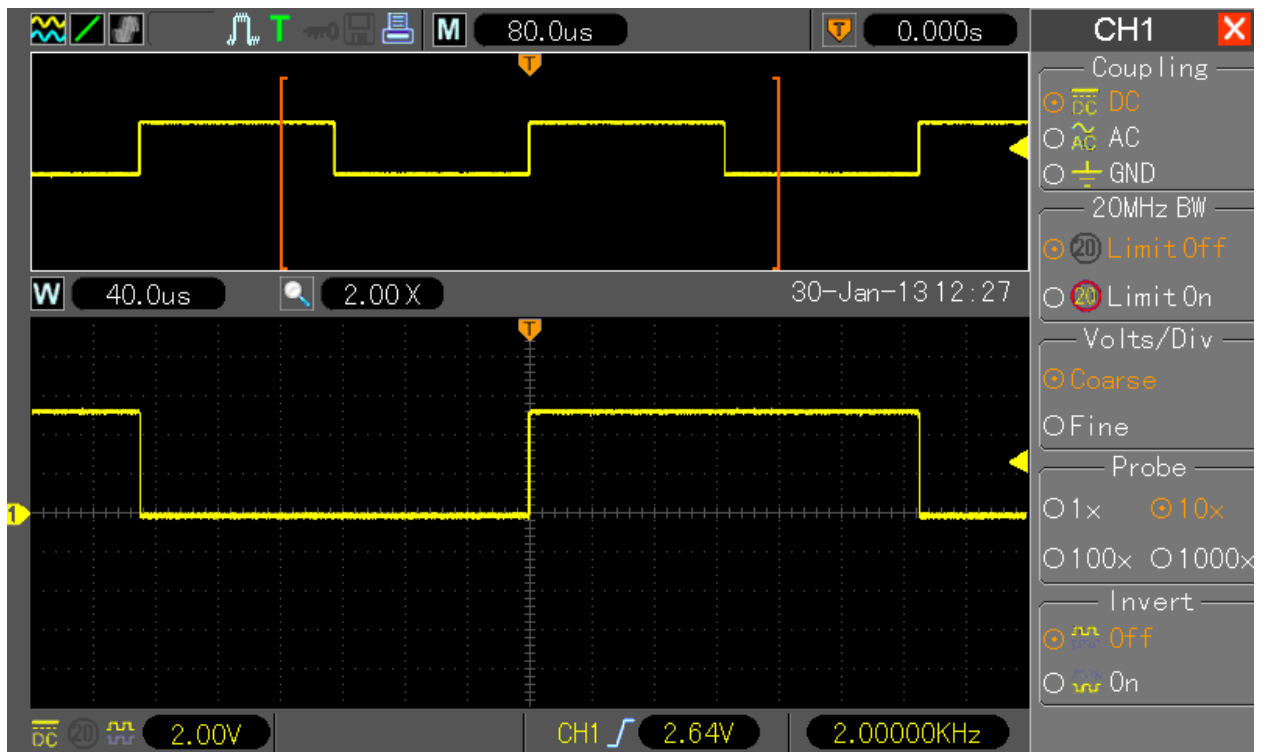
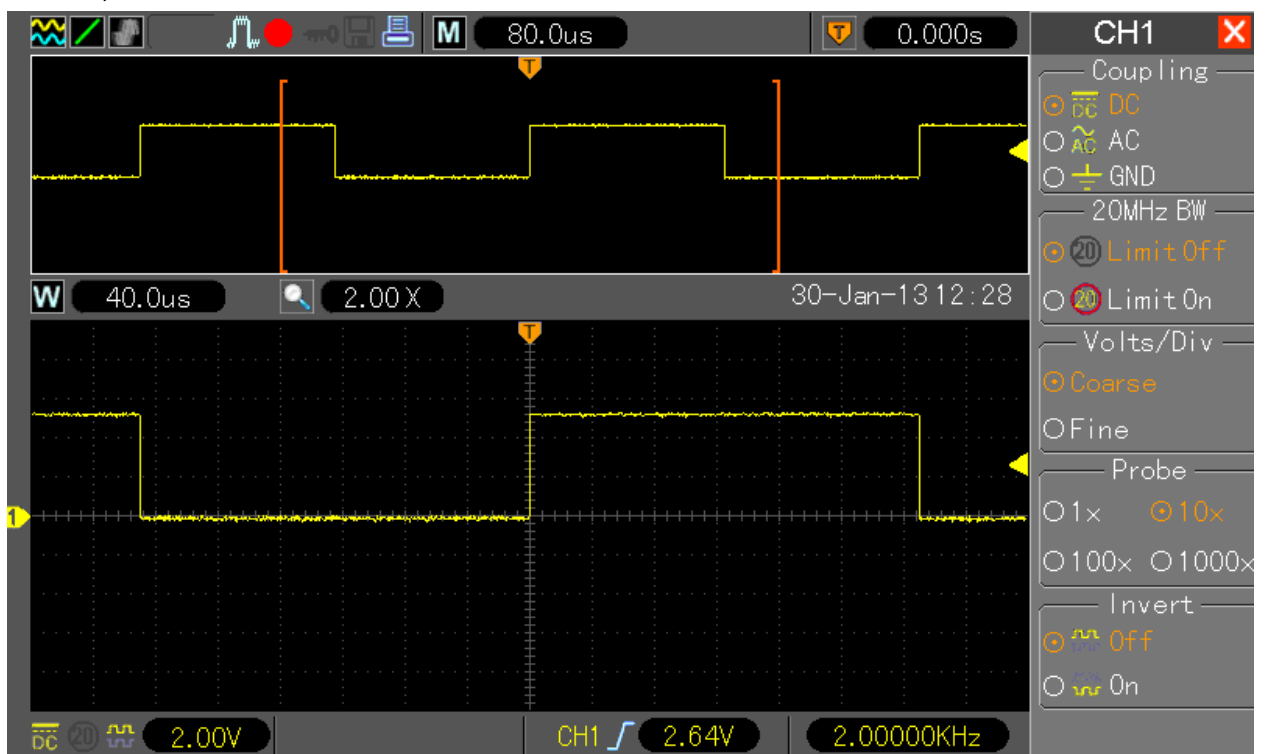
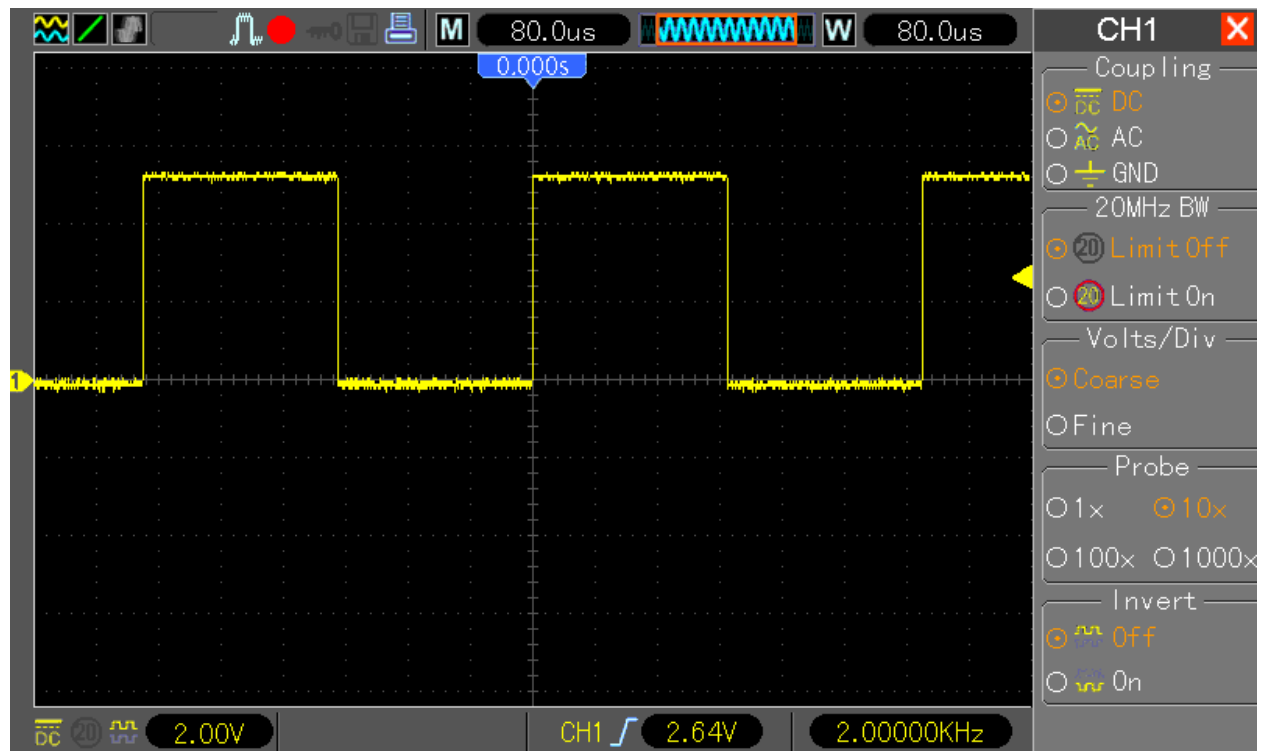
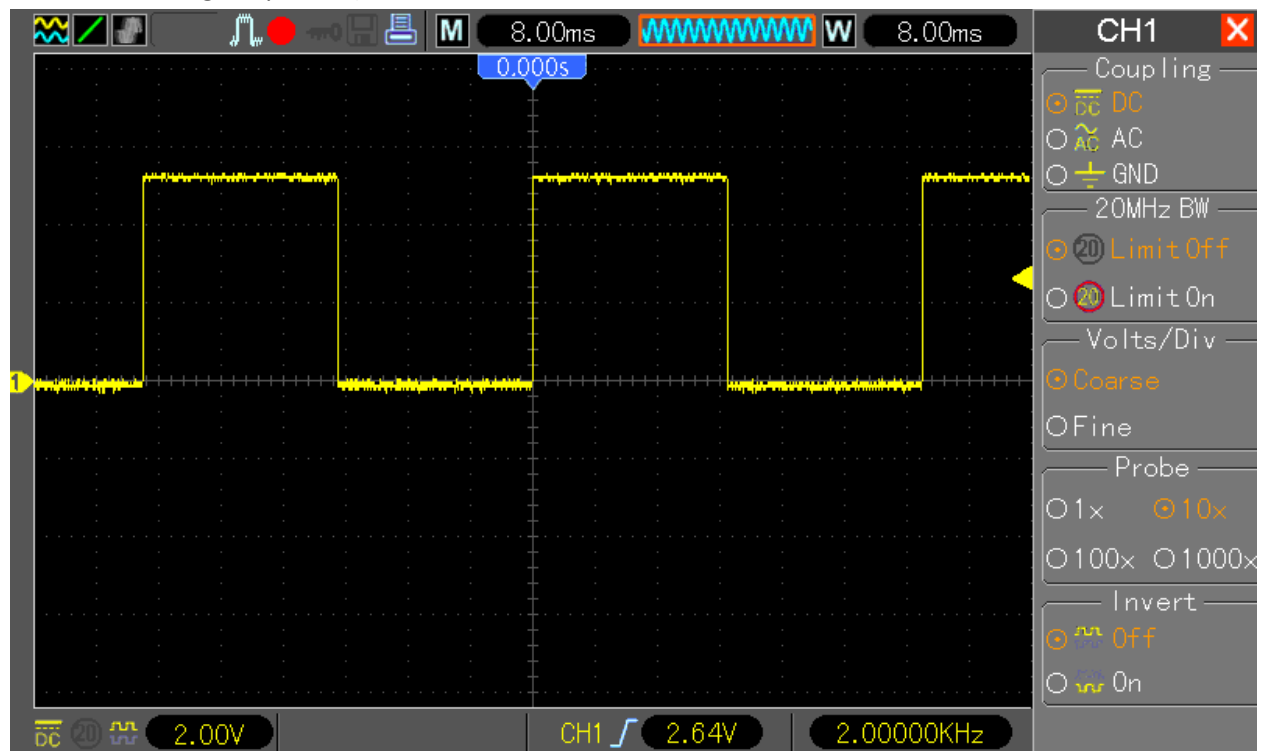
Set DSO to 1ch, 4k memory depth, signal generator to 2kHz square, timebase to 80ns/DIV, dual window mode enabled:

now push "RUN/STOP" button to stop acquisition, the waveform is still ok, can be moved or zoomed, etc:

push now F7 to switch to single window mode, the waveform seems to look ok:

but when you try to move it, or turn timebase nothing changing (see my picture, 8ms/DIV but DSO still showing 2.5 periods):

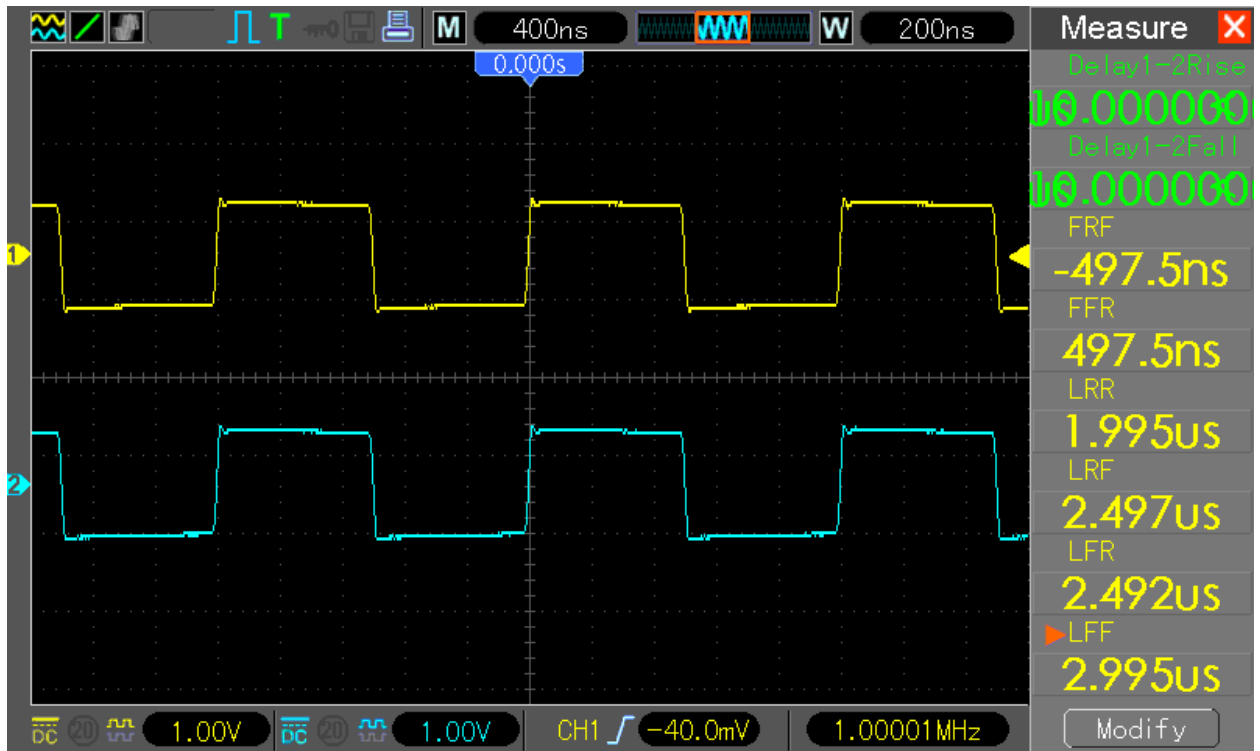
42. Measurement “Delay1-2Rise” and “Delay1-2Fall” displaying too long (wrong) result when the delay is equal zero (no delay):

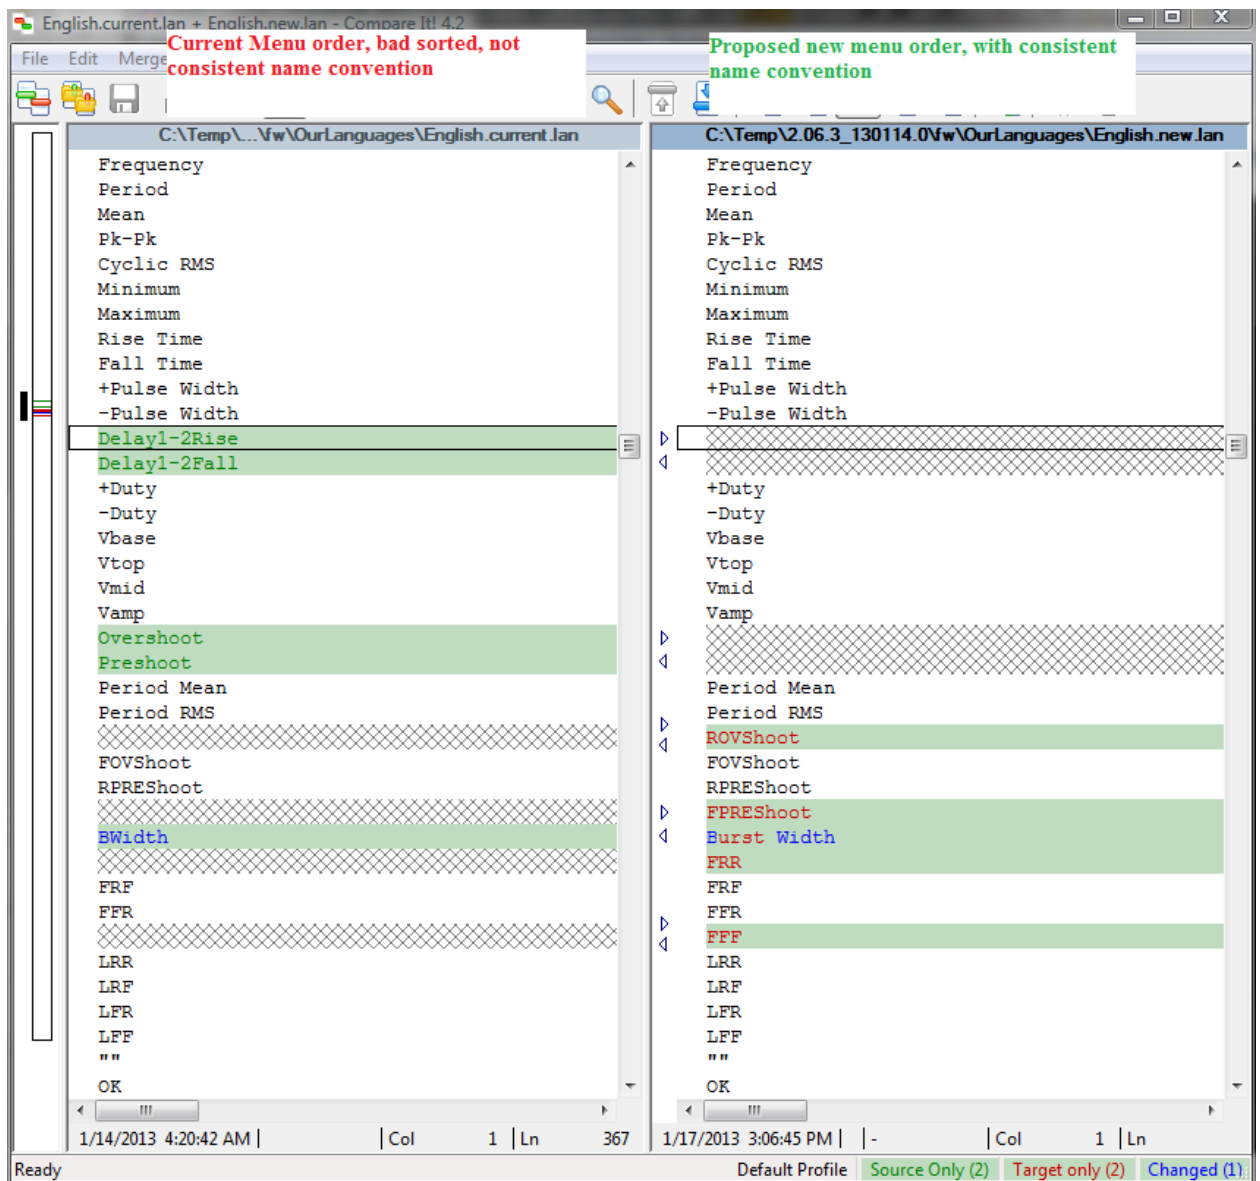
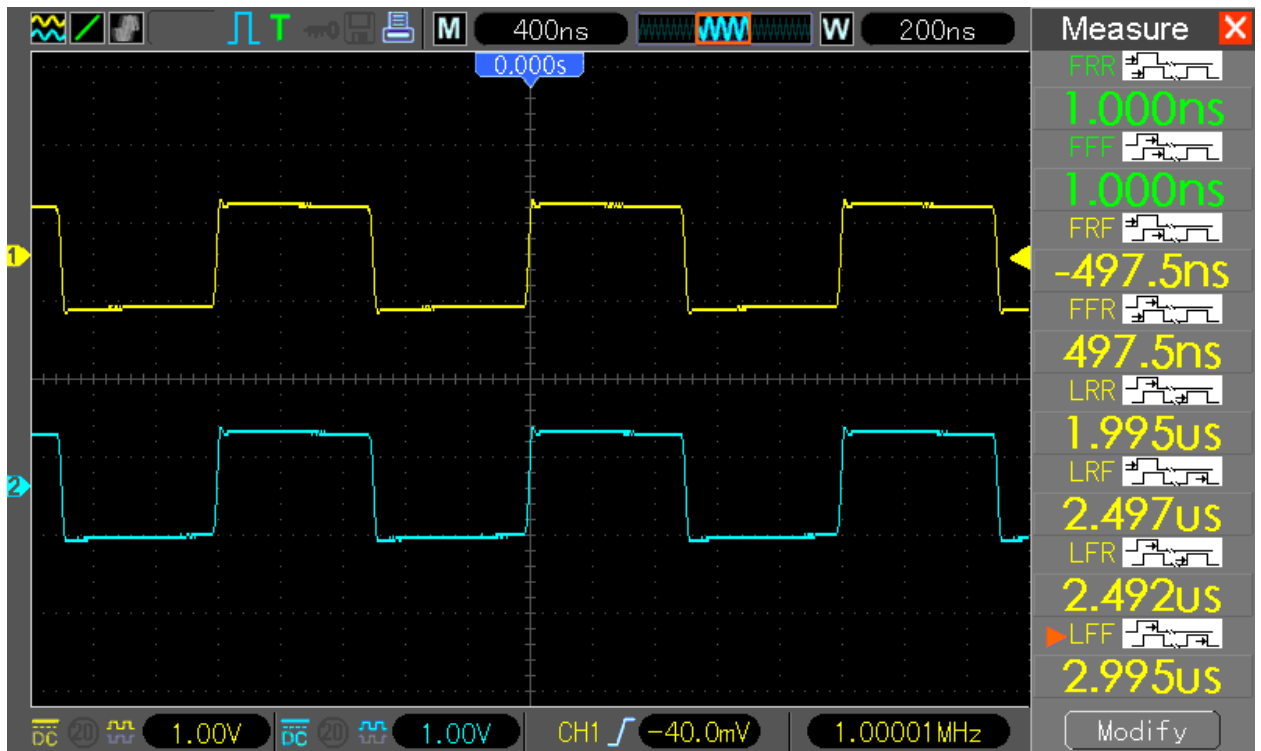
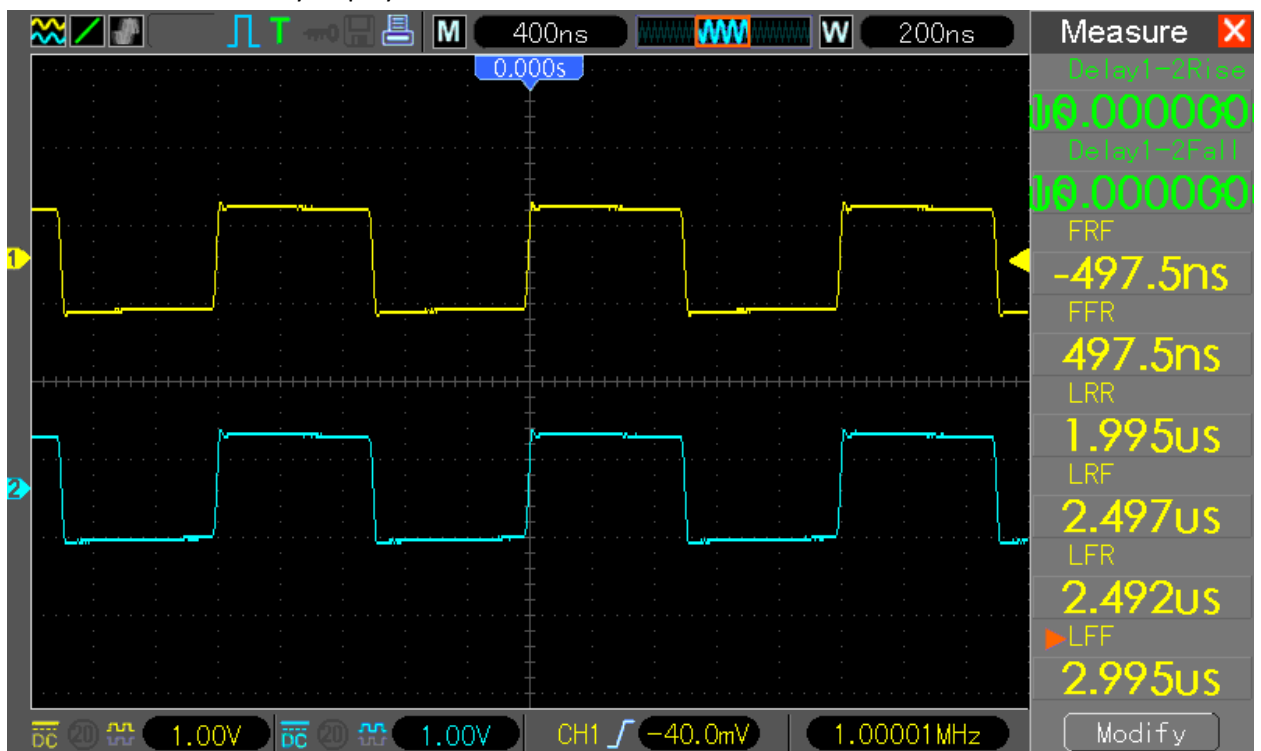
43. The current Measurement menu not consistent (sorting/name convention) and hard readable.  
New proposed sorting and name convention :

The measure menu can then looks like following picture :

instead of what currently displayed:

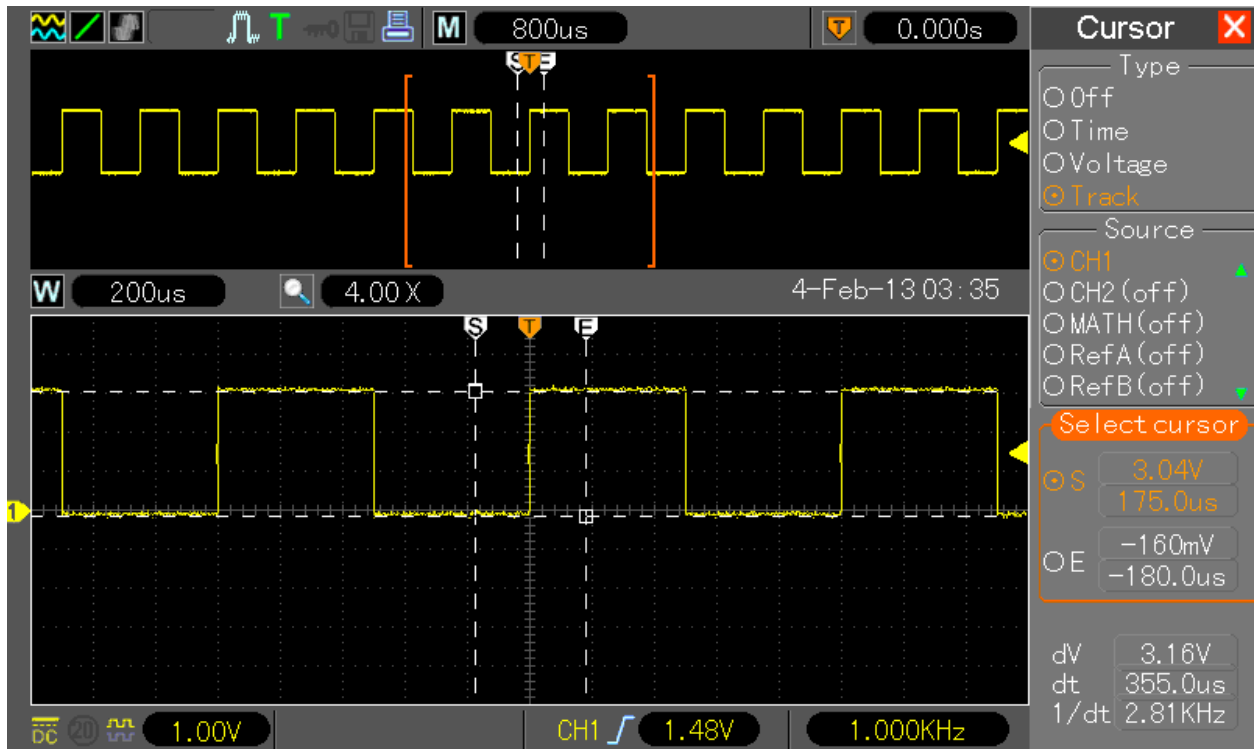
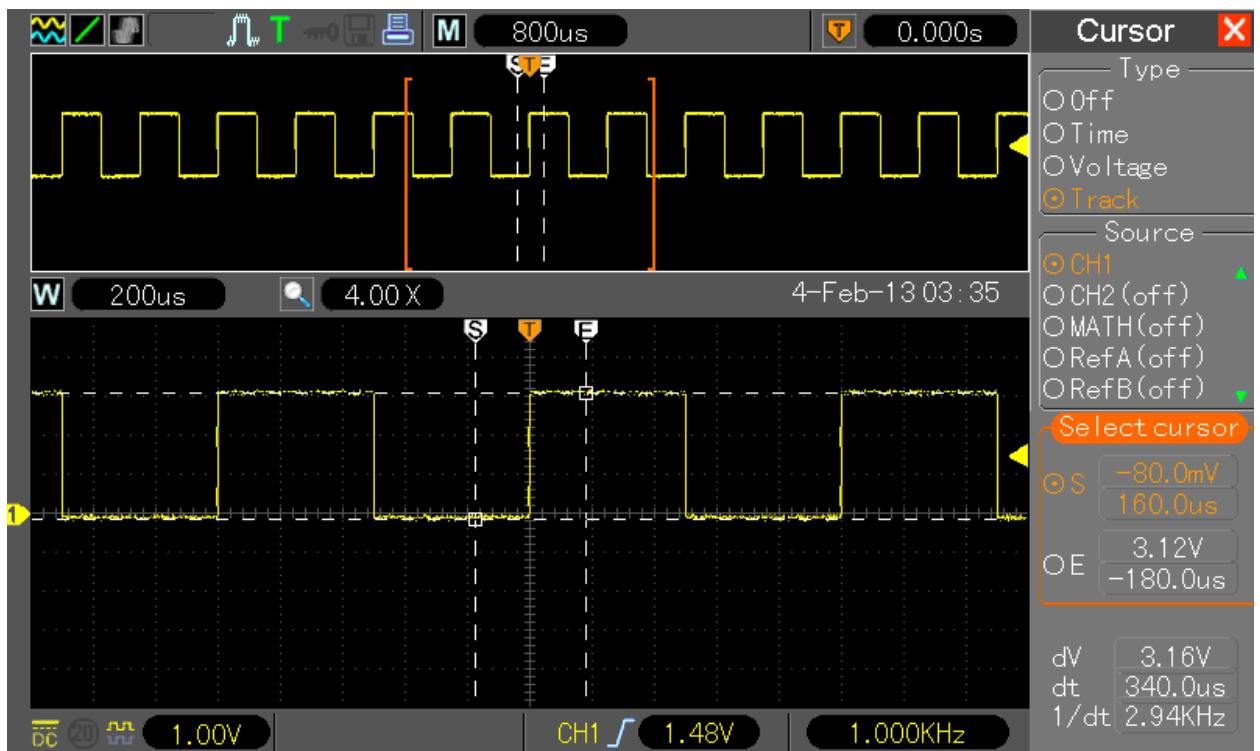
47. Tracking cursor not working when Zoom (W) window focused

When Main Windows selected (M) the tracking cursor however works good:

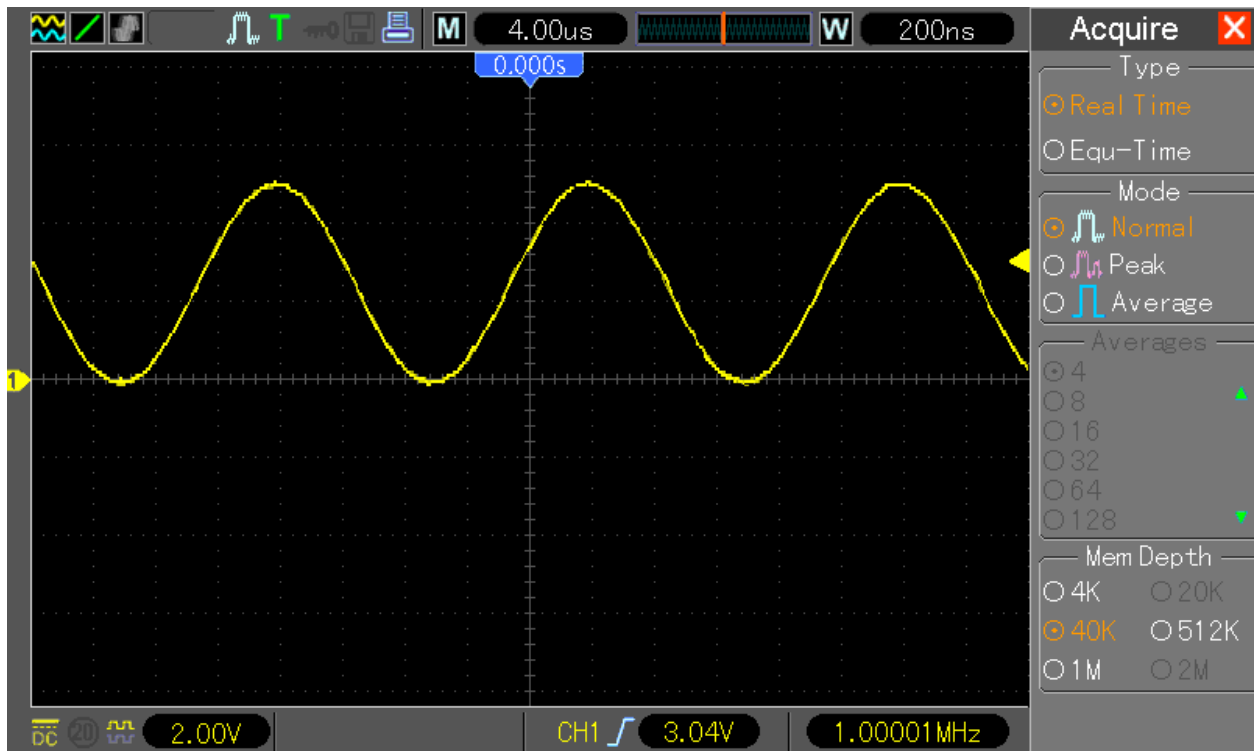
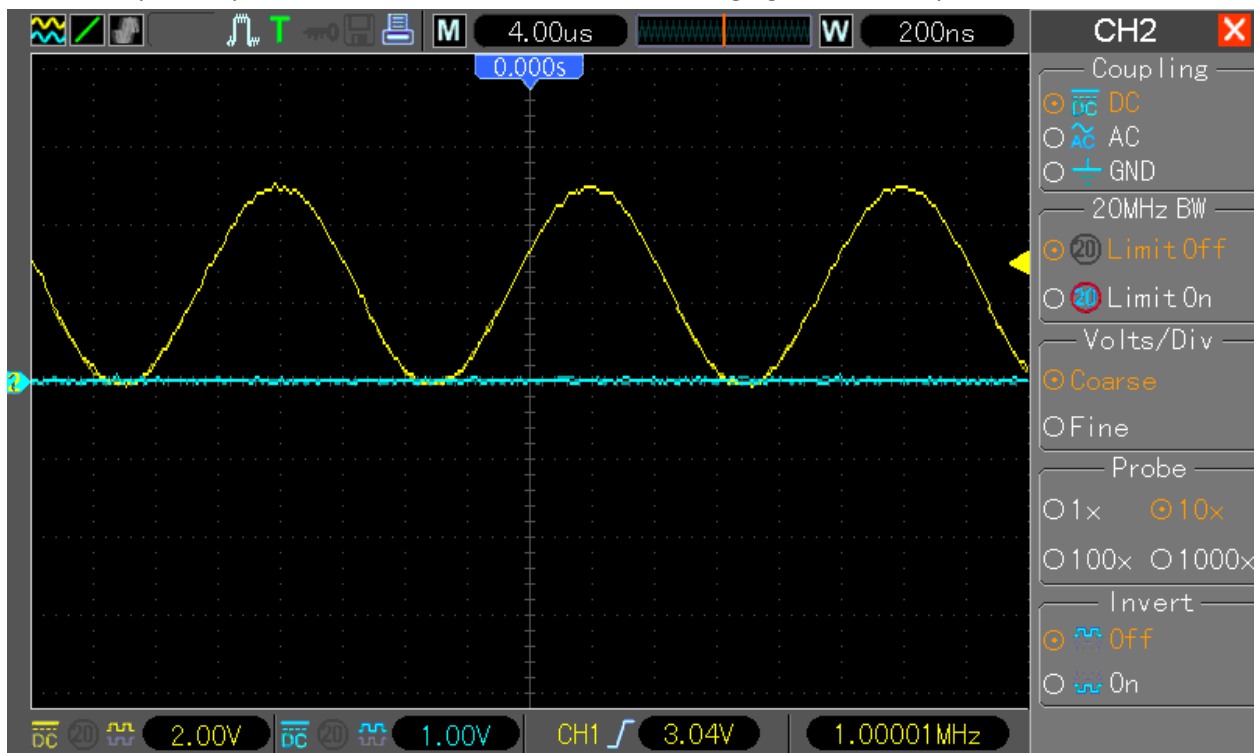
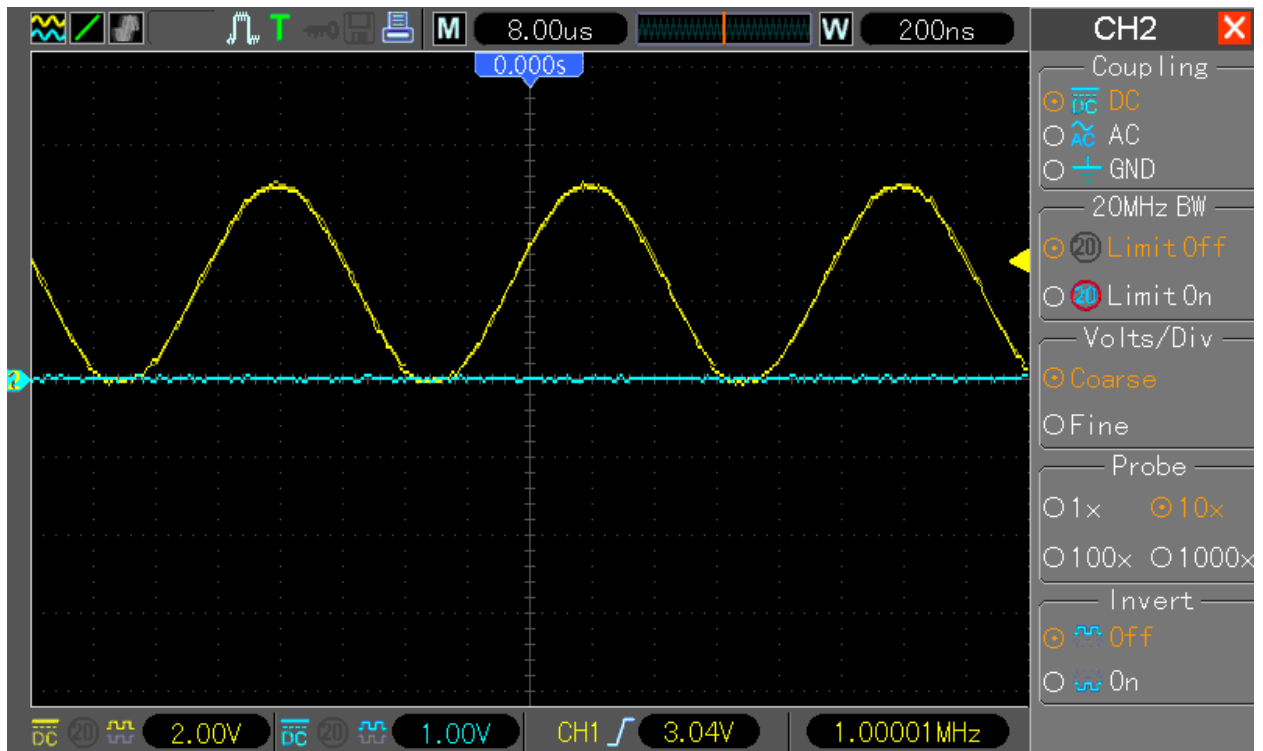
48. When changing memory depth, the MTB is not changing automatically together. Set following on DSO, 4k, 1ch, 200ns/DIV MTB:

when you turn now timebase now one position up and down the MTB is displaying proper value, 4us/DIV:

Additionally when you enable now ch2, the value is not changing automatically to 8us/DIV:

you have to turn again timebase knob one up and down position to get display updated to proper value which is in this example 8us/DIV:

All these error are as well when changing from 40k to 512k and from 51k to 1M.
