## Firmware 2.06.3 bug list:

## List of bugs/improvement requests

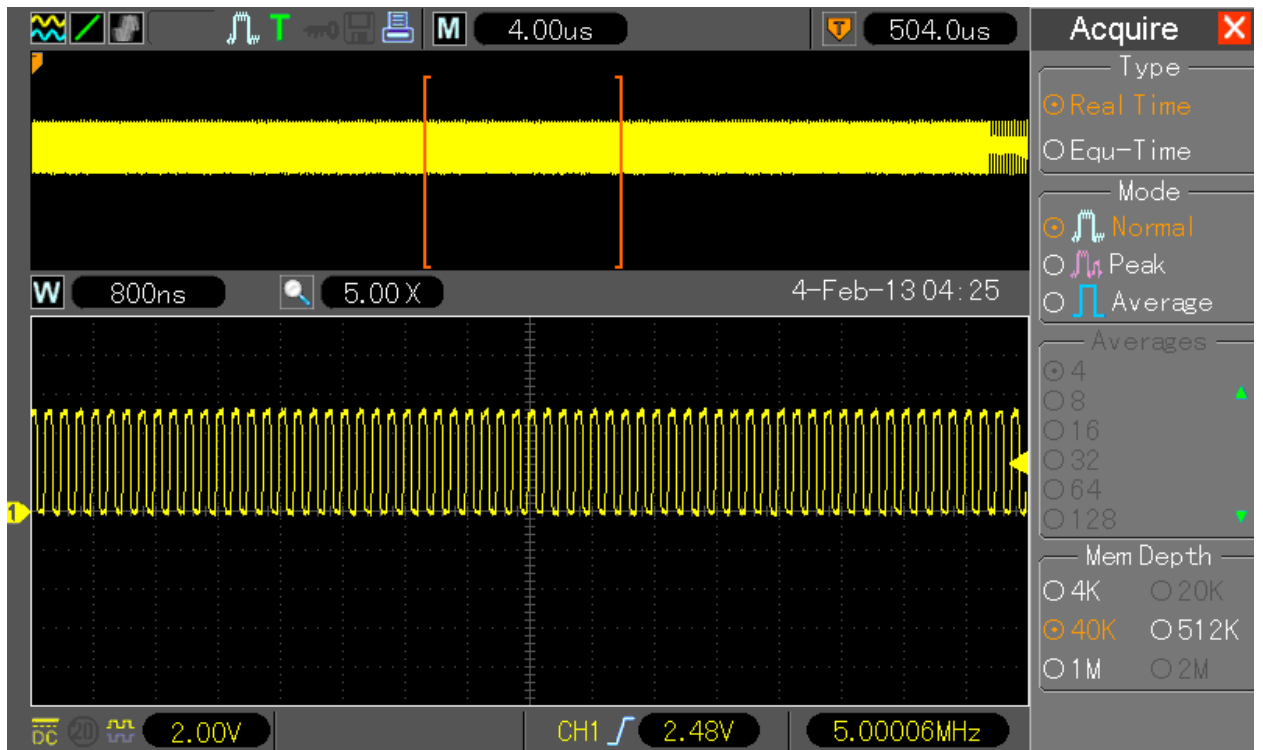
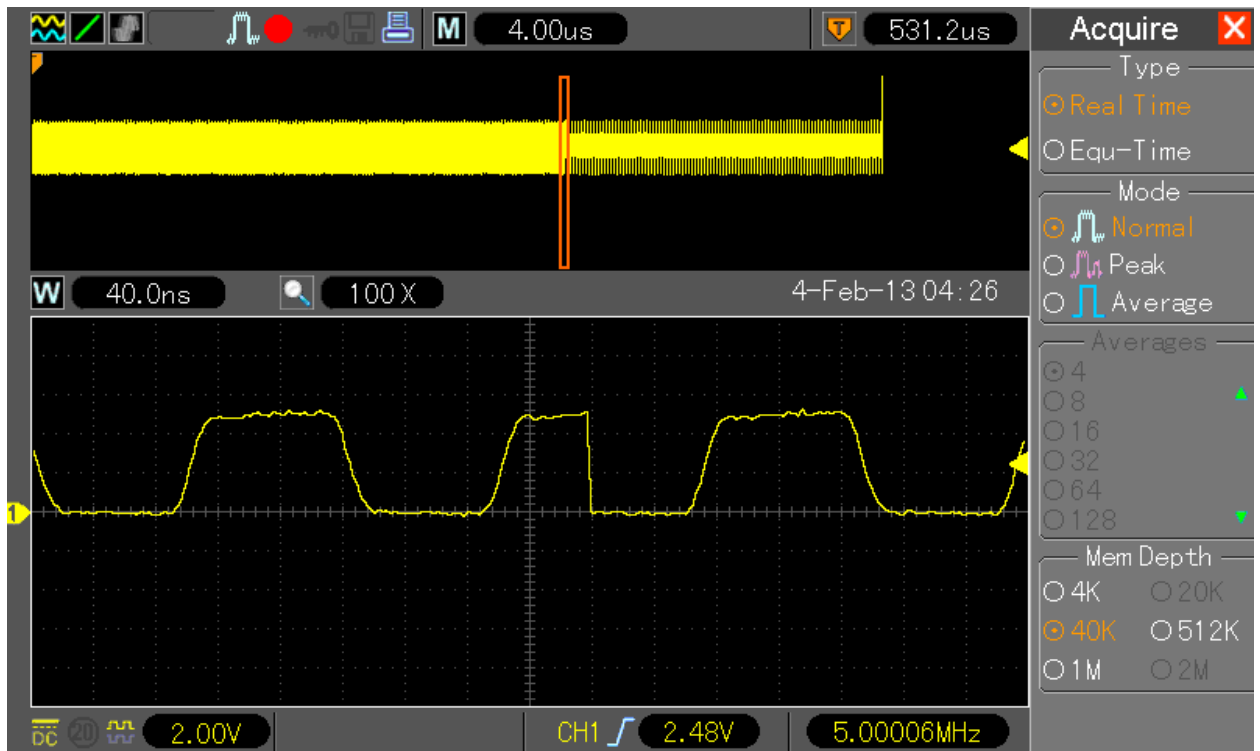
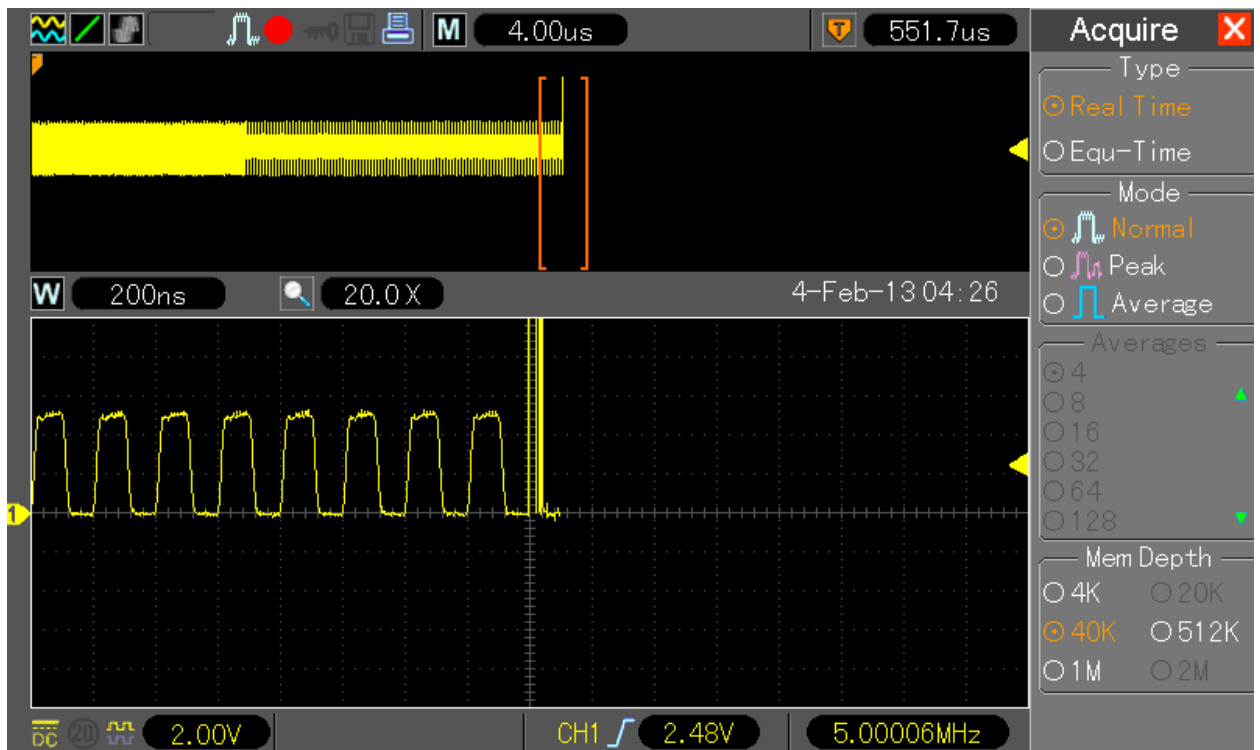
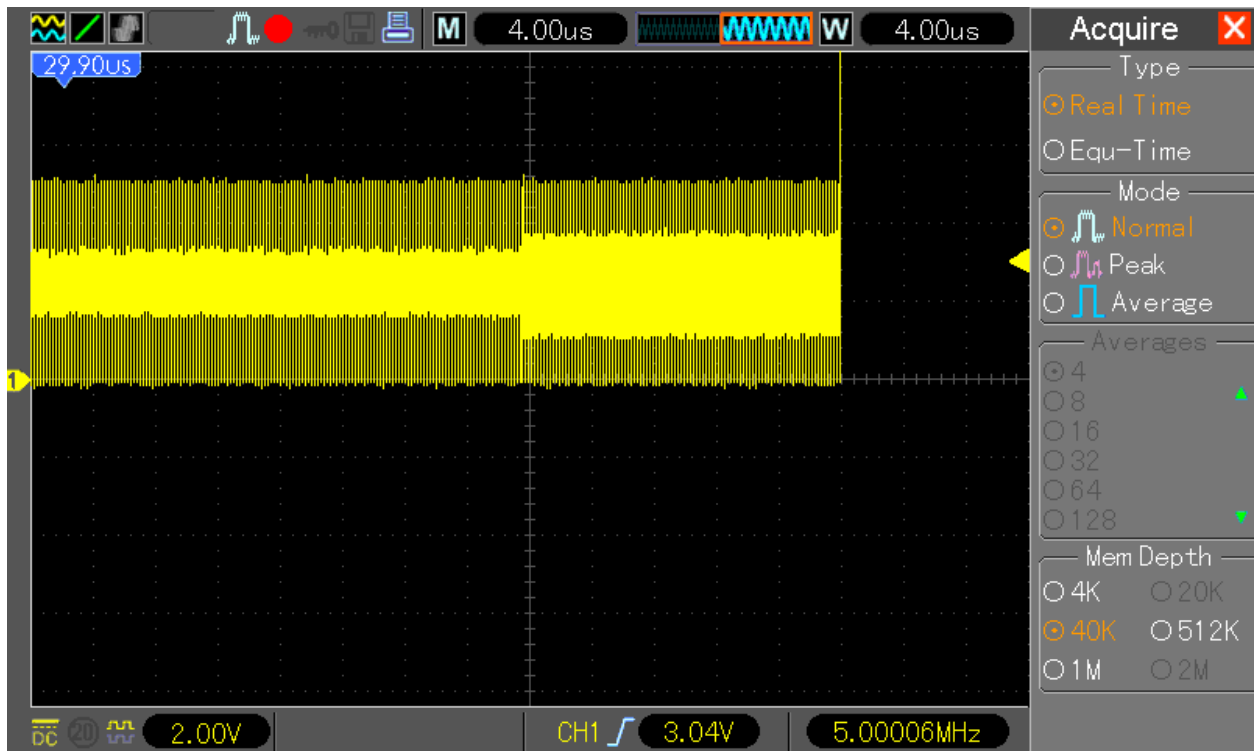
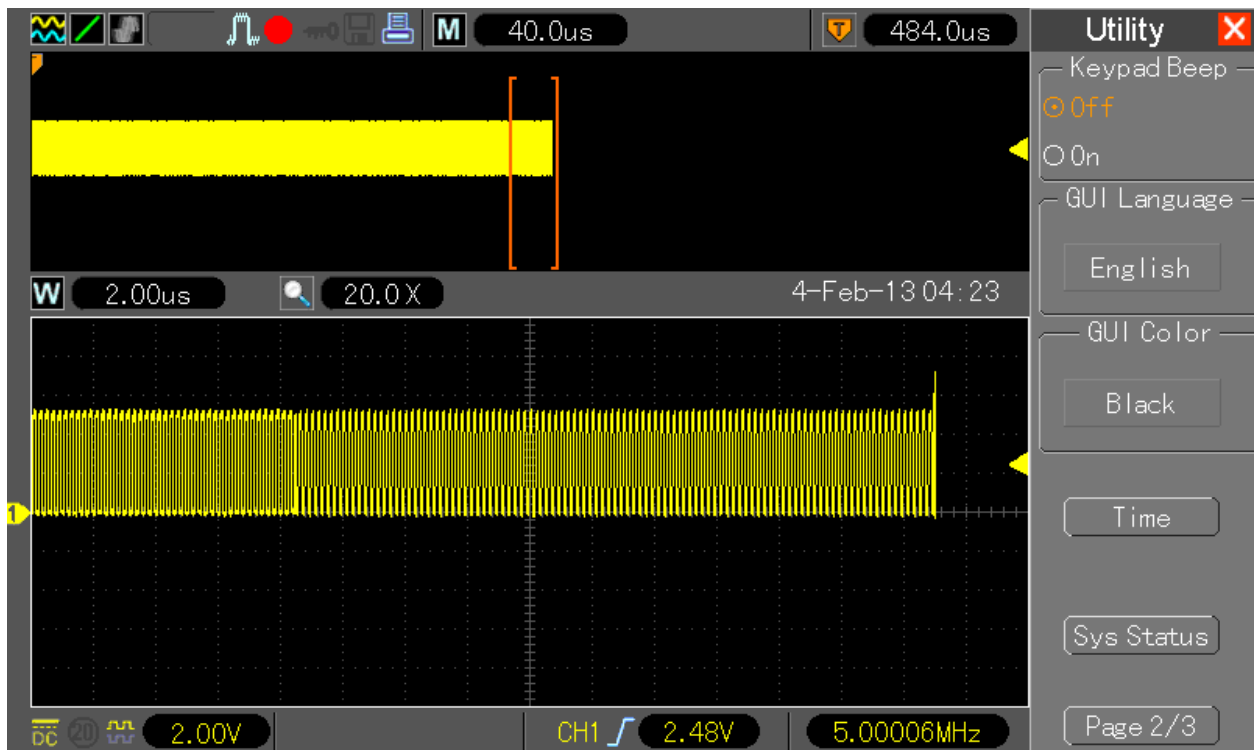
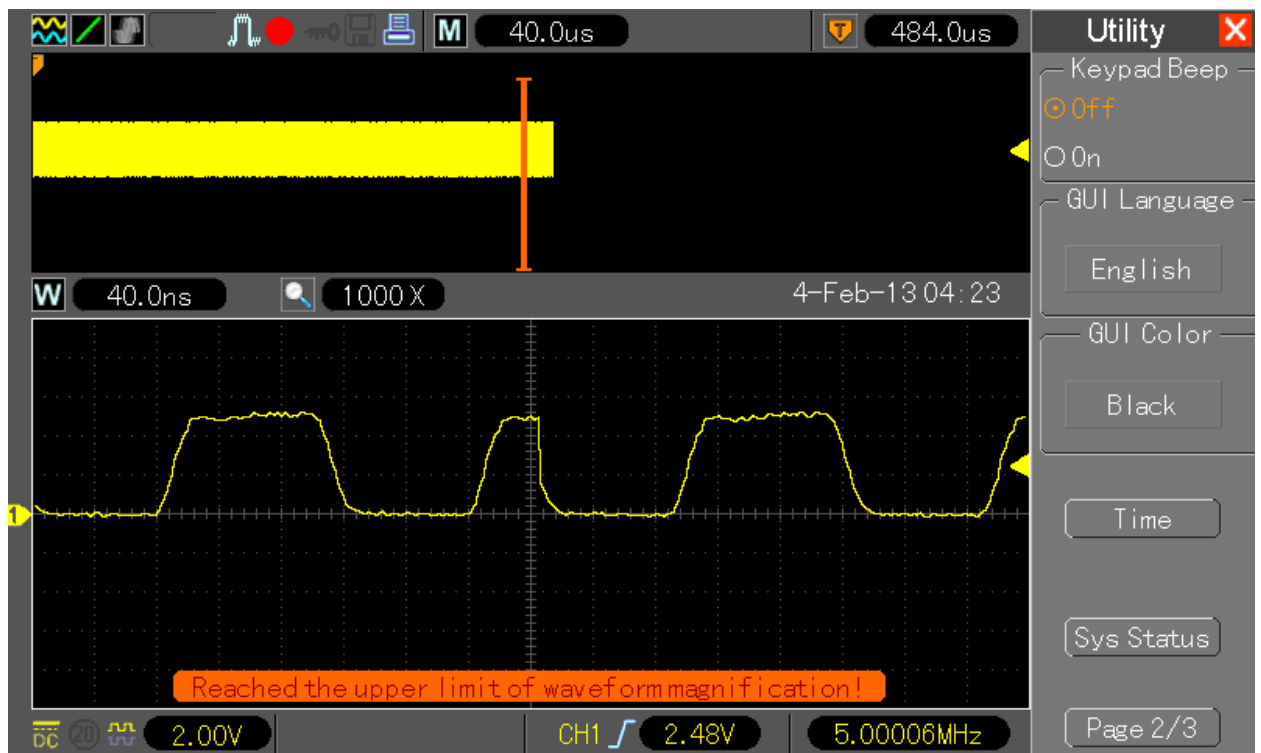
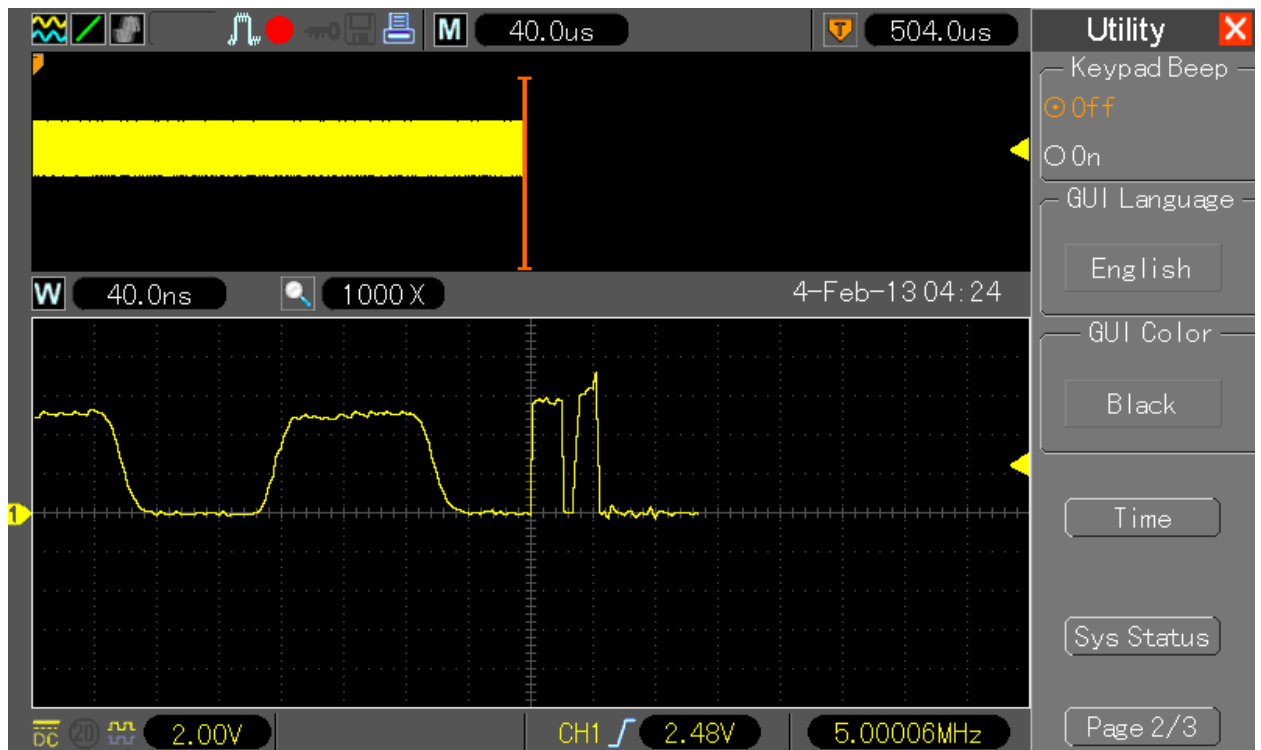
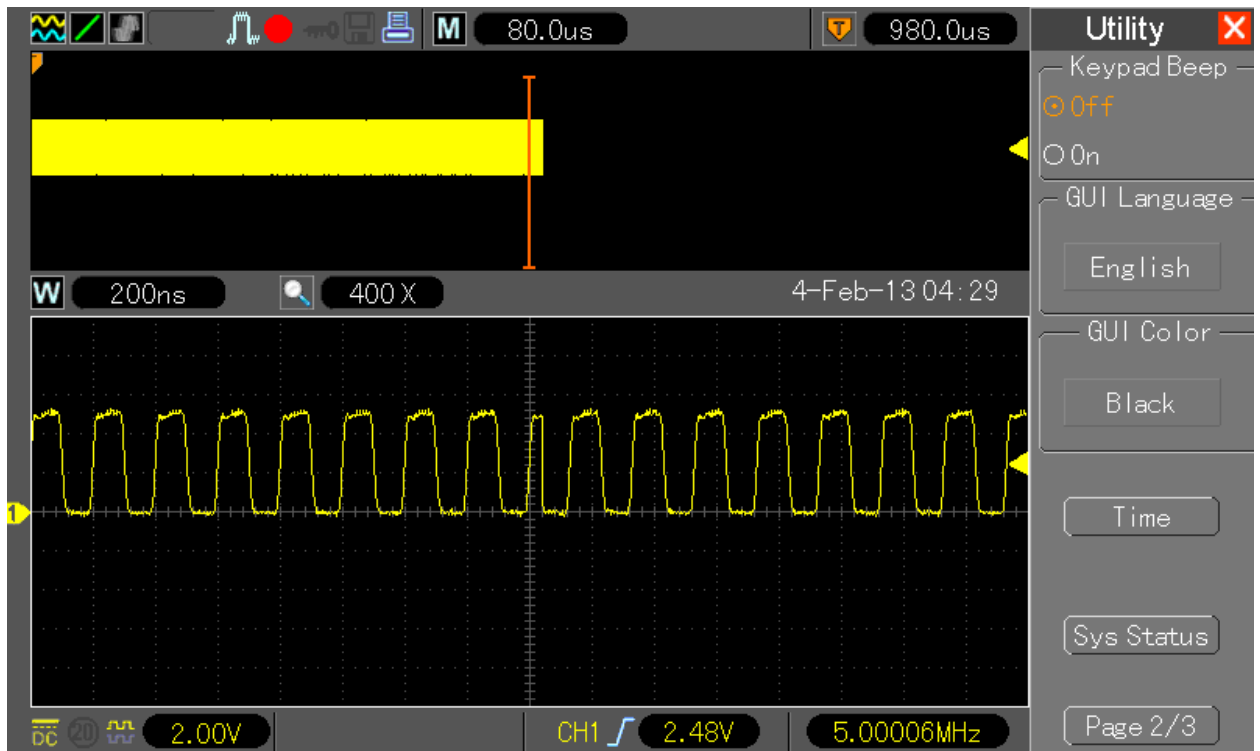
49. Artifacts on display when sampling with 400MS/s. Set 40k and 4us/DIV:

on the right part of the picture you can already see different waveform, when you move and zoom you see what's wrong:

Of course the same is visible in single window mode, so it does not have anything to do with window mode:

Same kind of error in 512k memory selection and 40us/DIV:

and as well in 1M and 80us/DIV:

It seems that no matter if the DSO is sampling with 200MS/s, 400MS/s or even 500MS/s (I played a bit deeper) the error is there in 40k, 512k and 1M always somewhere at the end of buffer (up to last ~ 3%).

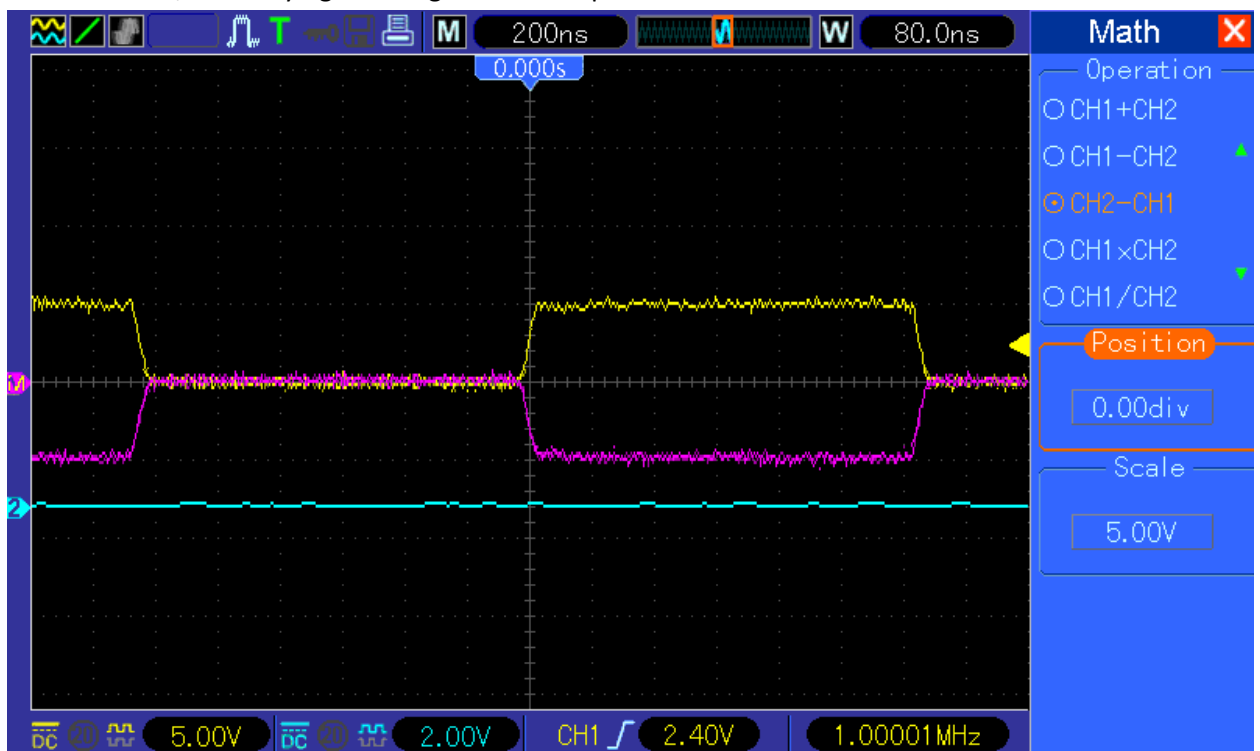
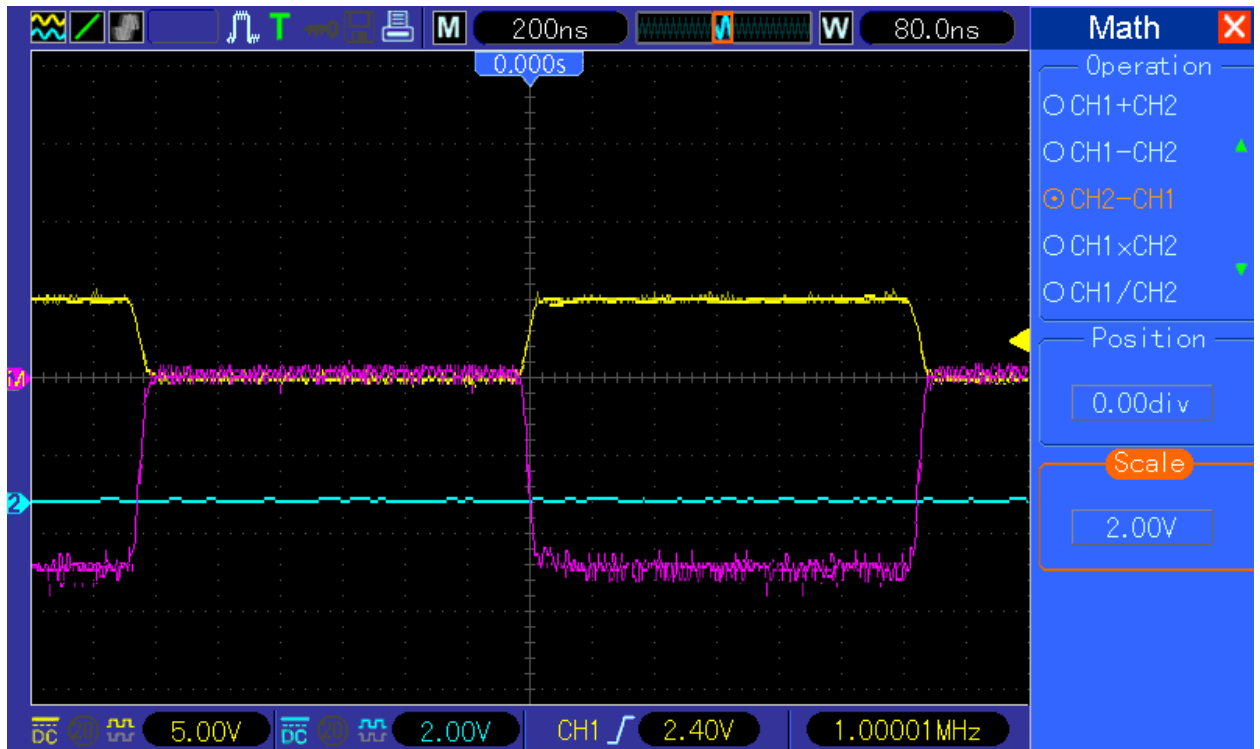
50. In Math menu, when trying to change waveform position with V0 knob:

the value of “Position” is not changing. Additionally the focus is jumping to “Scale” from “Position” and the value changing there:

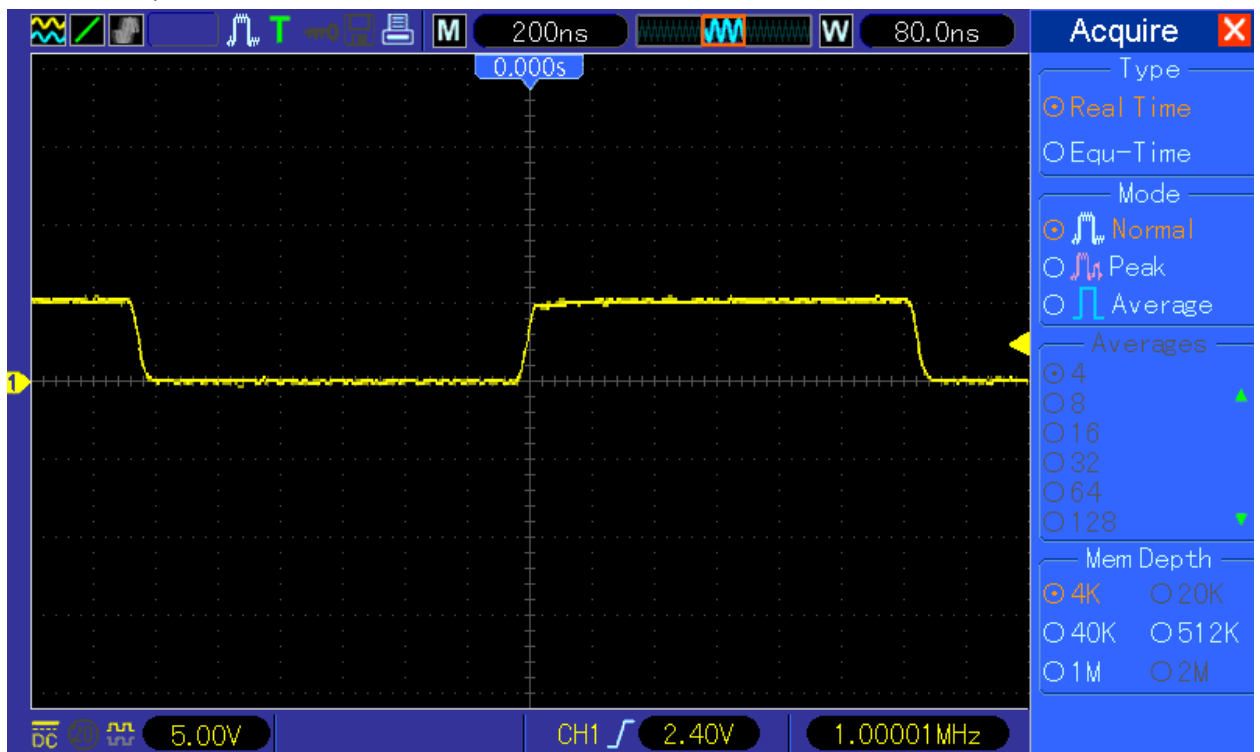
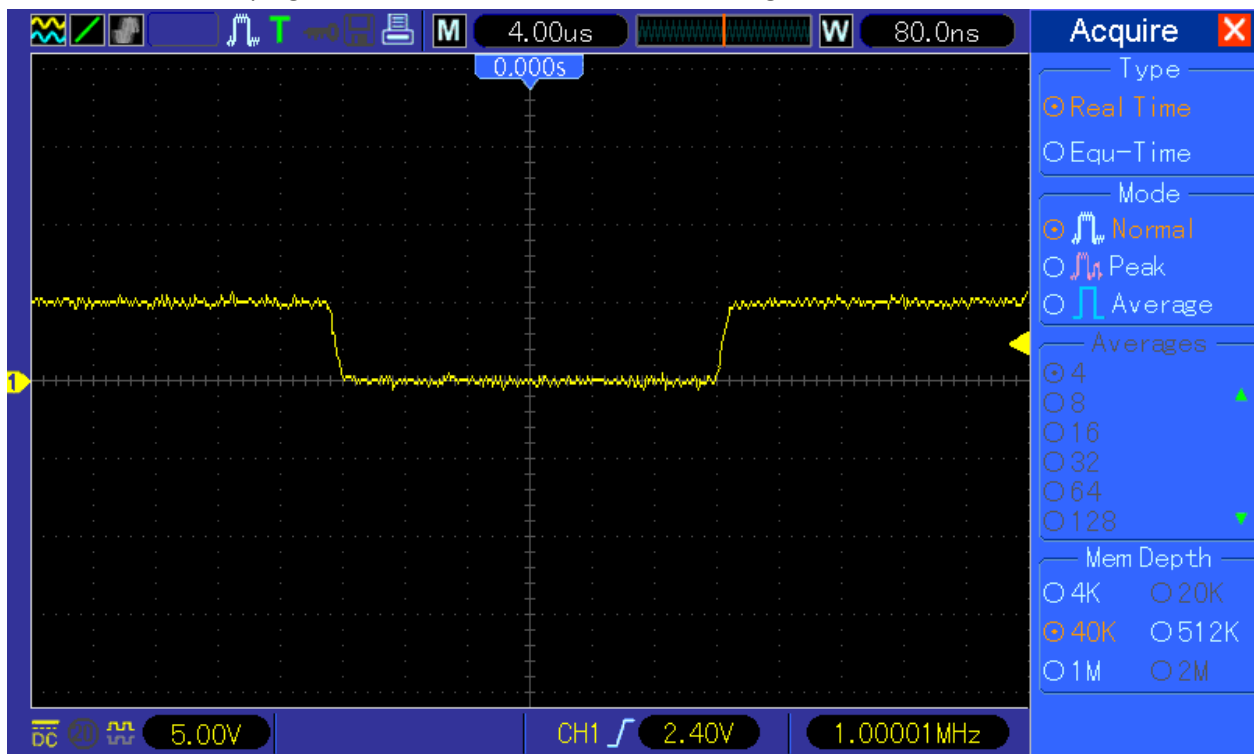
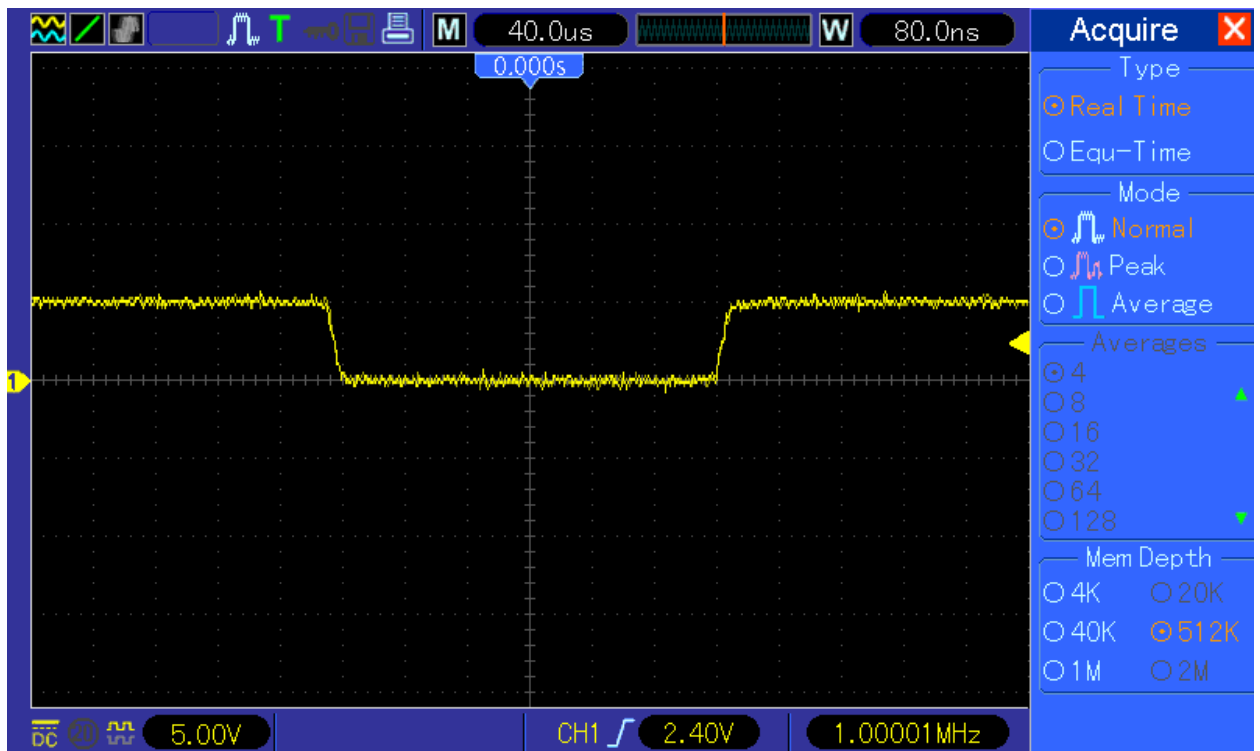
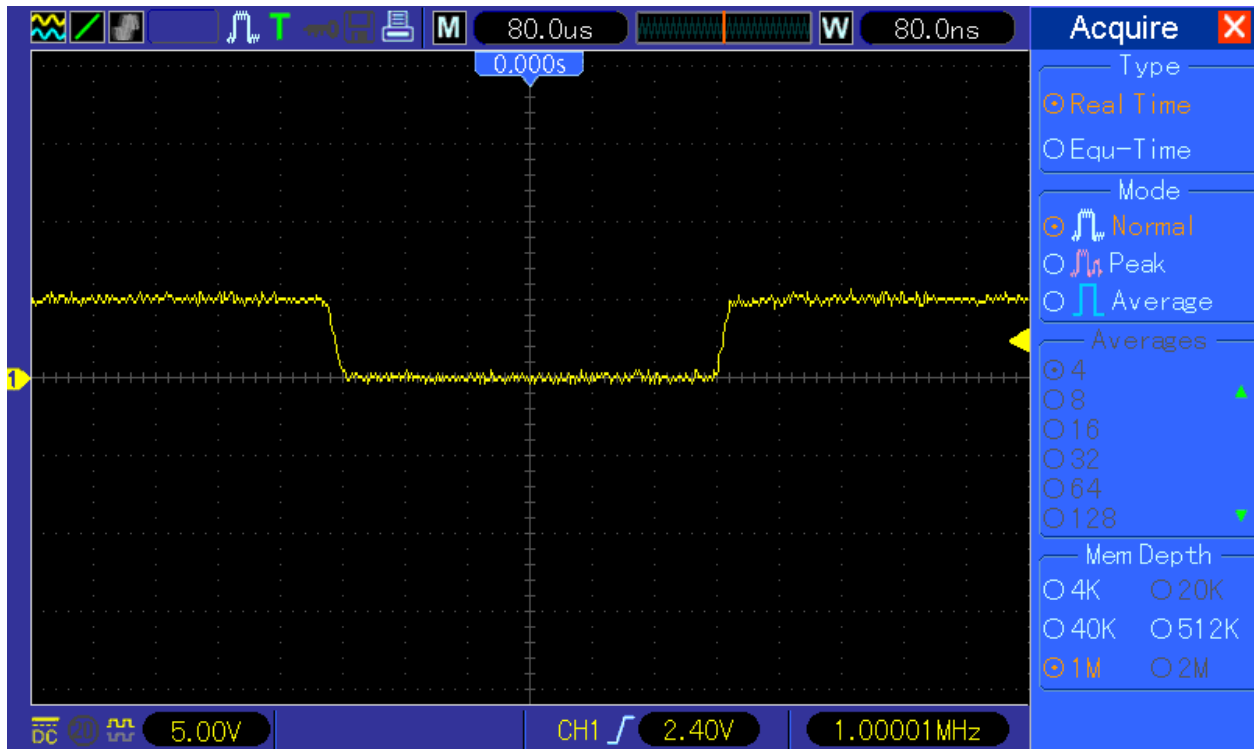
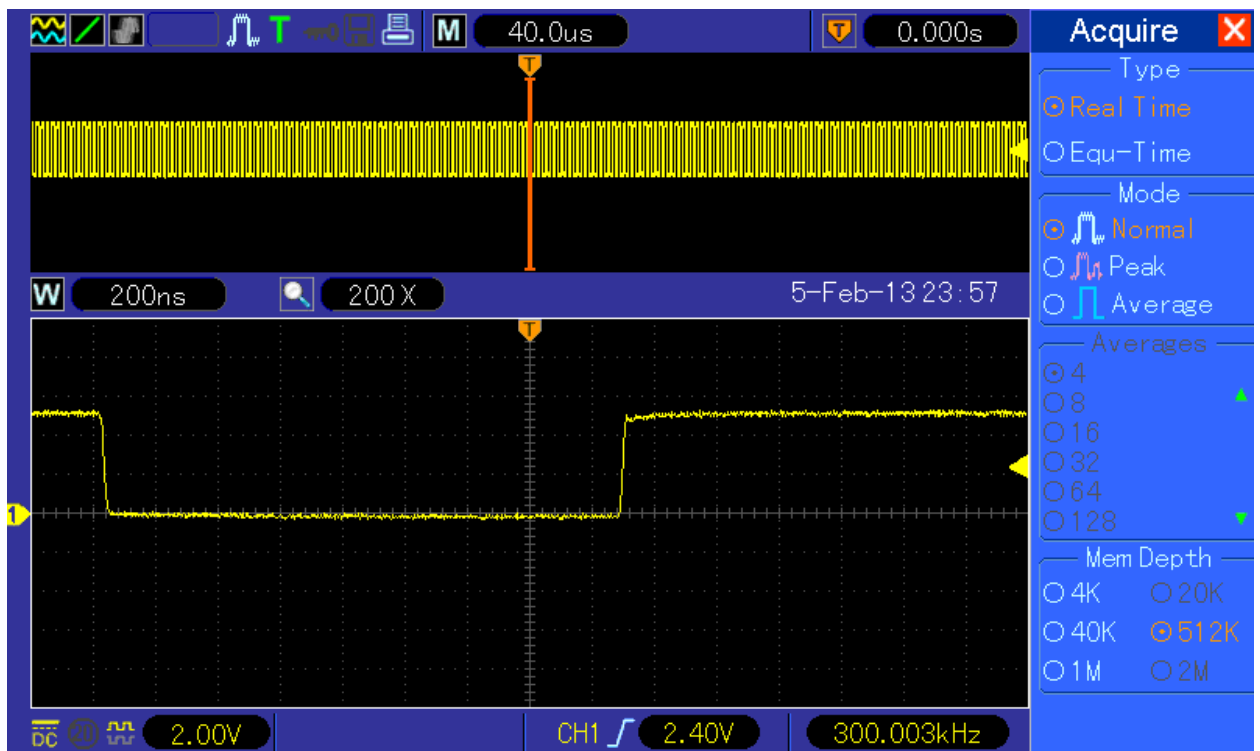
51. Trigger position broken in 40k, 512k and 1M memory depth mode.

Set DSO to 4k, 80ns/DIV, ch1 enabled, apply 1MHz square, the trigger is in the middle of the screen as expected:

Switch now to 40k, trigger is moved, zeroing of trigger position, selfcalibartion and even factory calibration is not helping. Tested with 83E9 and 83EB FPGA designs:

same problem in 512k:

and in 1M:

in dual window same problem in 40k/512k and 1M memory depth:

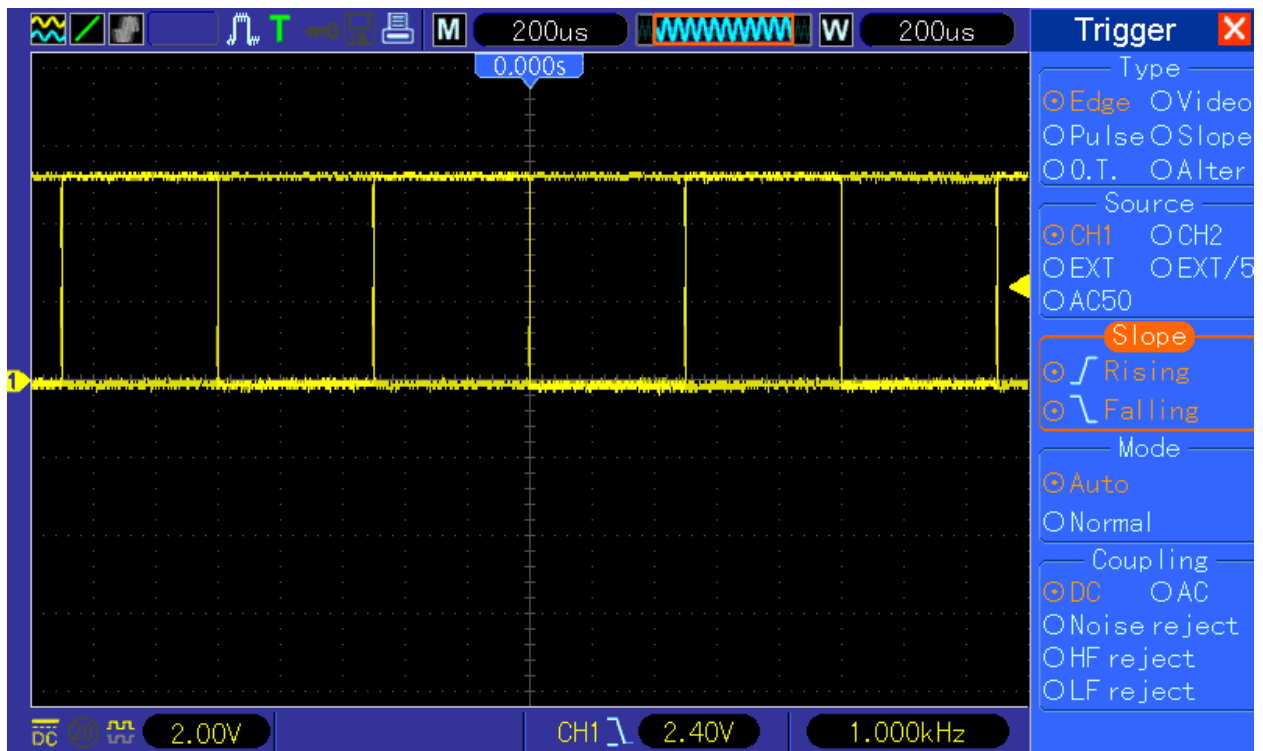
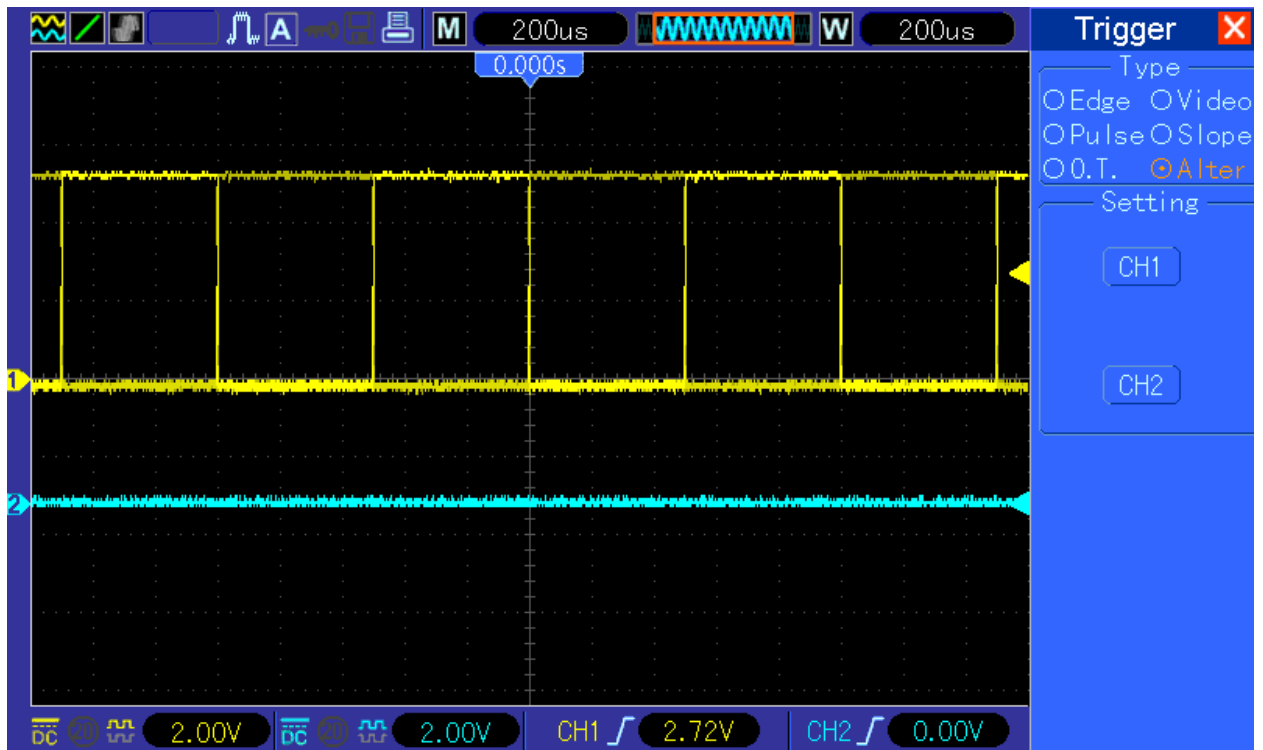
52. After enabling the Dual Slope in Edge trigger:

and changing to Alternate Trigger mode, the Dual Slope seems to be still on:

but I assume should be off? (I'm not sure about the intention here).

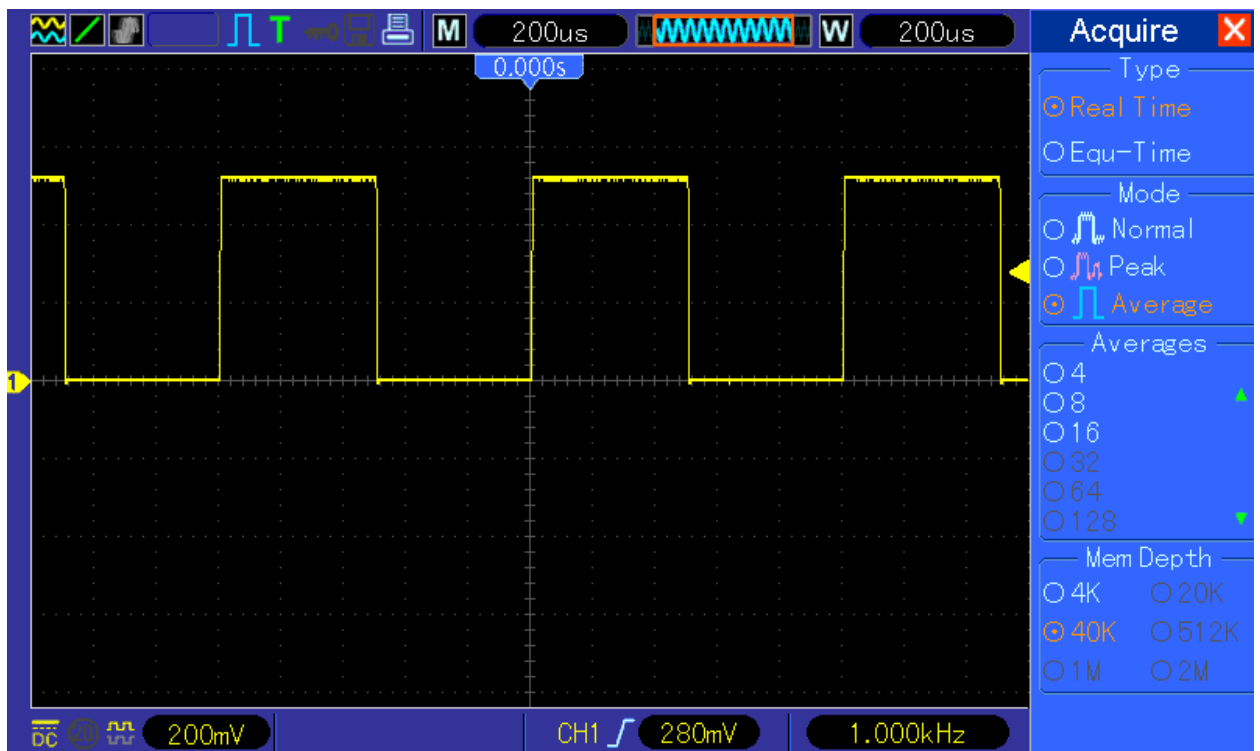
53. When number of Averages is higher than 16, and changing from 4k memory depth:

to 40k memory depth, the number of averages is showing nothing:
