## Firmware 2.06.3 bug list:

## List of bugs/improvement requests

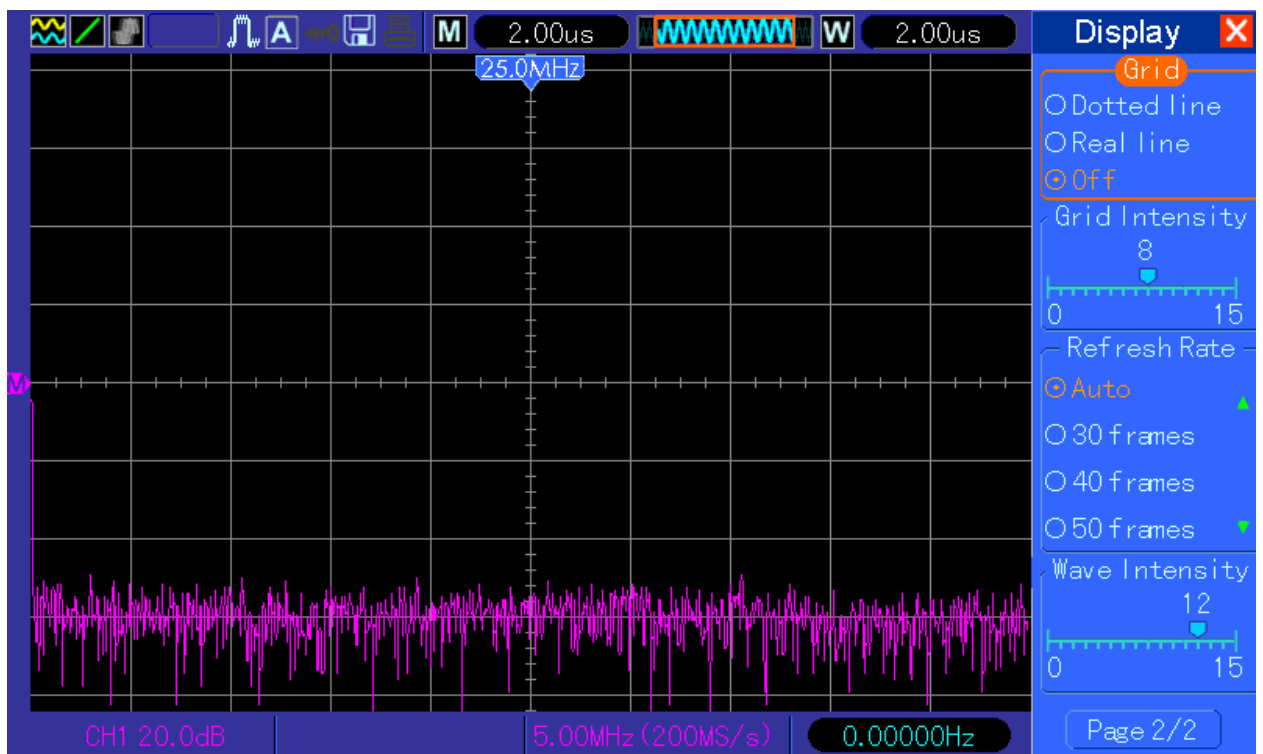
11. In FFT mode the Display -> Grid option is not changing the grid, it is always “real line” and not possible to change to “dotted line” or “off”.

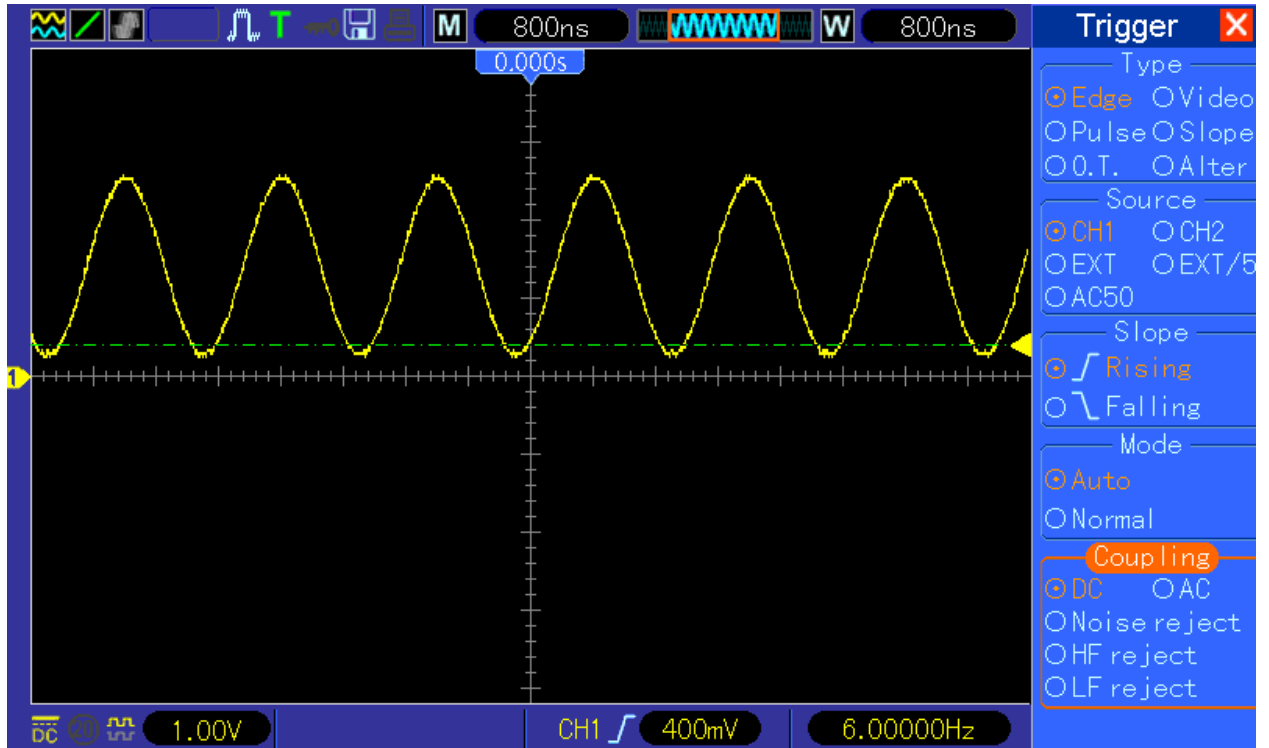
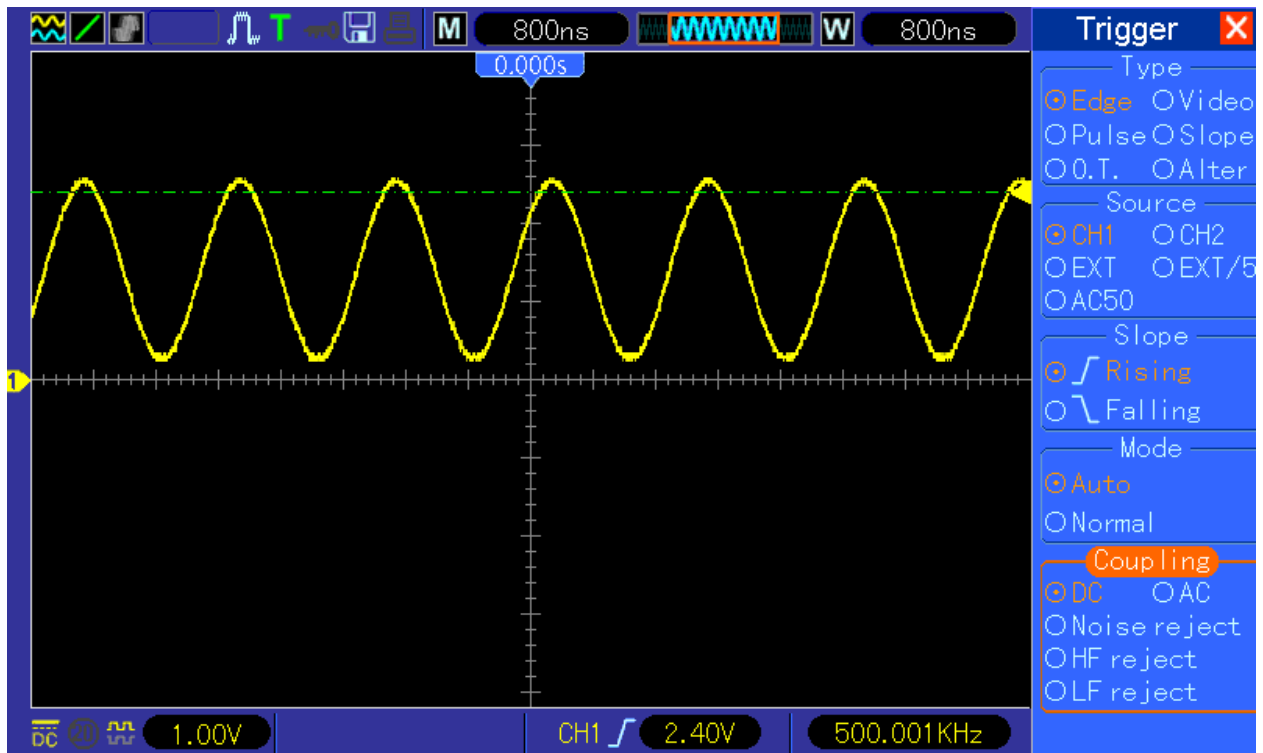
13. AC trigger indicator and line wrong. Set ch1, signal DC coupled, trigger AC coupled. The trigger lowest level below signal :

highest level only mid of signal

But both should look like when trigger coupled in DC mode:

13. Use DC trigger coupling or “add offset” when you set trigger point. On some other good known DSOs (e.g. Tektronix TDS7xxx) there is exact the same DC-signal/AC-trigger “dependency” (bug) and nobody ever complained about.

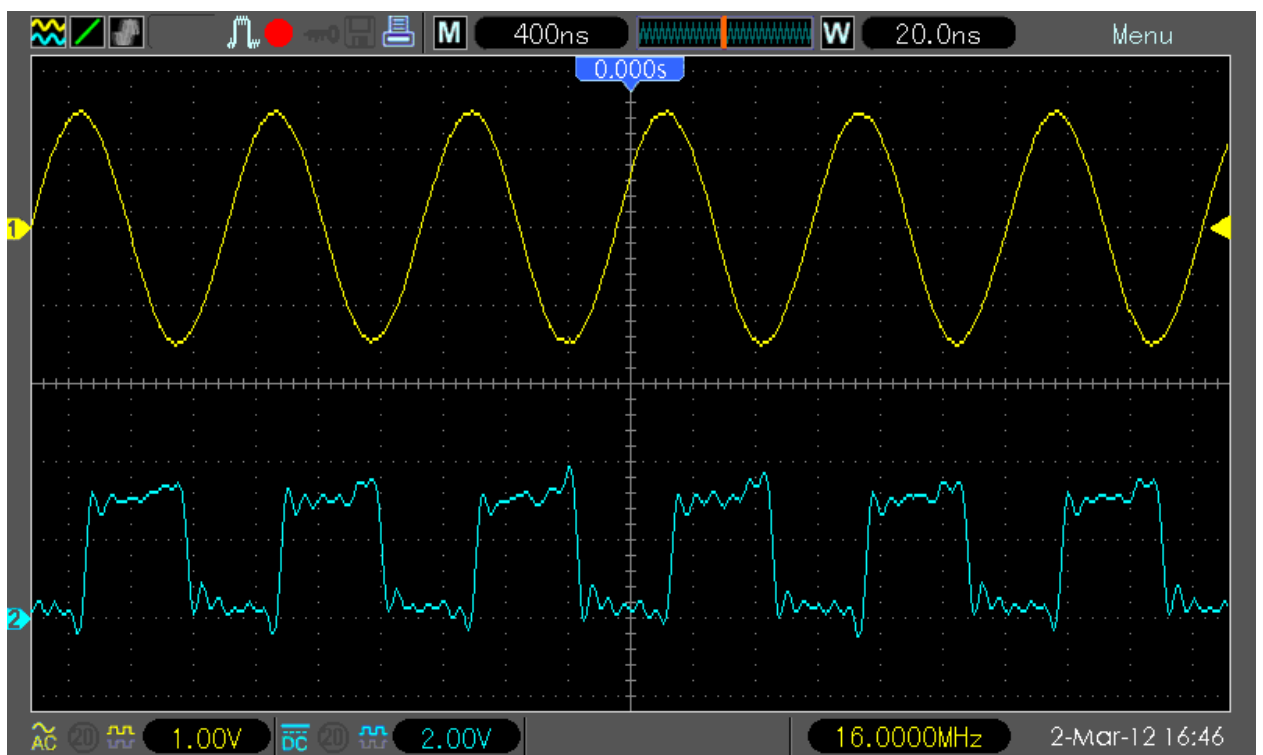
14. Dithering/interpolation filter of waveform too sharp. When enabling both channels (this also occurs in single channel mode and 1GSs, but test signal need to be higher to get same error) and applying for example 16MHz square wave the waveform is switching between proper square:

14. For sure a stupid bug, but since you can see when the signal is “wobbling” you can quick change (when necessary) to single channel to observe the waveform with better resolution and without

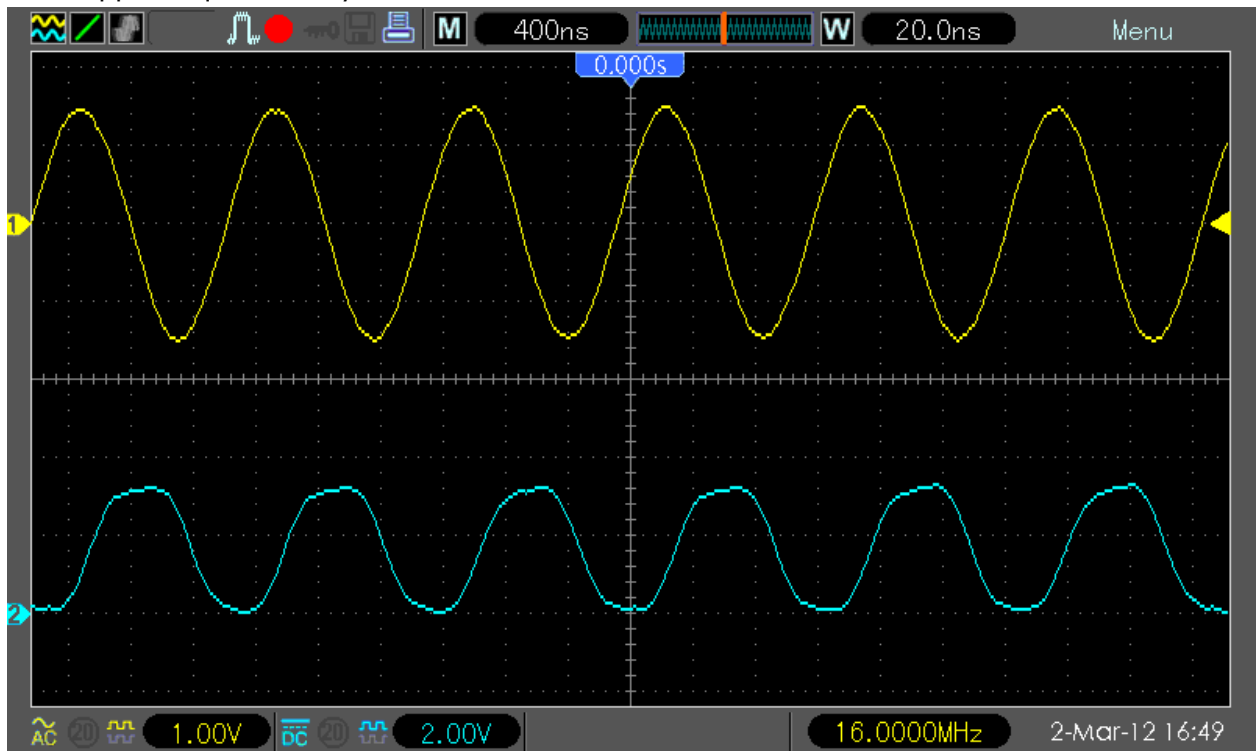
and crippled square every second:

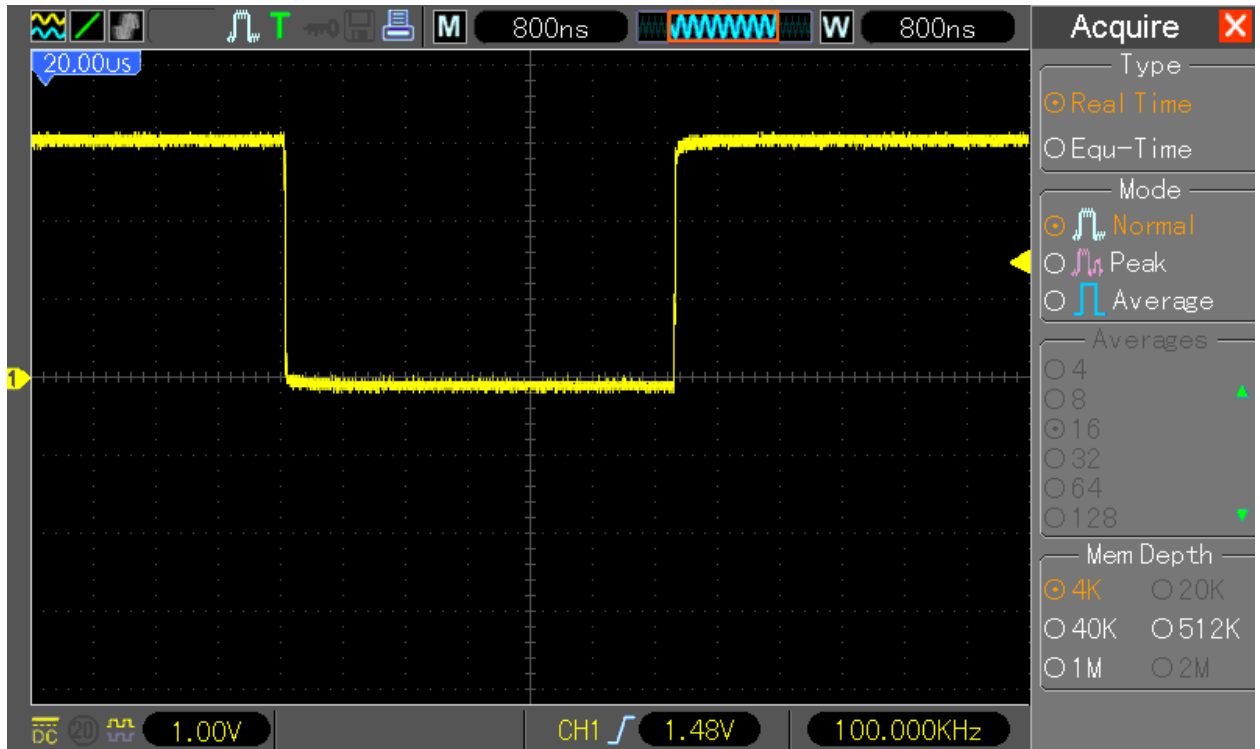
when zoomed it is not ok, it is off by 1.8us already!

in principle in 4k, 40k and 512k everywhere same error, move waveform by more that MTB, do zoom and it is not ok anymore.

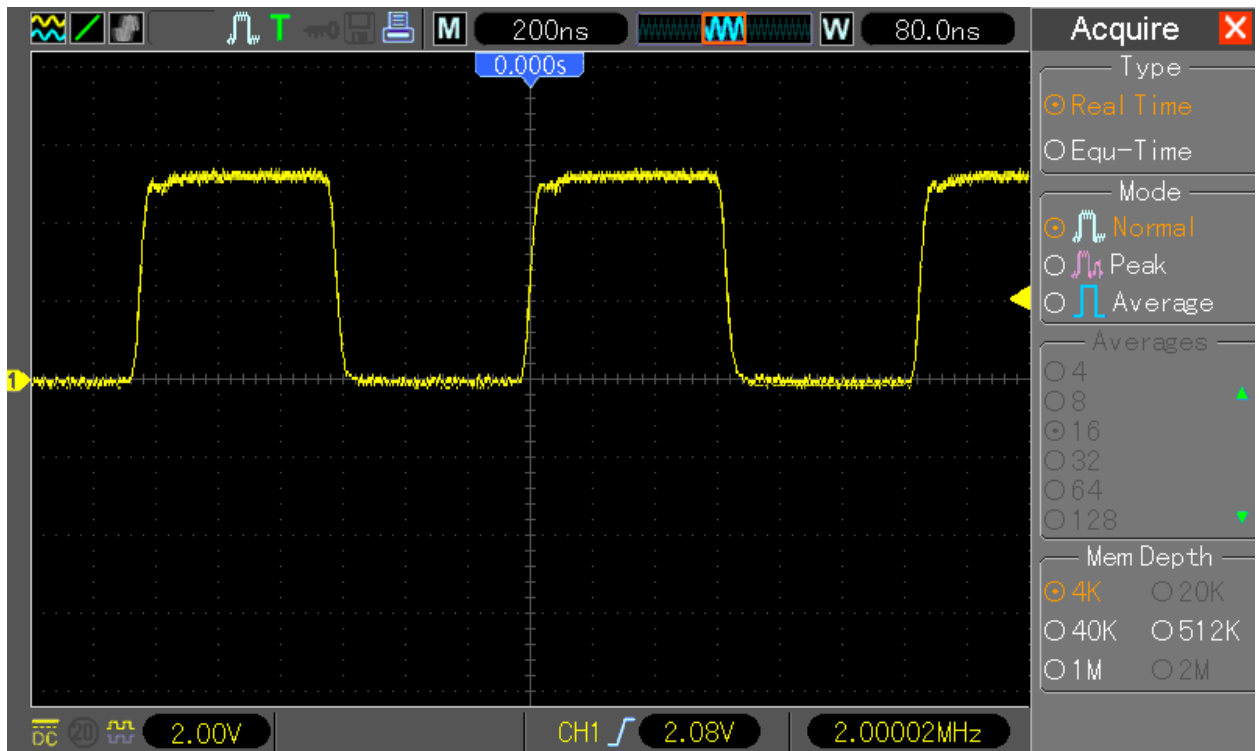
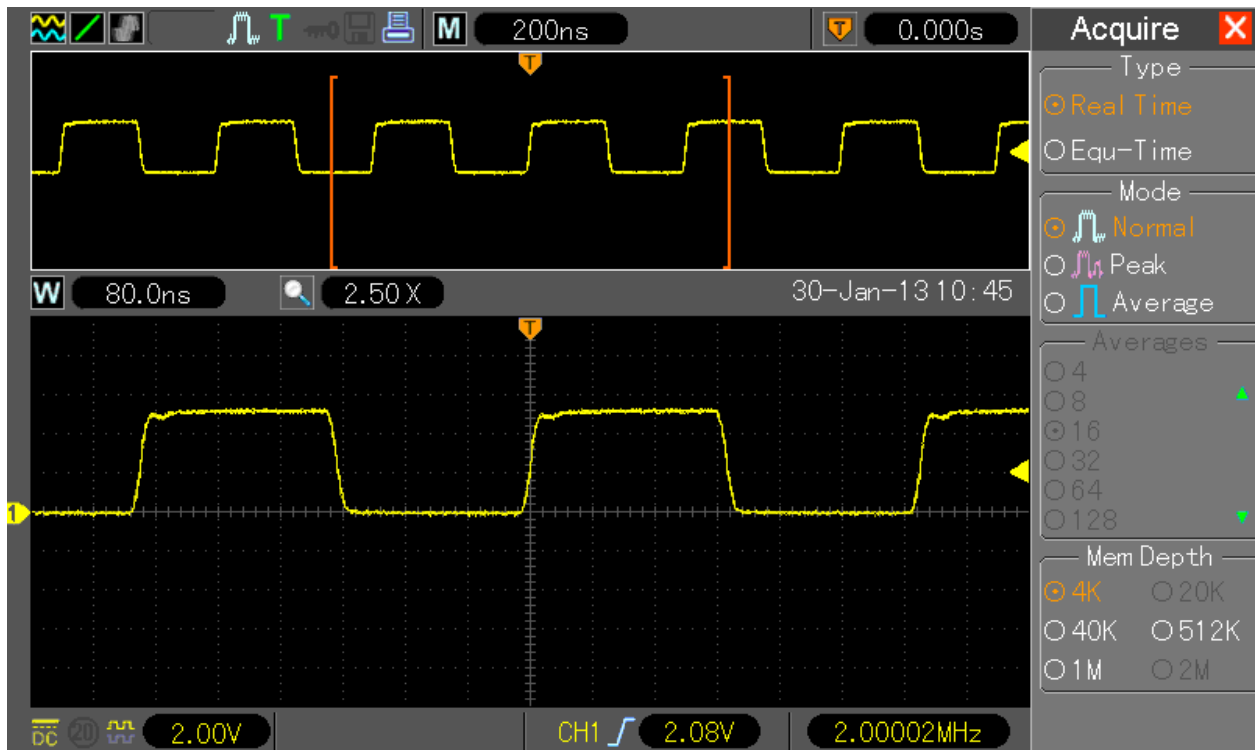
You should see now 2.5 period on screen like here:

Now press F7 to enable dual window. The top MTB window show 6.5 periods and bottom window WTB shows 2.5 periods, which is what it should be:

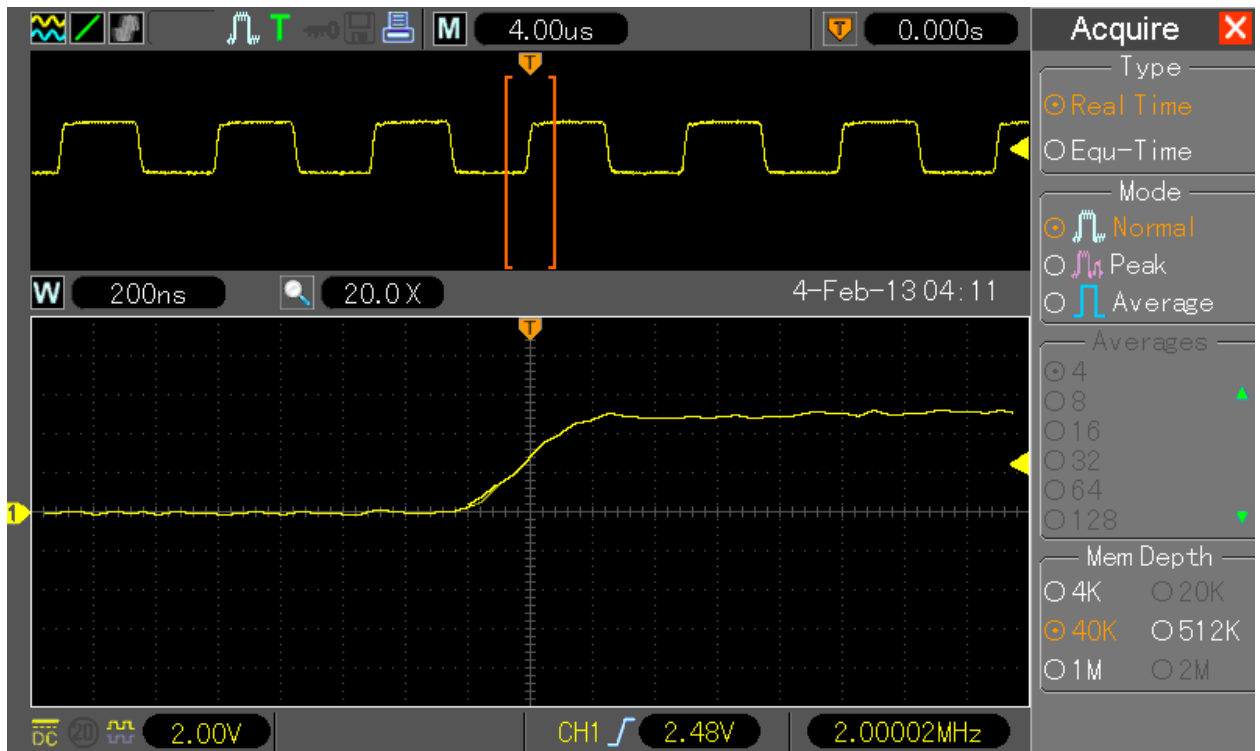
Now change memory depth to 40k, top window is having still 6.5 periods, this is **wrong**

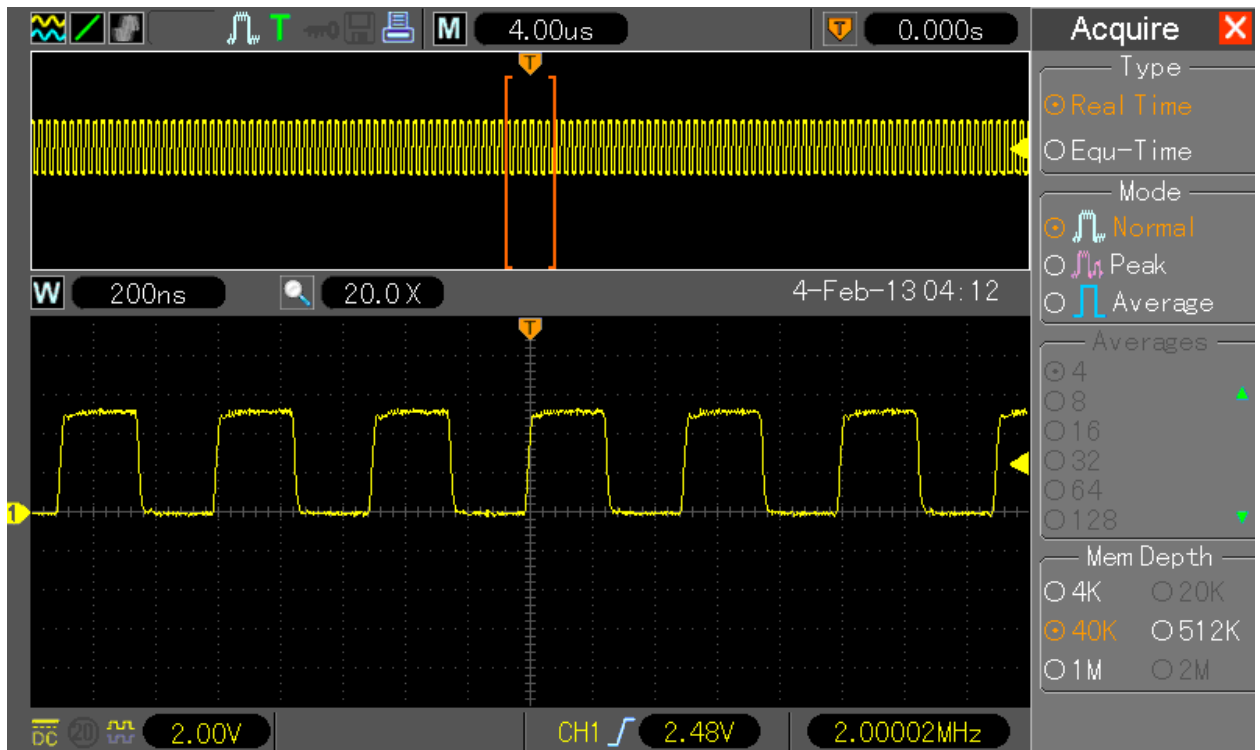
Switch now focus to top window and turn timebase one position up, the display will be now refreshed to **proper values**:

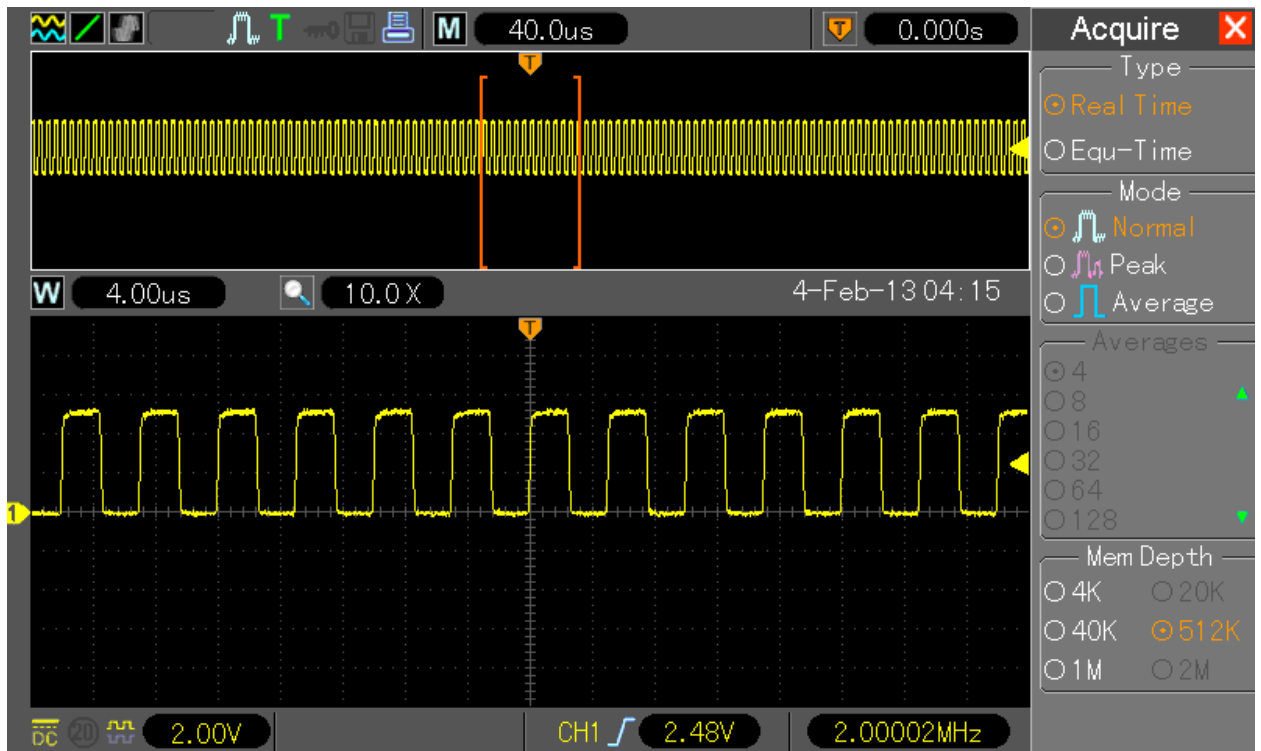
the same error is there if you change to 512k (and 1M exact same error), push now F5 to change to 512k, picture looks like

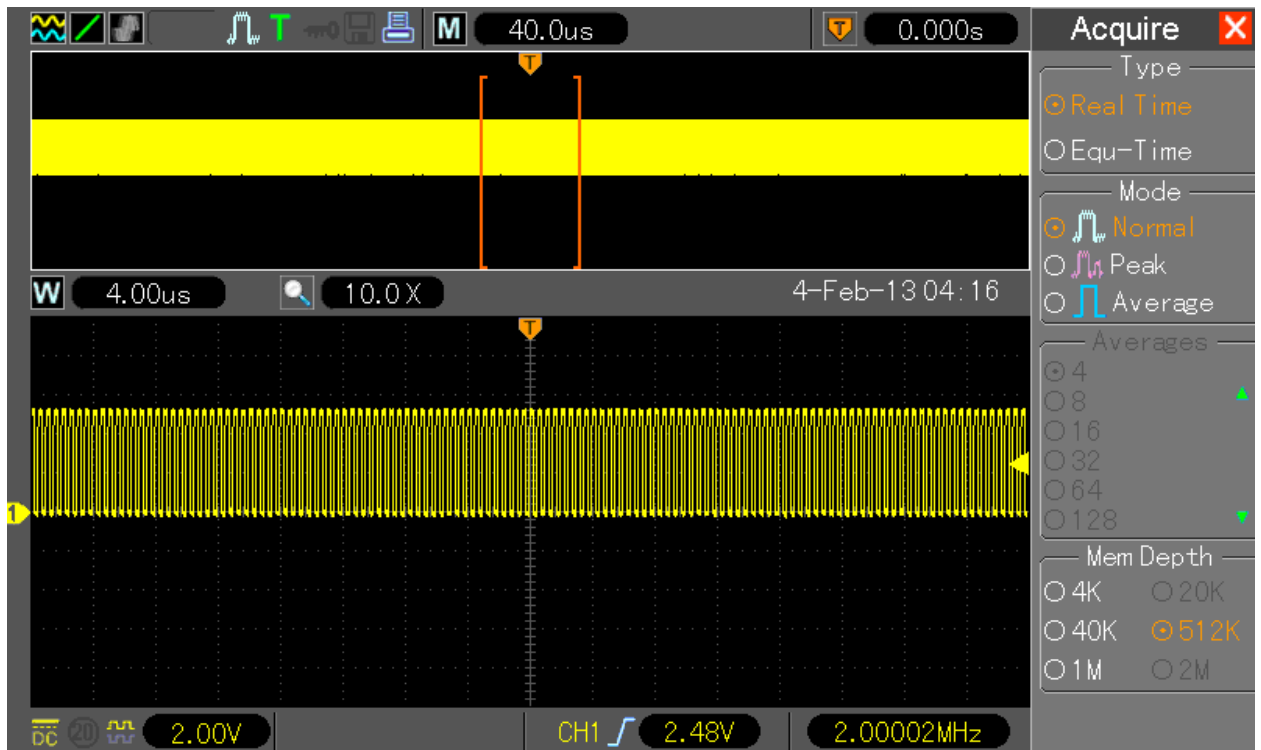
Switch now focus to top window and turn timebase one position up, the display will be refreshed to **proper values**:

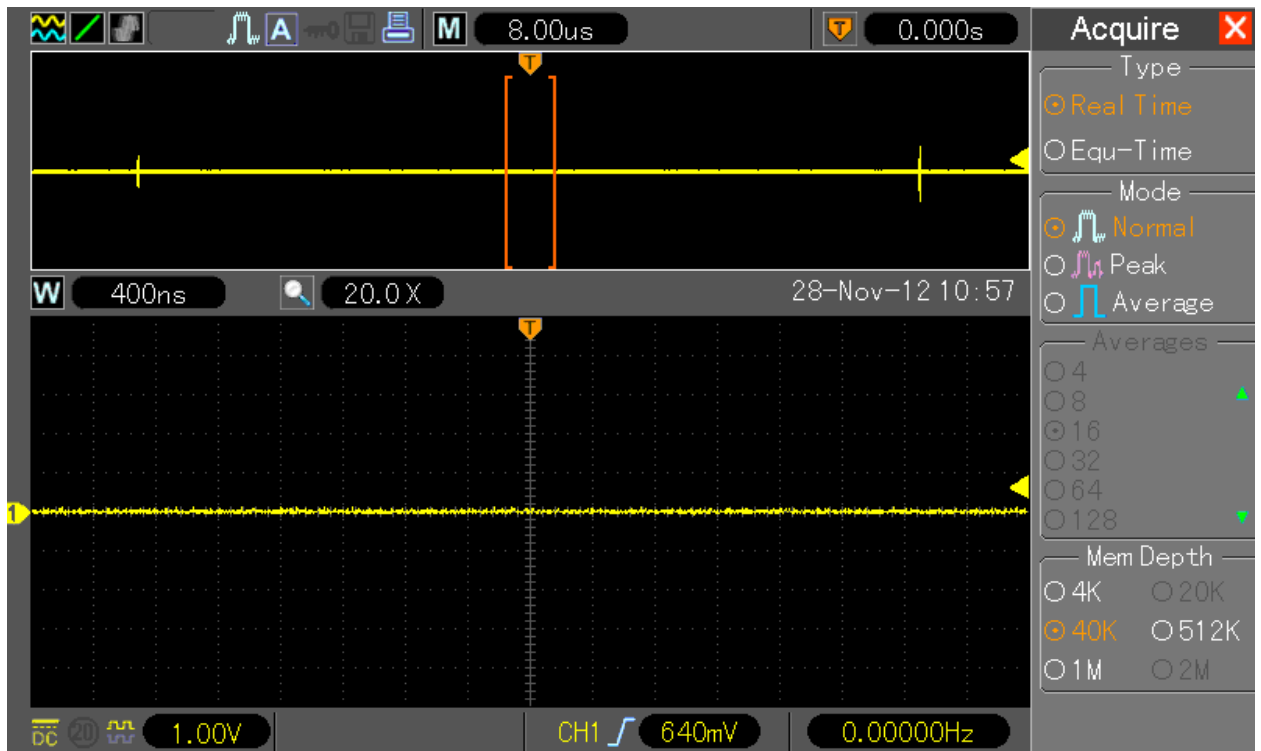
Now when switching to dual window the Main TB is changing to wrong value (here from 4us/DIV to 8us/DIV – actually it will be always doubled in length) and artifacts from “end of buffer” right and left in top window are shown:

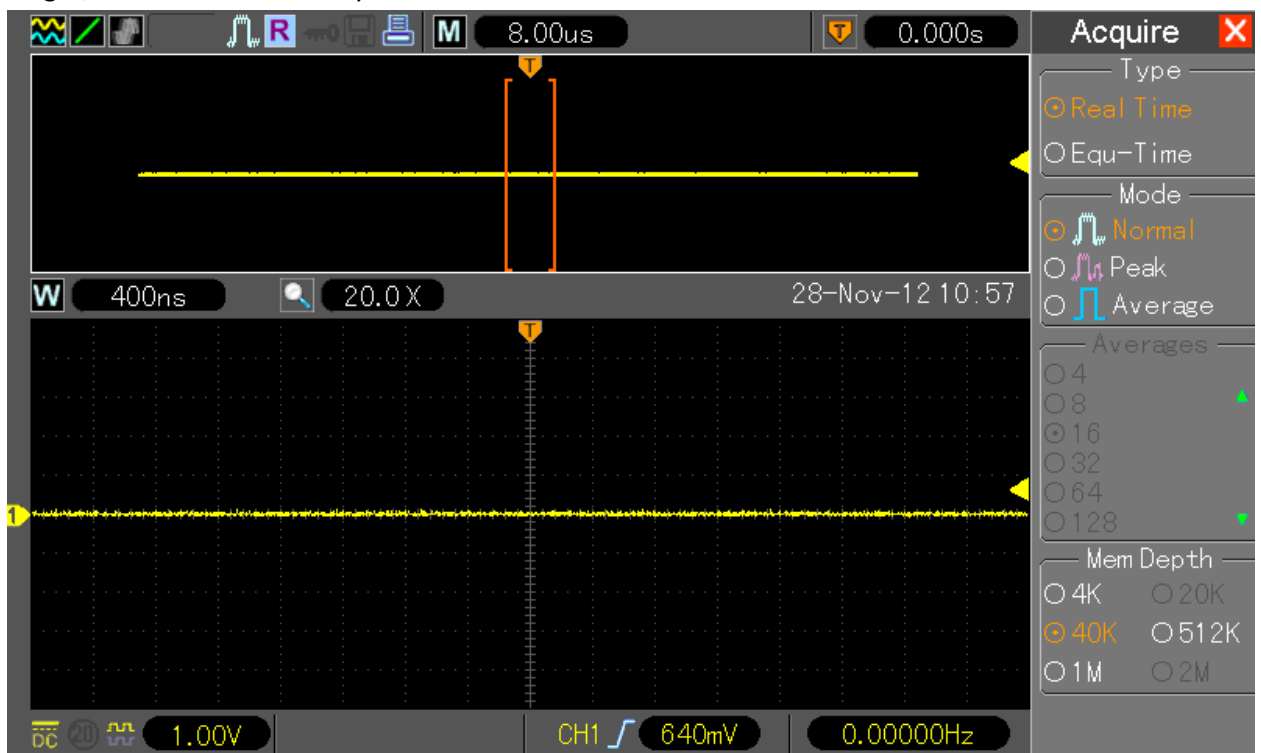
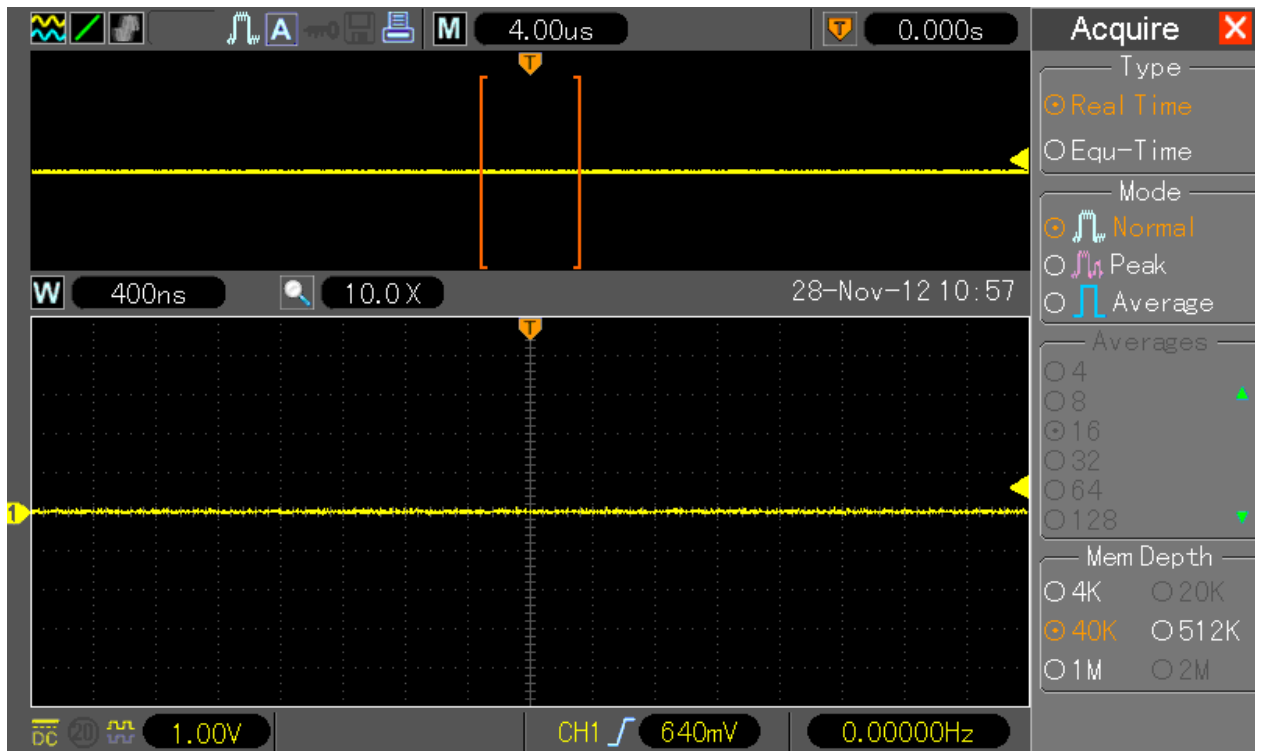
When the Acquisition would be stopped and restarted or Timebase changed one position forth and back (while Main window is focused) the Main TB and displayed data will be fixed to proper length; no artifacts shown anymore:

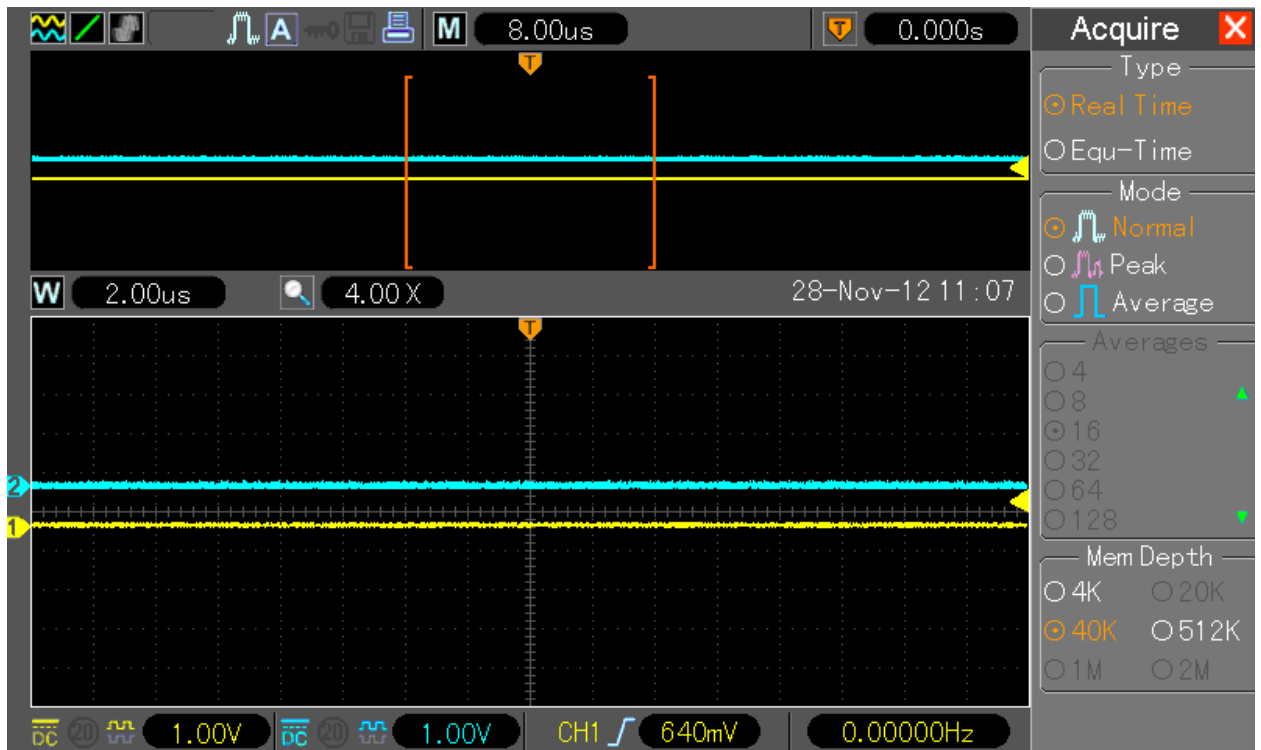
With 2 channels enabled this bug **DOES NOT EXIST**, this is because the doubled Main TB value is exactly what it should be for dual channel view:

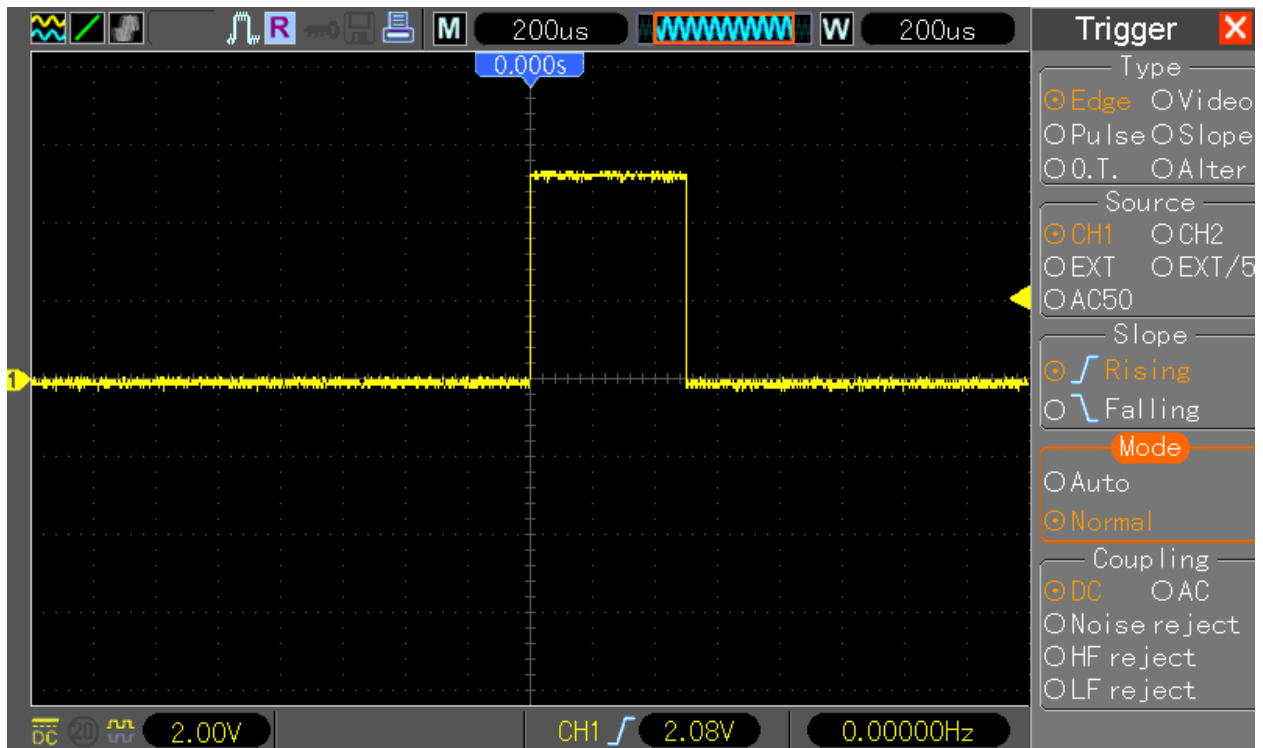
After first trigger event the waveform will appear as following on screen:

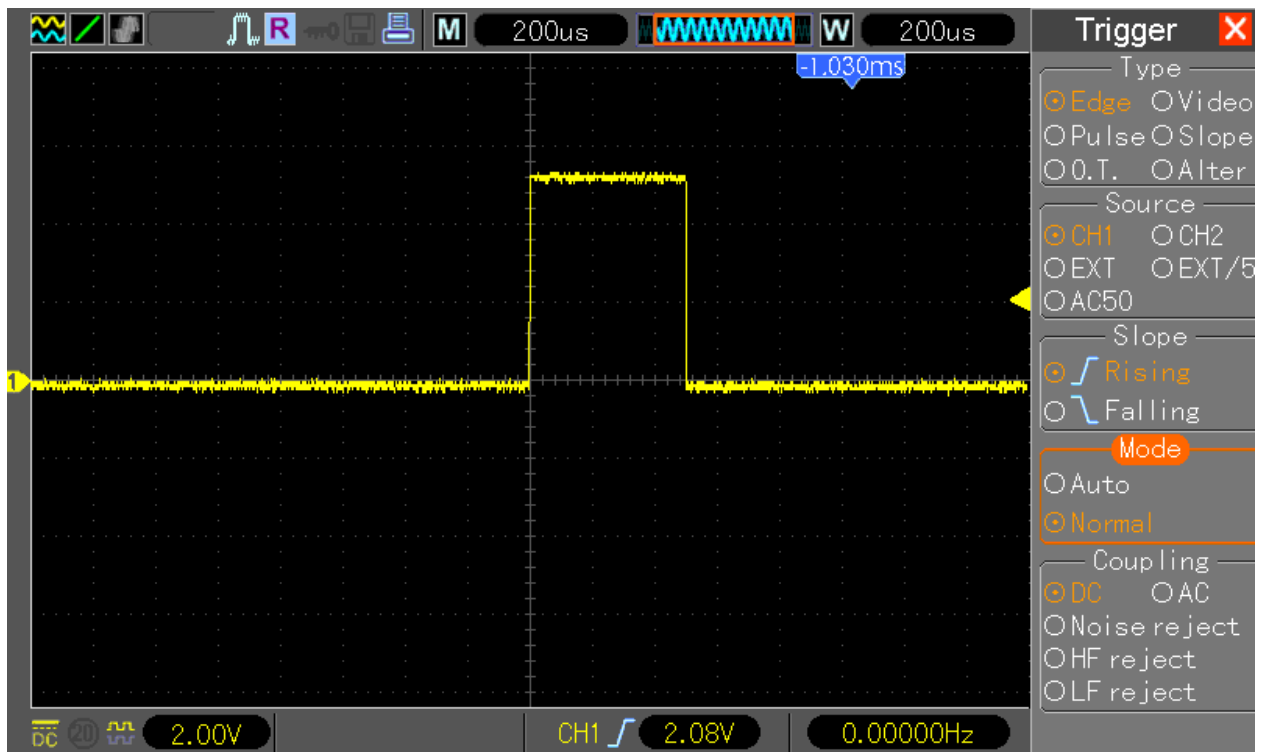
Now when you turn the Horizontal position knob to left or right to change the position, the blue trigger indicator is changing as expected, but the already captured waveform is not moving (which is a bug, it make sense to be able to move already captured waveform while waiting for next trigger event. )

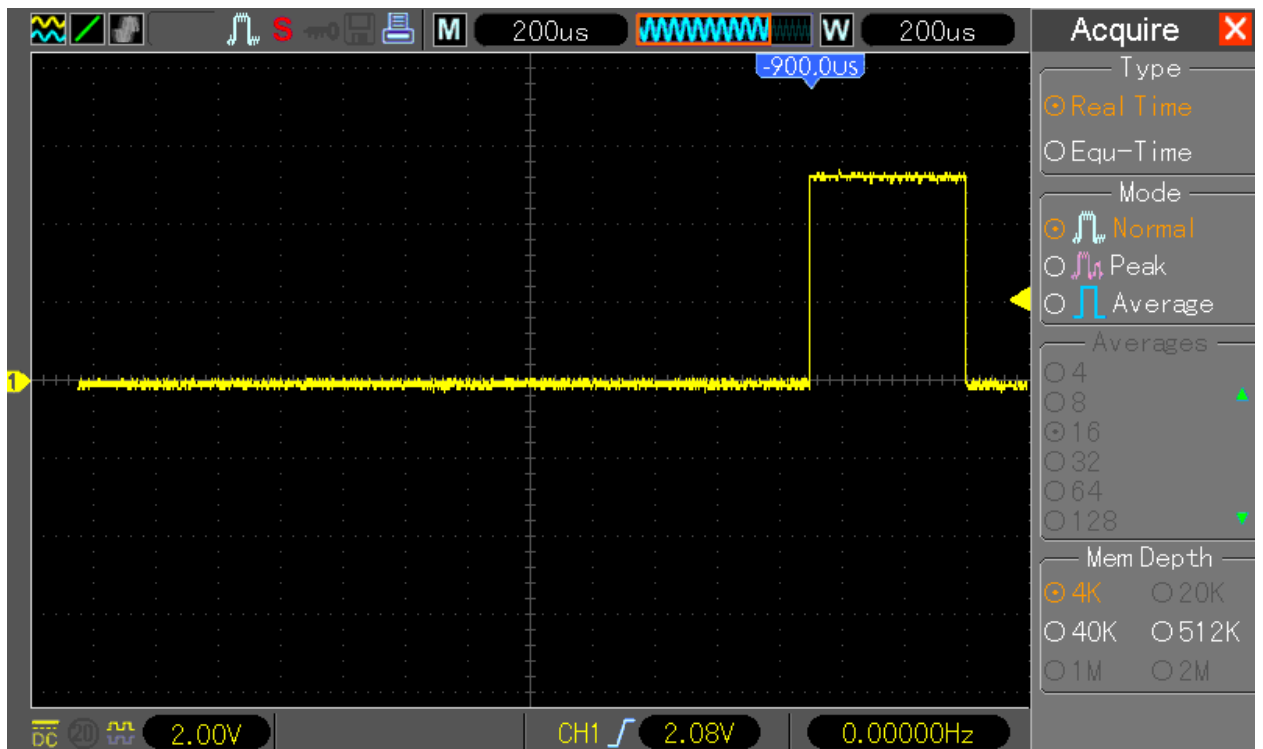
However, when working with acquisition in “Single shot” mode the waveform can be moved together with the trigger indicator :

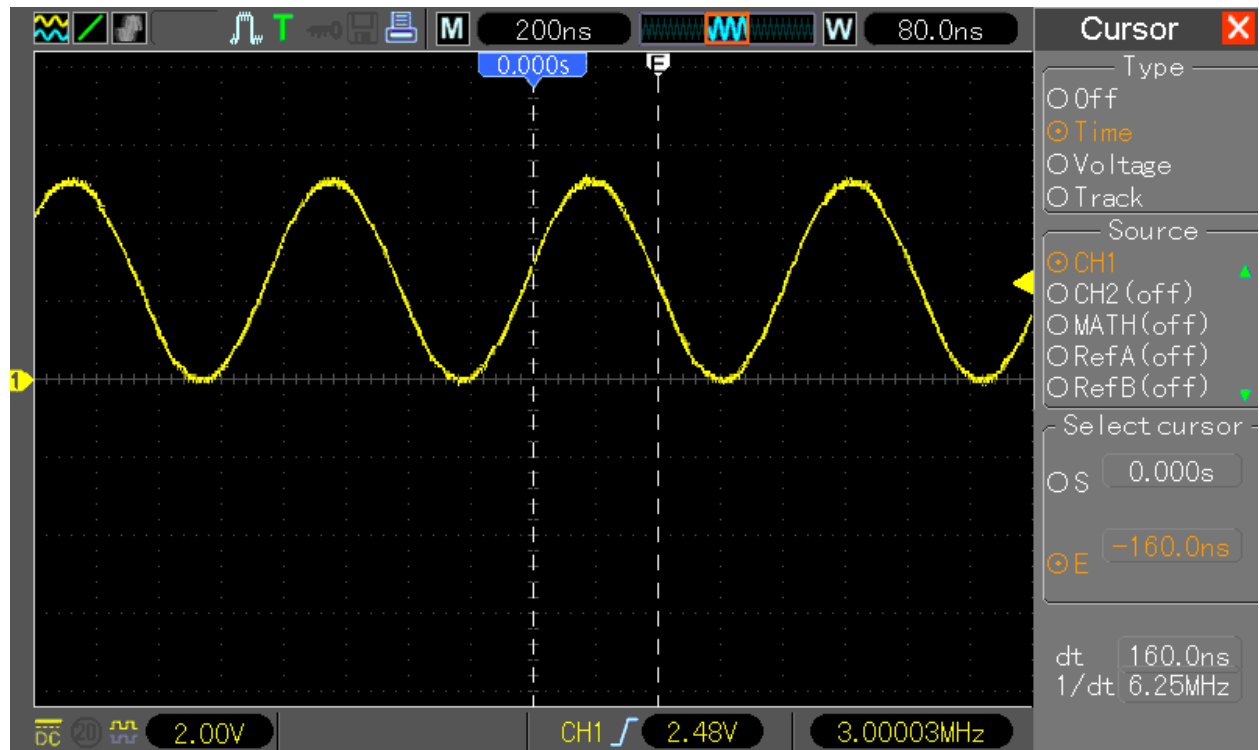
Here example, TB set to 80ns/DIV, cursor S to 0.0ns and E to -160ns:

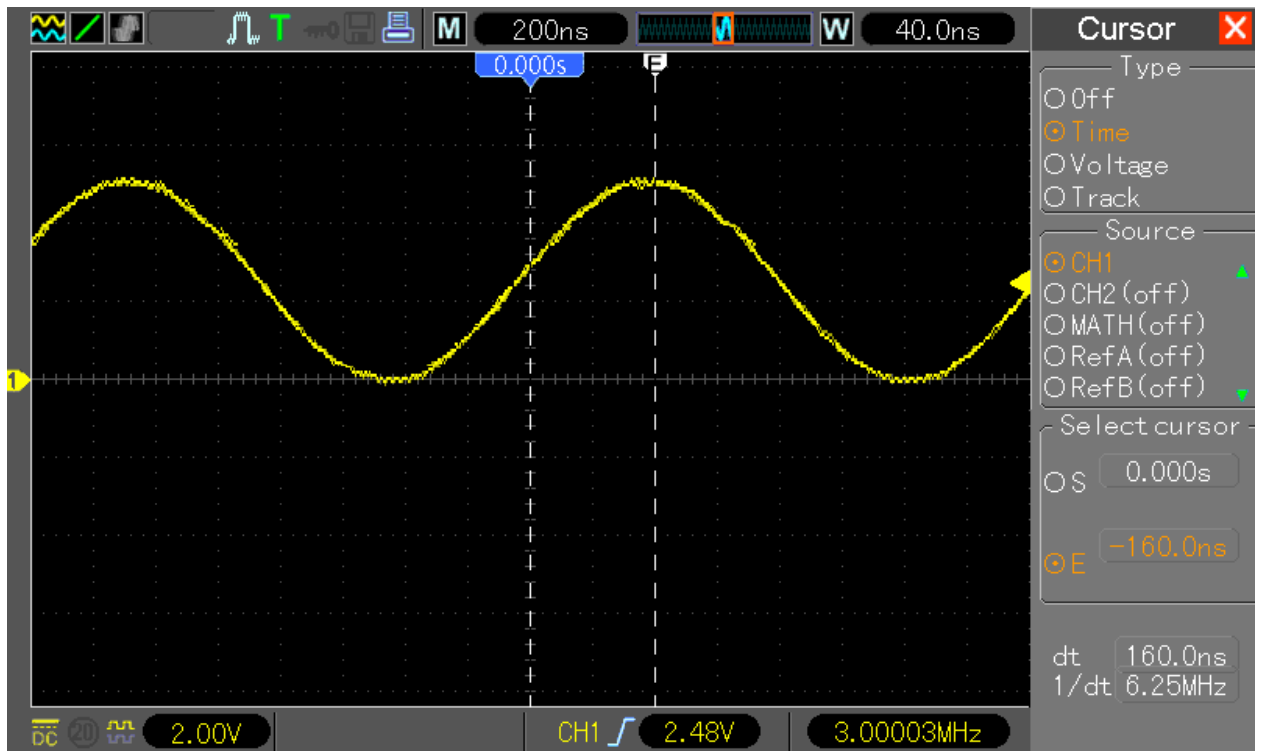
Then TB changed to 40ns/DIV, but displayed value for E still -160ns:

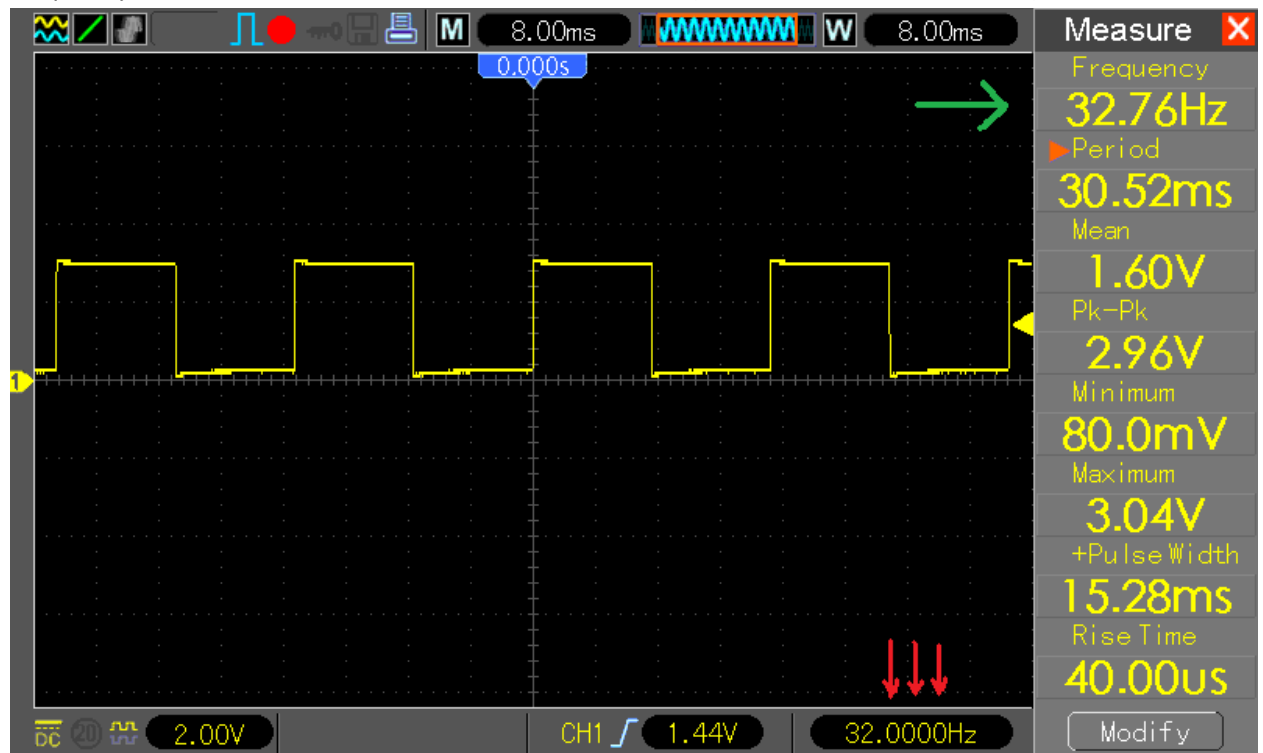
frequency of 32.768Hz – the counter will show 32.000Hz (and Wave measure 32.76Hz).

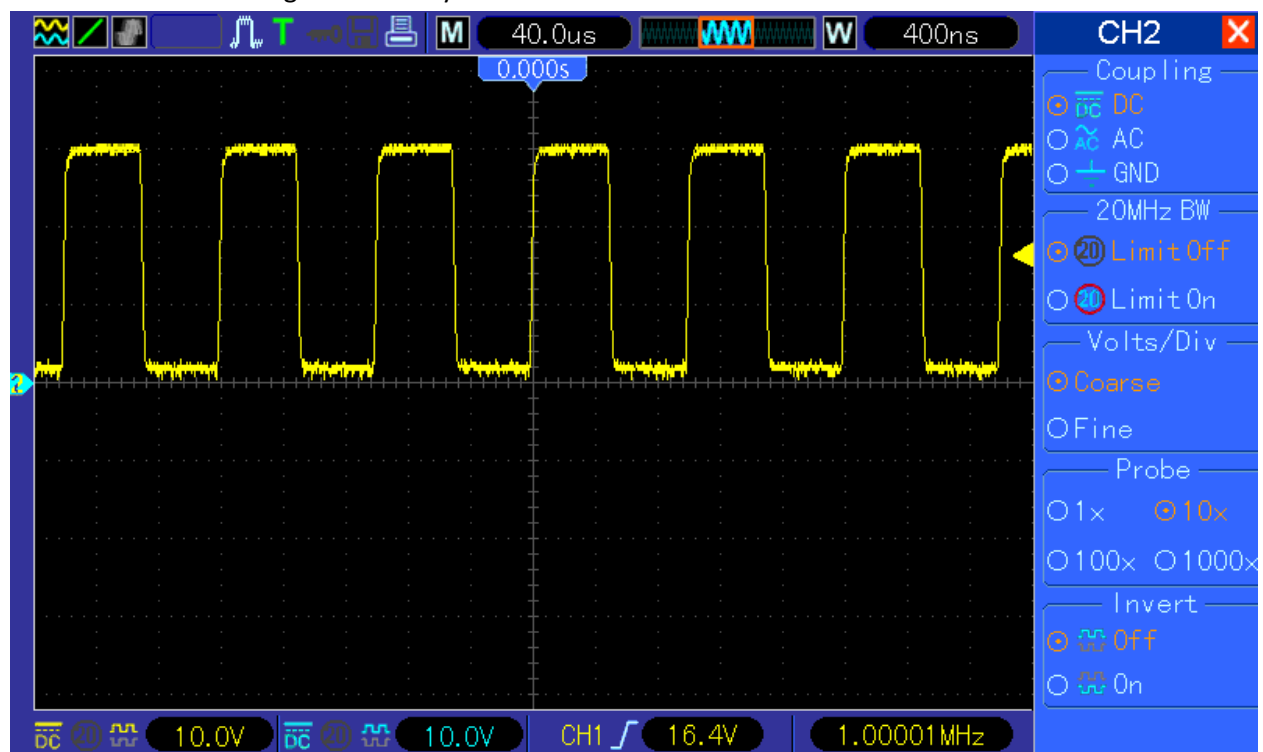
37. With Long Memory enabled (40k, 512k, 1M, 2M?) when the WTB is 400ns/DIV (and lower, up to 2ns/DIV) when enabling second channel the indicator in status line will be already displayed but the waveform is missing. Additionally the CH2 LED is off :
