## Firmware 2.06.3 bug list:

## List of bugs/improvement requests

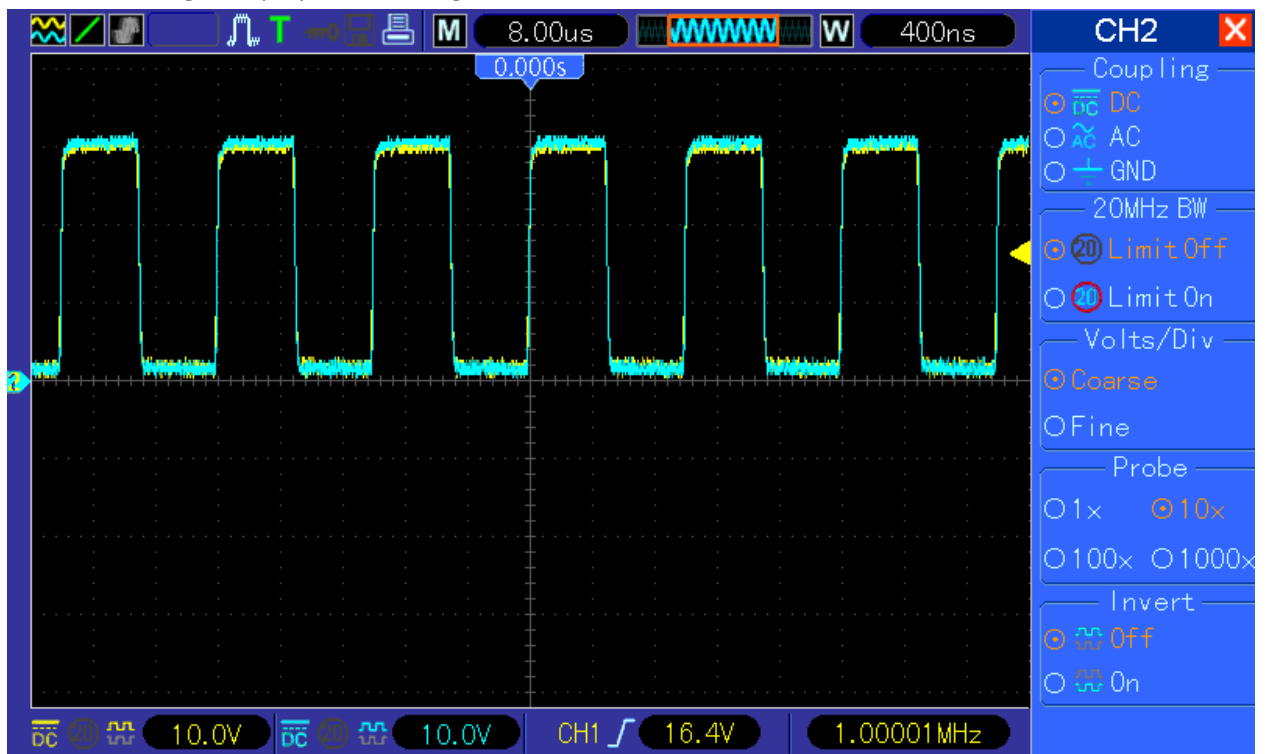
But after changing Timebase (or wave position) one position forth and back the second channel waveform will get displayed and LED gets on :

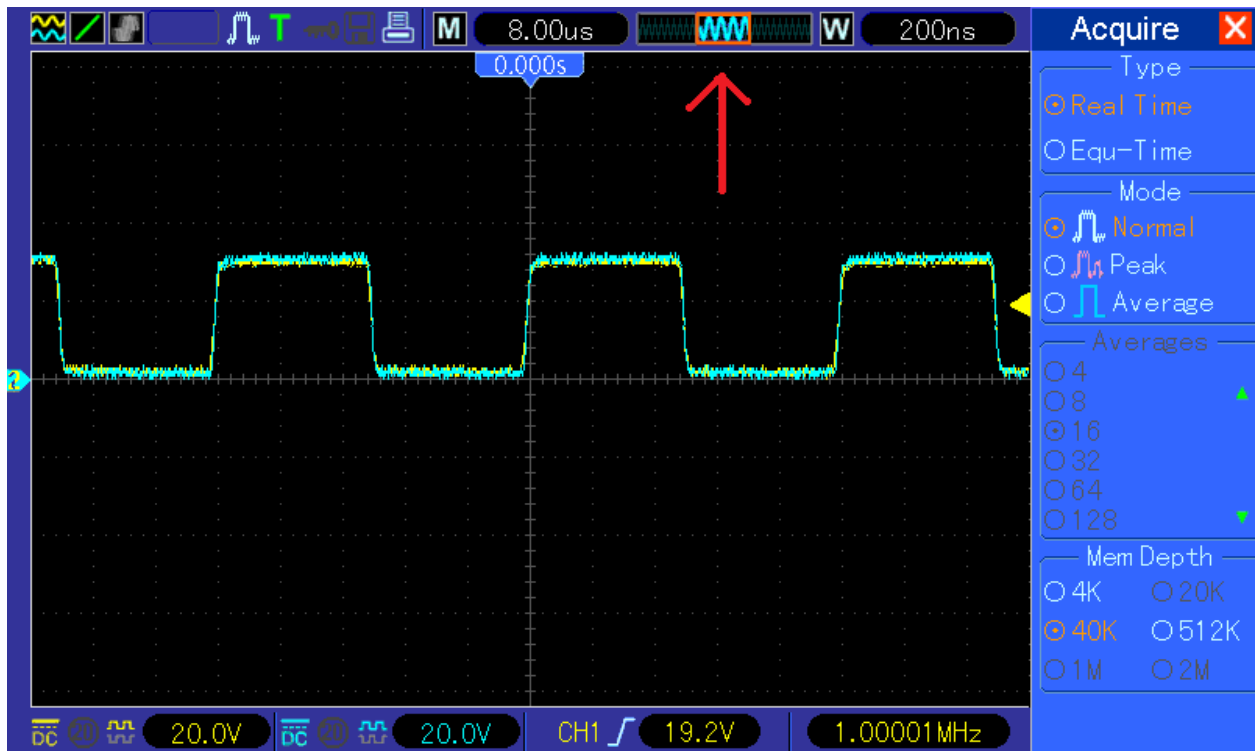
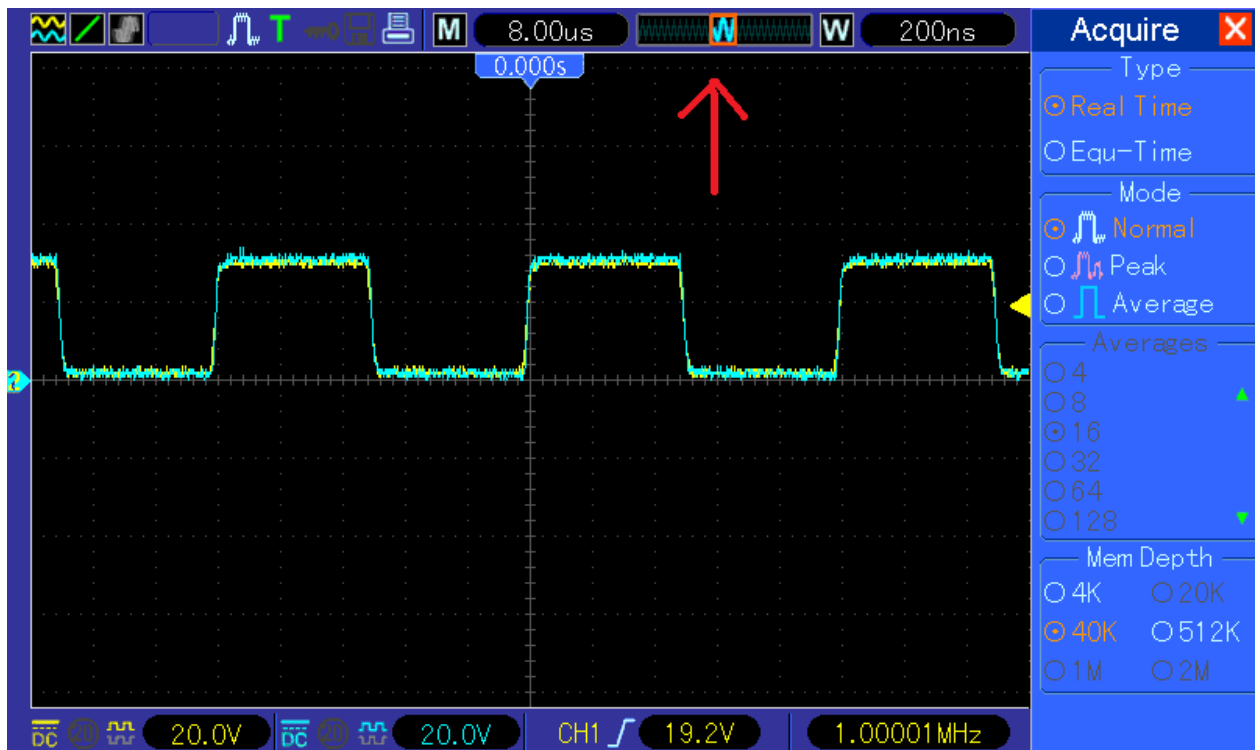
38. MTB Area indicator is blinking! Select 40k depth (or 512k), enable both channels set WTB to 400ns/DIV or 200ns/DIV and watch the area blinking :

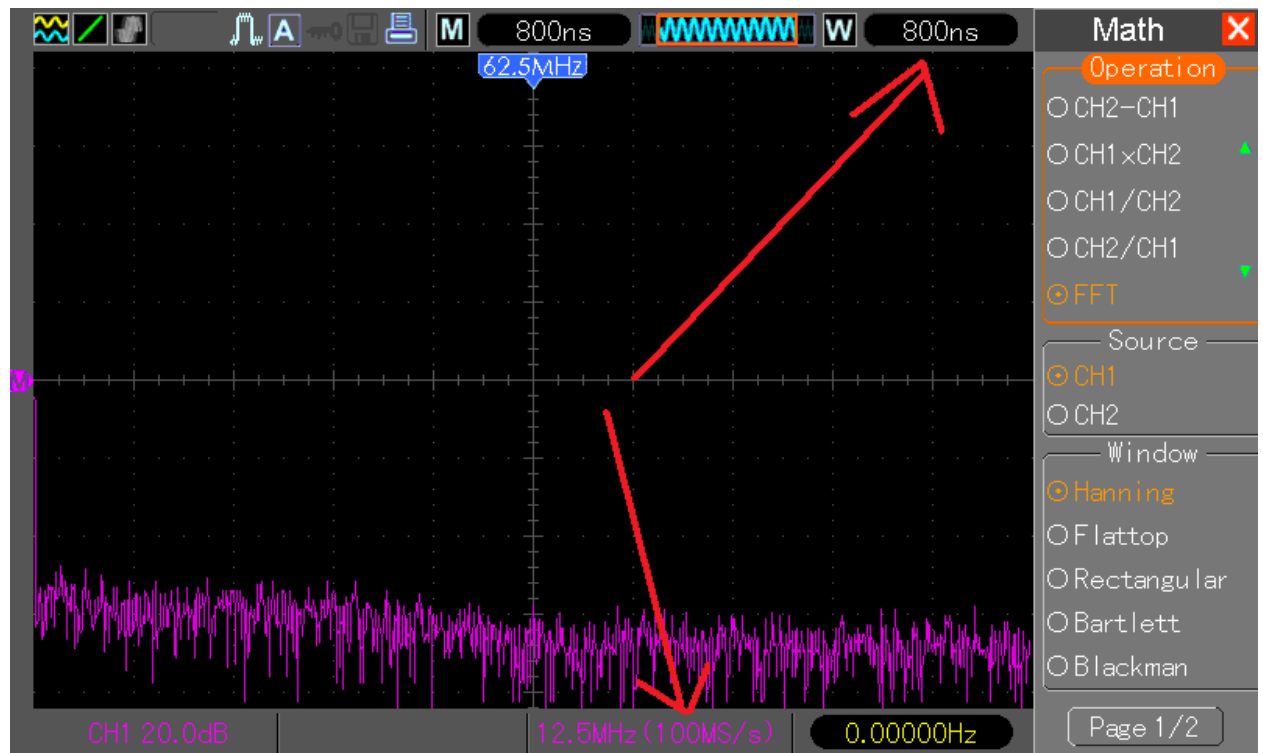
39. Within FFT the information in status bar is not always showing the proper sampling rate, sometimes even jumping from proper to bad value. As the FFT cursor is taking in count the sampling rate, the measure value might be not correct. Example random values in 800ns/DIV

FFT , here 100MS/s

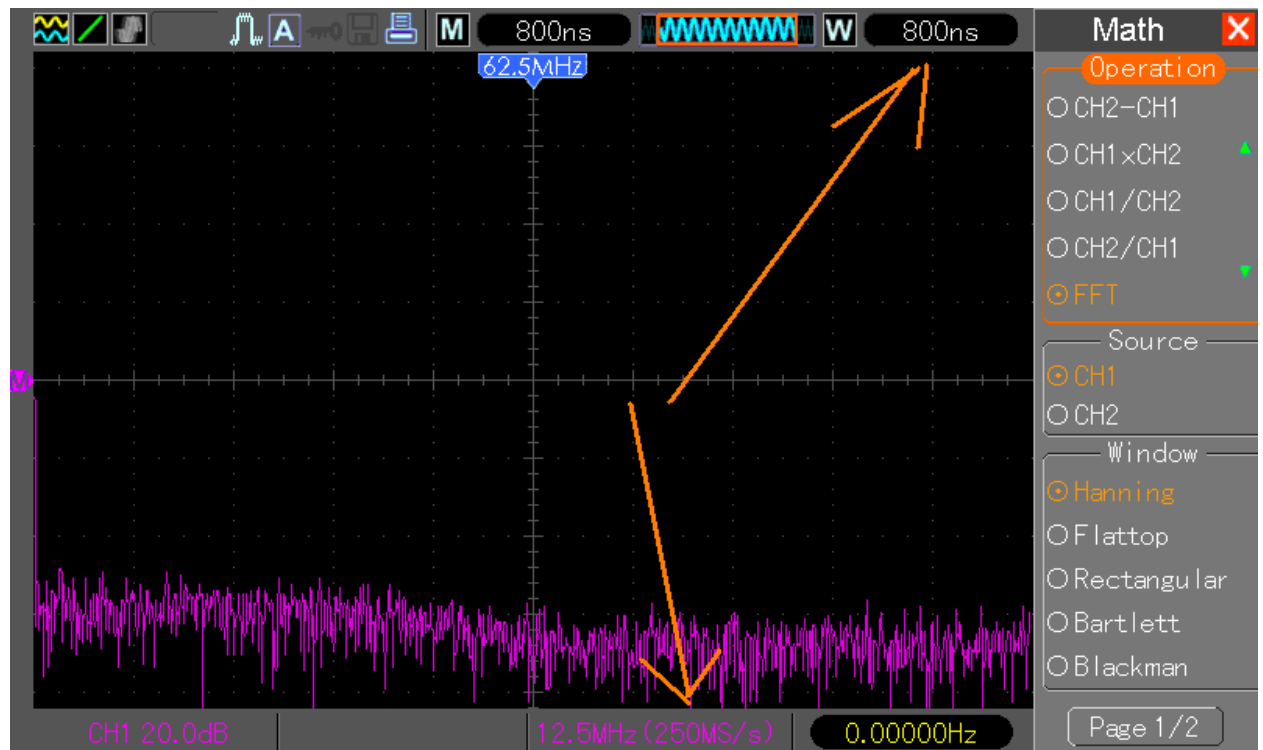
then 250MS/s (but still 800ns/DIV)

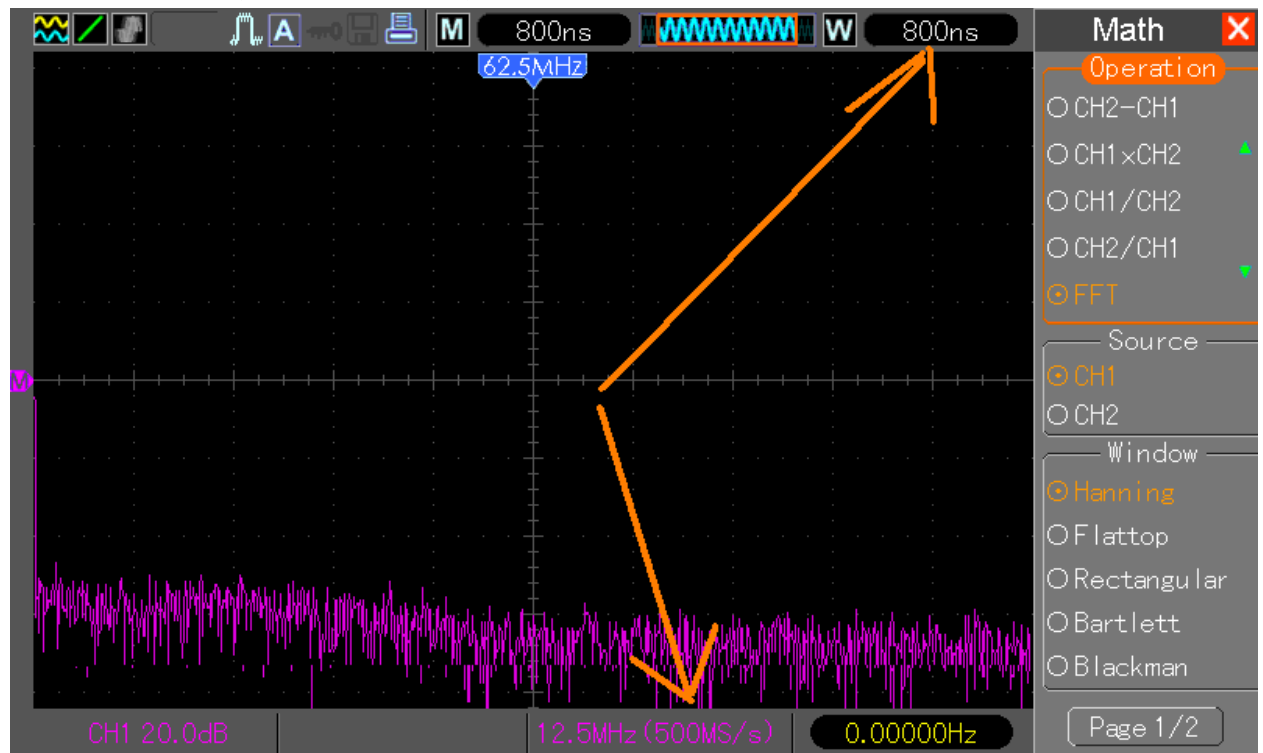
and here 500MS/s (but still 800ns/DIV)

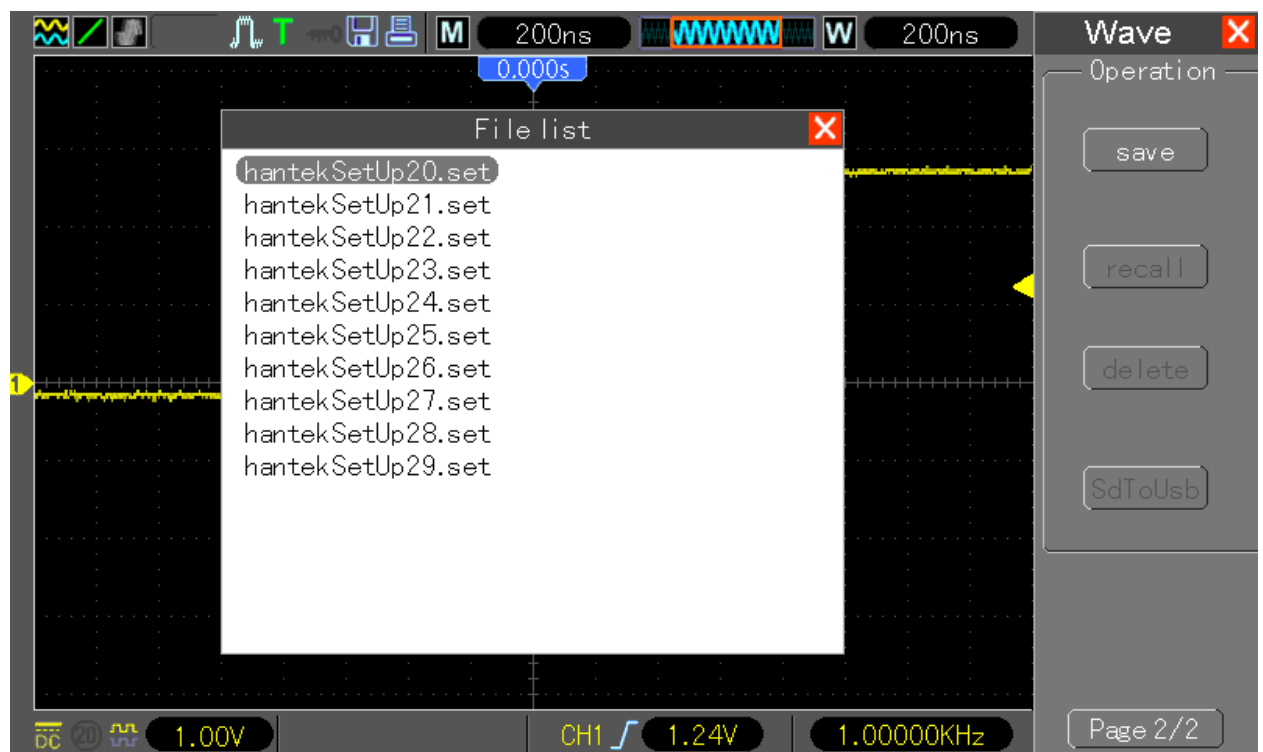
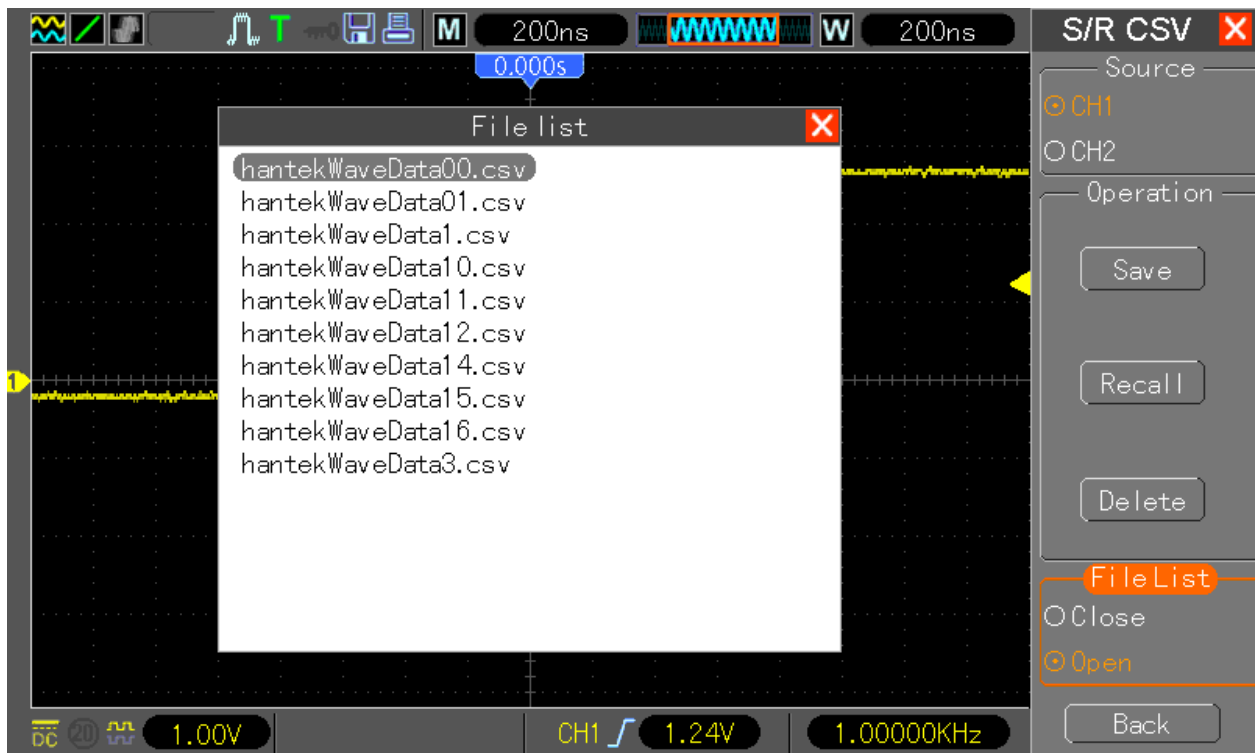
40. Flash Drive directory listing (in CSV Save/Recall and DSO Setup Save/Recall menus) is showing maximum 10 files. Additionally no option to scroll over the directory to choose other than one of the listed 10 files

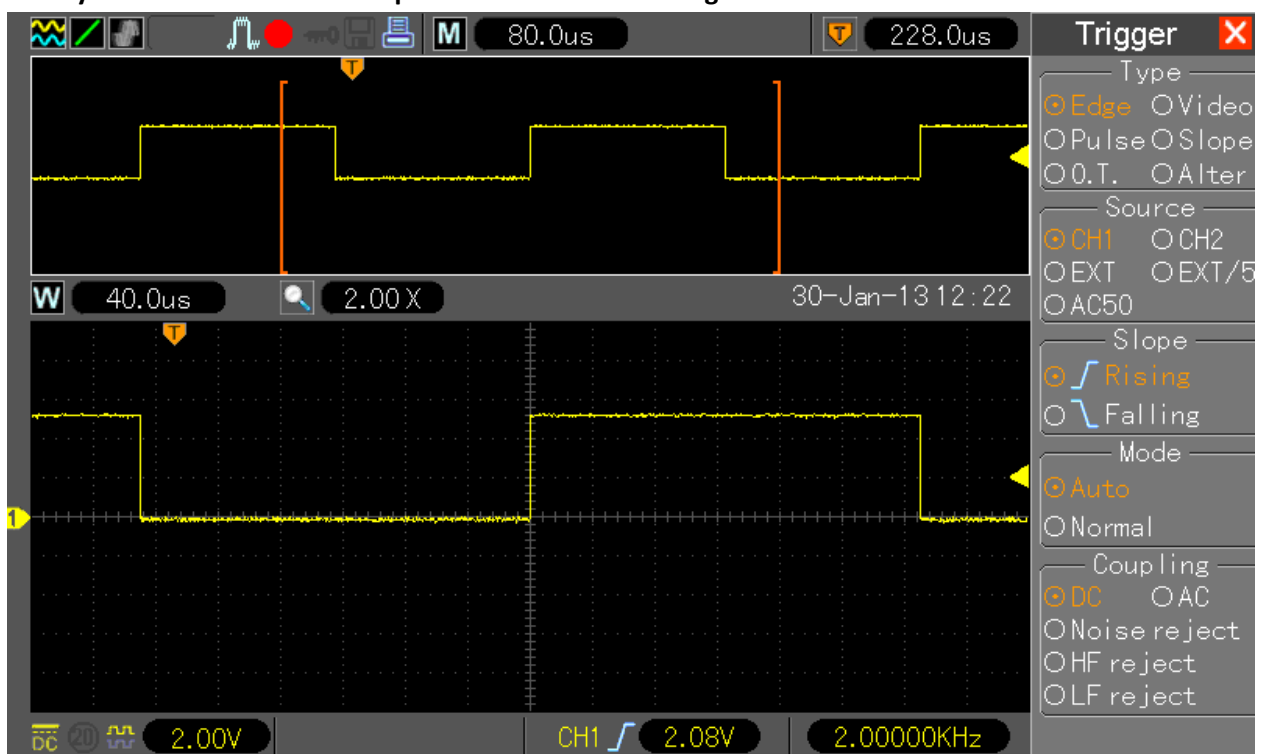
but try now to move horizontal position: wave not moving:

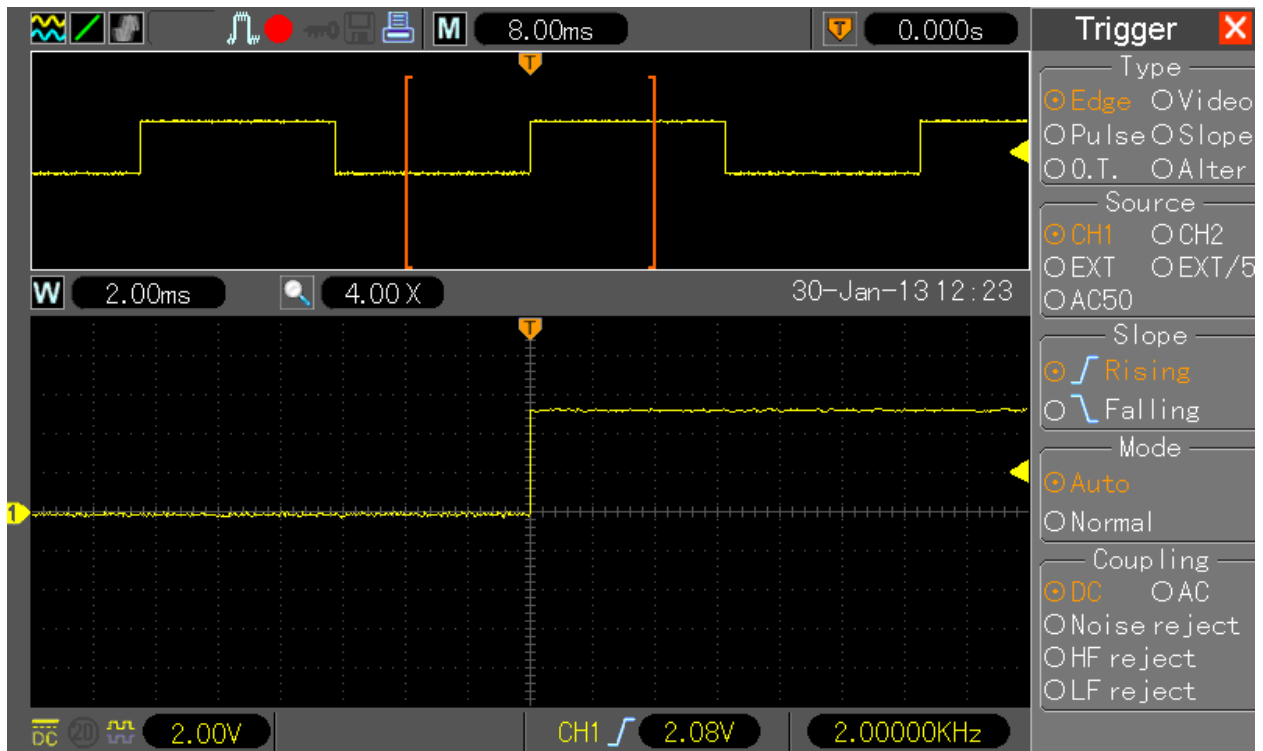
or try to change in MTB window (top window) the timebase, look on my picture, already 8ms/DIV but still only 2.5 periods displayed, so nothing refreshed on display:

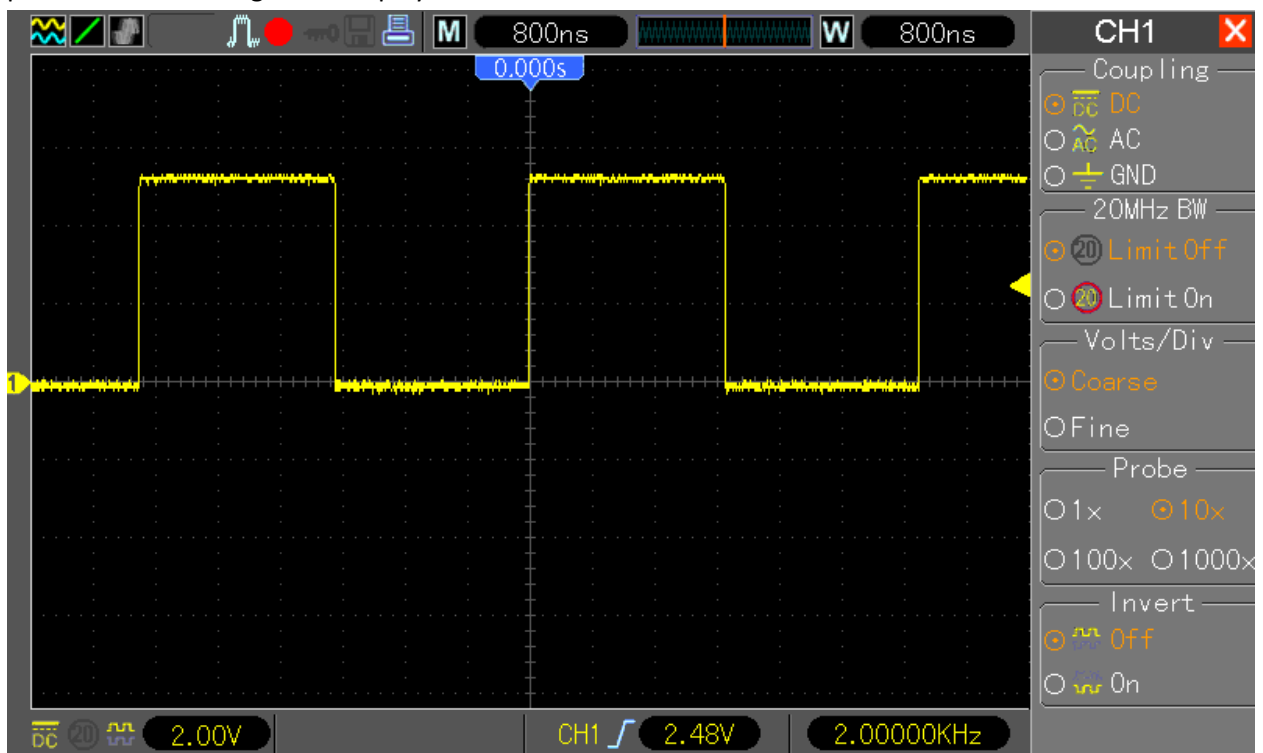
or try to push again F7 to go back to single window mode, the waveform will be there but it can not be moved not changed by tuning timeabse knob, look on my picture, 800ns/DIV but still 2.5 periods from 1kHz signal on display:

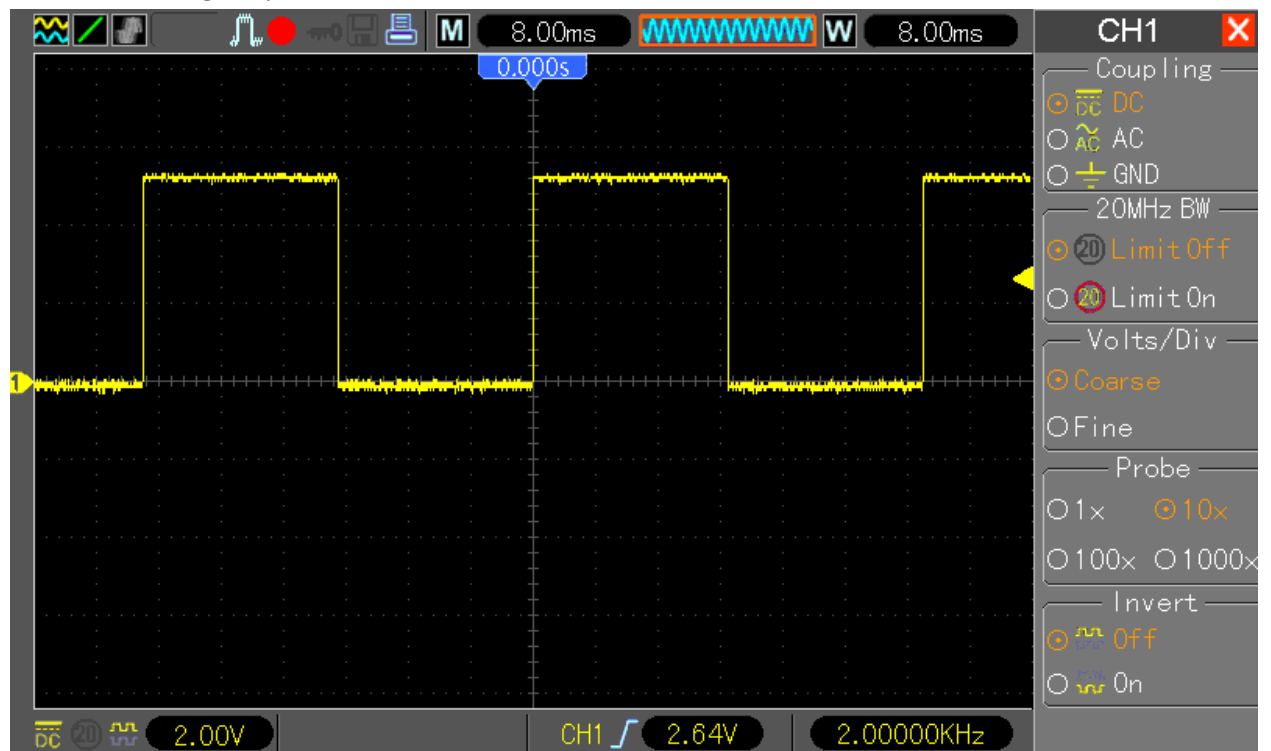
but when you try to move it, or turn timebase nothing changing (see my picture, 8ms/DIV but DSO still showing 2.5 periods):

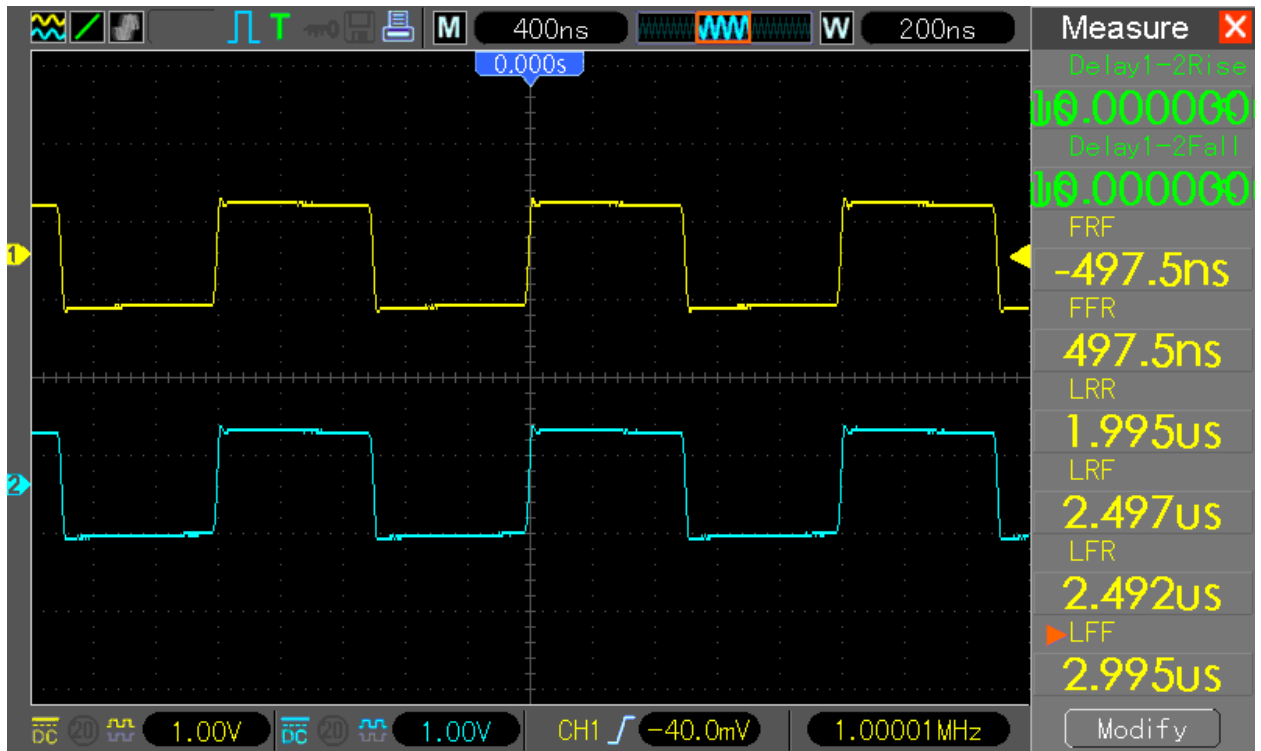
42. Measurement “Delay1-2Rise” and “Delay1-2Fall” displaying too long (wrong) result when the delay is equal zero (no delay):

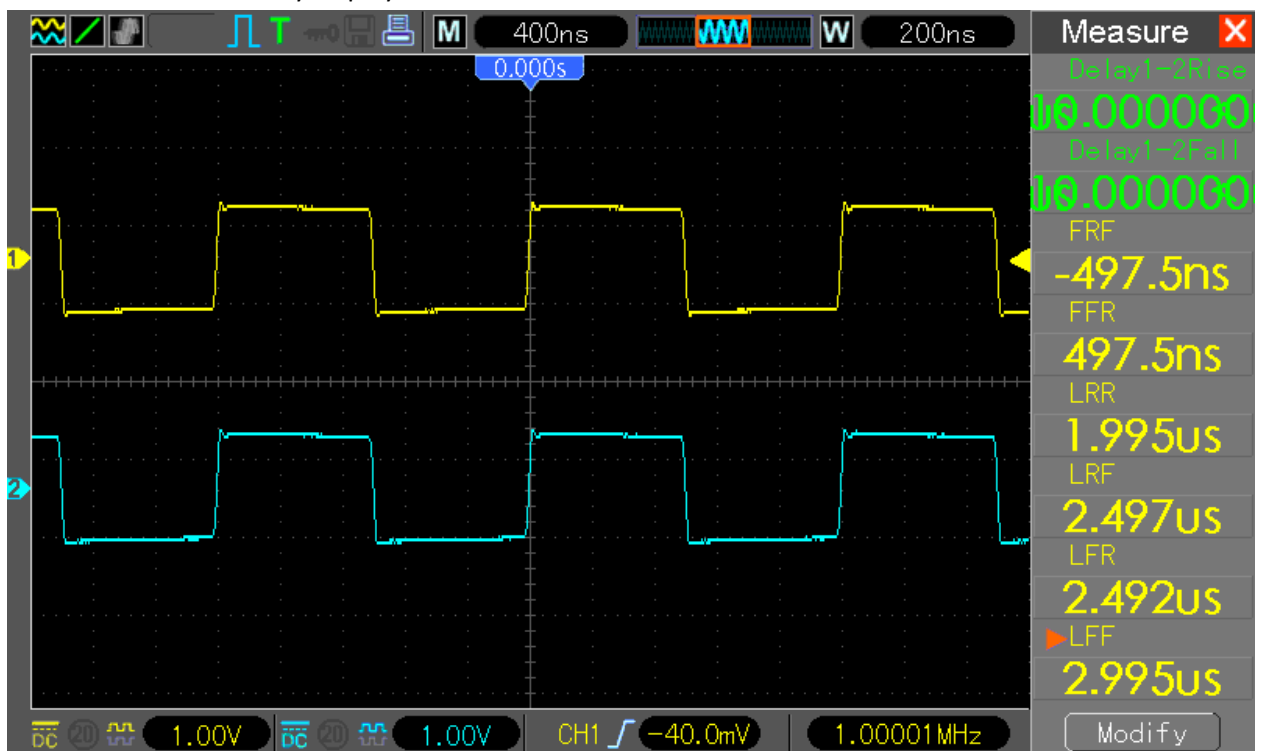
43. The current Measurement menu not consistent (sorting/name convention) and hard readable.  
New proposed sorting and name convention :

instead of what currently displayed:

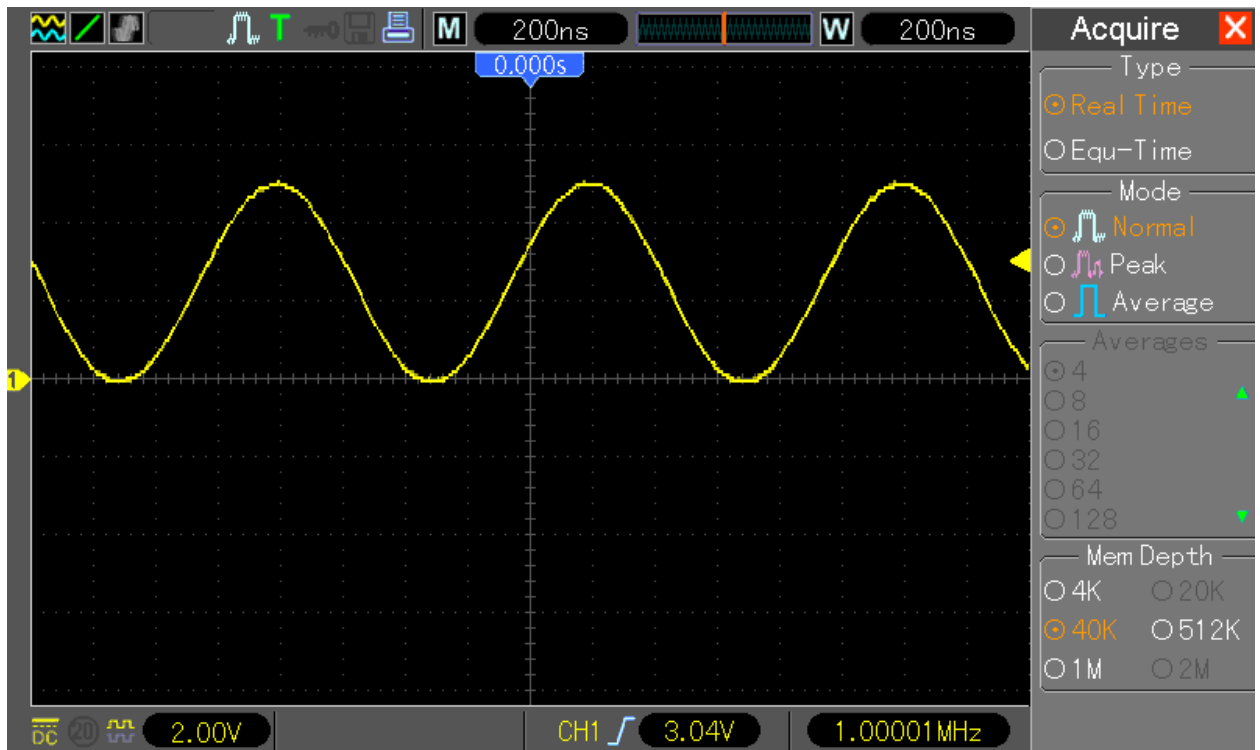
change now memory depth to 40k, the MTB is still displaying 200ns/DIV

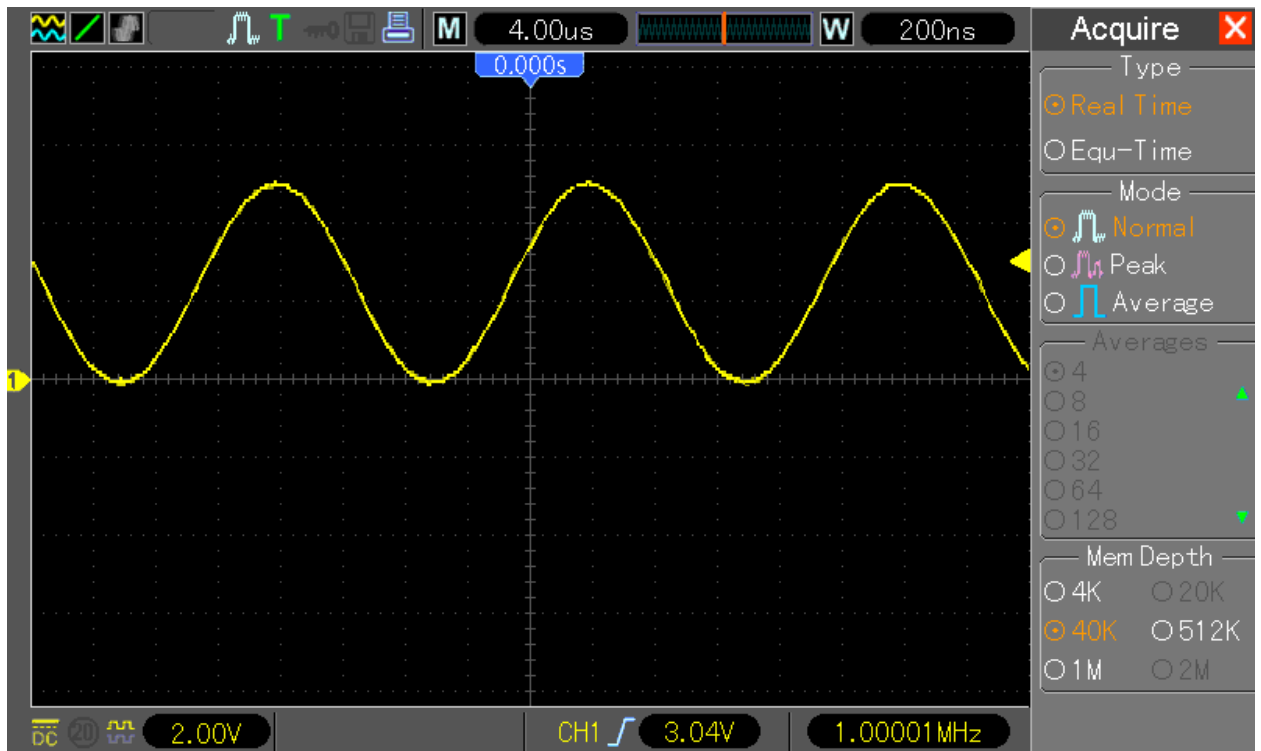
when you turn now timebase now one position up and down the MTB is displaying proper value, 4us/DIV:

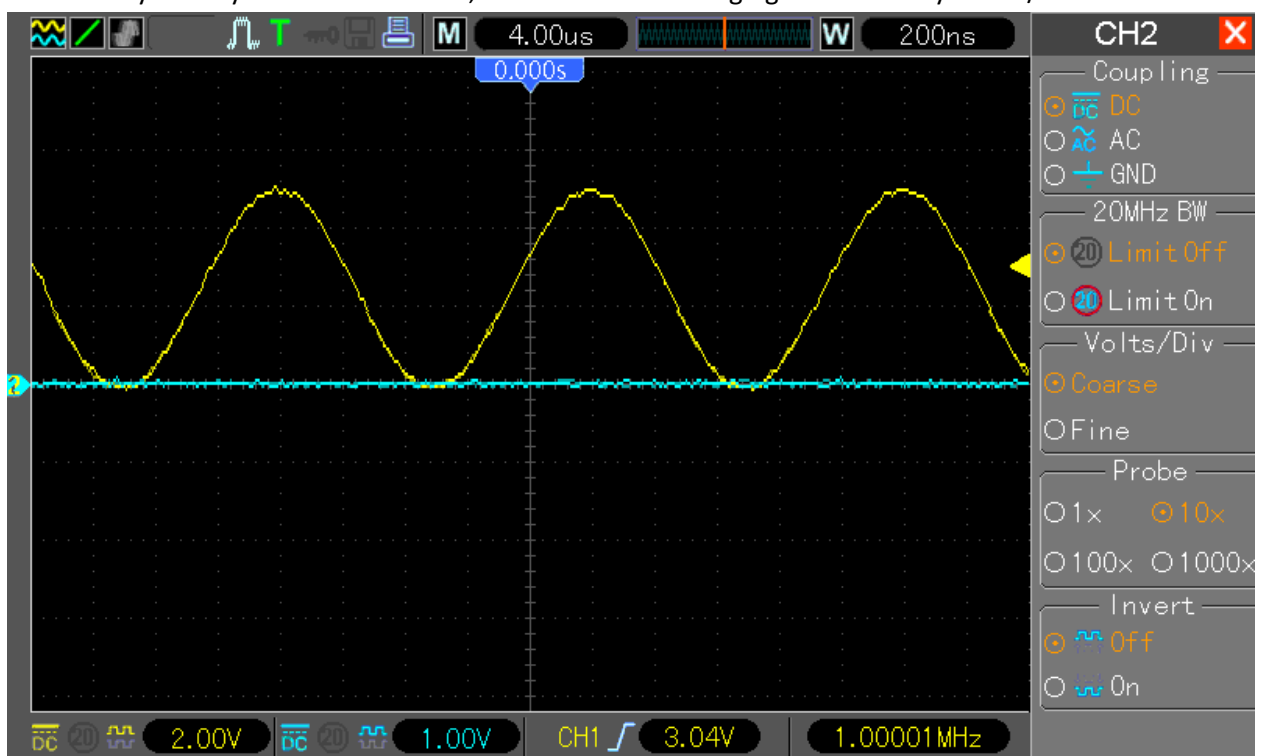
Additionally when you enable now ch2, the value is not changing automatically to 8us/DIV:

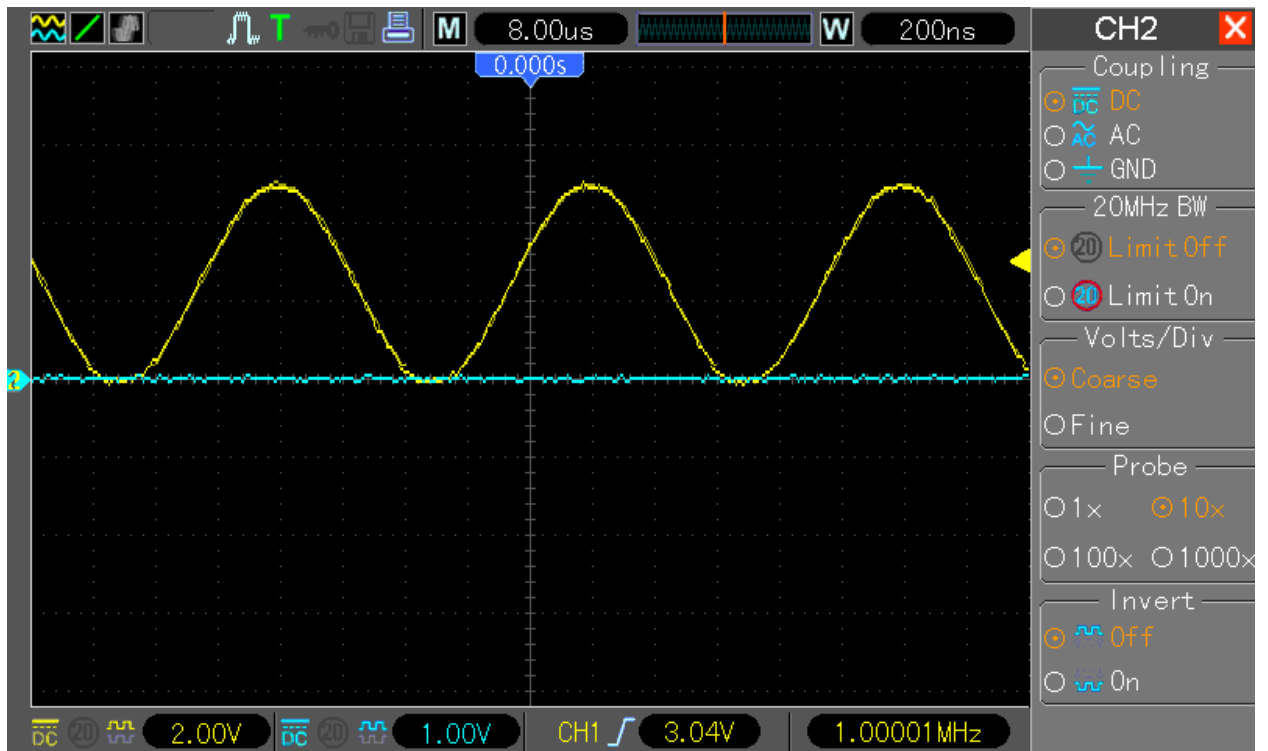
you have to turn again timebase knob one up and down position to get display updated to proper value which is in this example 8us/DIV:

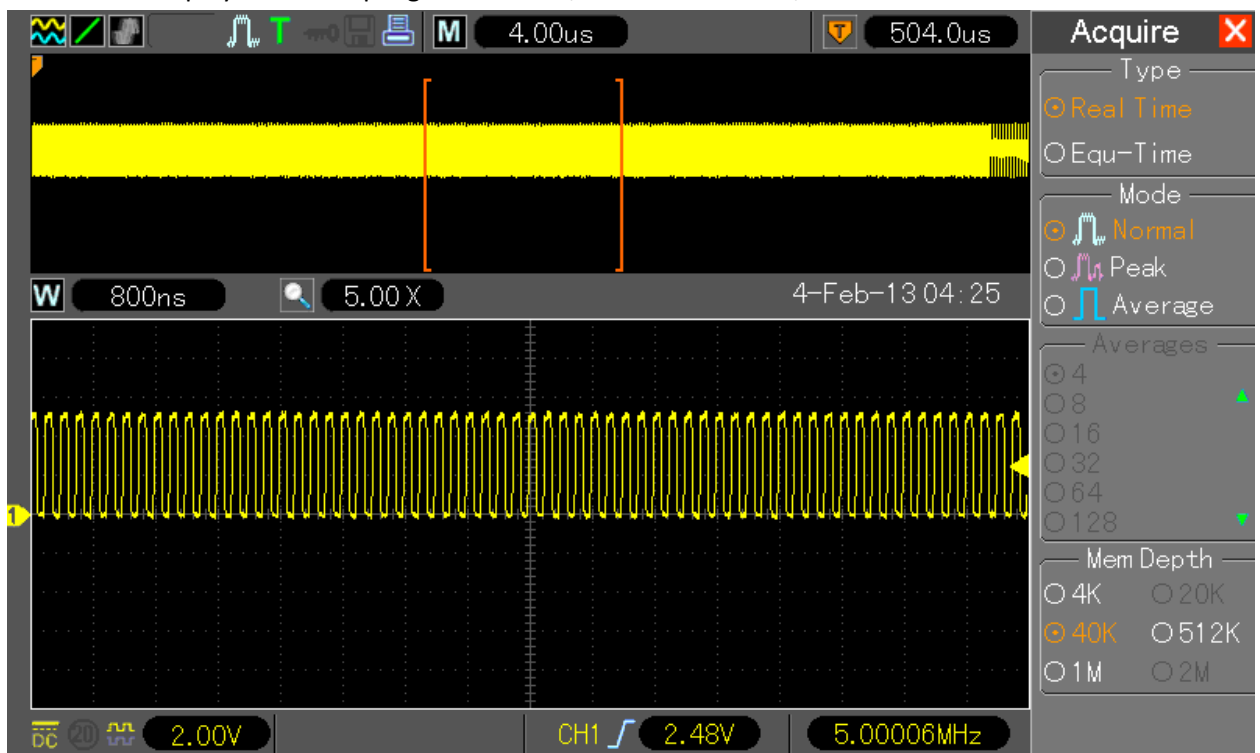
49. Artifacts on display when sampling with 400MS/s. Set 40k and 4us/DIV:

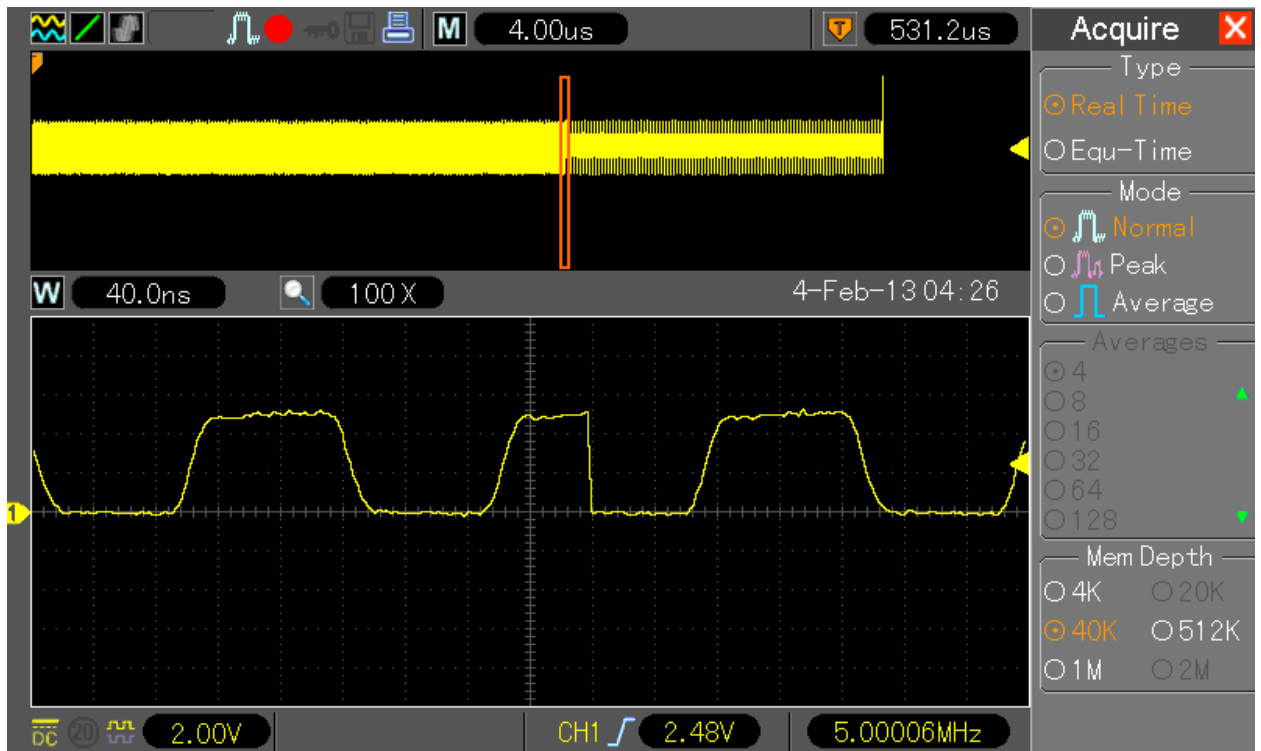
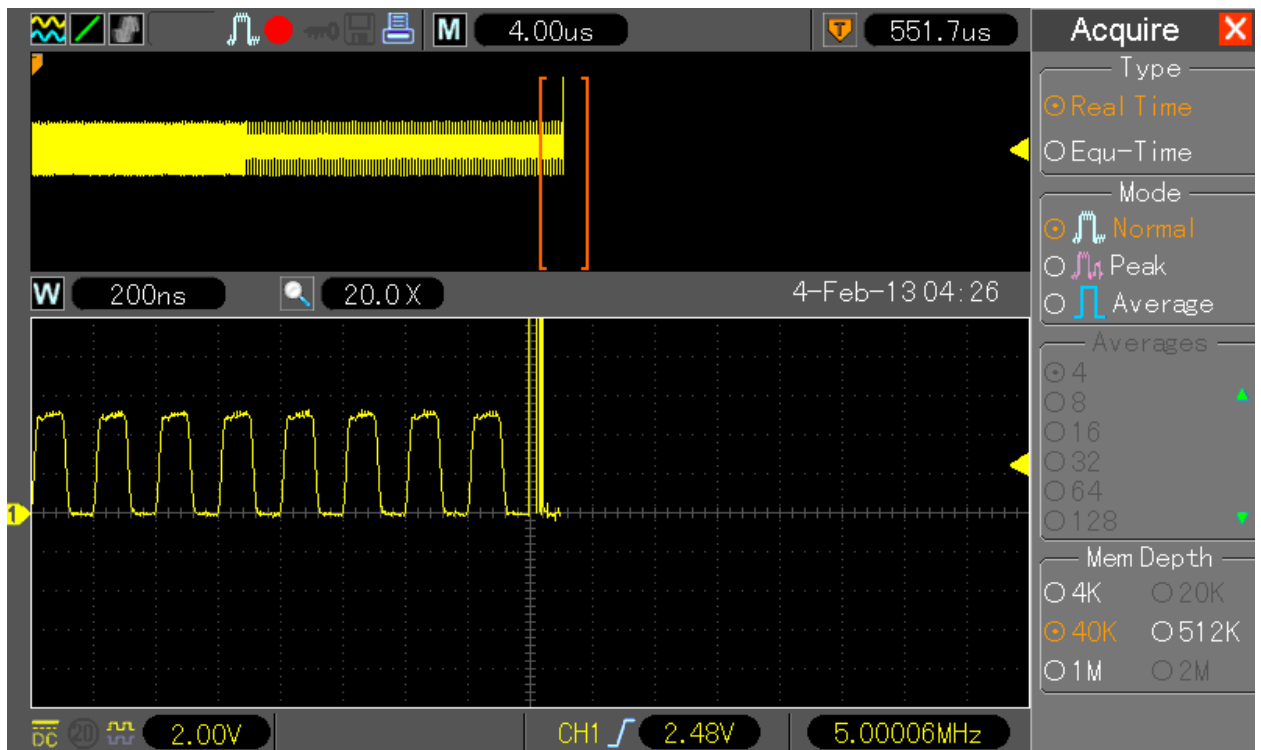
on the right part of the picture you can already see different waveform, when you move and zoom you see what's wrong:

It seems that no matter if the DSO is sampling with 200MS/s, 400MS/s or even 500MS/s (I played a bit deeper) the error is there in 40k, 512k and 1M always somewhere at the end of buffer (up to last ~ 3%).

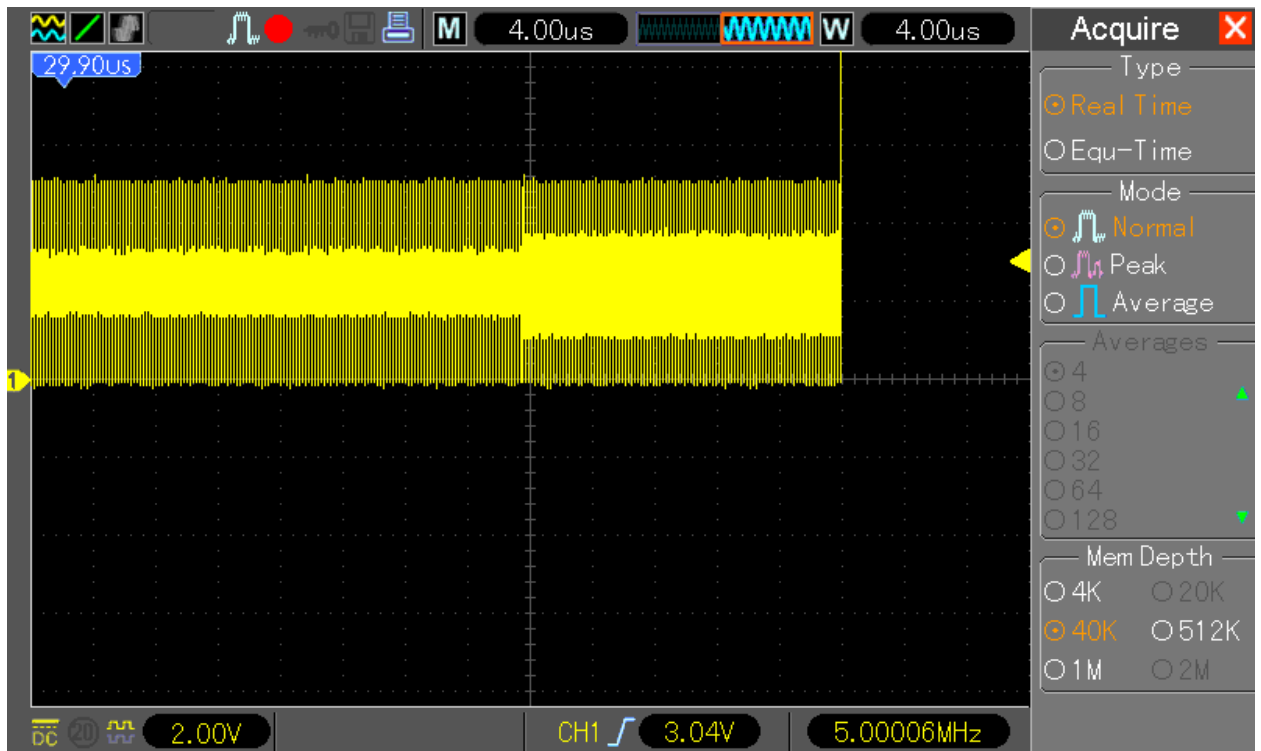
Of course the same is visible in single window mode, so it does not have anything to do with window mode:
