## Firmware 2.06.3 bug list:

## List of bugs/improvement requests

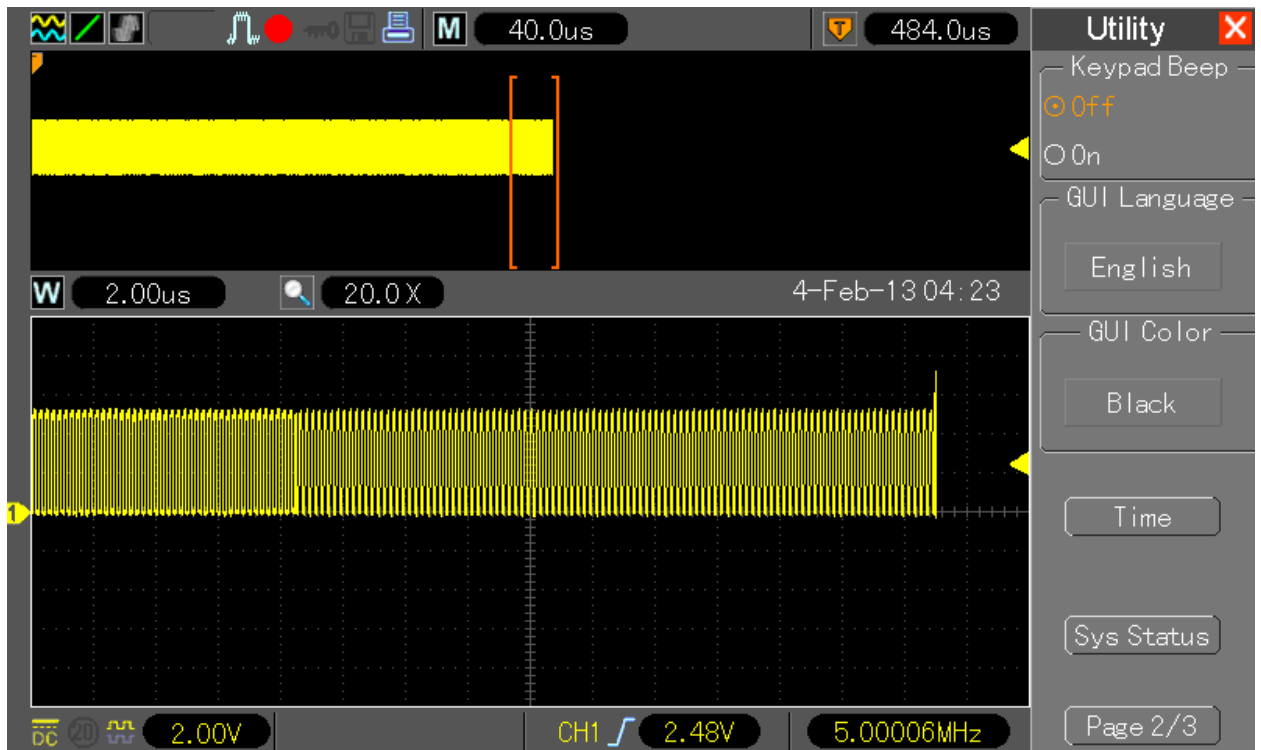
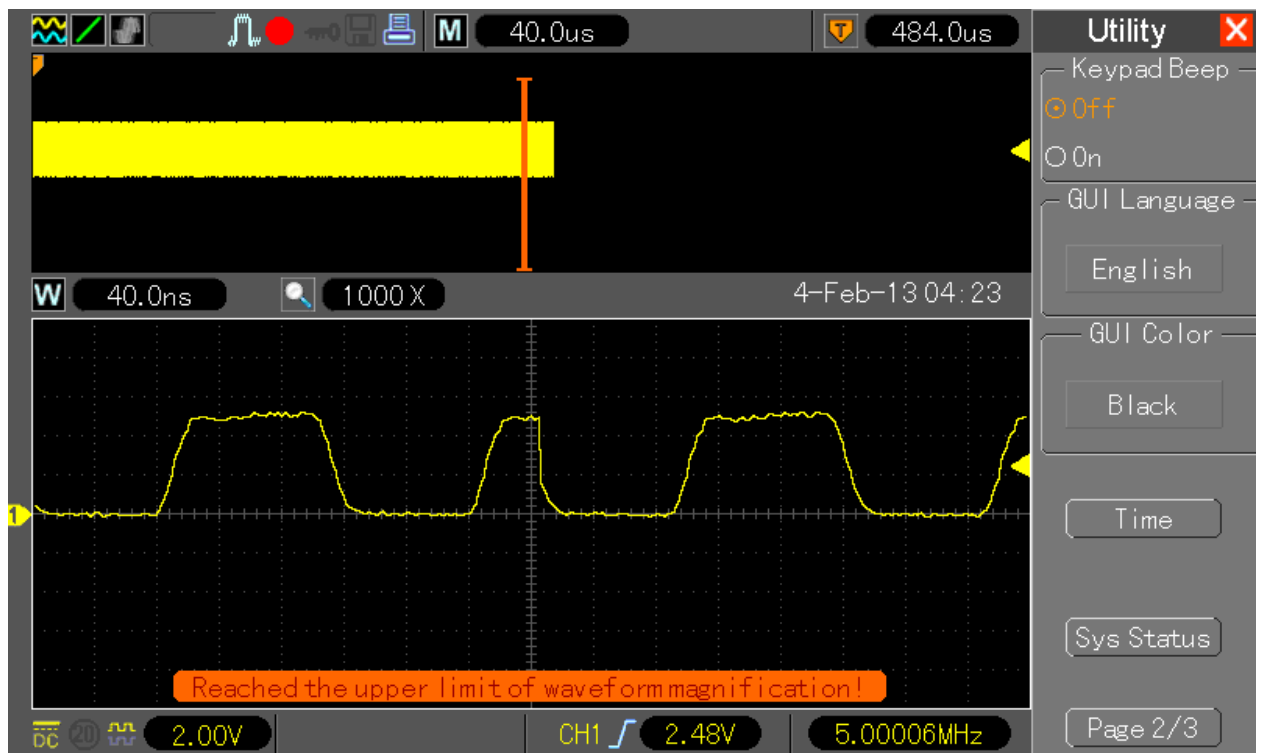
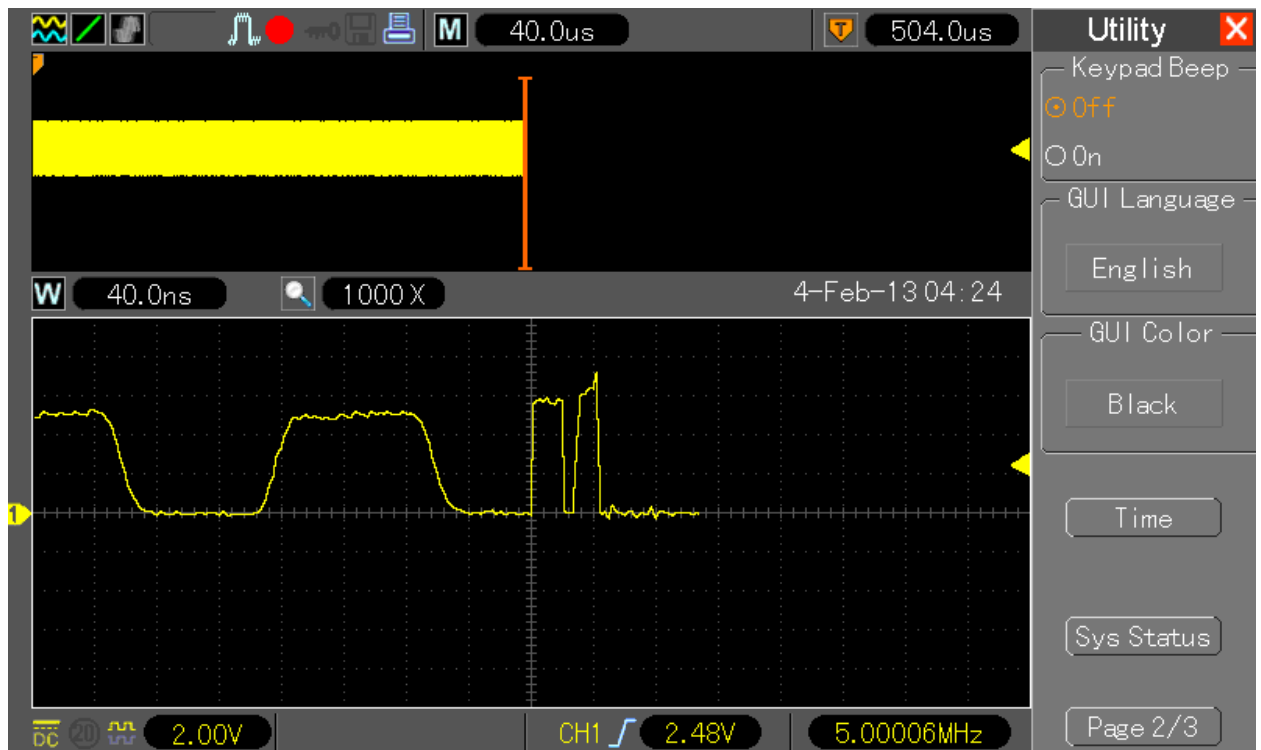
Same kind of error in 512k memory selection and 40us/DIV:

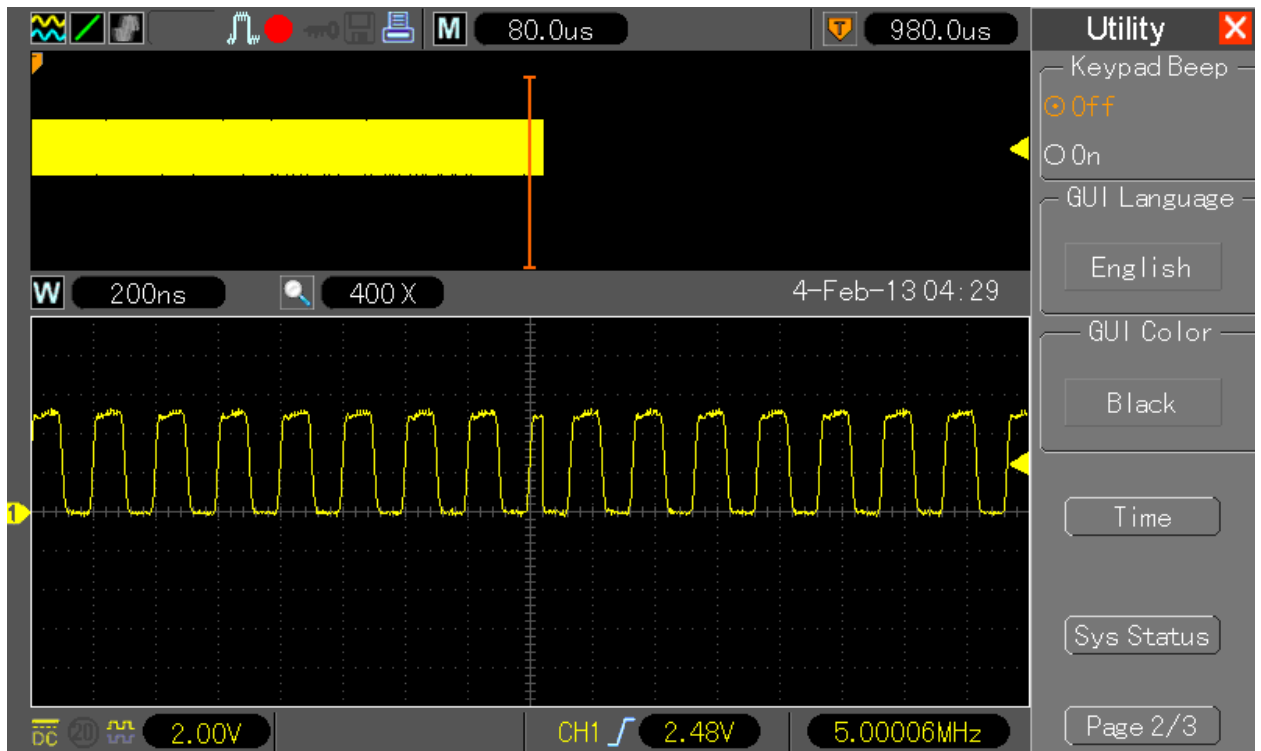
and as well in 1M and 80us/DIV:

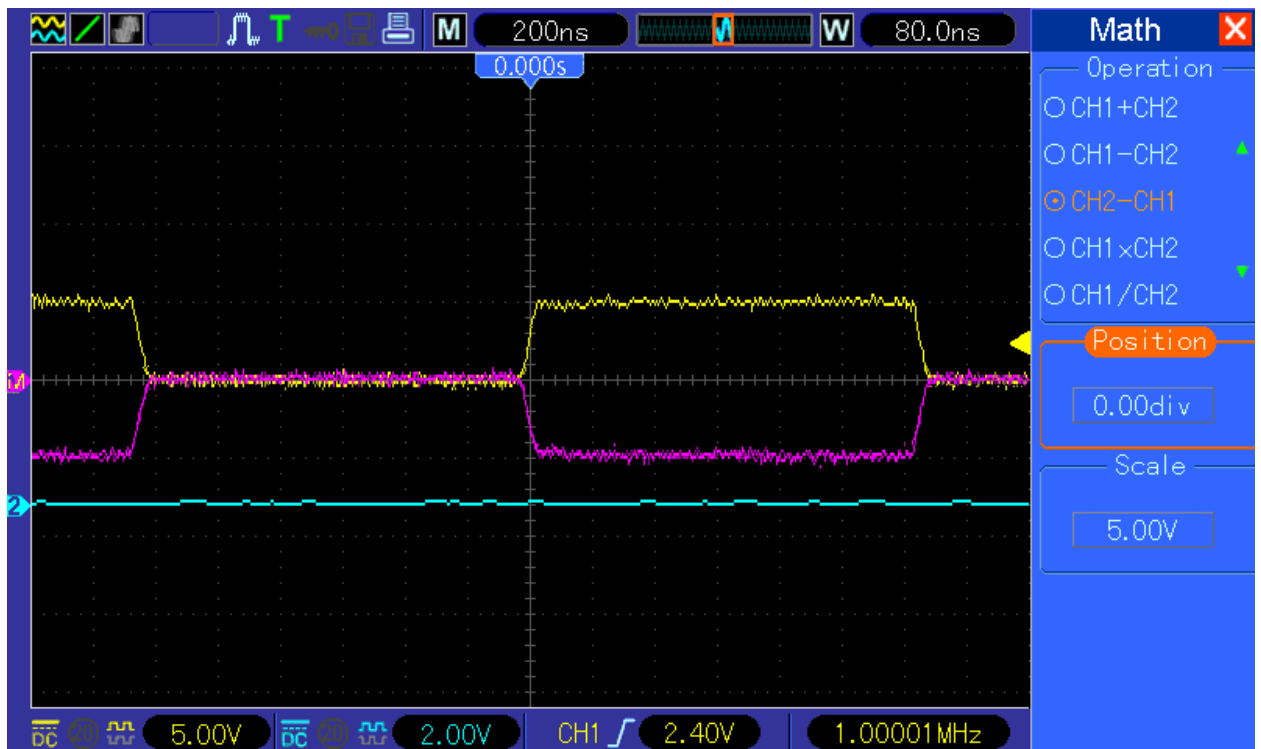
50. In Math menu, when trying to change waveform position with V0 knob:

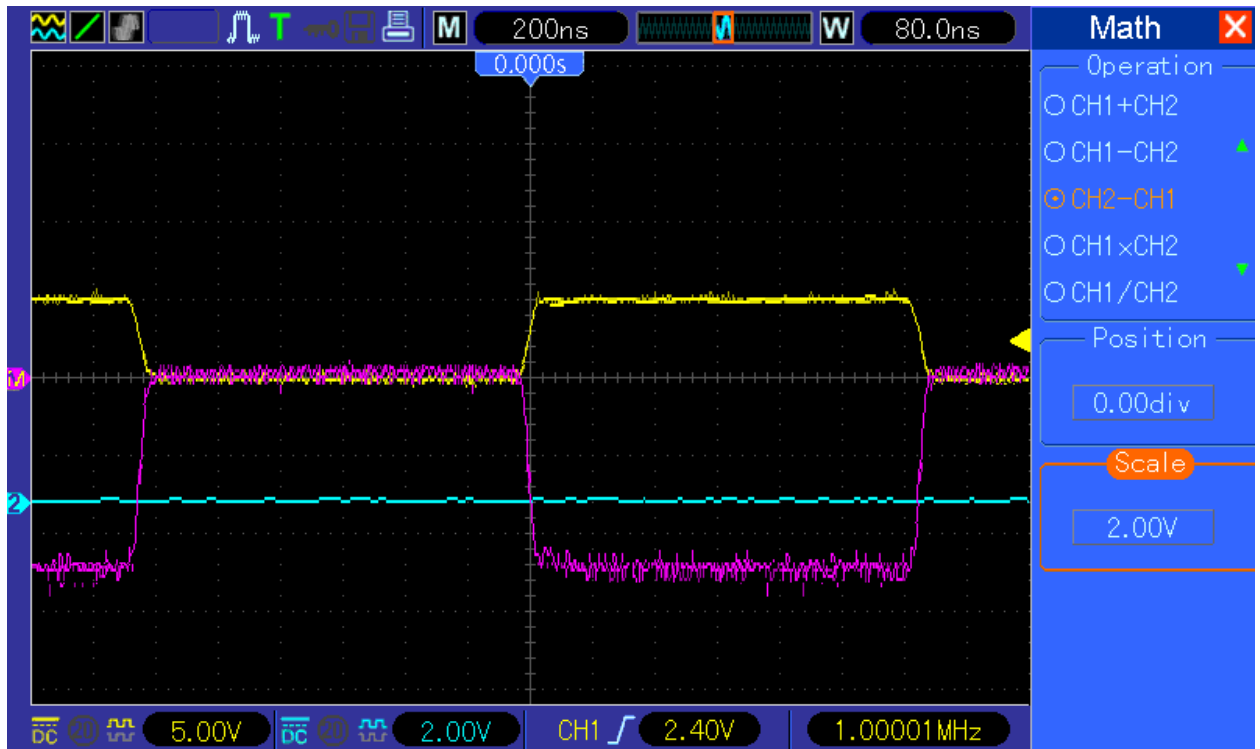
the value of “Position” is not changing. Additionally the focus is jumping to “Scale” from “Position” and the value changing there:

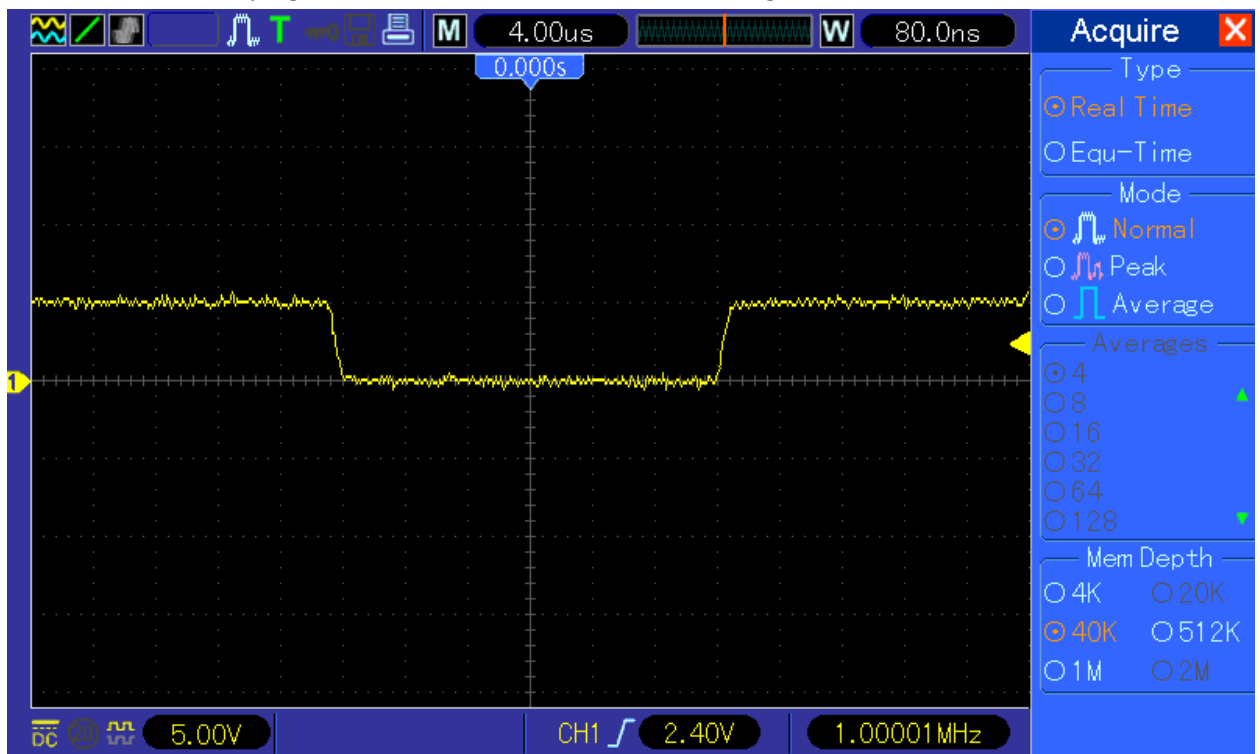
Switch now to 40k, trigger is moved, zeroing of trigger position, selfcalibartion and even factory calibration is not helping. Tested with 83E9 and 83EB FPGA designs:

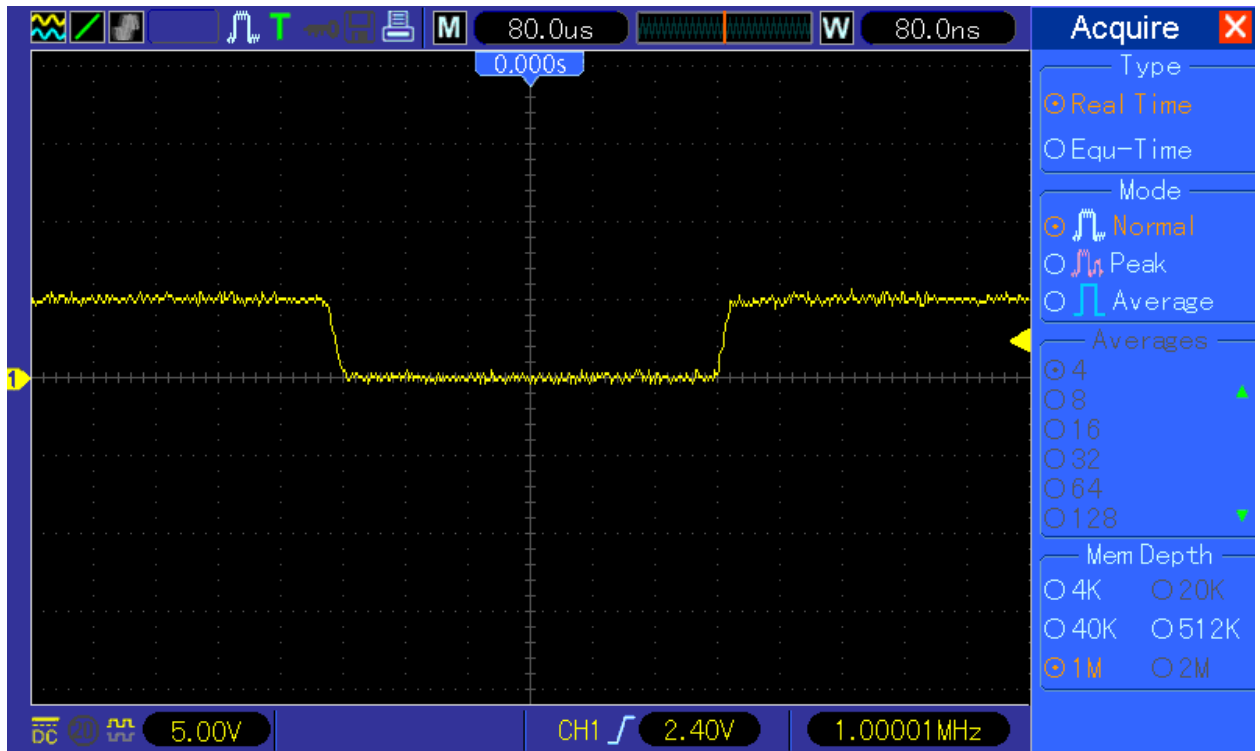
and in 1M:

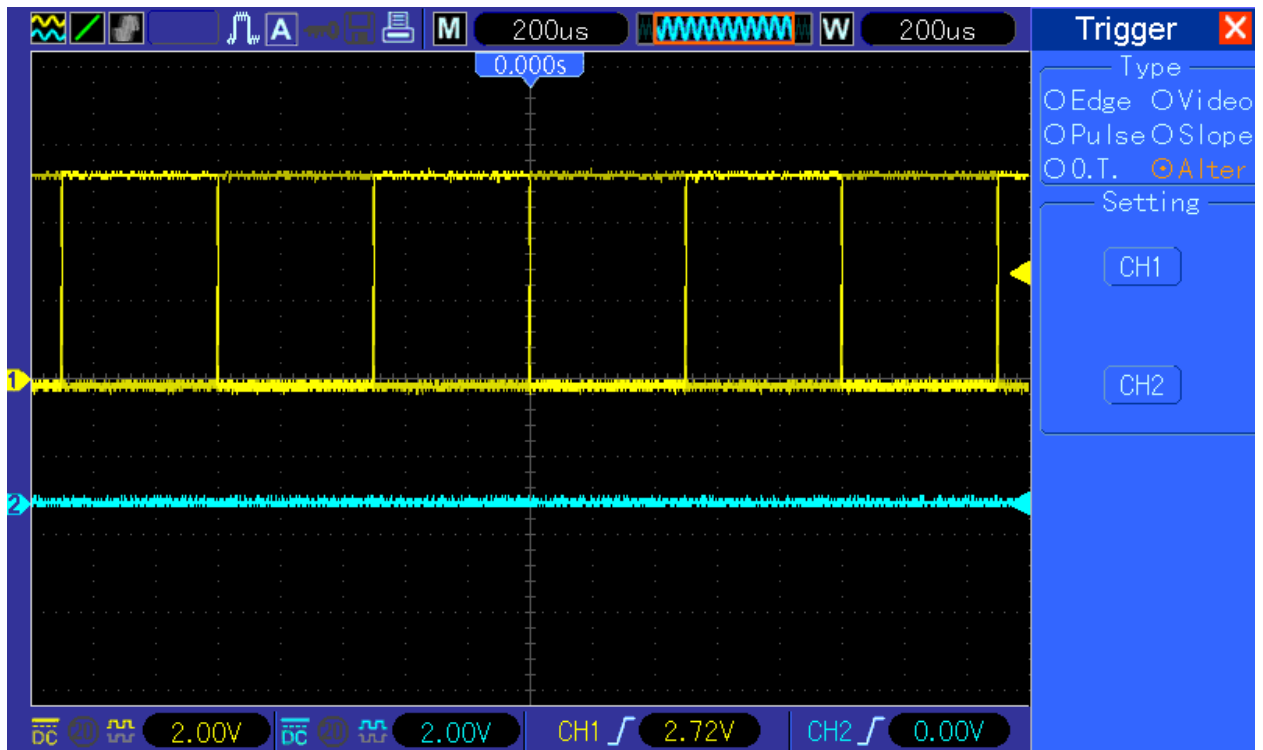
and changing to Alternate Trigger mode, the Dual Slope seems to be still on:

but I assume should be off? (I'm not sure about the intention here).

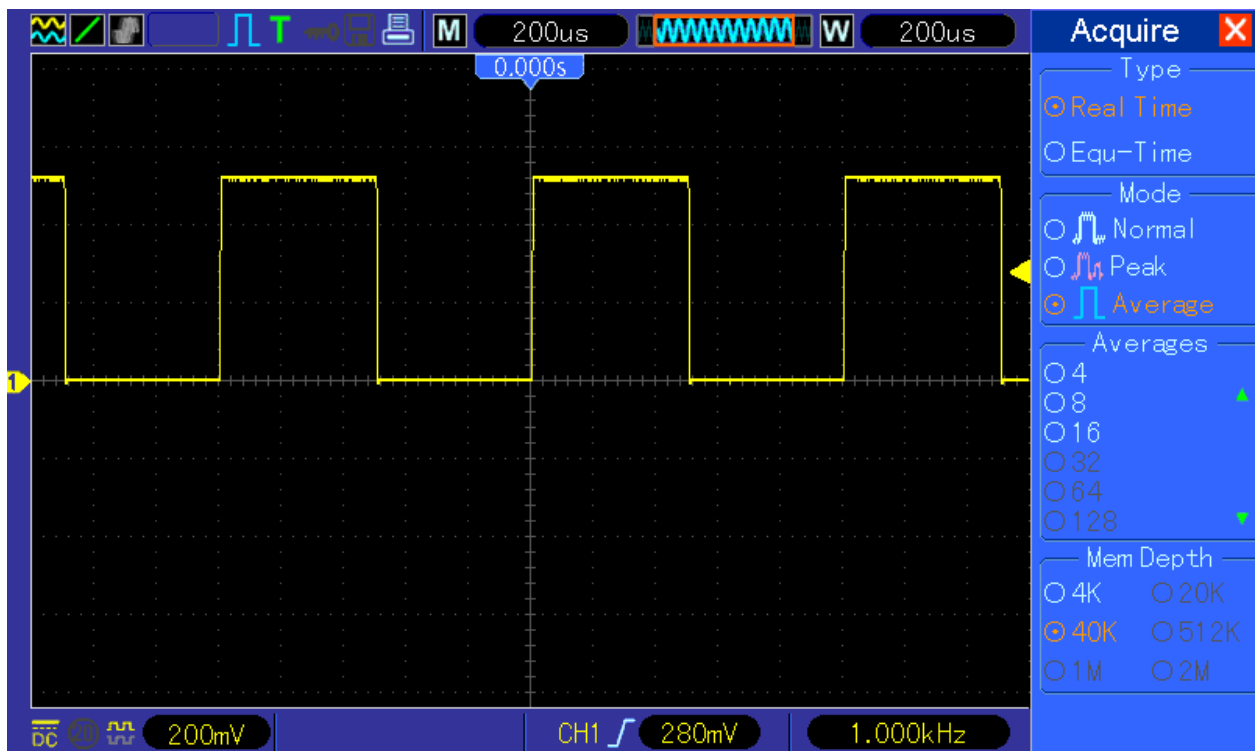
to 40k memory depth, the number of averages is showing nothing:
