MSO/MST Firmware 2.07.x bug list:

Bug number	2.07.1 130826.0 / hw1007_83E9
1	bug
2	proposal
3	bug
4	request
5	bug
6	bug
7	bug
8	bug
9	bug
10	bug
11	bug
12	bug
13	bug
14	bug
15	bug
16	bug
17	bug

List of bugs/improvement requests

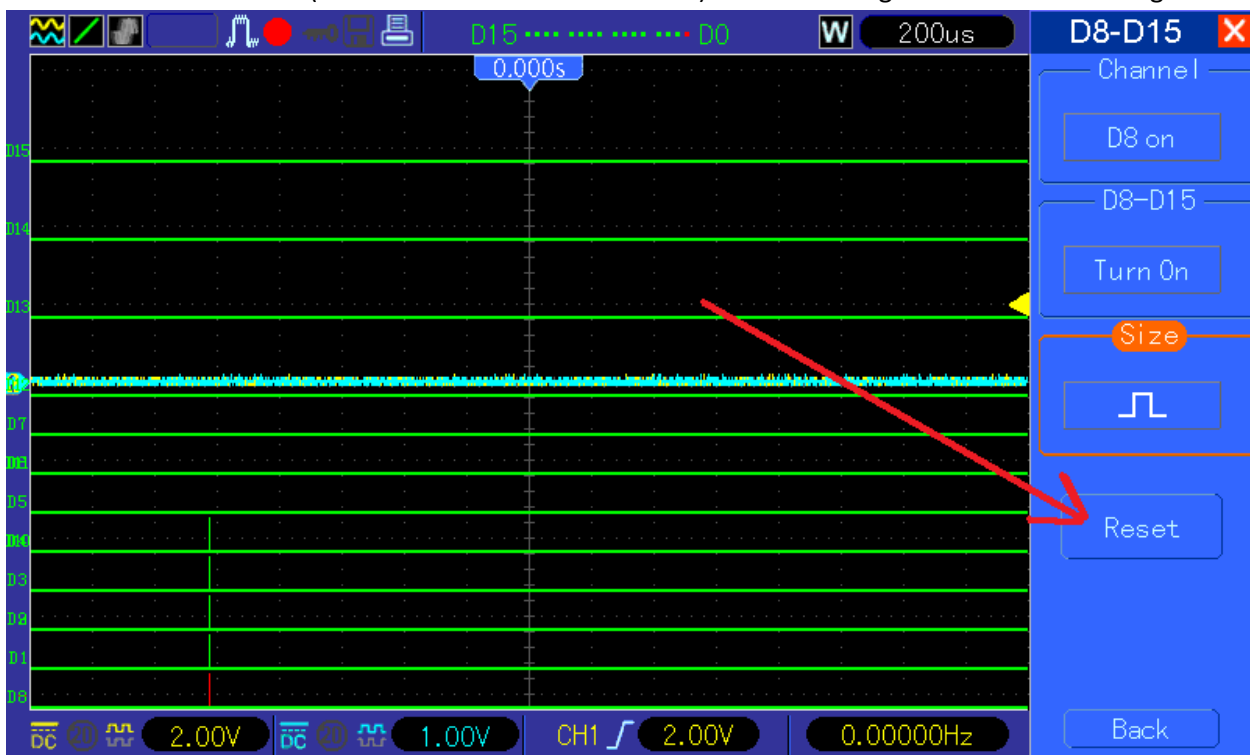
5. Reset Button in LA mode (in D0-D7 and D8-D15 submenus) is not resetting the LA channel settings:

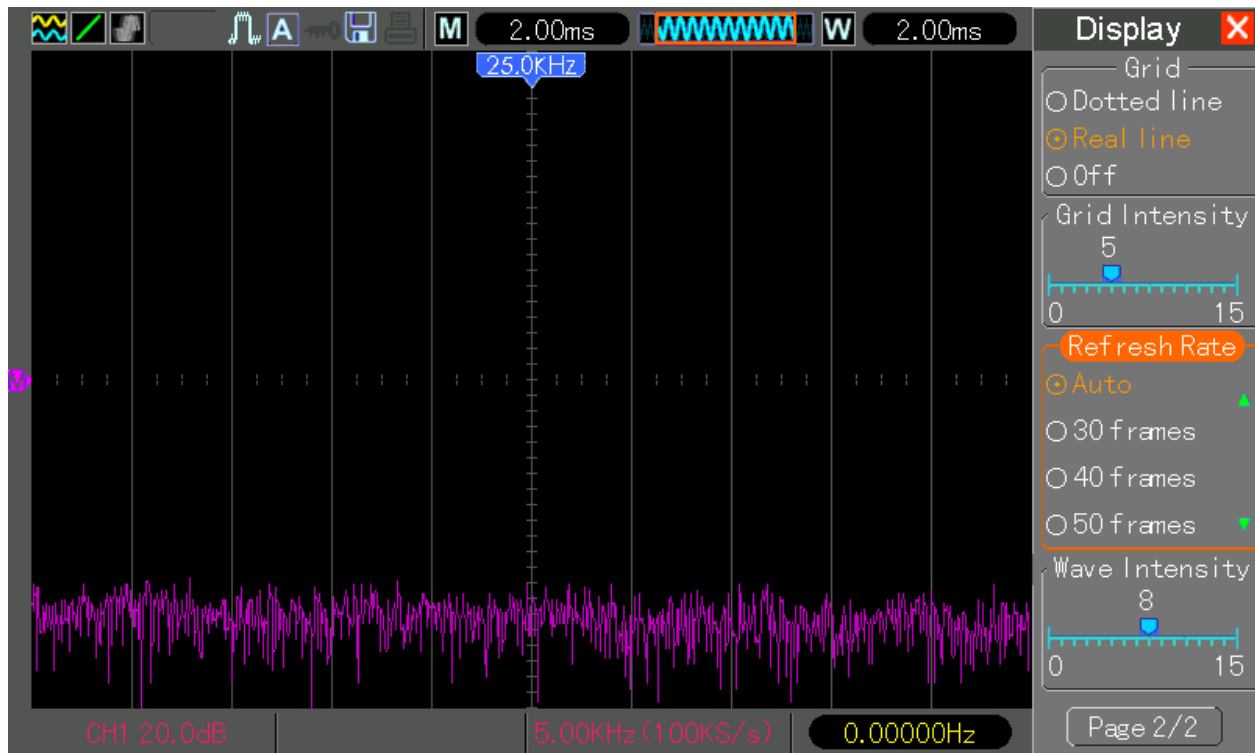
7. In FFT mode when Display -> Grid set to “Real Line” only vertical lines are visible, horizontal lines are missing

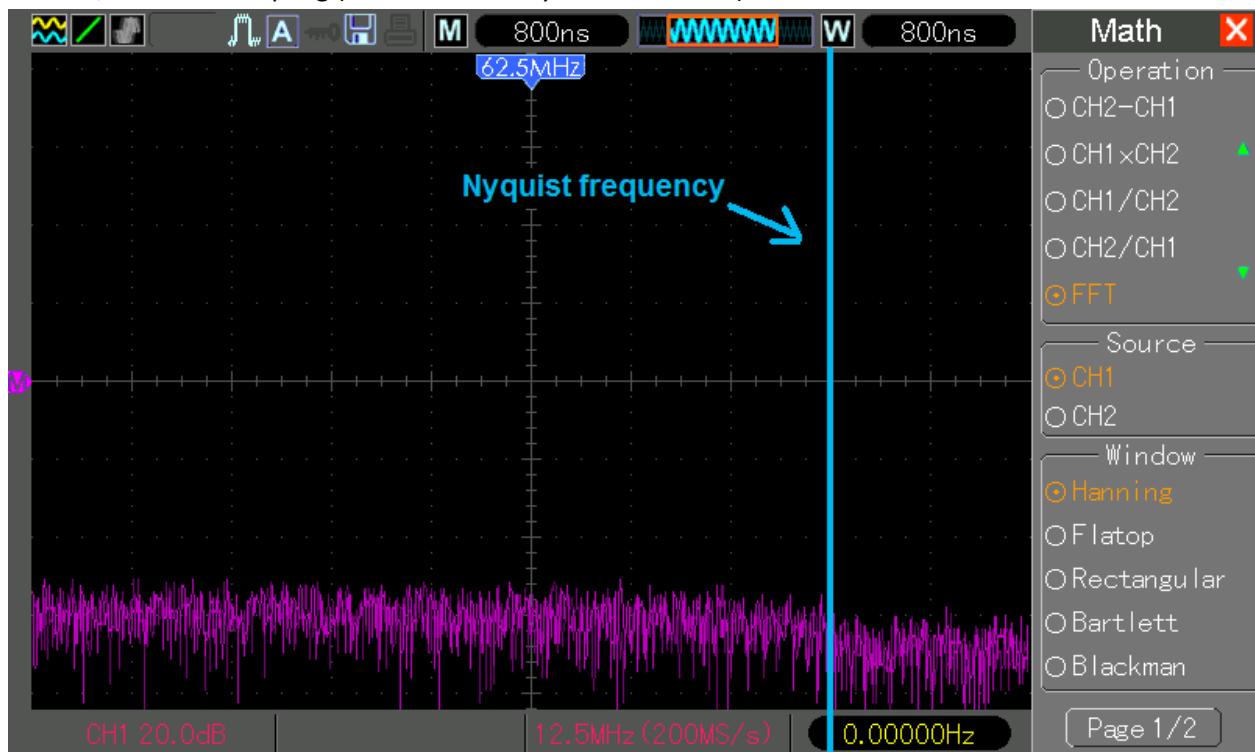
8. In FFT mode “Full span” is higher than Nyquist (sample rate / 2)
Example: 800ns/DIV, sample rate is 200MS/s, full span 125MHz. Easy to fix by enabling from 800ns/DIV to 20ns/DIV 1GS/s sampling (when 4k memory or FFT enabled)

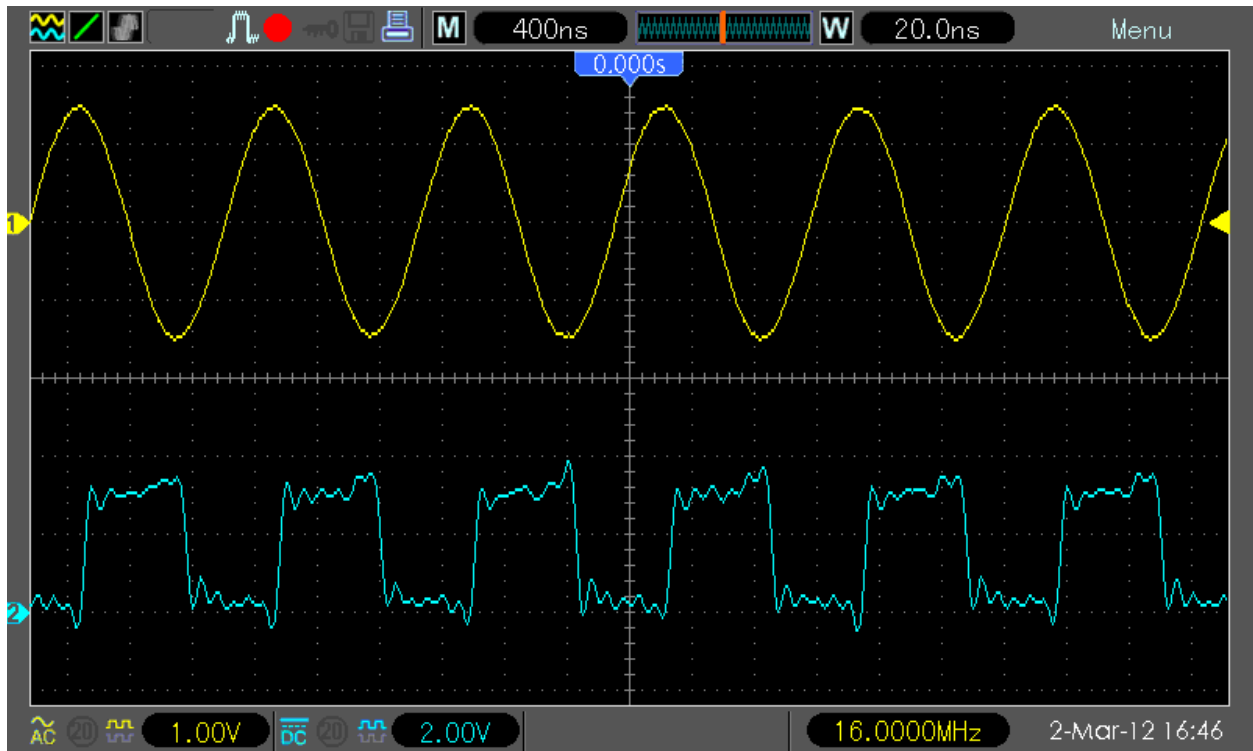
9. Dithering/interpolation filter are too sharp. When enabling both channels (this also occurs in single channel mode and 1GSs, but test signal need to be higher to get same error) and applying for example 16MHz square wave the waveform is switching between proper square:

The best would be to disable (or let user to choose in options) it.

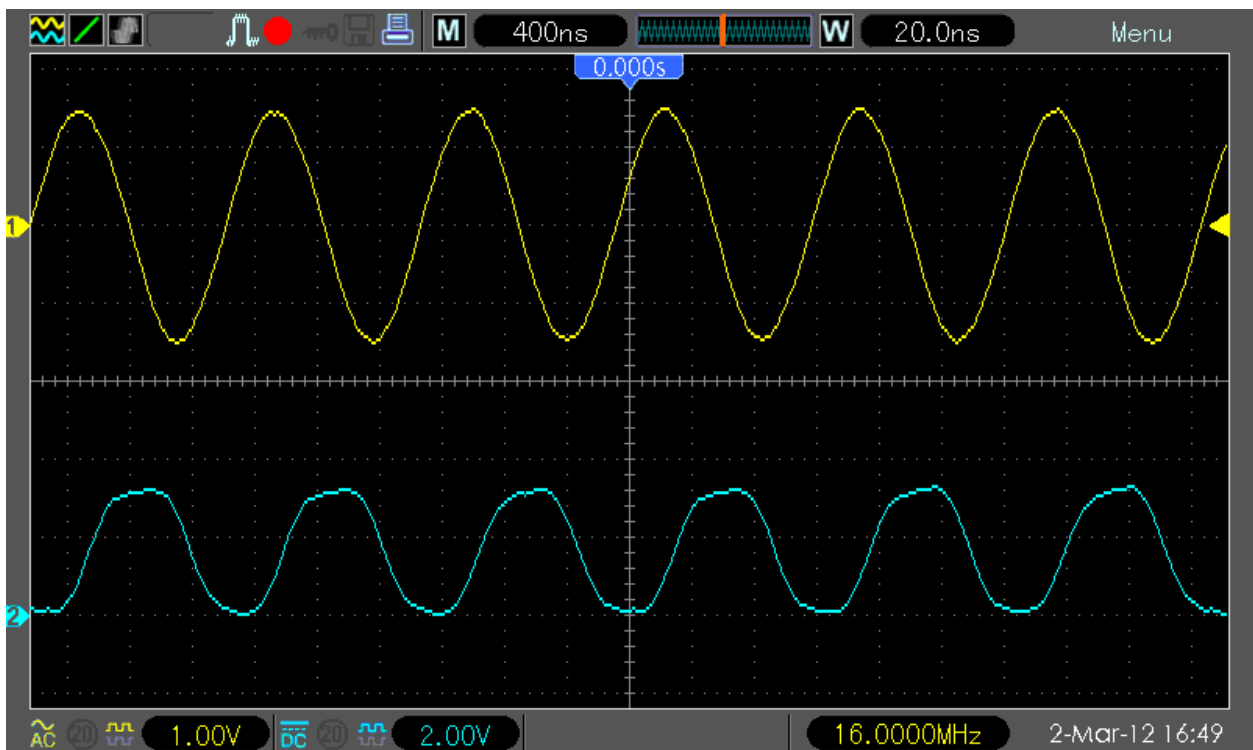
and crippled square every second:

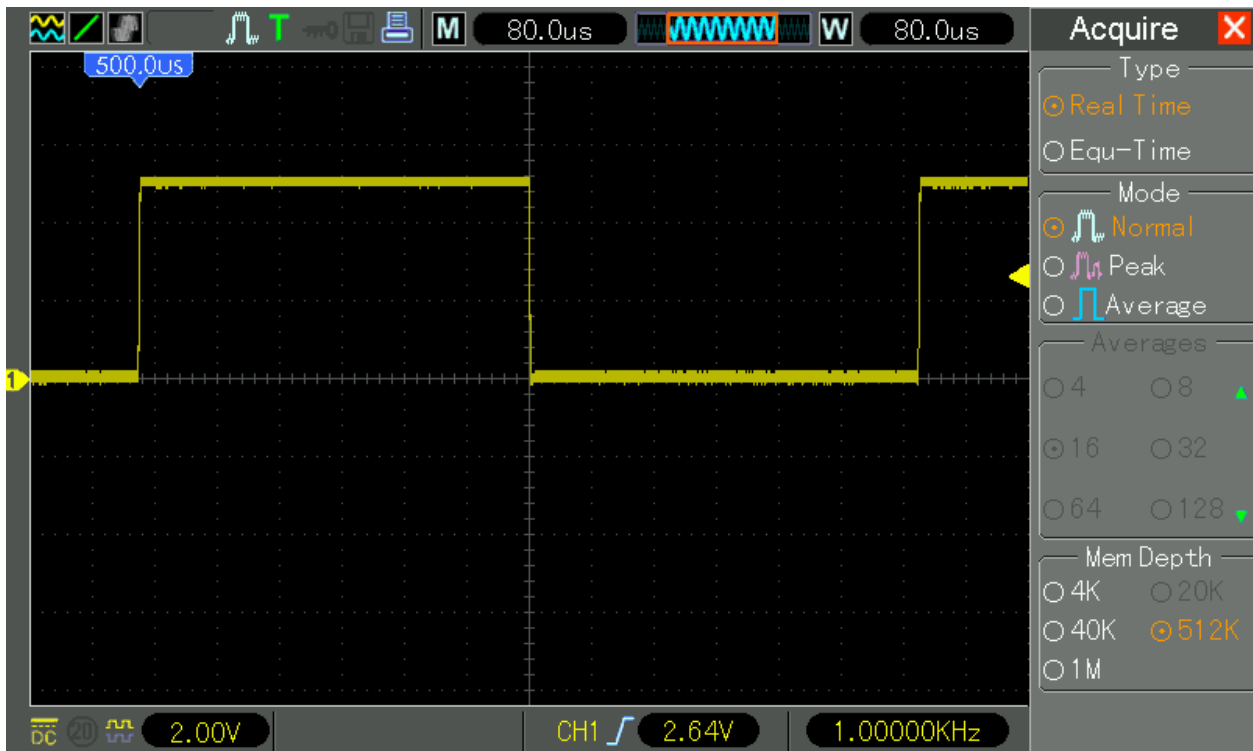
10. Display / Time base scaling strange behavior with 512k memory depth. Apply e.g. 1kHz signal, chose 512k memory depth, set time base to 80us/DIV and move the waveform to 500us/DIV:

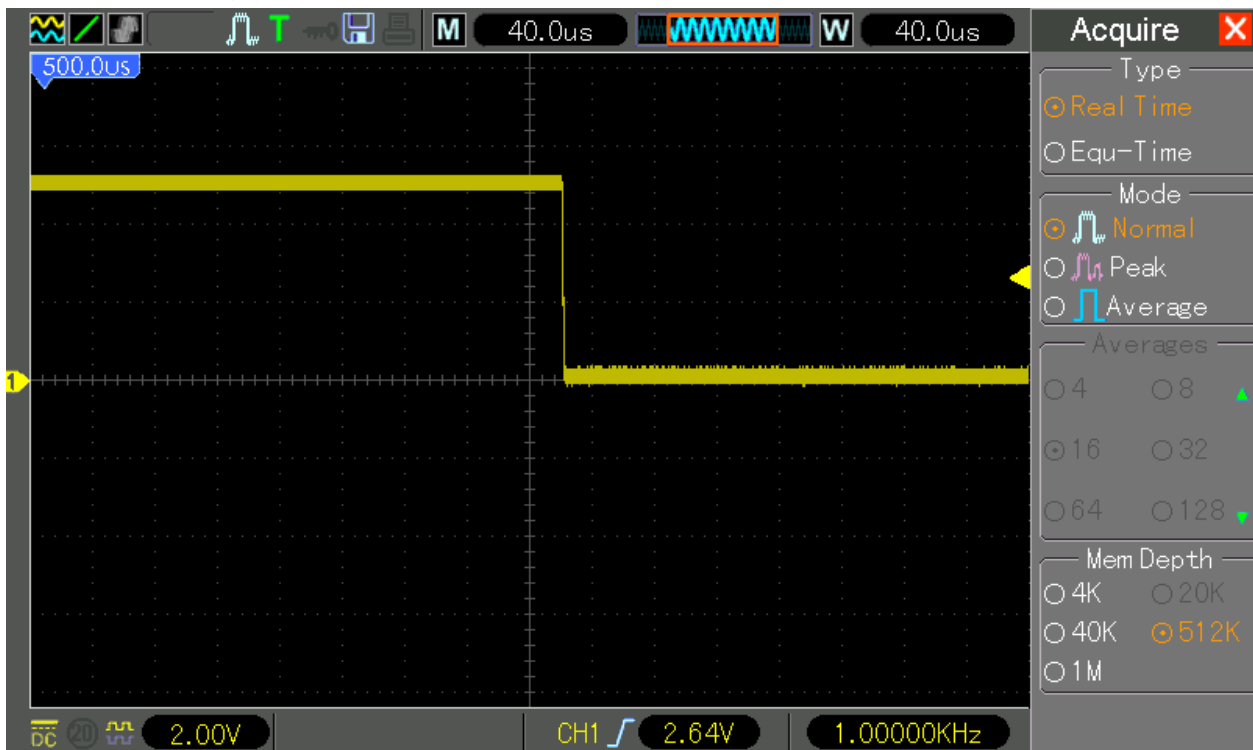
When you now change time base to 40uS/DIV the falling edge (which should be still in the middle of the screen) has been moved to 522uS position (but it should stay on 500uS). The same happens of course with 20uS/DIV, etc):

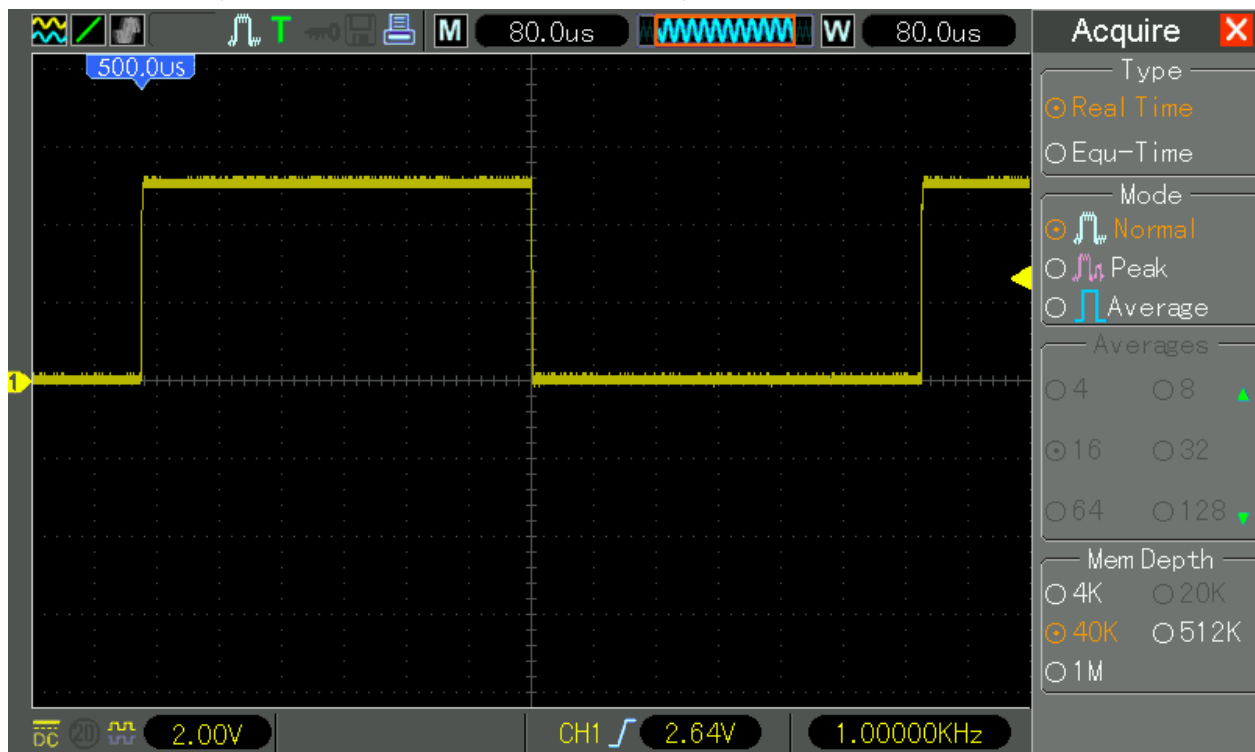
11. Missing Waveform refresh with 40k memory depth. Apply e.g. 1kHz signal, chose 40k memory depth, set time base to 80us/DIV and move the waveform to 500us/DIV:

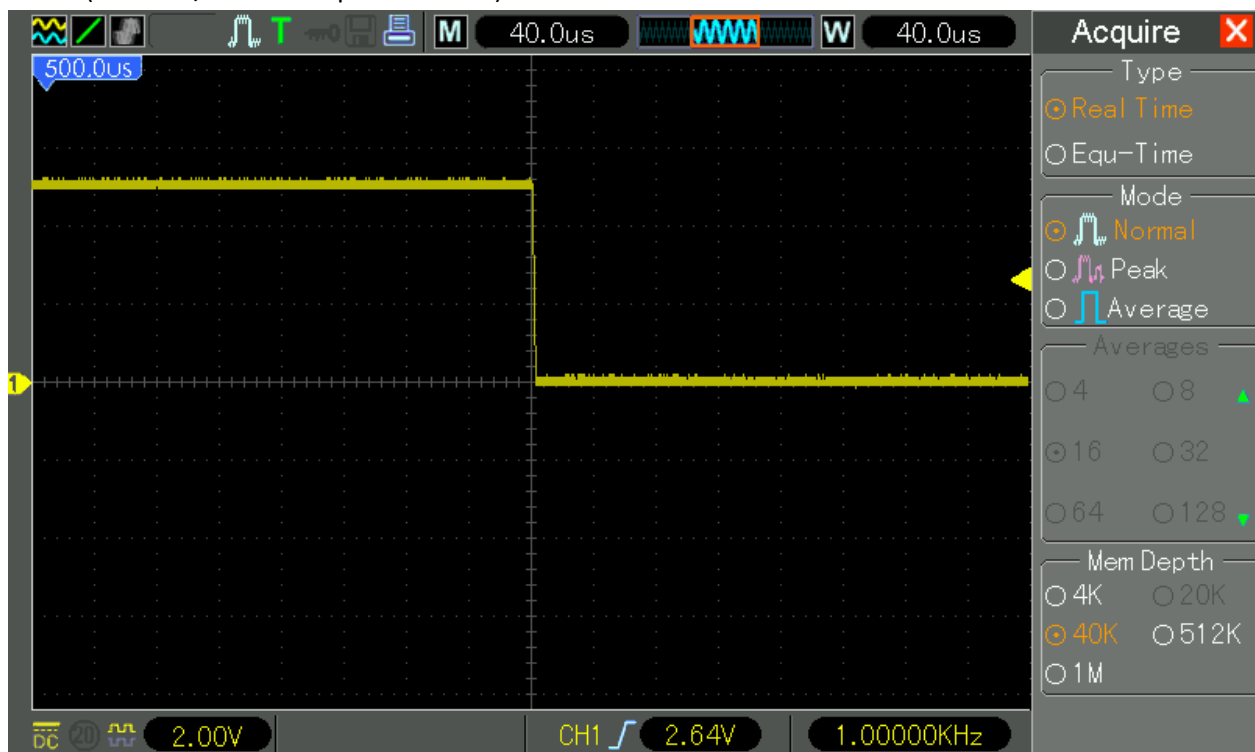
When you now change time base to 40us/DIV the falling edge is in the middle of the screen (not like in similar 512k bug), but the waveform is completely static – no refresh, as if the DSO would be in STOP mode (but RUN/STOP is on position RUN):

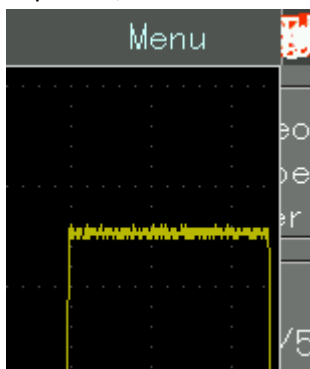
21. When in LA mode and LA menu selected off, the next push of button F7 brings normal DSO screen, as expected, but remains of a previously selected menu are visible in the right-hand edge of the screen:

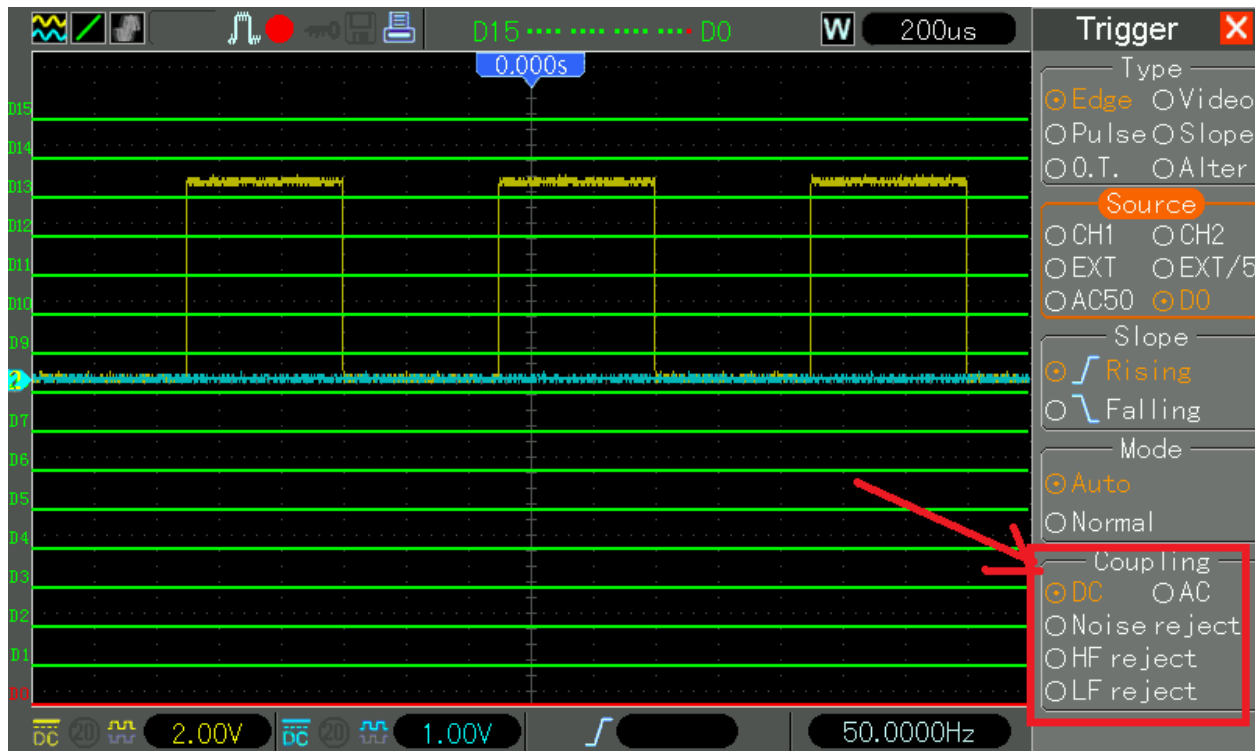
22. Pushing the Utility button several times brings on the next Utility pages. **REQUEST: Make the Horizontal and Display button behavior like the Utility button.**
23. **PROPOSAL:** When trigger source is one of the LA channels menu item "Coupling" of the trigger menu is not relevant, can be grayed out, removed, or the button can be used for something else:

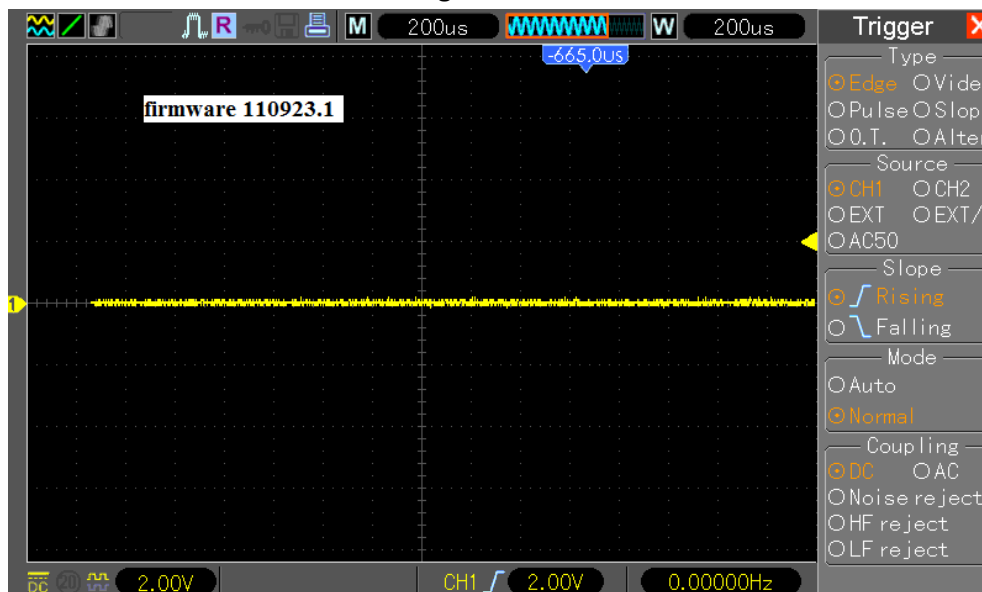
24. Horizontal Position knob not moving display data. Set Trigger to "Normal" – when MSO not triggered the waveform/horizontal screen position cannot be changed. Once triggered it changing rapidly. Another example – set trigger to Single Sequence and Auto , while trigger in "R" (ready) mode waveform/horizontal screen position cannot be moved. Again, once triggered it change rapidly. **In DSO firmware 110923.1 this was working :**

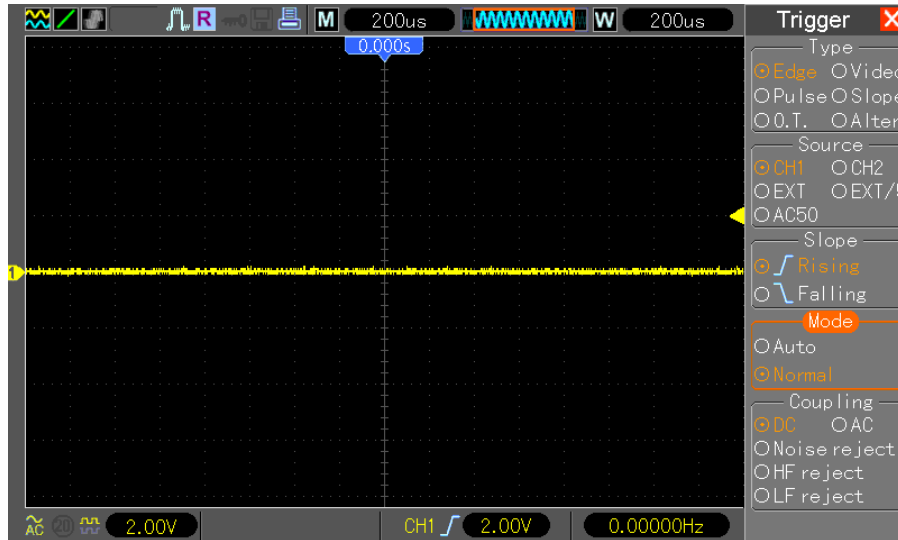
but in the MSO is not working (same condition, Horizontal position knob already turned few times but no move on screen):

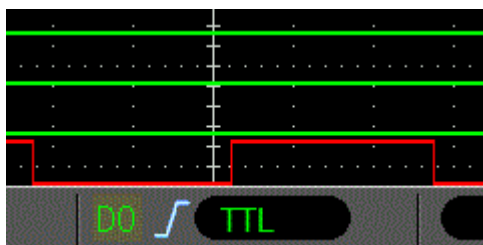
30. REQUEST: Add LA External signals (FPGA pin A15 and B10) to the list of triggers (assumed this is supported by LA FPGA design) as X1 and X2.
31. REQUEST: Display green colored LA trigger source and level in status area, just like the analog trigger sources

- Source: one of the LA signals D0, D1 .. D15, X1, X2.
- Edge: symbol for rising or falling.
- Level: one of the settings TTL, CMOS, ECL or user set Threshold Voltage.

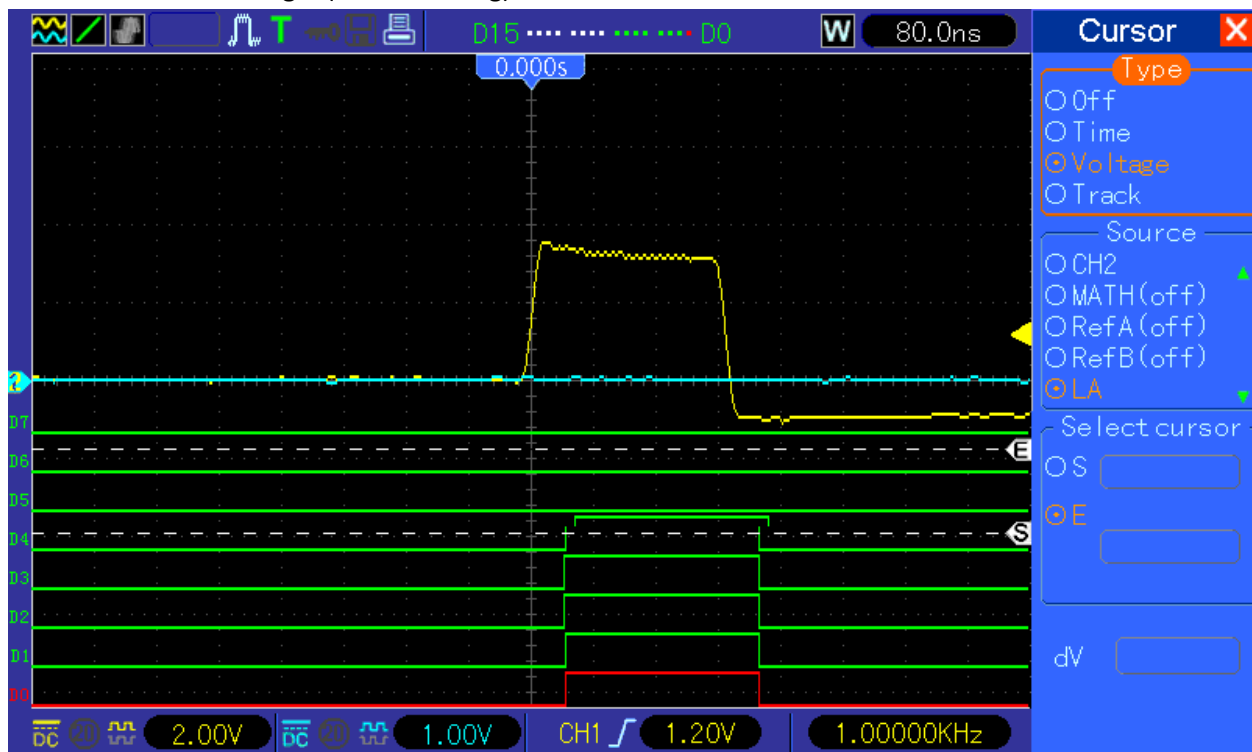
32. Voltage Cursor error: It is possible to choose Voltage Cursor for LA, which is useless/bug
Directly the firmware is blocking to select LA as source for Voltage Cursor (which is like it should be),

but when I select first Time Cursor, select LA as Source and the change Cursor type from Time to Voltage the firmware is allowing it (which is a bug):

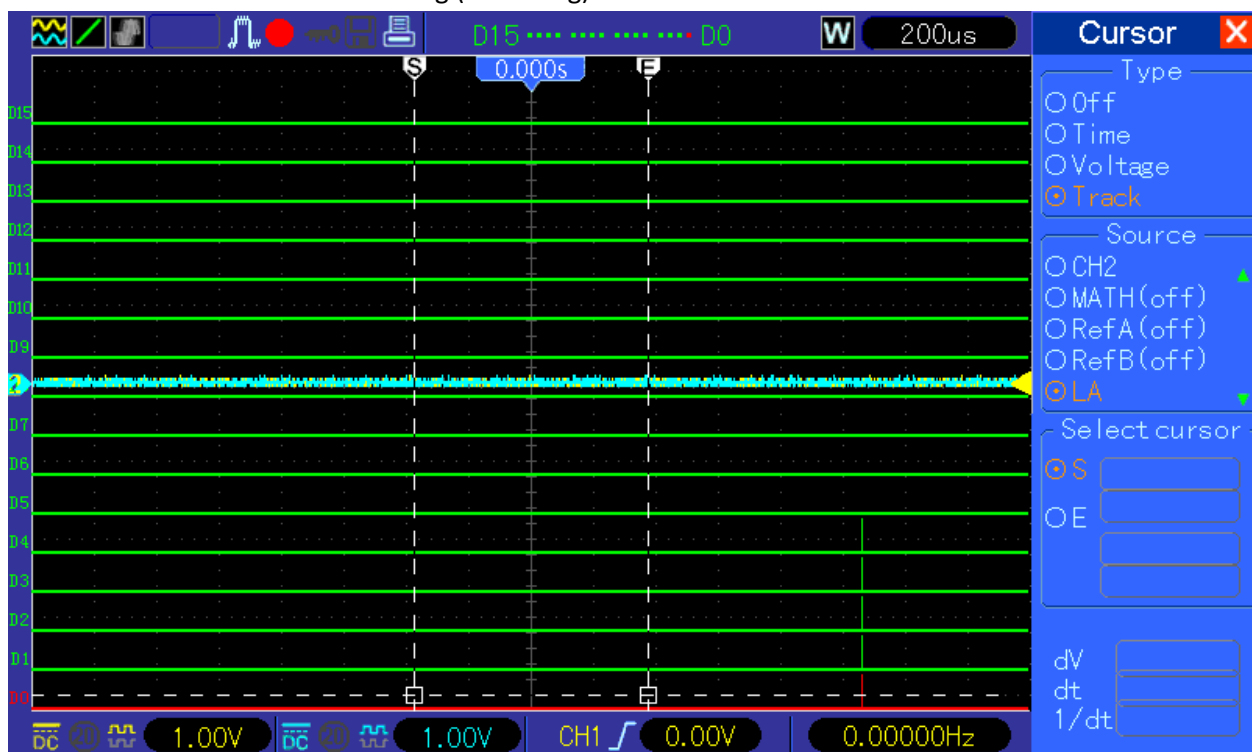
33. Tracking Cursor error: It is possible to choose Tracking Cursor for LA, which is useless/bug. Directly the firmware is blocking to select LA as source for Tracking Cursor (which is like it should be), but when I select first Time Cursor, select LA as Source and the change Cursor type from Time to Tracking the firmware is allowing it (which is a bug):. Additionally, in this mode as soon V0 has been turned or clicked the MSO is freezing (rebooting):

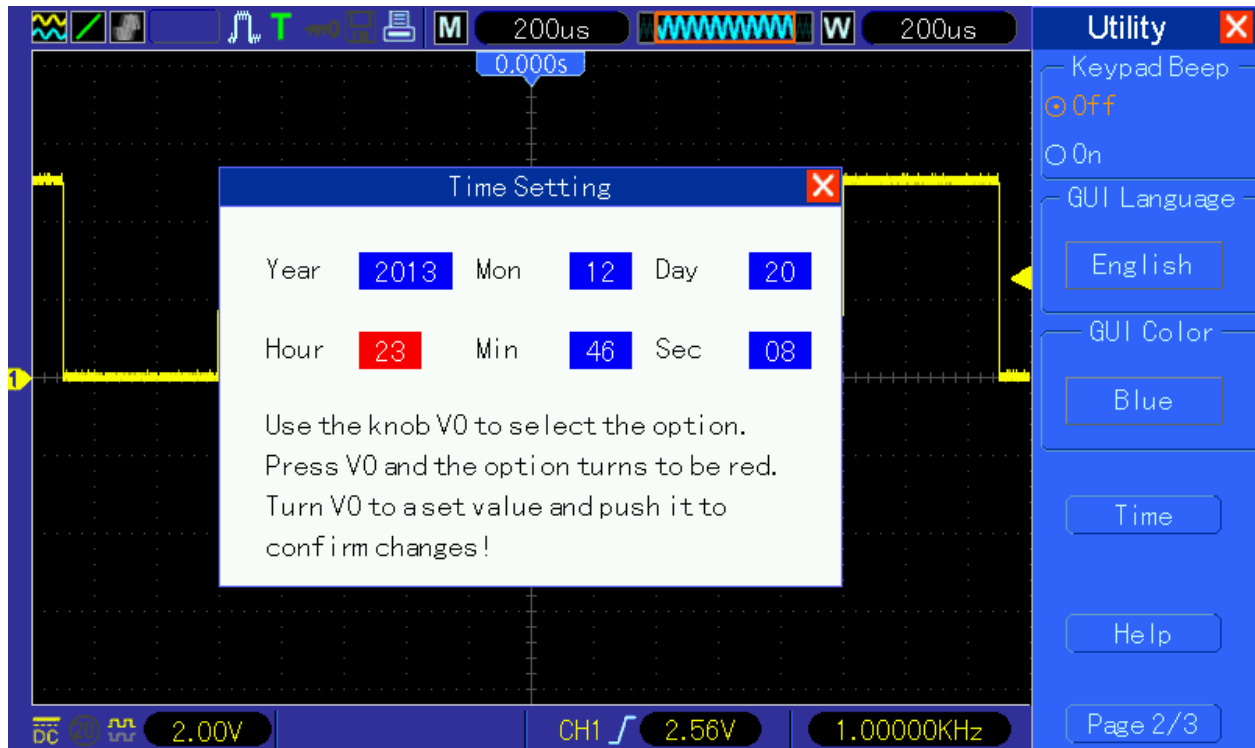
34. It is not possible to set 00:00 as time, the last possible hour is 23:xx:xx

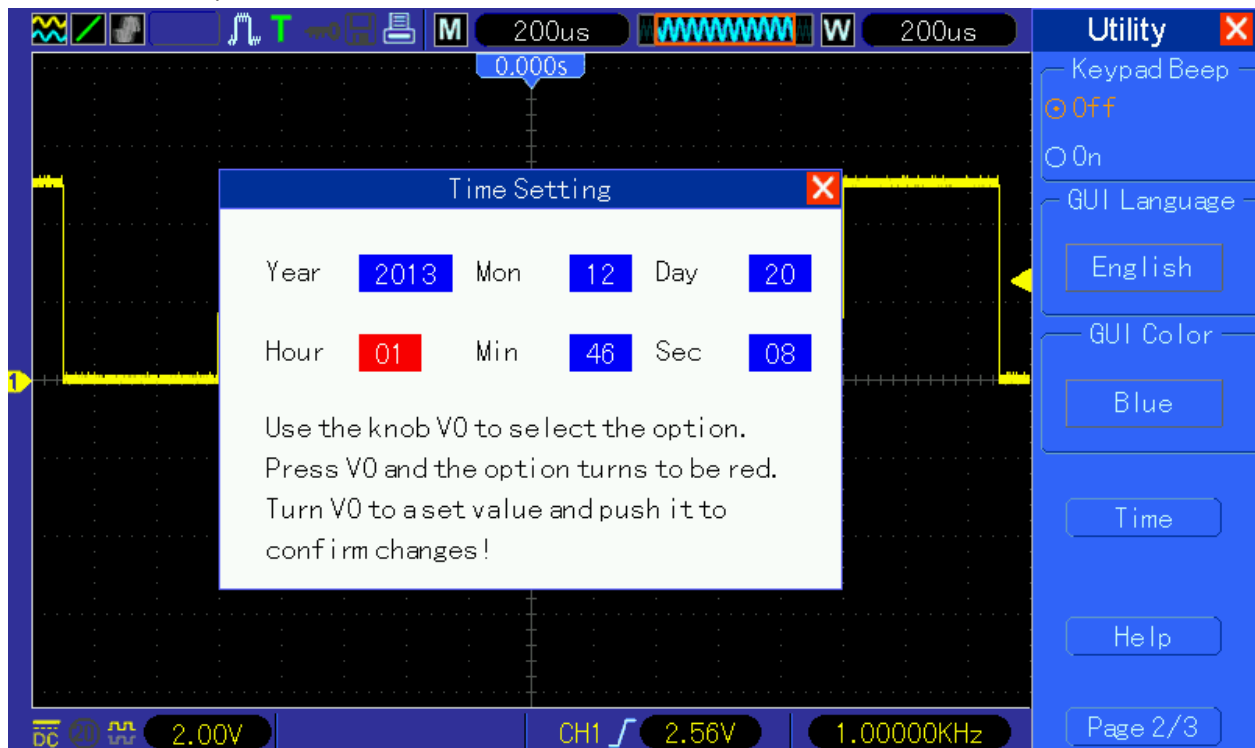
the next hour step is not 00:xx:xx but 01:xx:xx

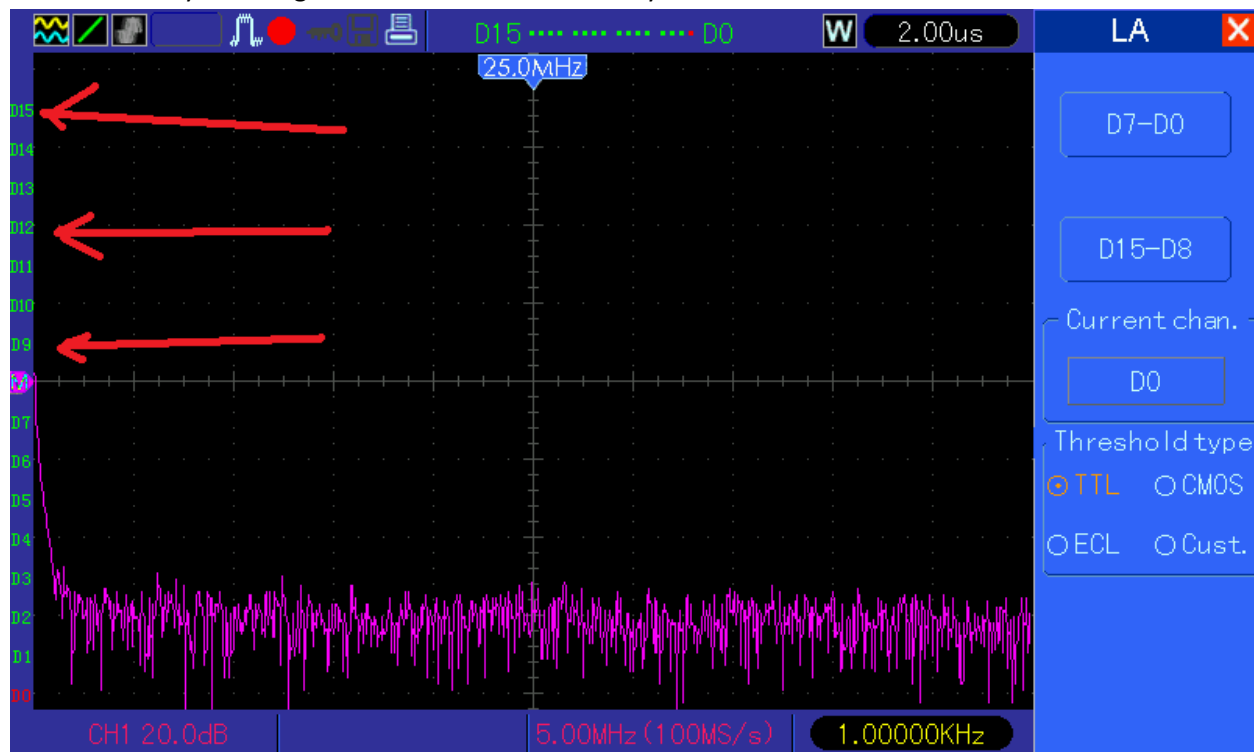
35. LA can be activated when FFT is enabled; this does not make any logical sense, so disable this combination by checking of CheckIsModeFFT in DoKeyMenuF7 or similar.

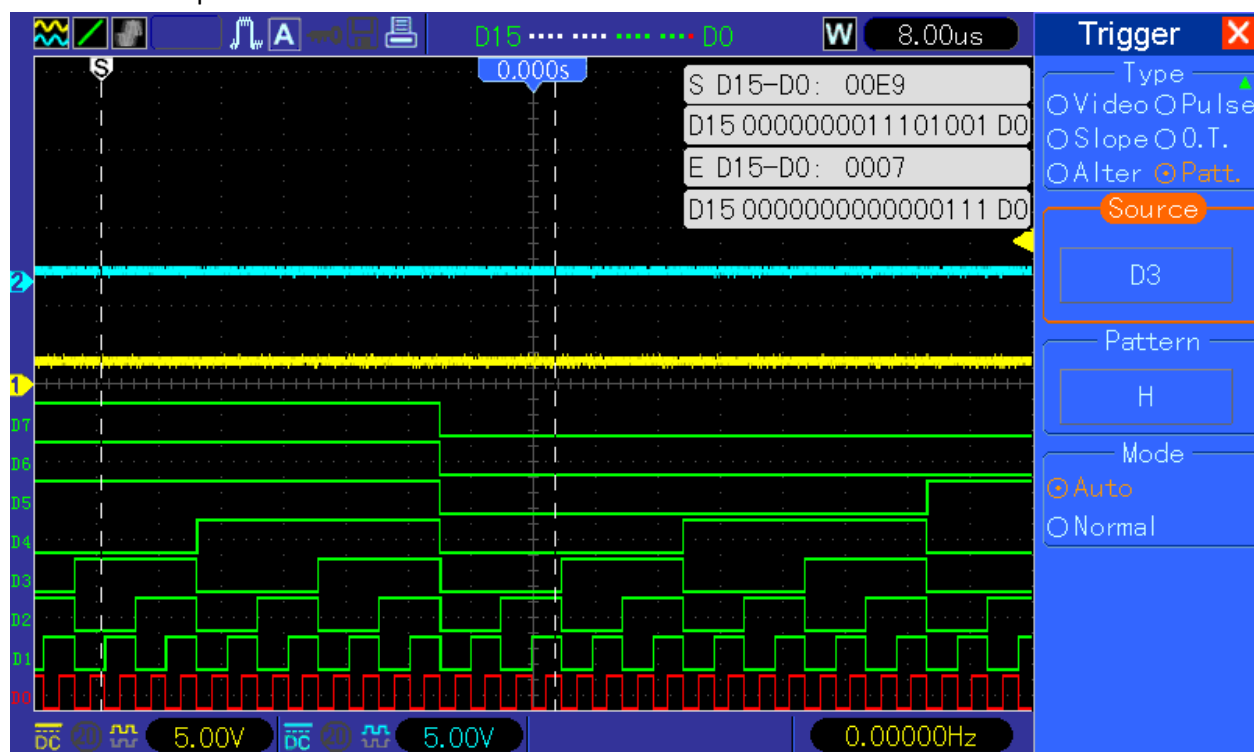
36. H and L letters swapped in Show_MenuItem3 function.

When I set "LA Pattern" trigger and create patter like 11111000 the LA is triggering on 00000111, cursor is showing as well 00000111. This means H and L letters are swapped in Show_MenuItem3 function. Binary (in dso.exe or dso_bin) in did search for 48 00 00 00 4C 00 00 00 58 00 00 00 and replaced with 4C 00 00 00 48 00 00 00 58 00 00 00 to fix that.

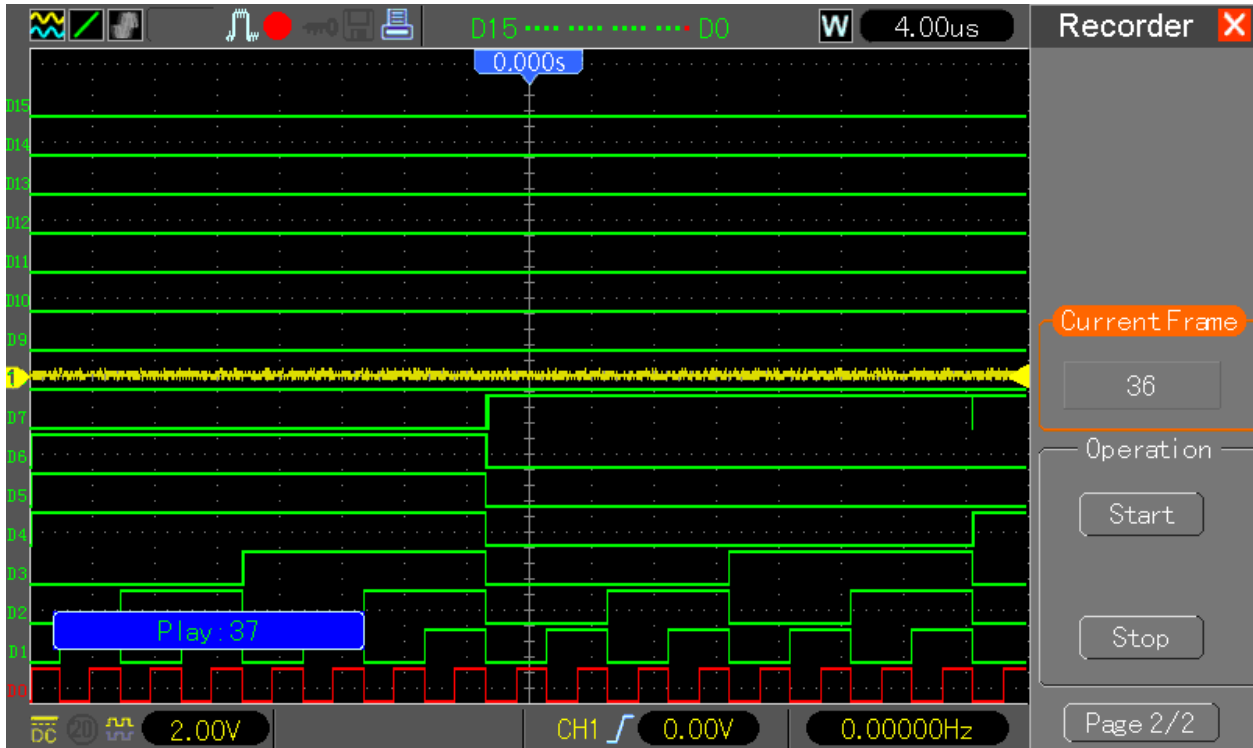
37. Recorder cannot record LA data, so disable recorder when LA enabled or implement recording of LA. Now the user will be misled, when playing back the recorded data waveform (CH1/CH2) are changing as expected but LA channels are not changing:

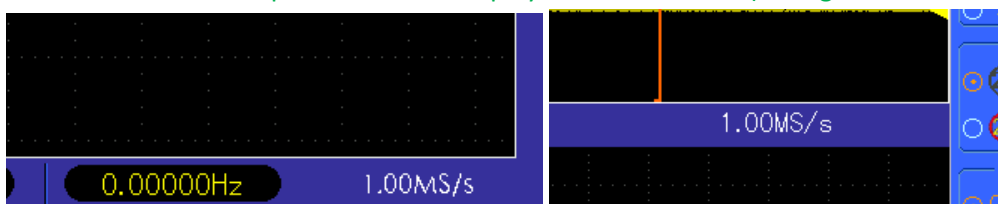
44. To avoid aliasing errors it is useful to know current sample rate. REQUEST: Add an option to select either “Time” or “Sample Rate” to be displayed in Status Area (in single and dual window):

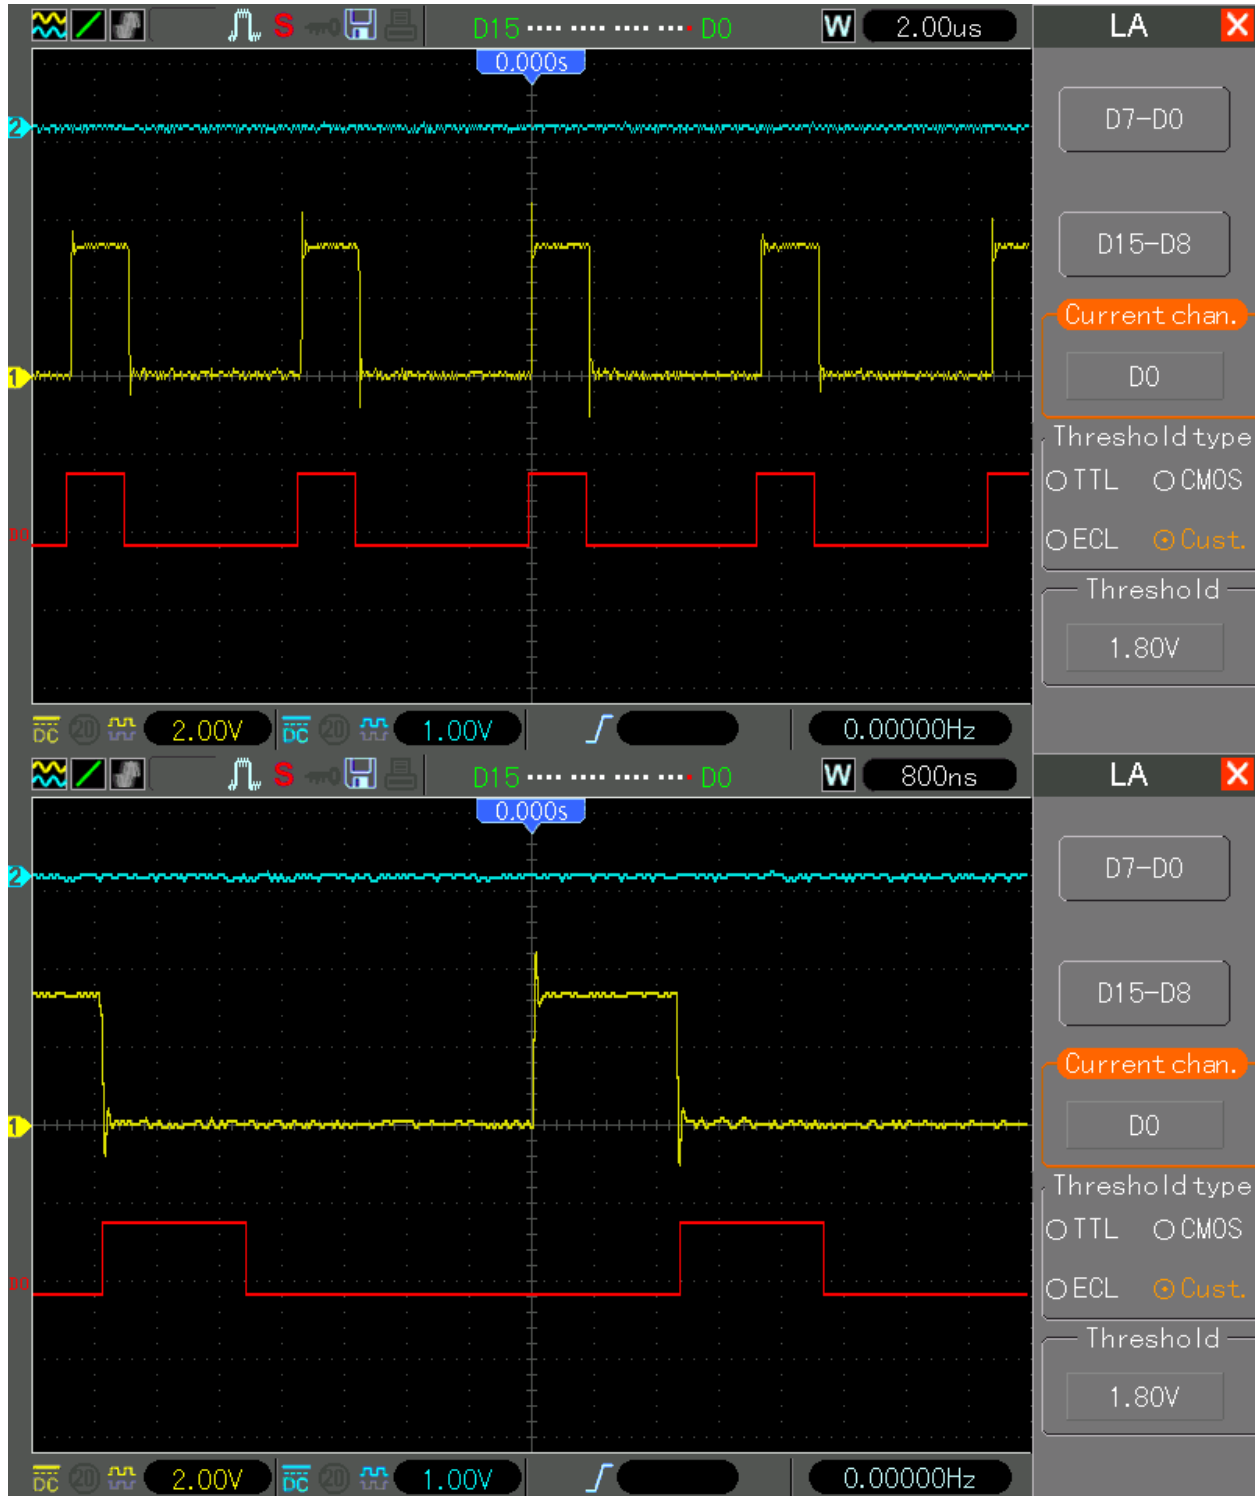
45. Error while zooming: signal previously sampled at 2us/DIV seems to be ok, but then when zooming to 800ns/DIV the LA seems to be delayed by the length of the analog signal pulse

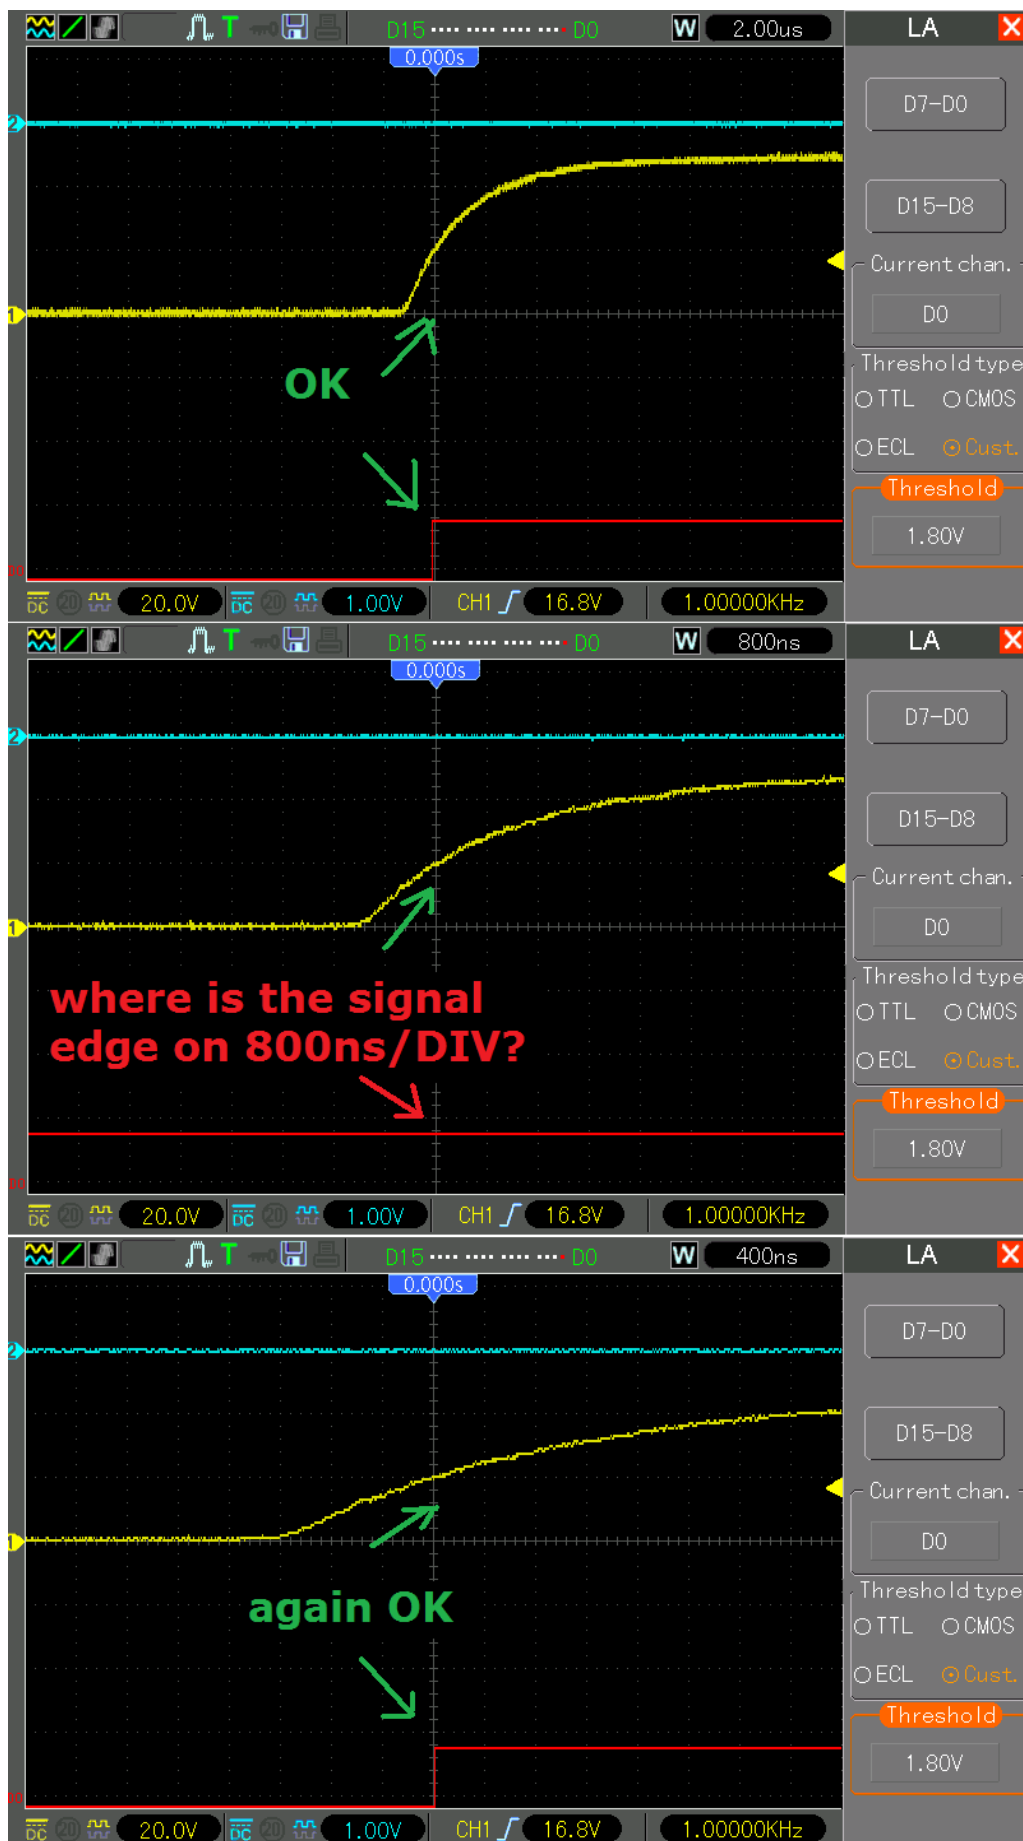
another example, with slower signal – again, sampled at 2us/DIV, both LA and analog edges seems to be aligned, when changing timebase to 800ns/DIV the waveform is delayed, then at 400ns/DIV is again ok.
