MSO/MST Firmware 2.07.x bug list:

Bug number	2.07.1 130826.0 / hw1007_83E9
1	bug
2	proposal
3	bug
4	request
5	bug
6	bug
7	bug
8	bug
9	bug
10	bug
11	bug
12	bug
13	bug
14	bug
15	bug
16	bug
17	bug

List of bugs/improvement requests

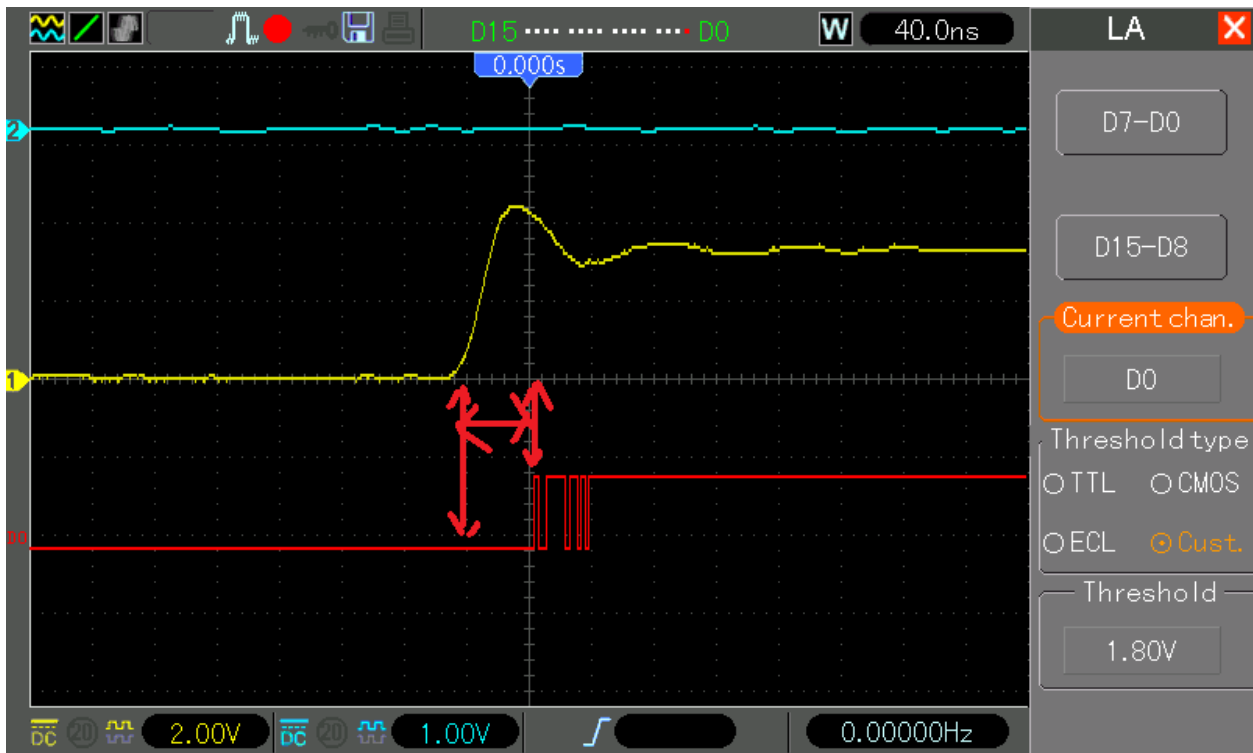
46. There seems to be skew between LA and analog channels, LA is delayed about 50ns. This is especially visible on timebases between 200ns/DIV and 2ns/DIV.

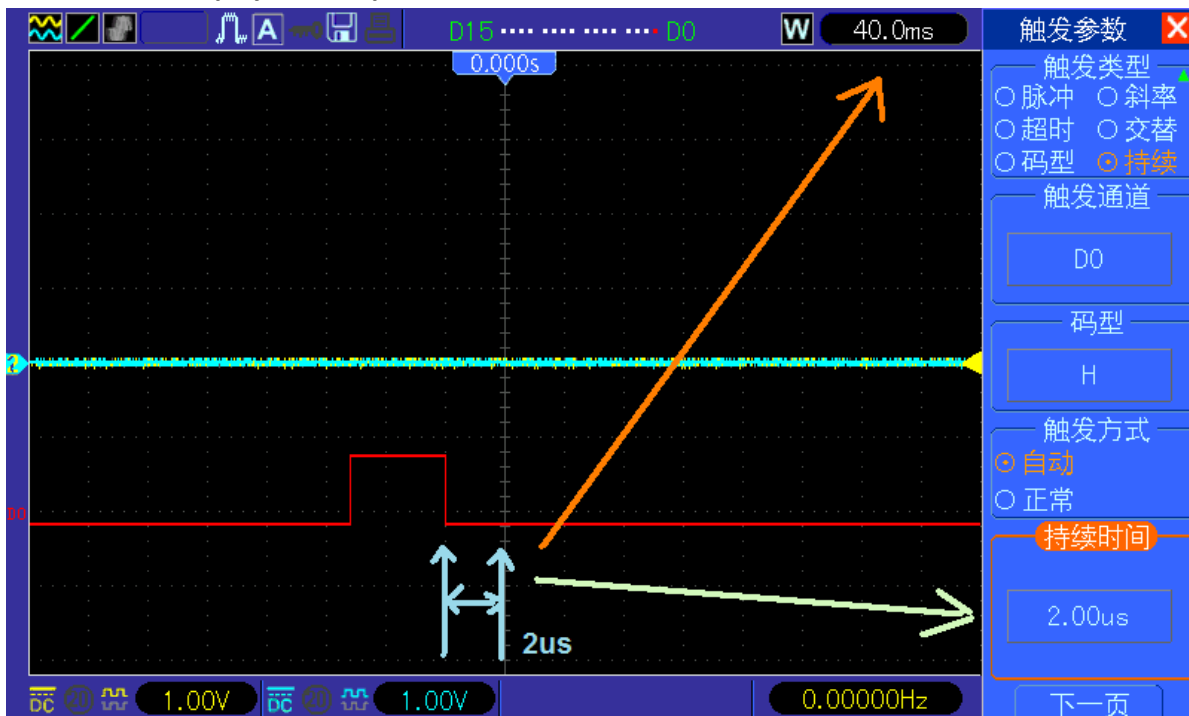
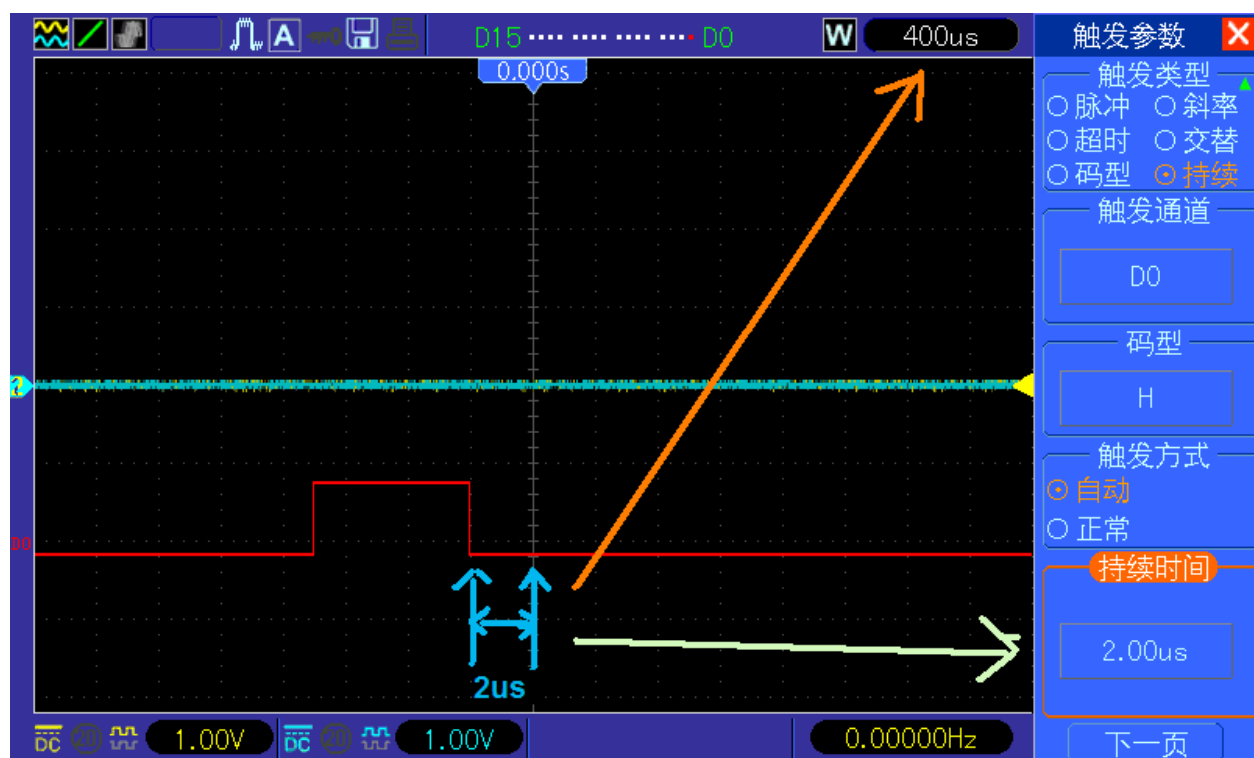
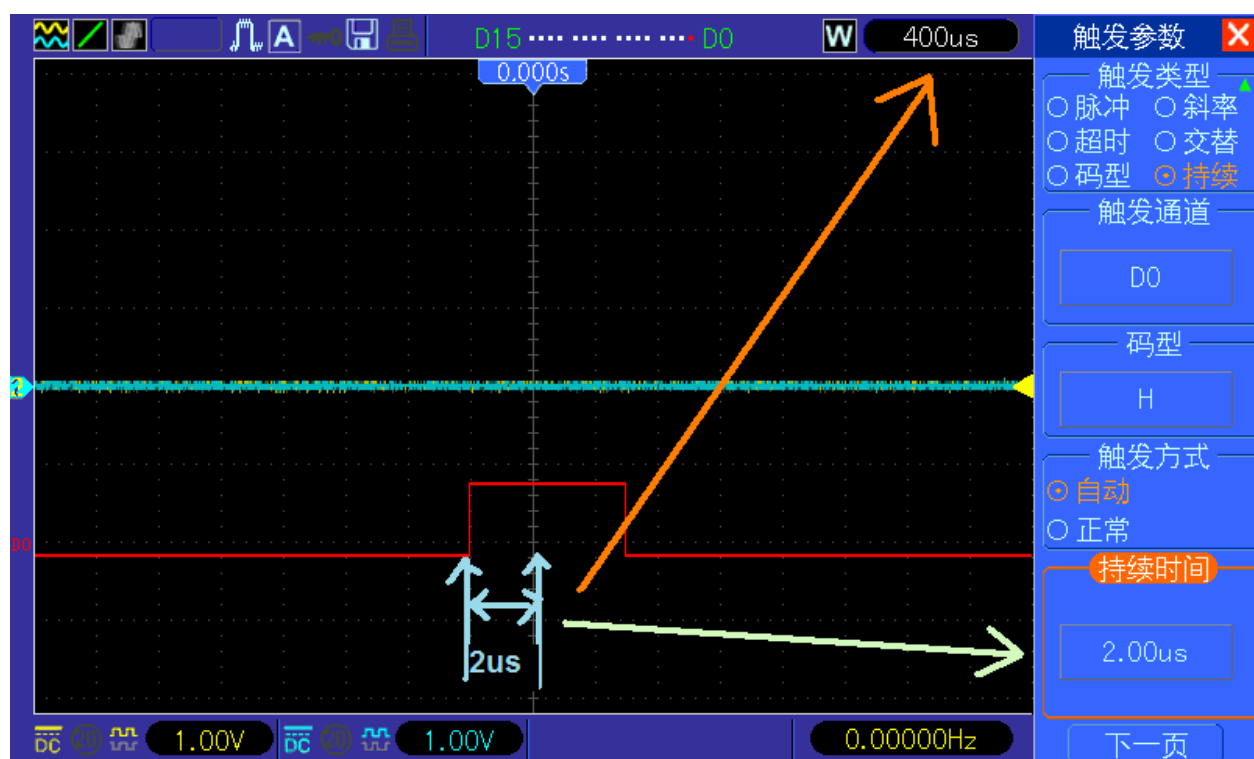
47. When LA enabled, the firmware is always enabling both channels, is this deliberately so?
48. LA - Duration trigger / "Begin of data" and "End of Data" (NOTE: the bug 36 "H and L letters swapped" need to be fixed first to properly see the duration trigger bug).
when timebase set from 40ms to 4us the duration scale is fixed to 2us/DIV. No matter what set as duration, one display DIV is equal 2us:

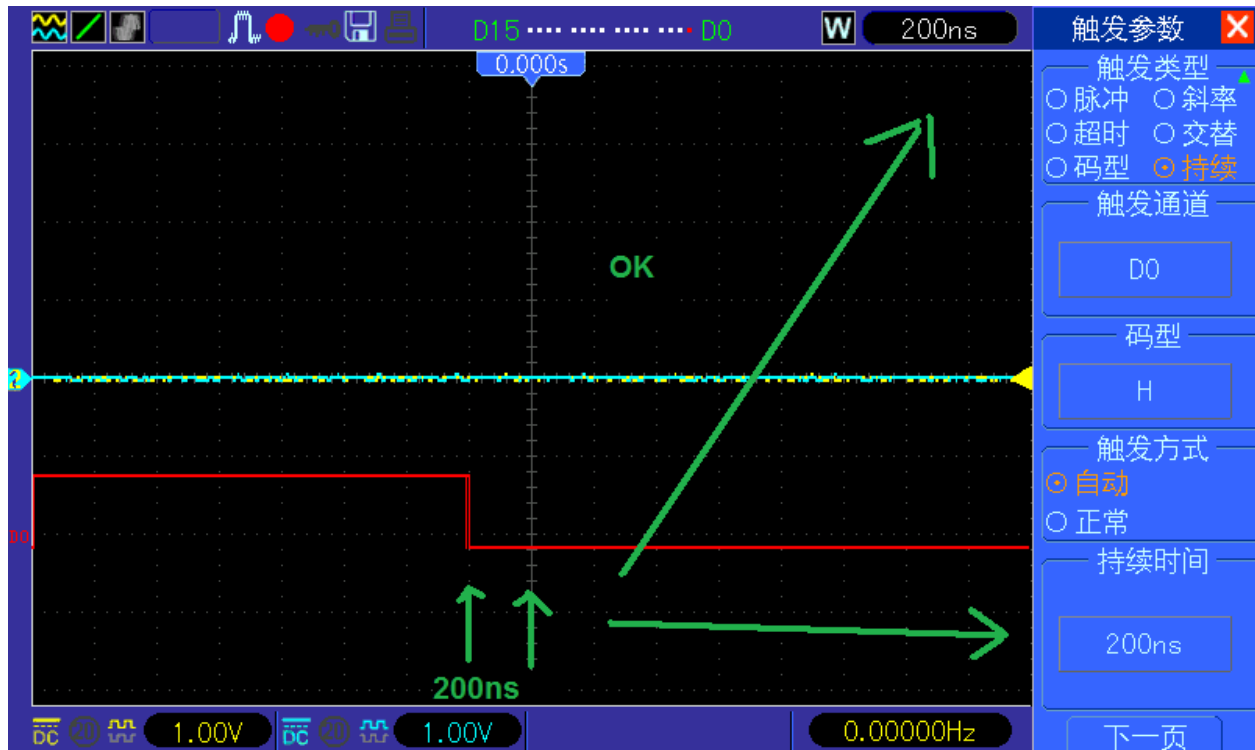
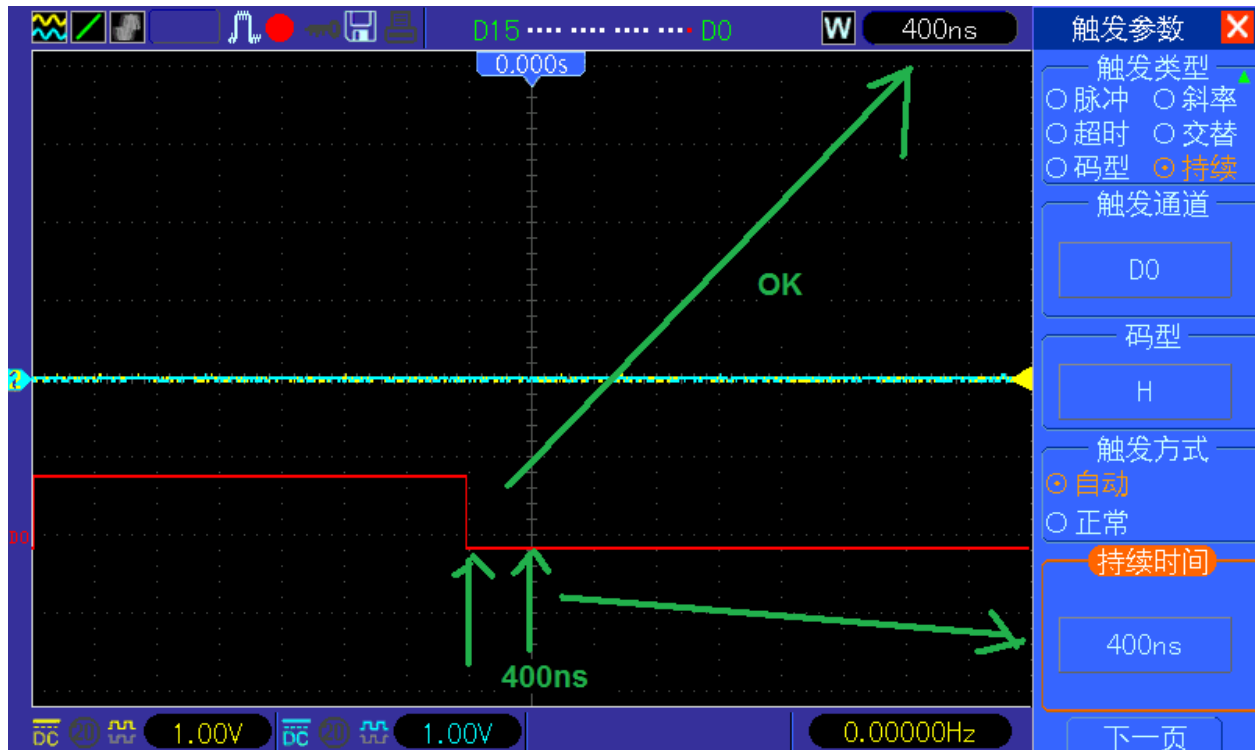
when timebase from 2us to 200ns - everything ok

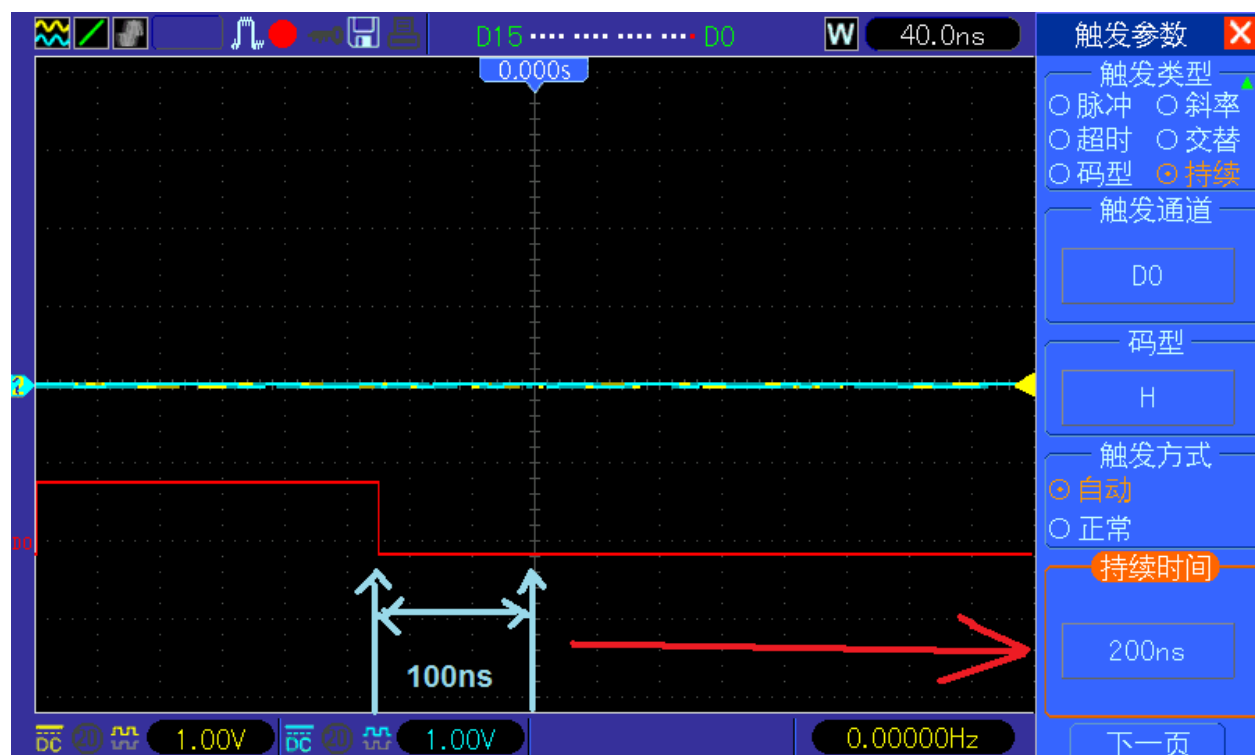
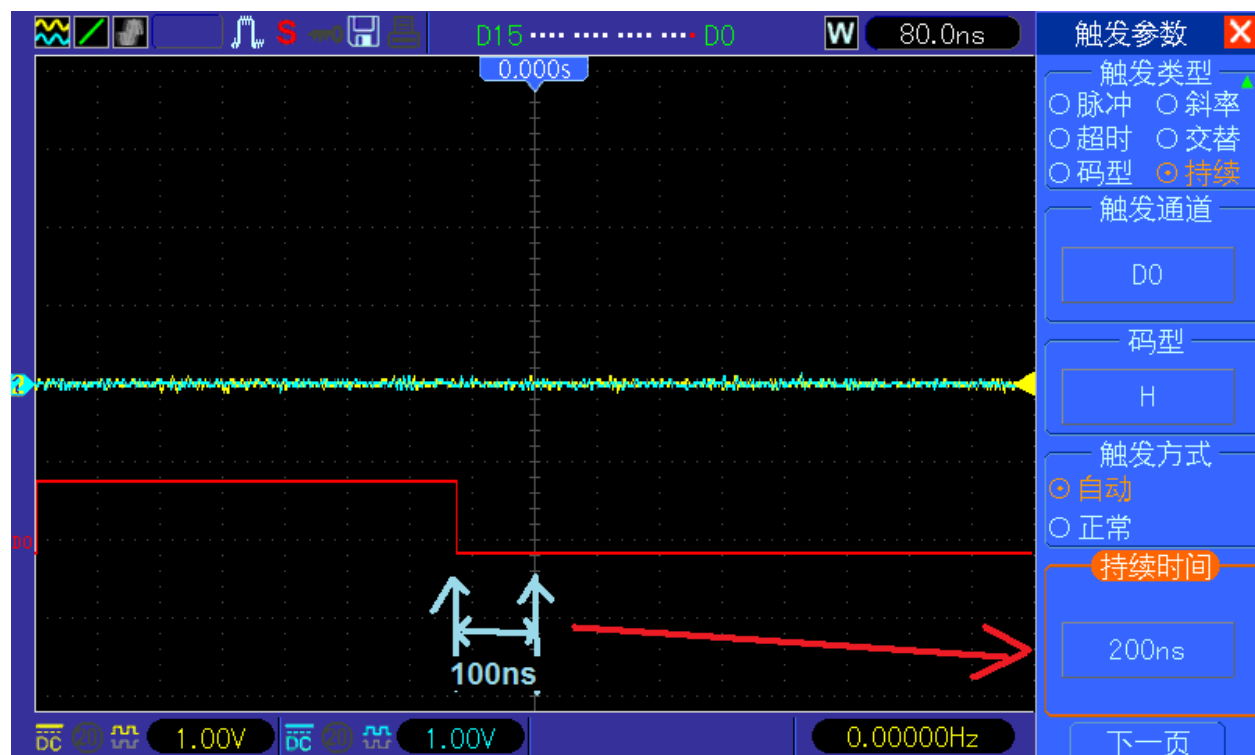
when timebase from 80ns to 2ns the duration scale is again wrong, like fixed always to 100ns no matter what set as duration:

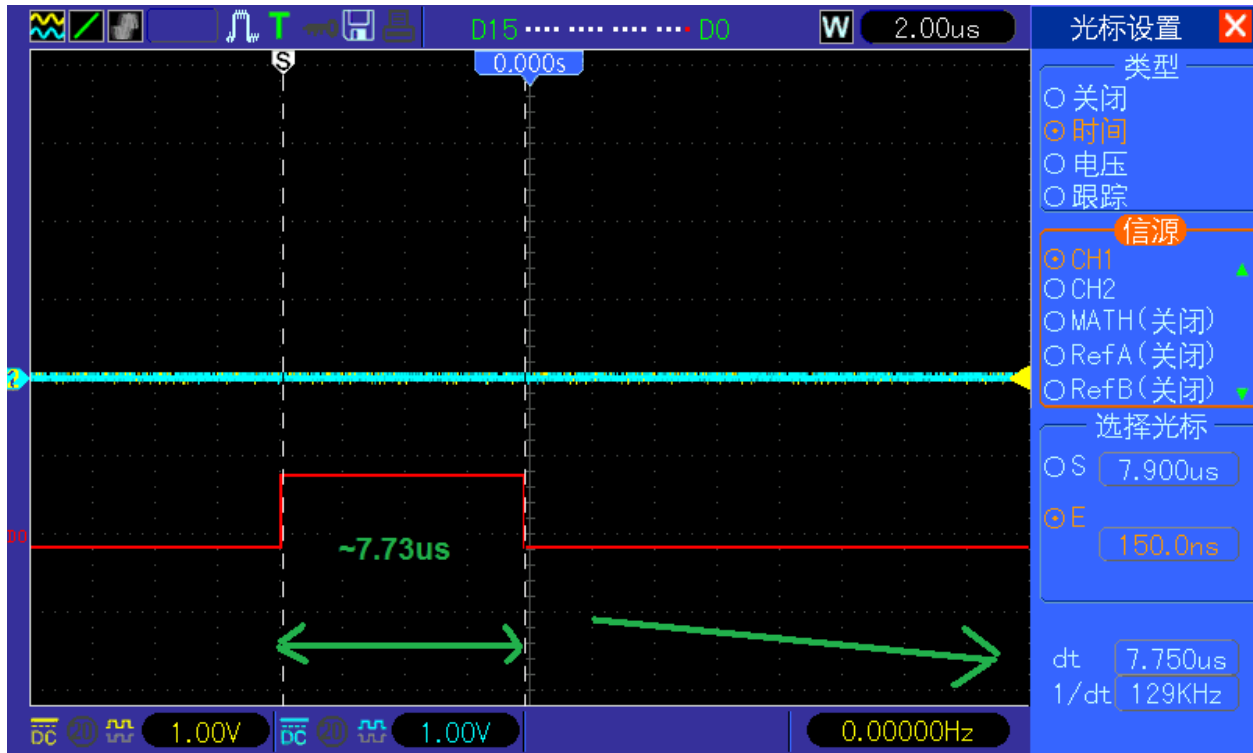
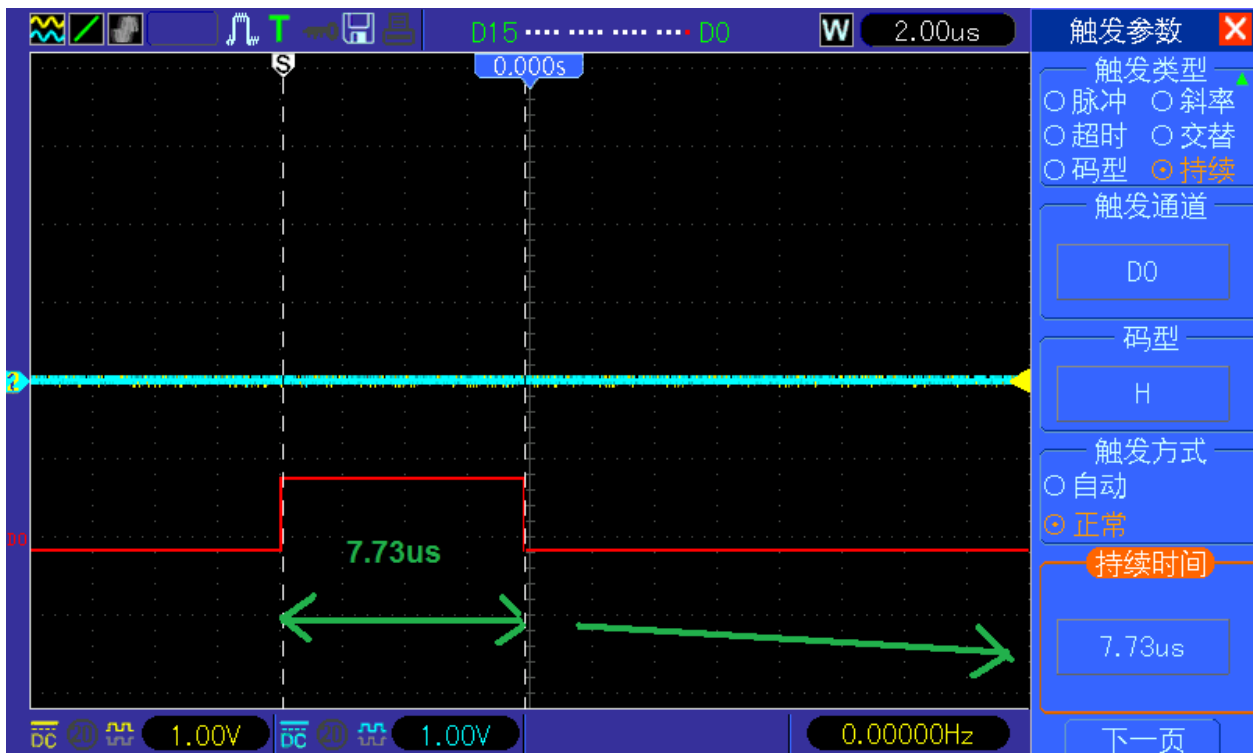
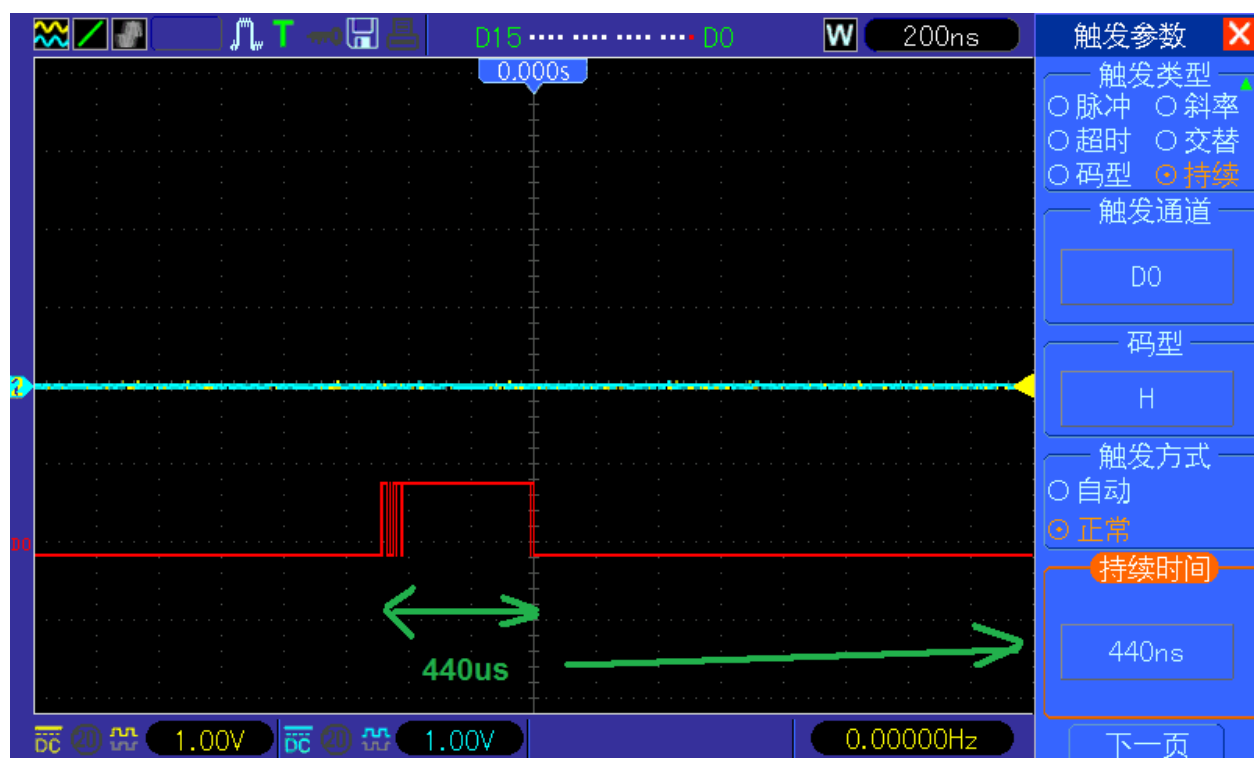
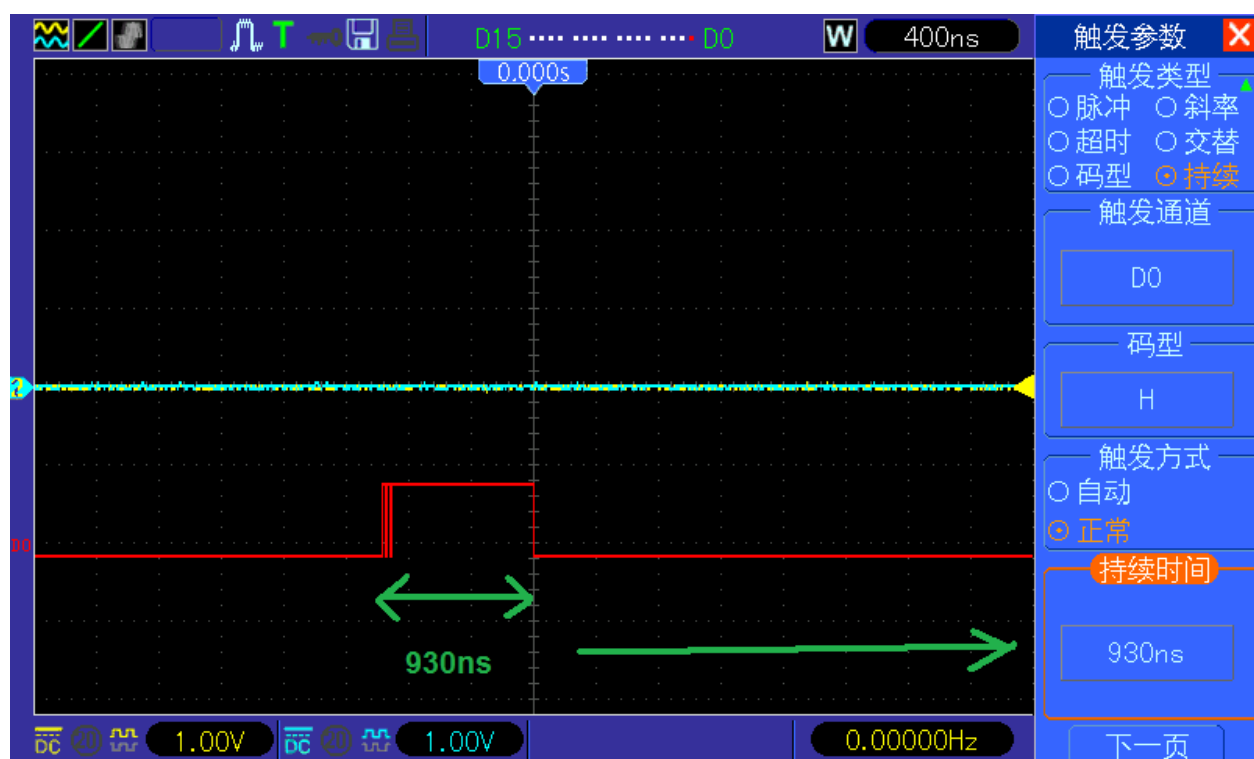
49. LA - Duration trigger / "Data delay" (NOTE: the bug 36 "H and L letters swapped" need to be fixed first to properly see the duration trigger bug).

Works properly only when timebase set from 2us/DIV to 200ns/DIV:

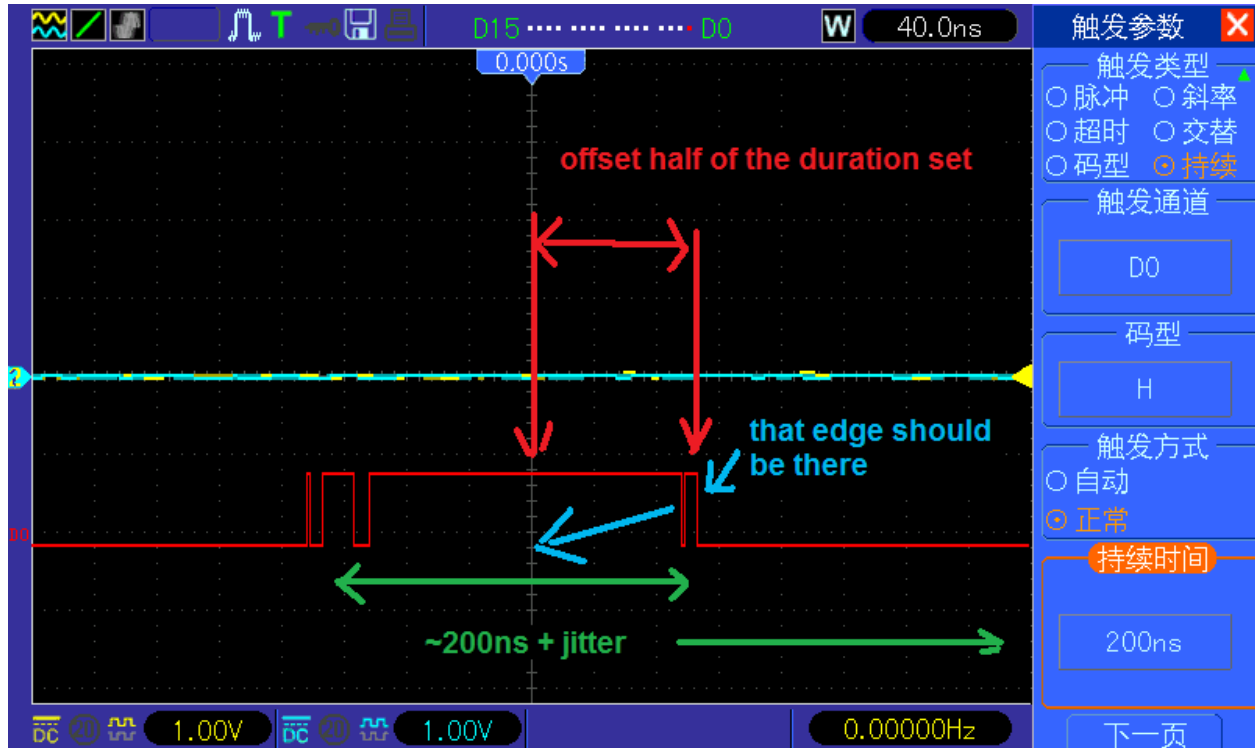
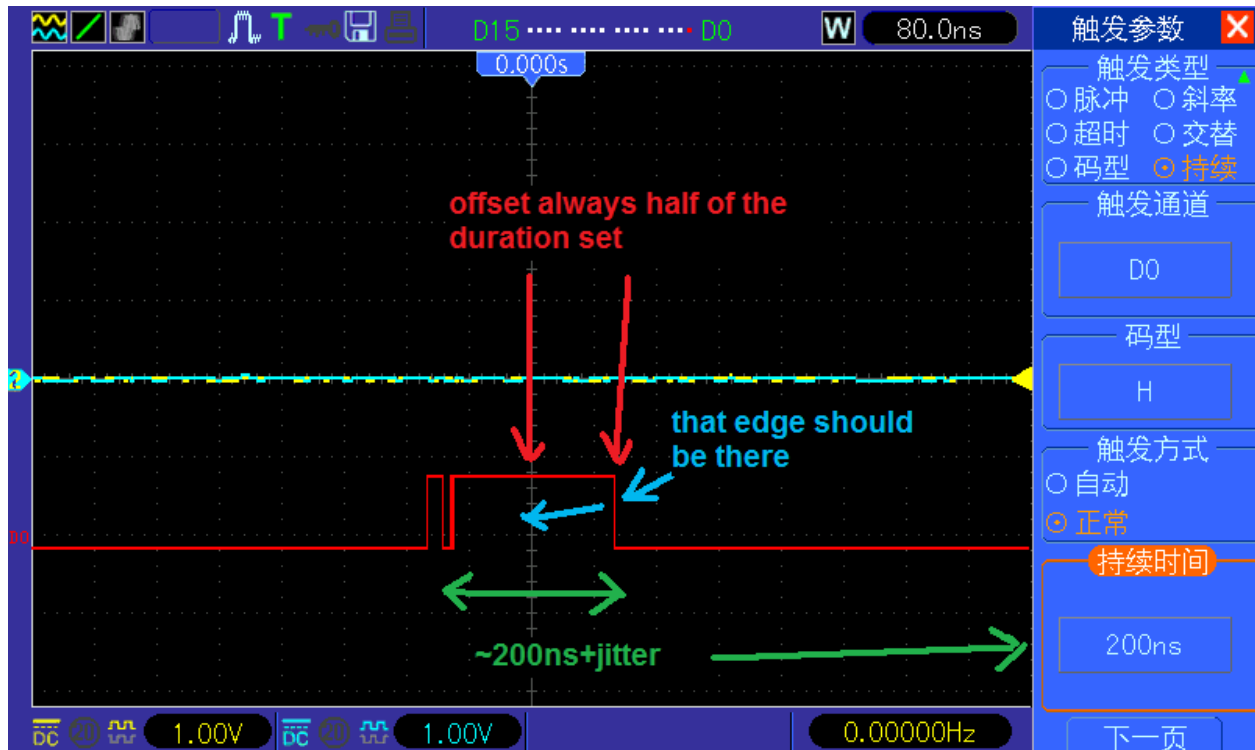
From 80ns/DIV to 2ns/DIV partially ok, the data delay length will be properly triggered (except jitter, but that's ok), however the position have some offset (always about half of the duration set):

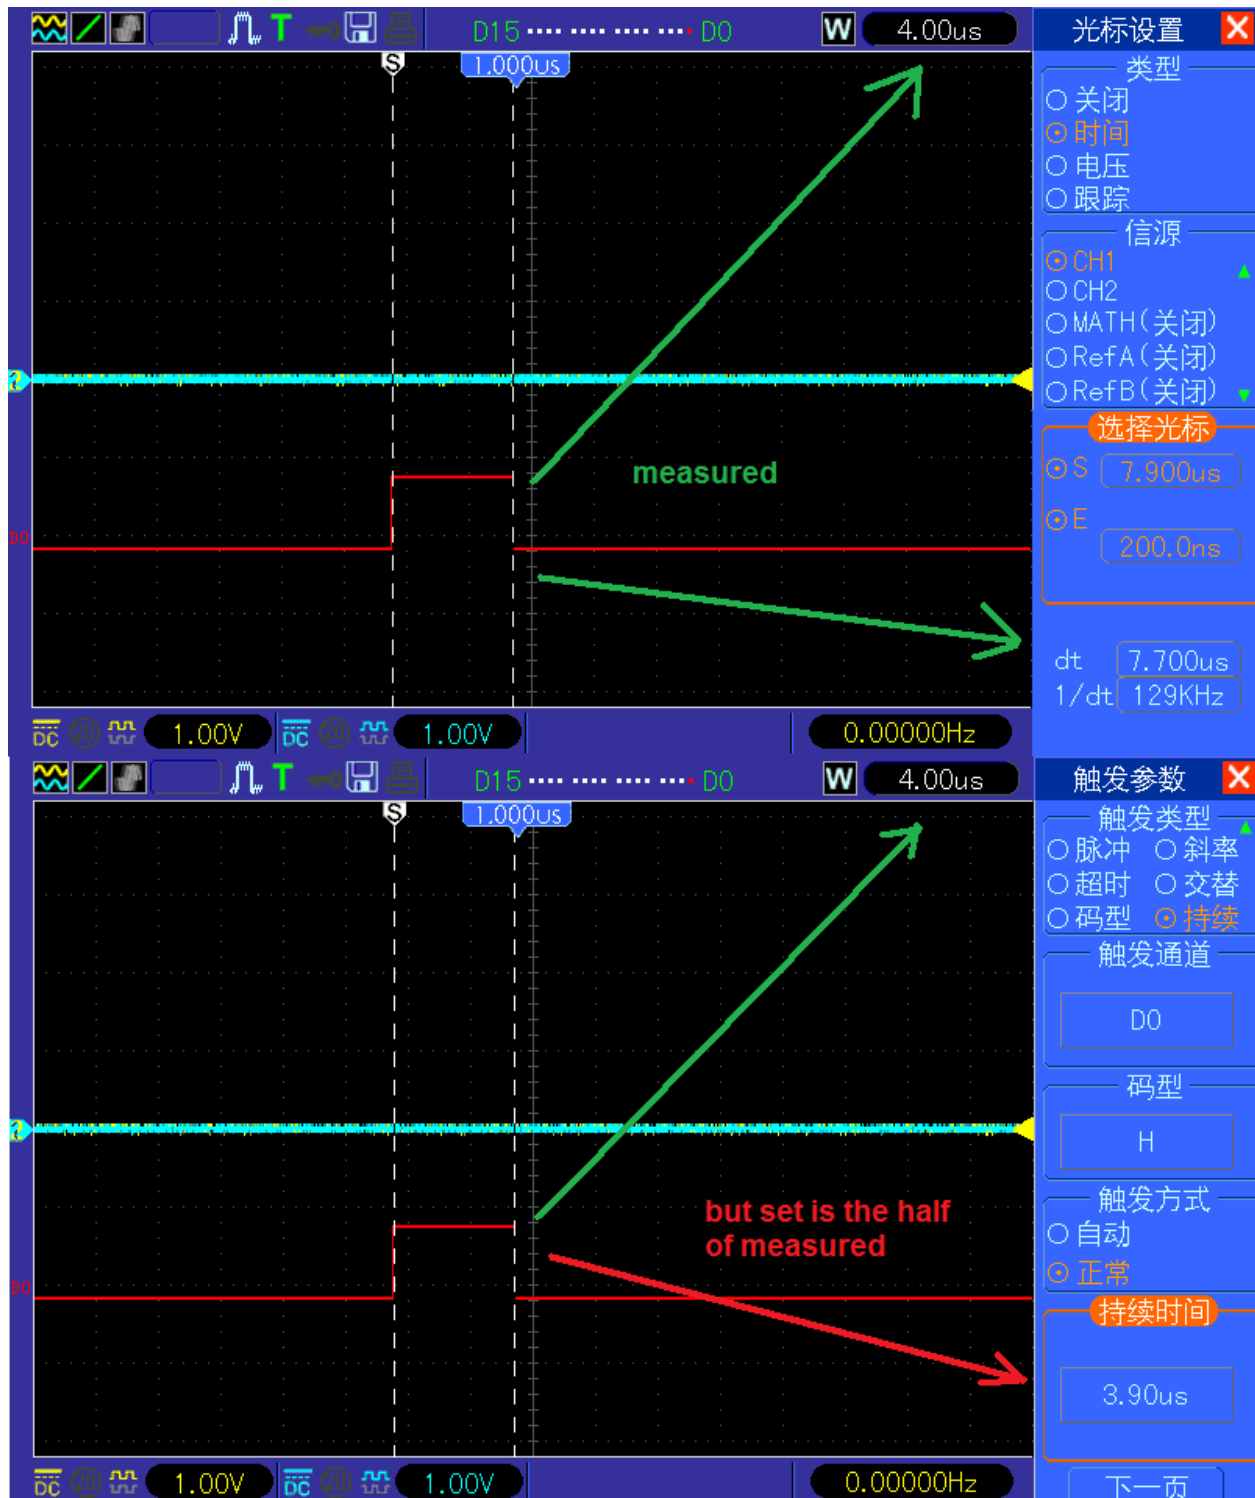
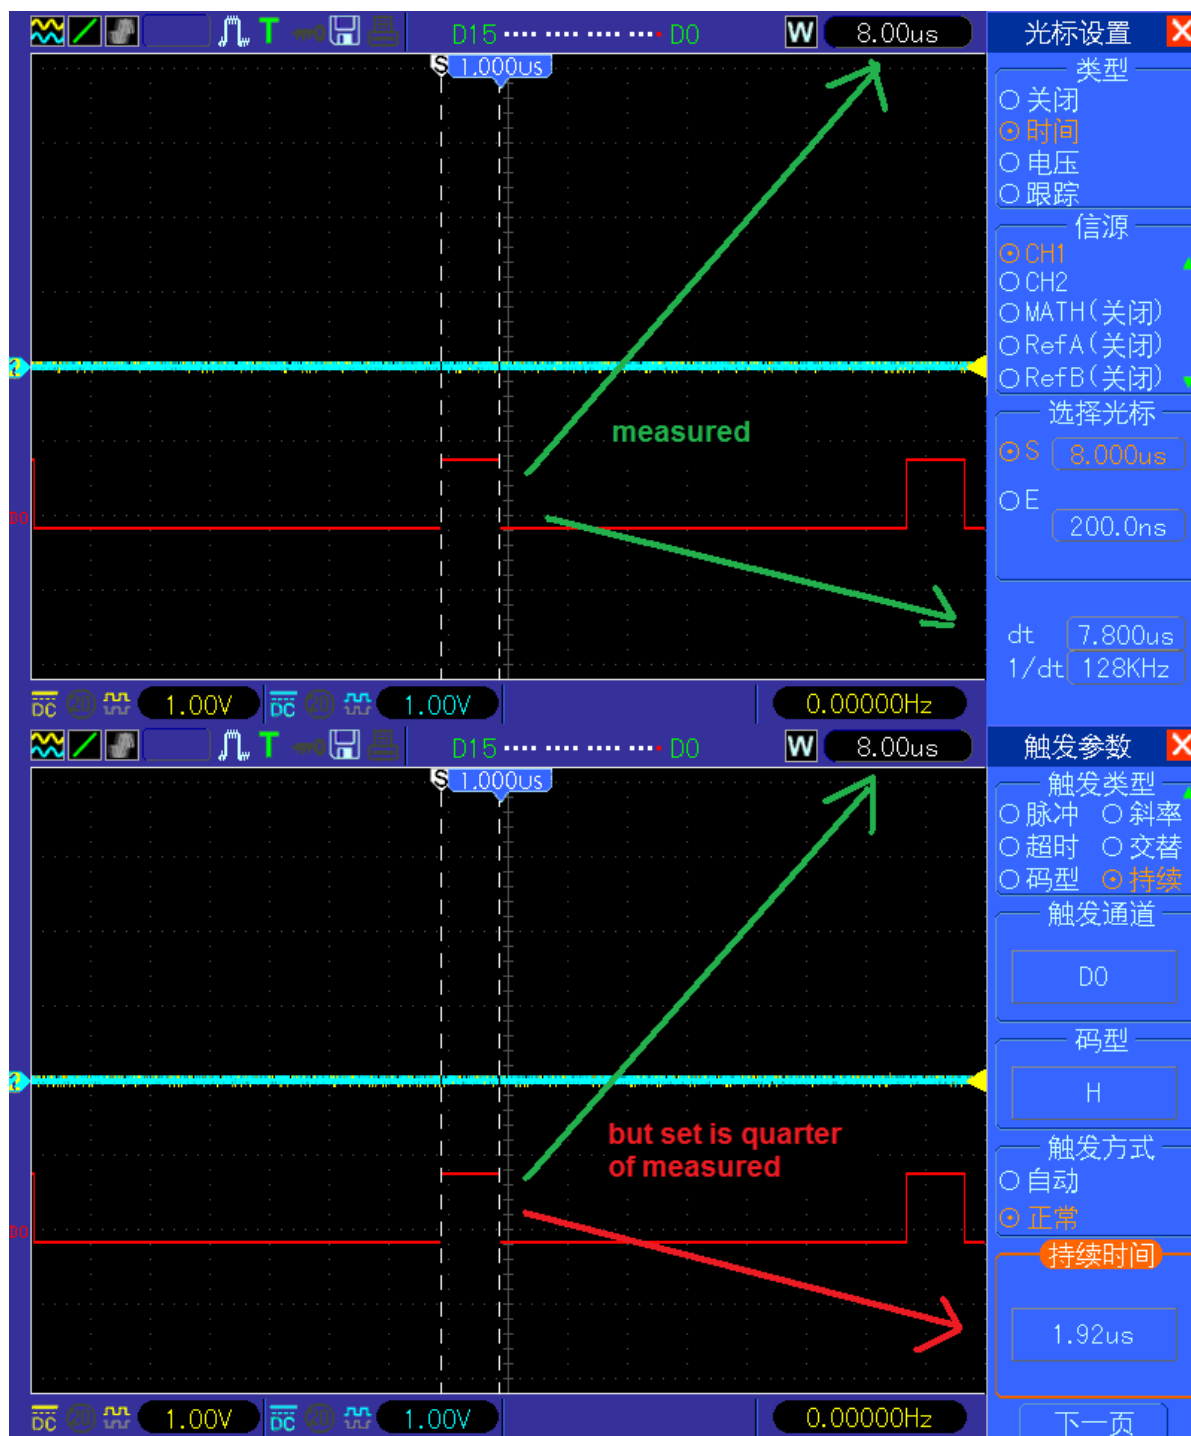
When timebase from 4us to 40ms the duration must be always set smaller and smaller to allow triggering. For example at 4us/DIV i have to set for duration the half of the real value. For 8us/DIV again half of the 4us/DIV value or 1/4th of the real pulse length. For 20us/DIV i need the set the pulse width / 2.5 / 2 / 2 to get the delayed data triggered. I have NOT tested bigger values than 2ms/DIV, this is because the resolution of LA is not allowing such small values (less than 10ns), but it seems that the whole range 40ms/DIV to 4us/DIV is affected by the "divide / 2 or 2.5" error:

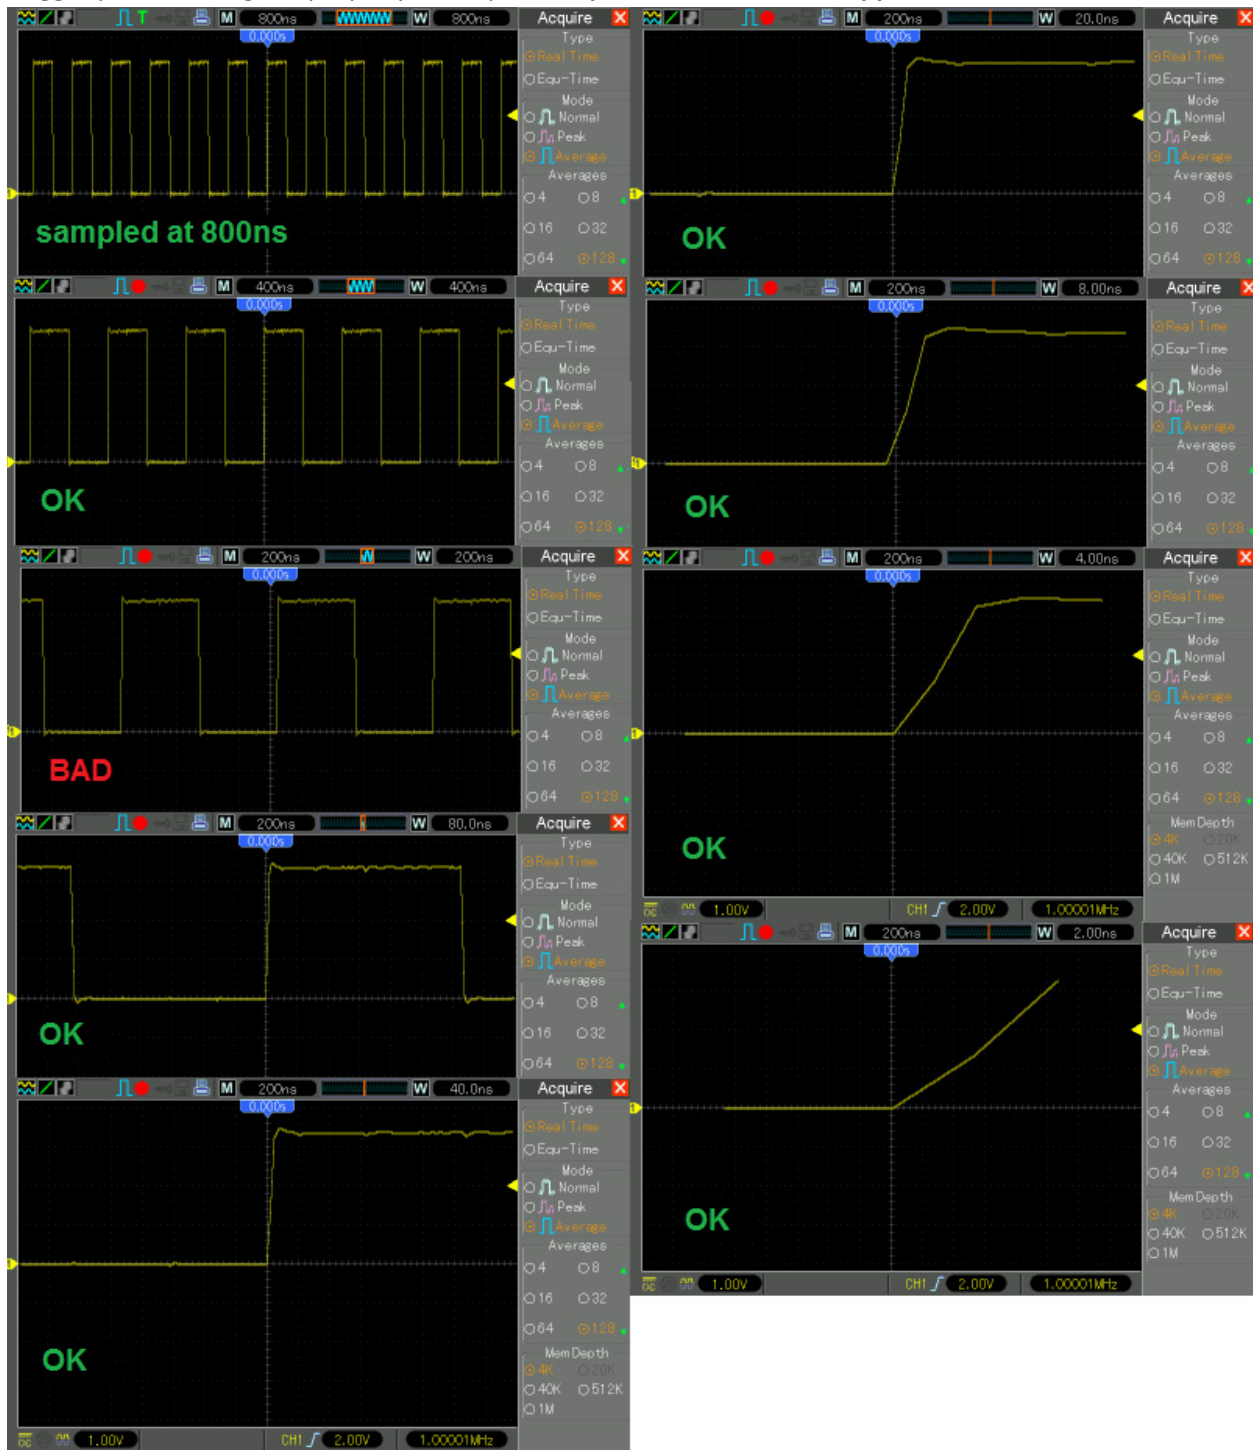
51. Trigger point not aligned properly, example: **sampled at 800ns/DIV, stopped and zoomed:**

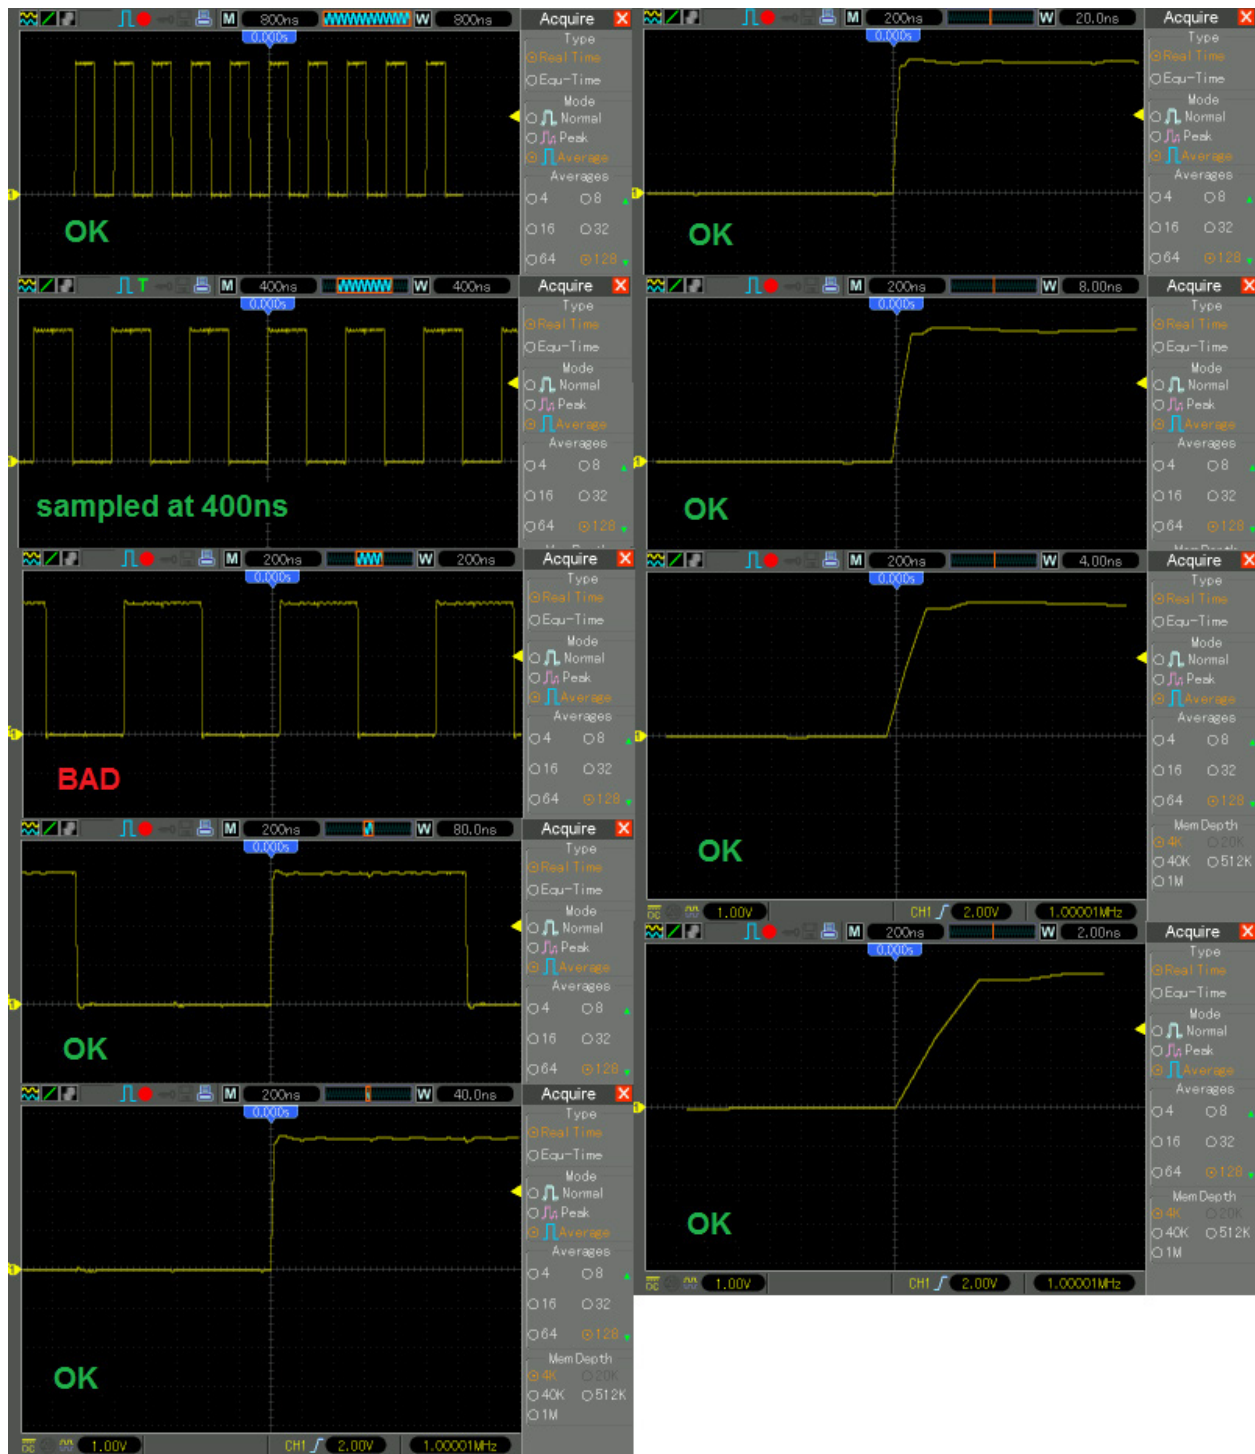
sampled at 400ns/DIV, stopped and zoomed:

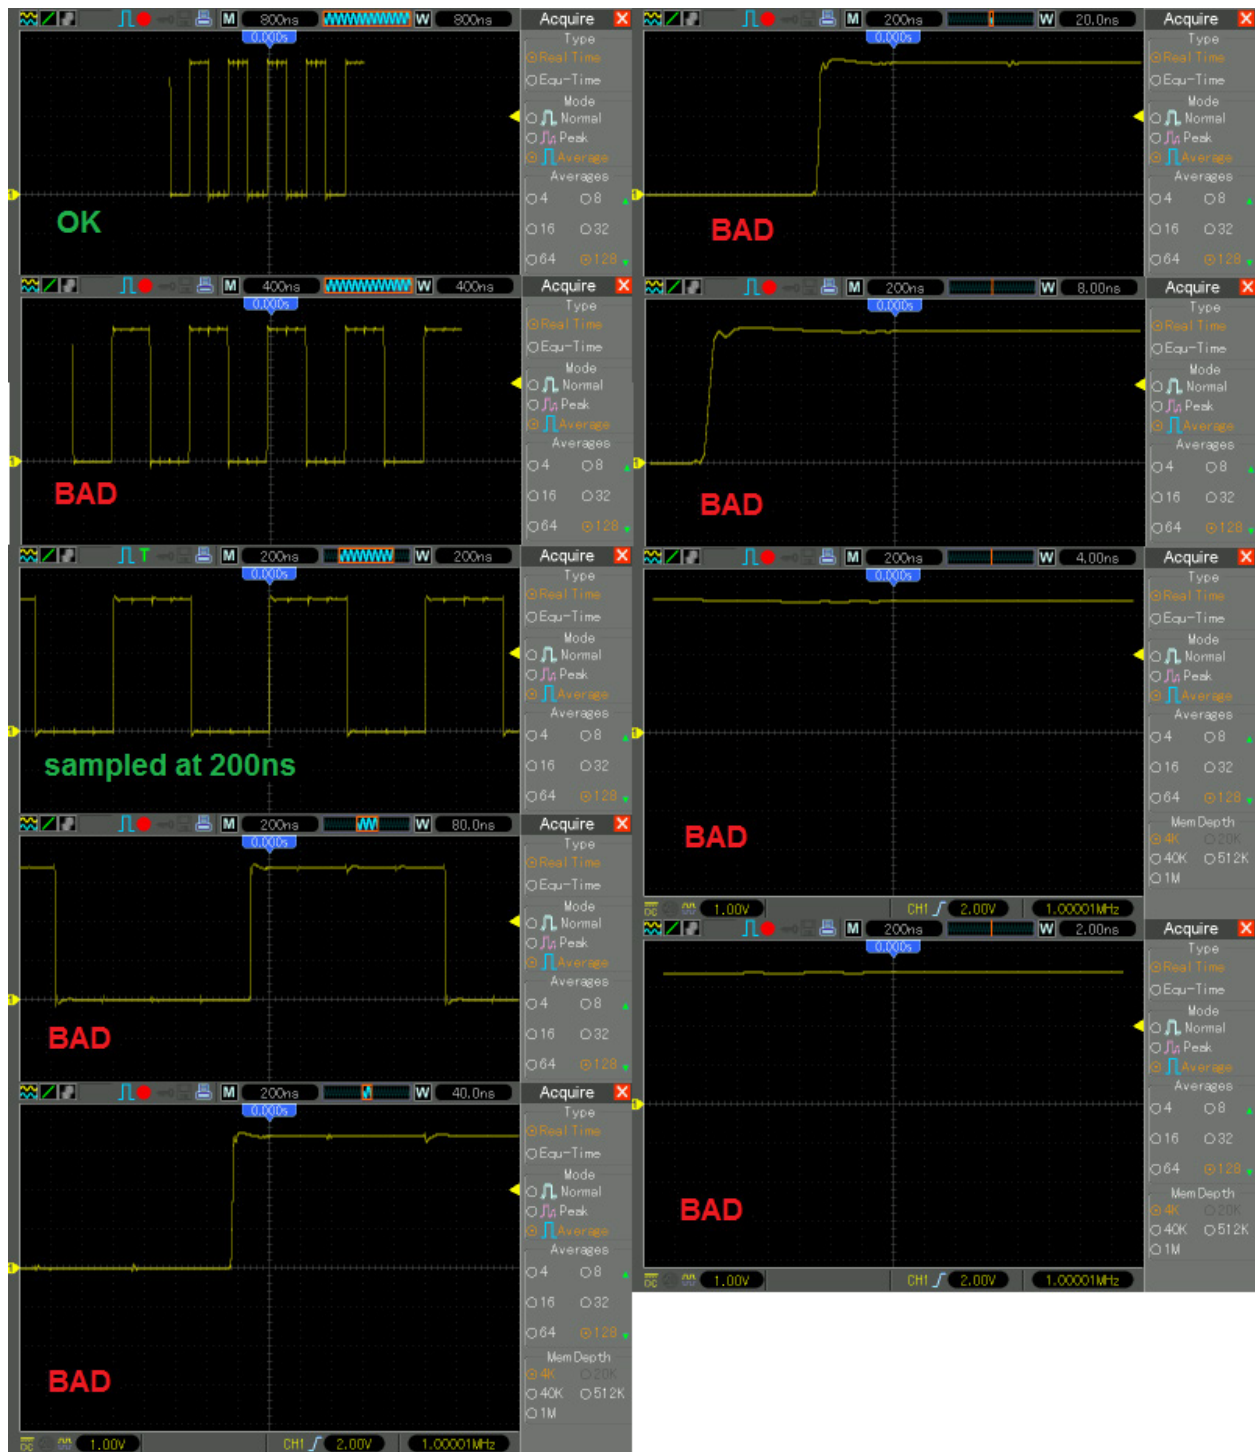
sampled at 200ns/DIV, stopped and zoomed:
