MSO/MST Firmware 2.07.x bug list:

Bug number	2.07.1 130826.0 / hw1007_83E9
1	bug
2	proposal
3	bug
4	request
5	bug
6	bug
7	bug
8	bug
9	bug
10	bug
11	bug
12	bug
13	bug
14	bug
15	bug
16	bug
17	bug

List of bugs/improvement requests

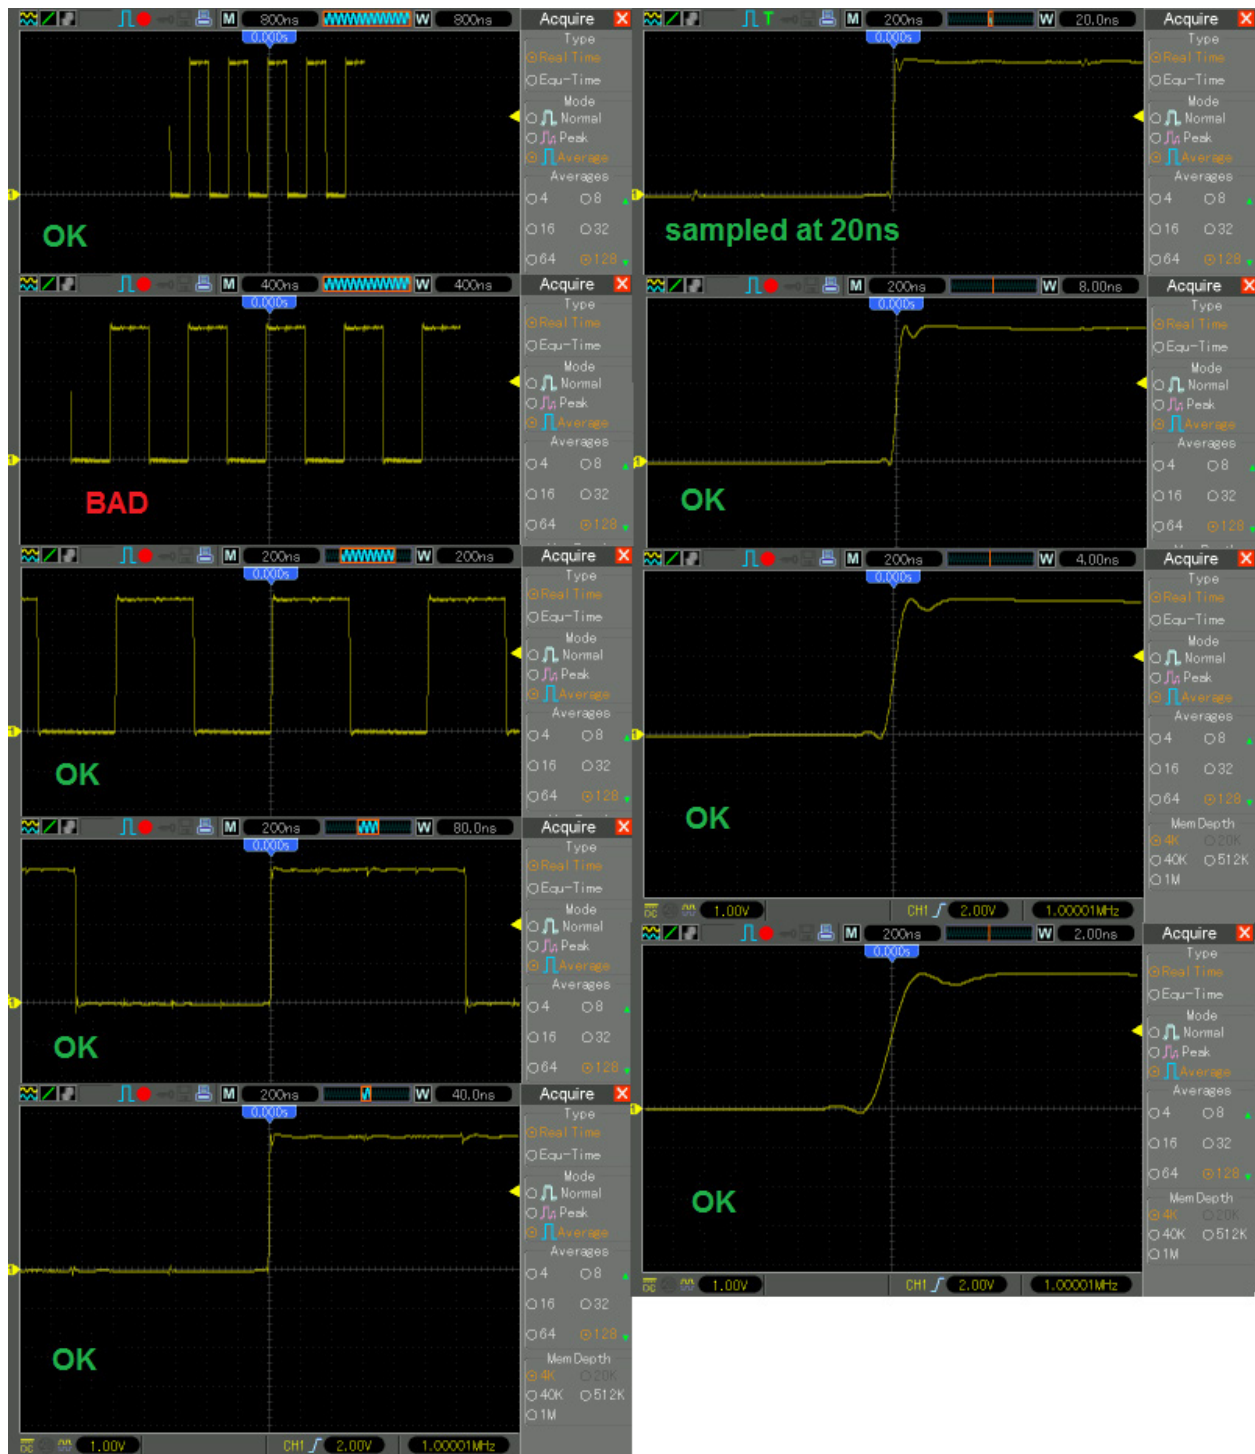
sampled at 80ns/DIV or 40ns/DIV or 20ns/DIV, stopped and zoomed:

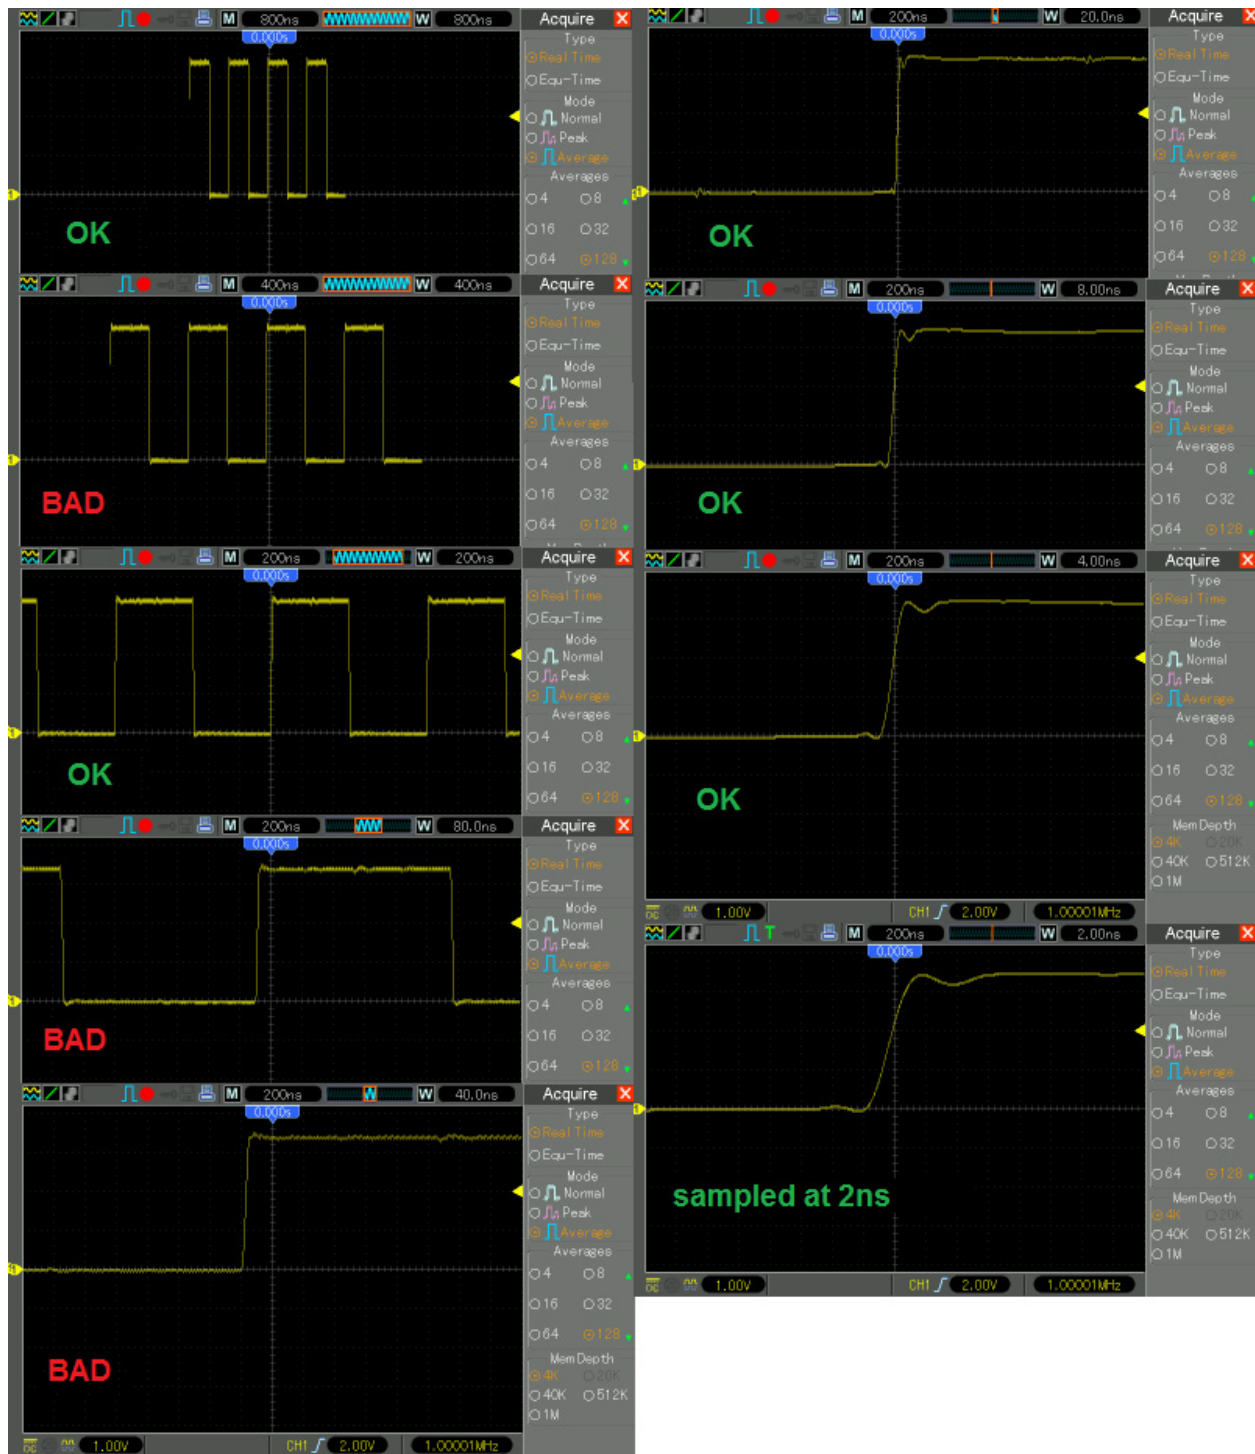
sampled at 8ns/DIV or 4ns/DIV or 2ns/DIV, stopped and zoomed:

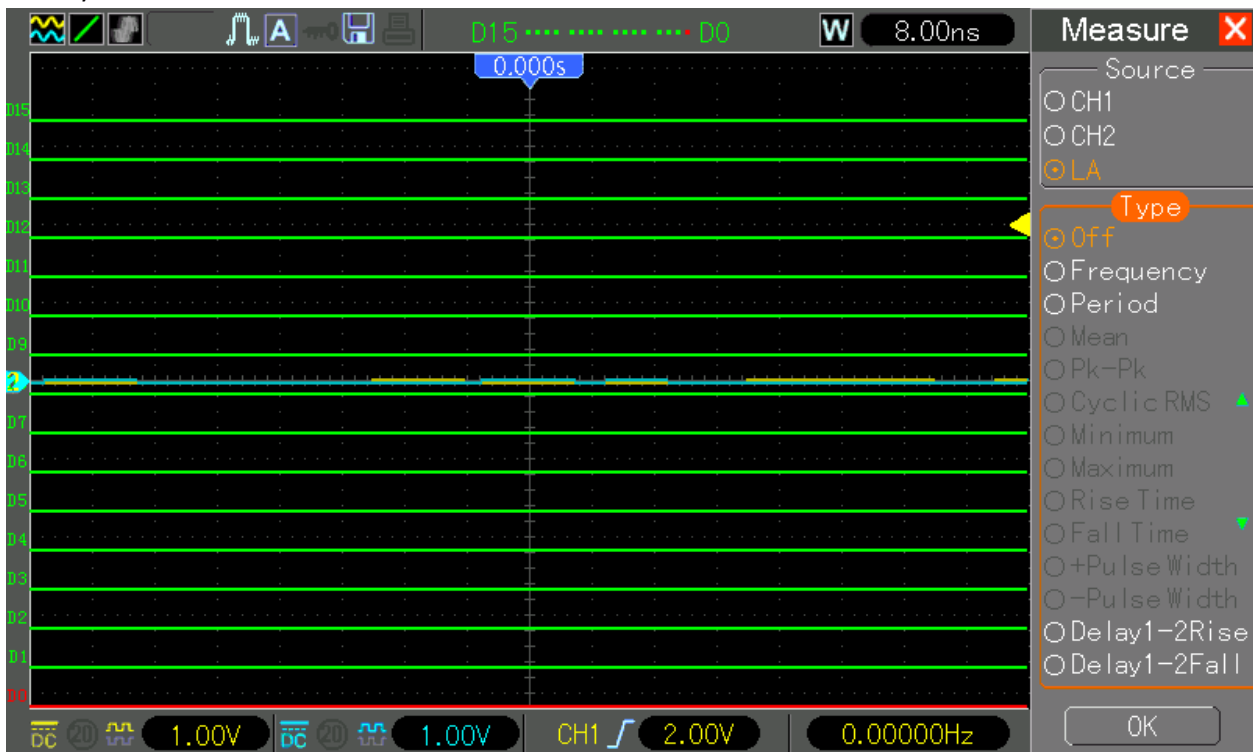
52. With LA enabled, Measure is showing “Delay1-2Rise” and “Delay1-2Fall”, but they should be grayed out as they have no function for LA:

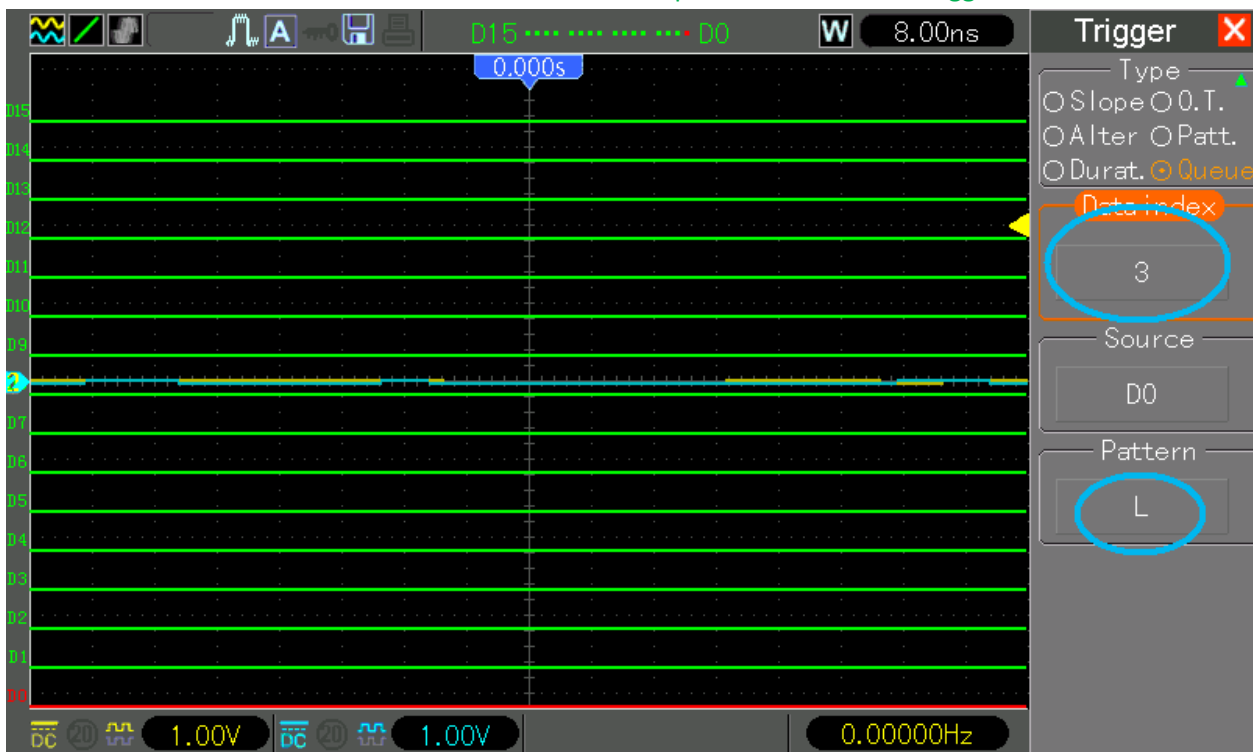
53. LA without protocol decoders has limited usefulness. PROPOSAL: Add protocol decoder and/or trigger or at least increase number of “data Indexes” and add hex pattern in LA Queue trigger.
