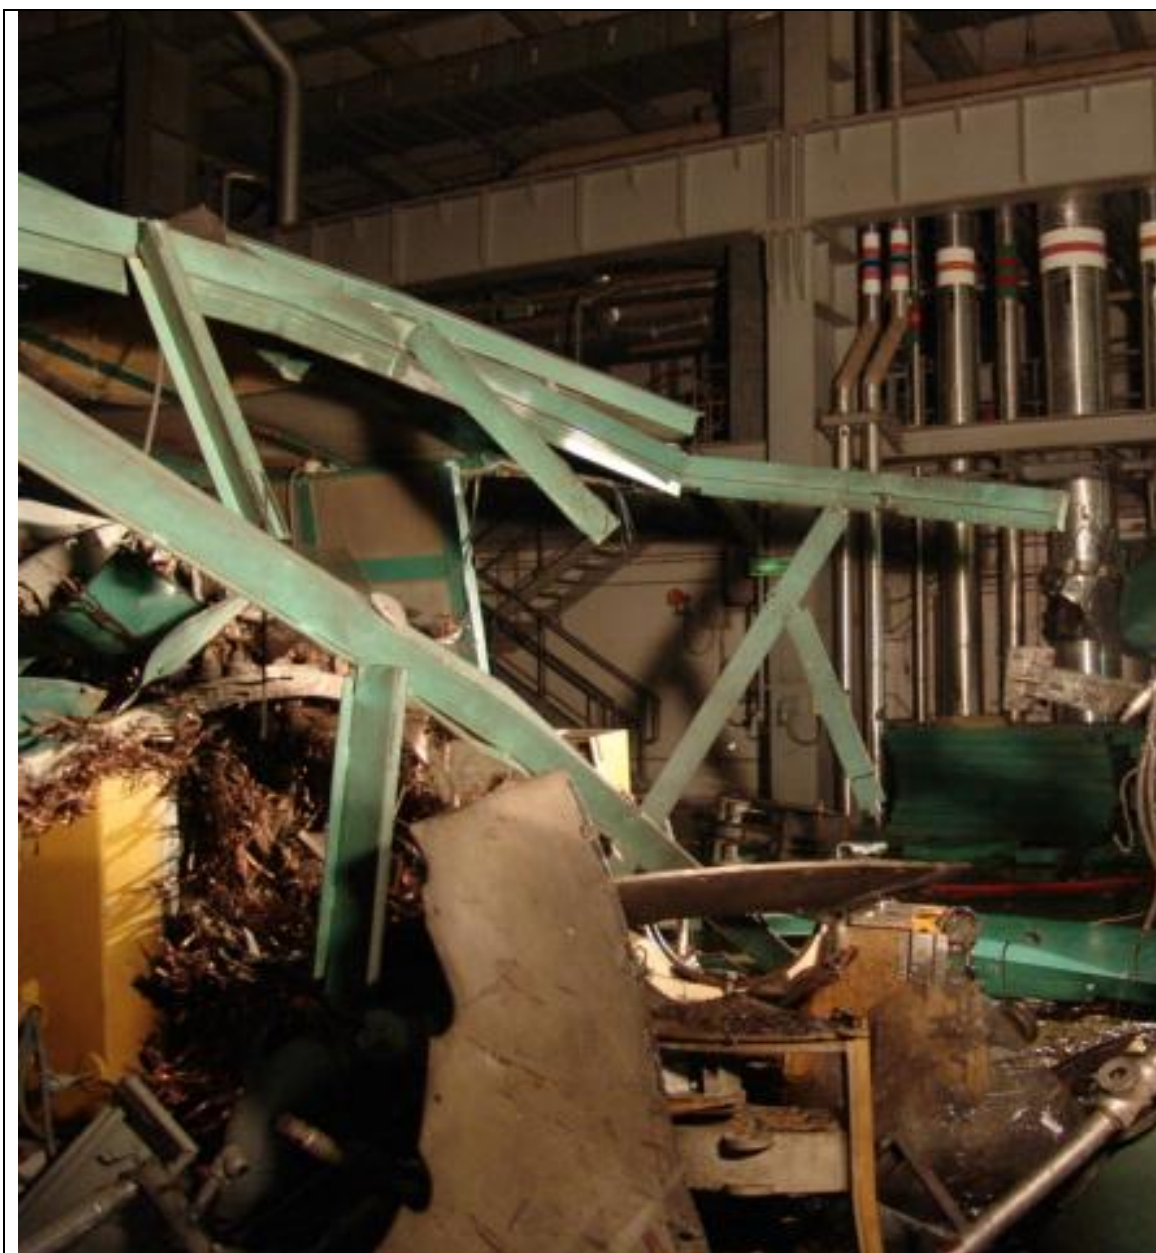
Pic#1: General View of the Generator # 7 on Slip Ring / Exciter Side

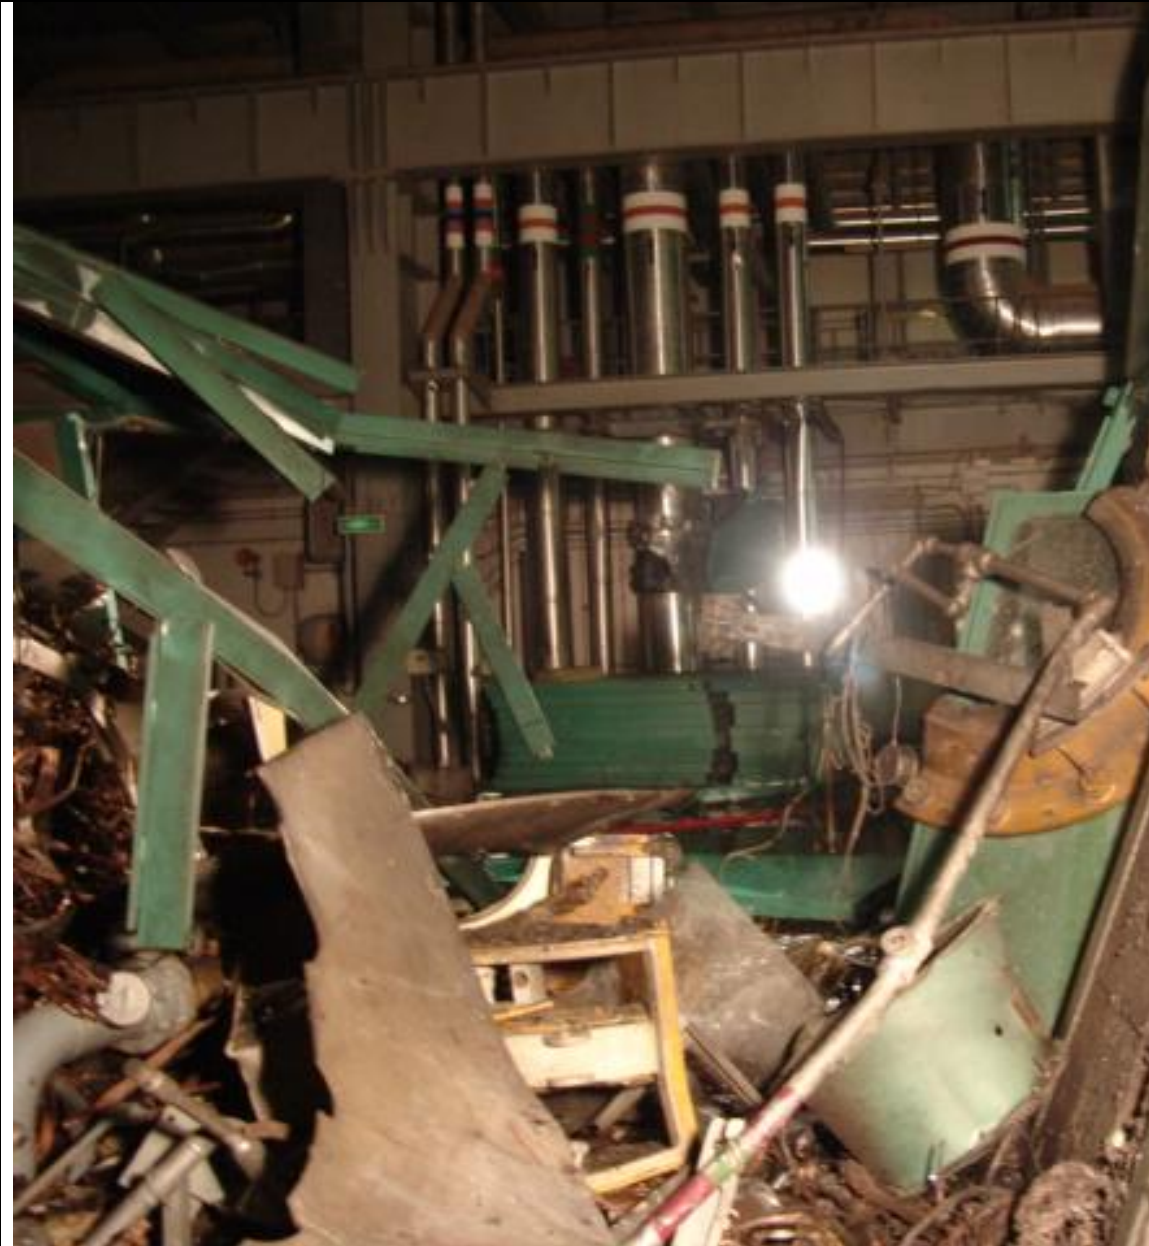
Pic#2: Extent of Damage to The Generator Viewed from Boiler Side-
General View.

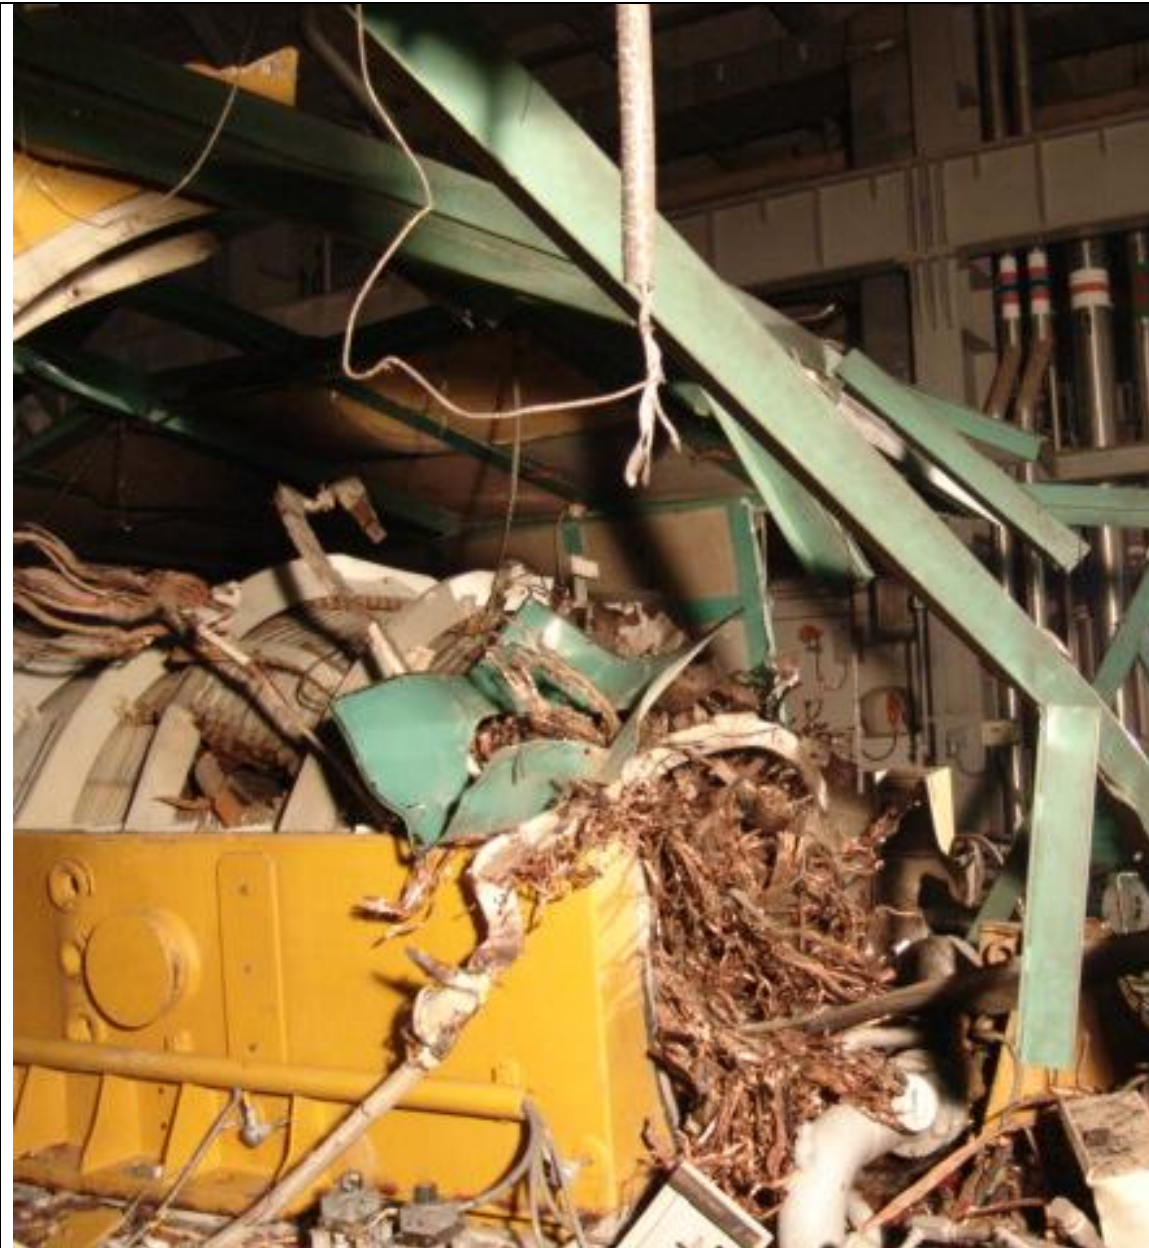
Pic#3: Extent of Damage to The Generator Viewed from Desal Side-
General View.

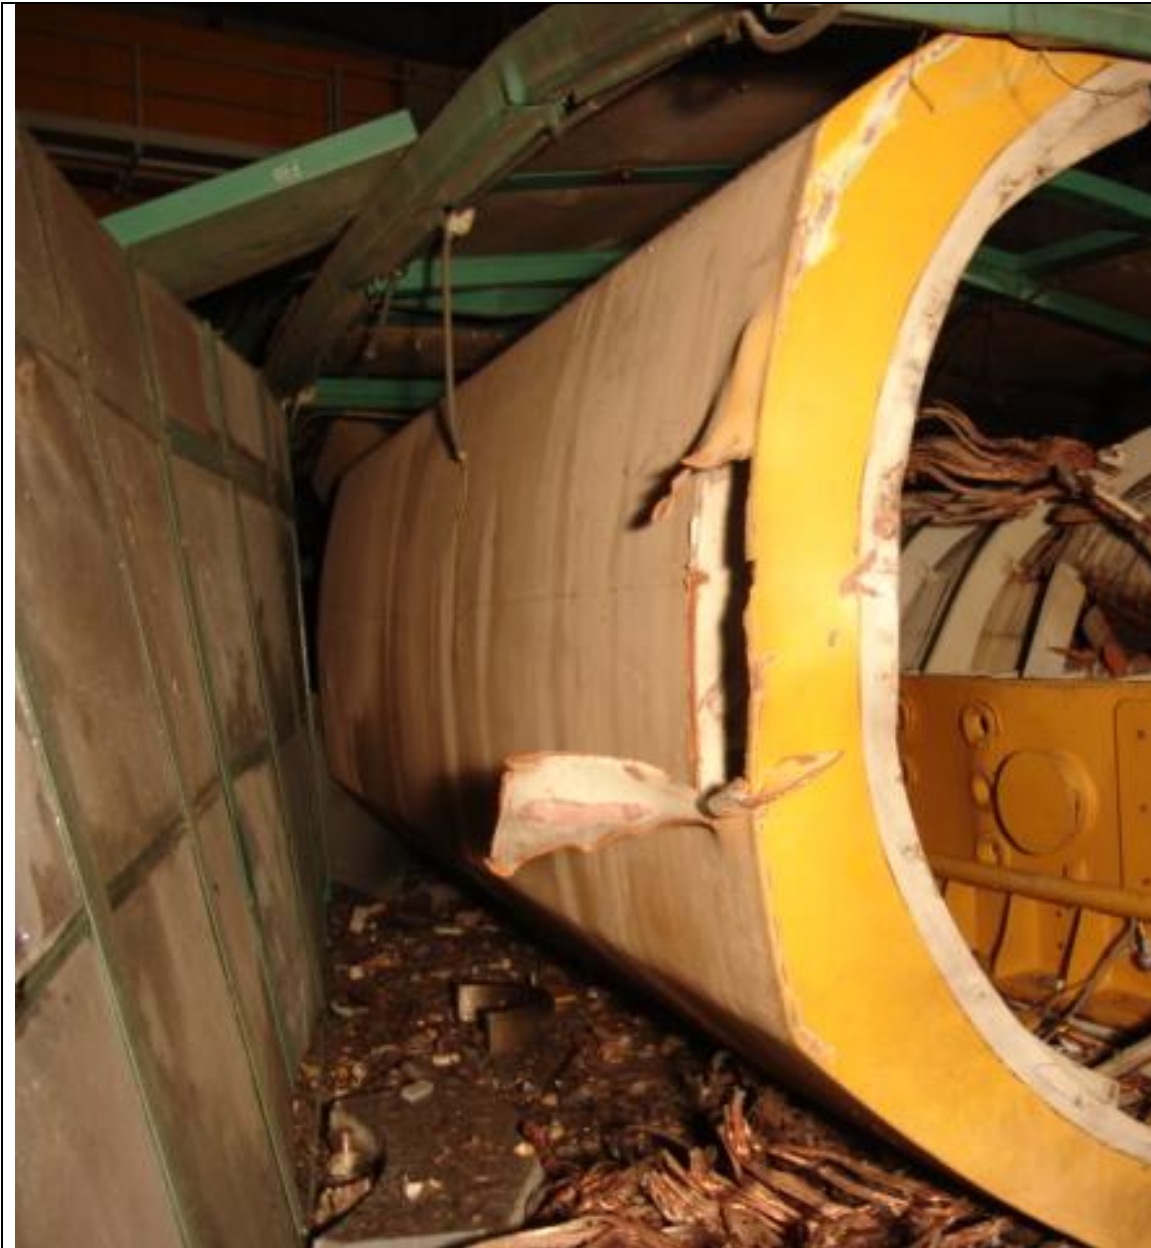
Pic# 4: General View of the Generator Viewed from Exciter Side.

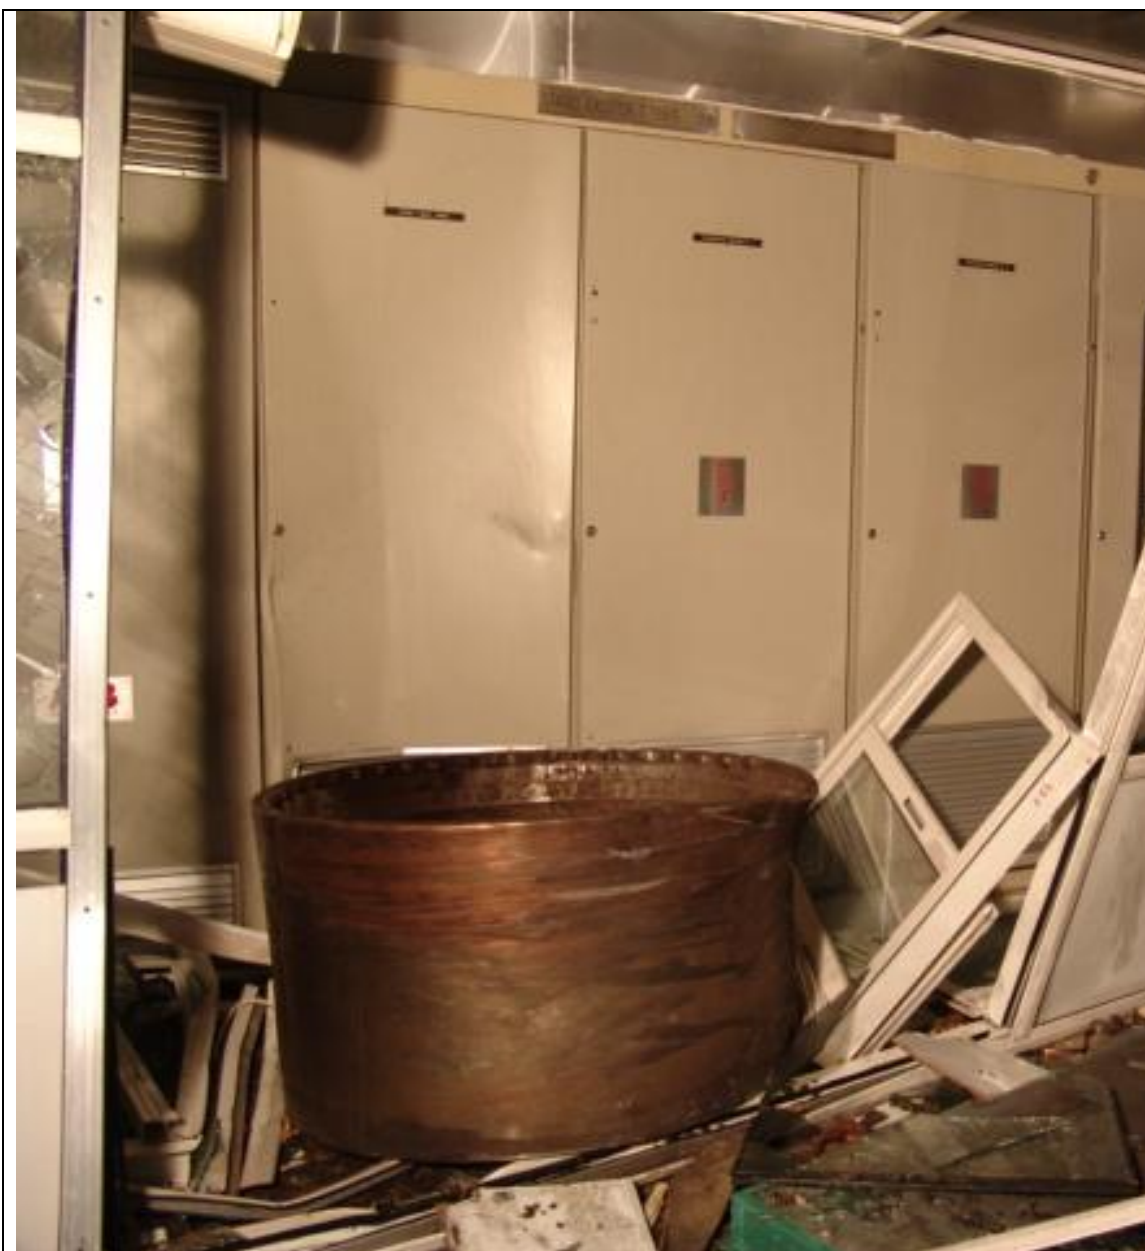
Pic#5: Exciter End Generator Rotor Retaining Ring Lying Near Static Exciter Panel.

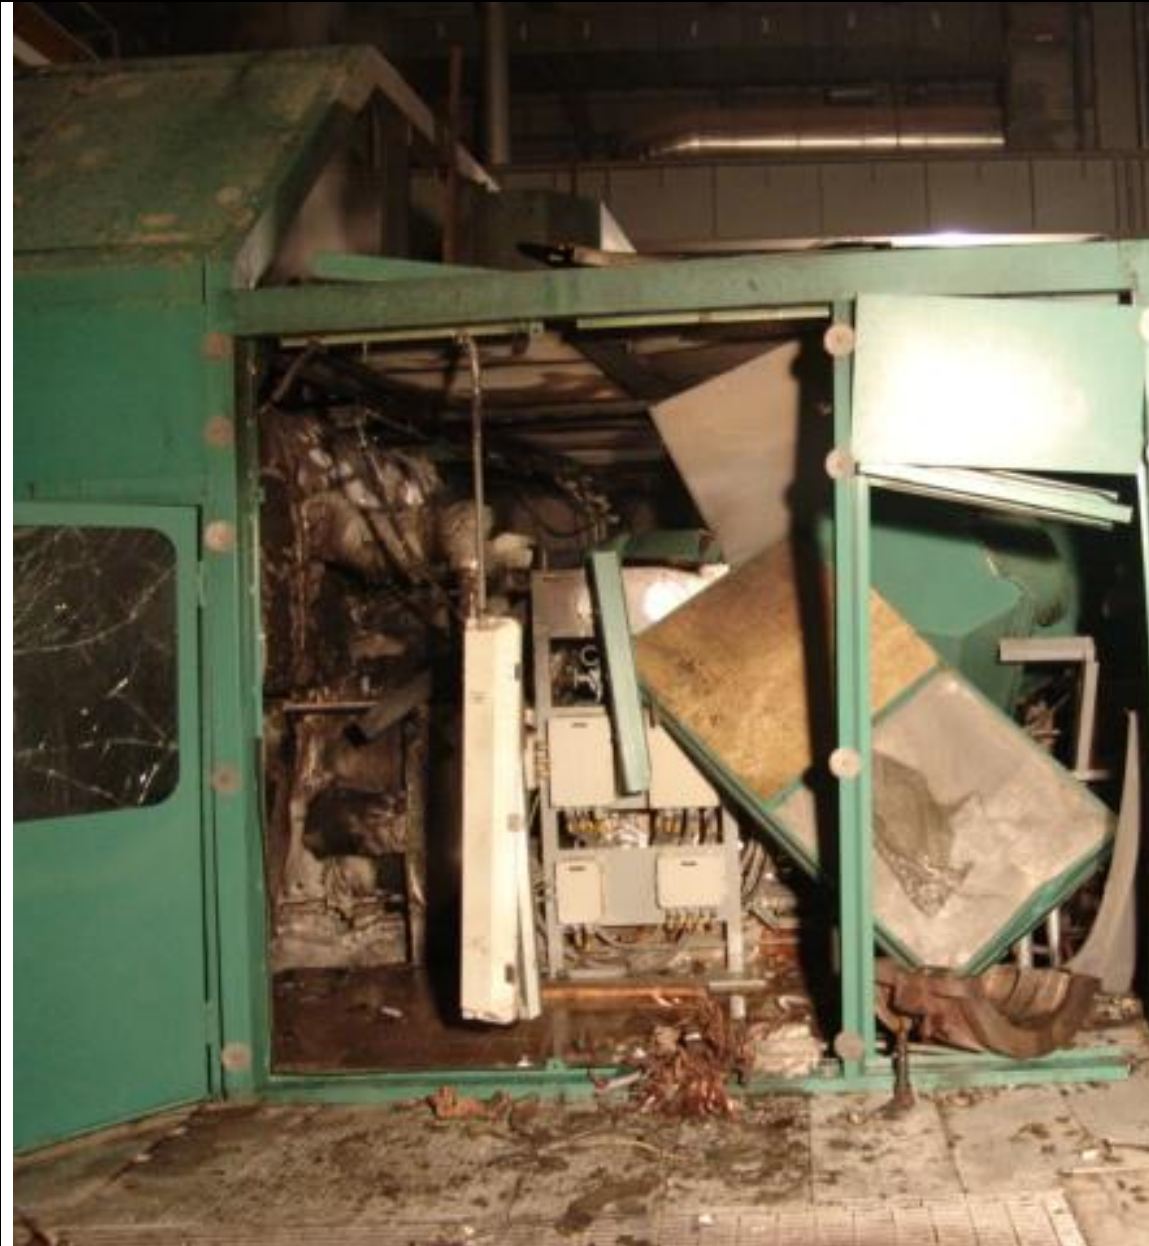
Pic# 6: Damage between Turbine-Generator Viewed from Desal Side.

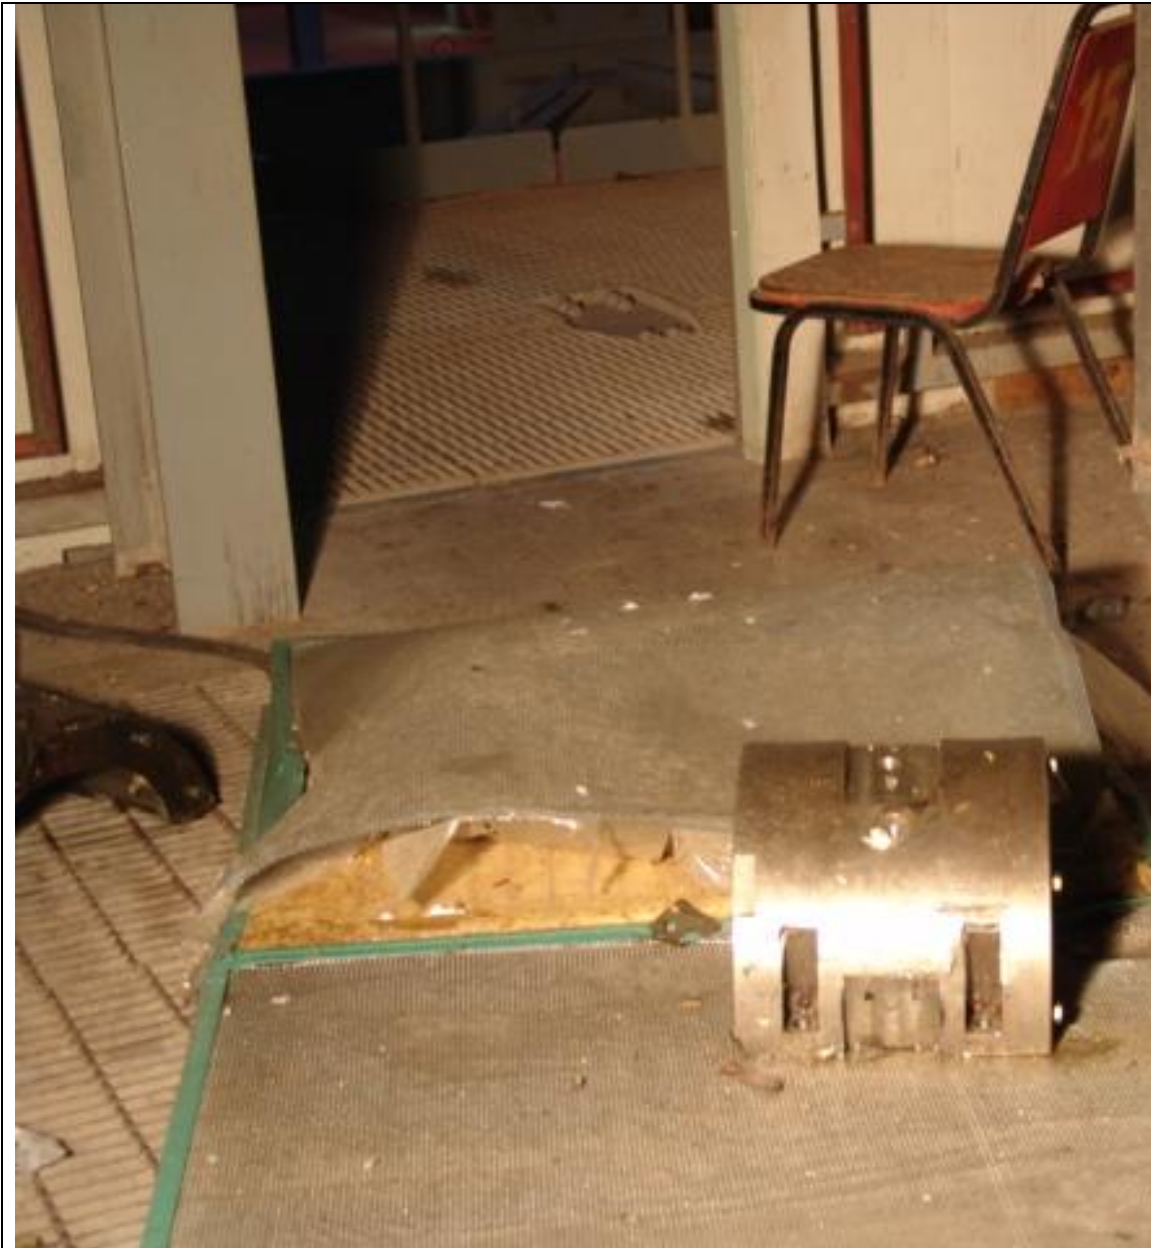
Pic# 7: Turbine Generator Bearing Lying Near Door on Desal Side.

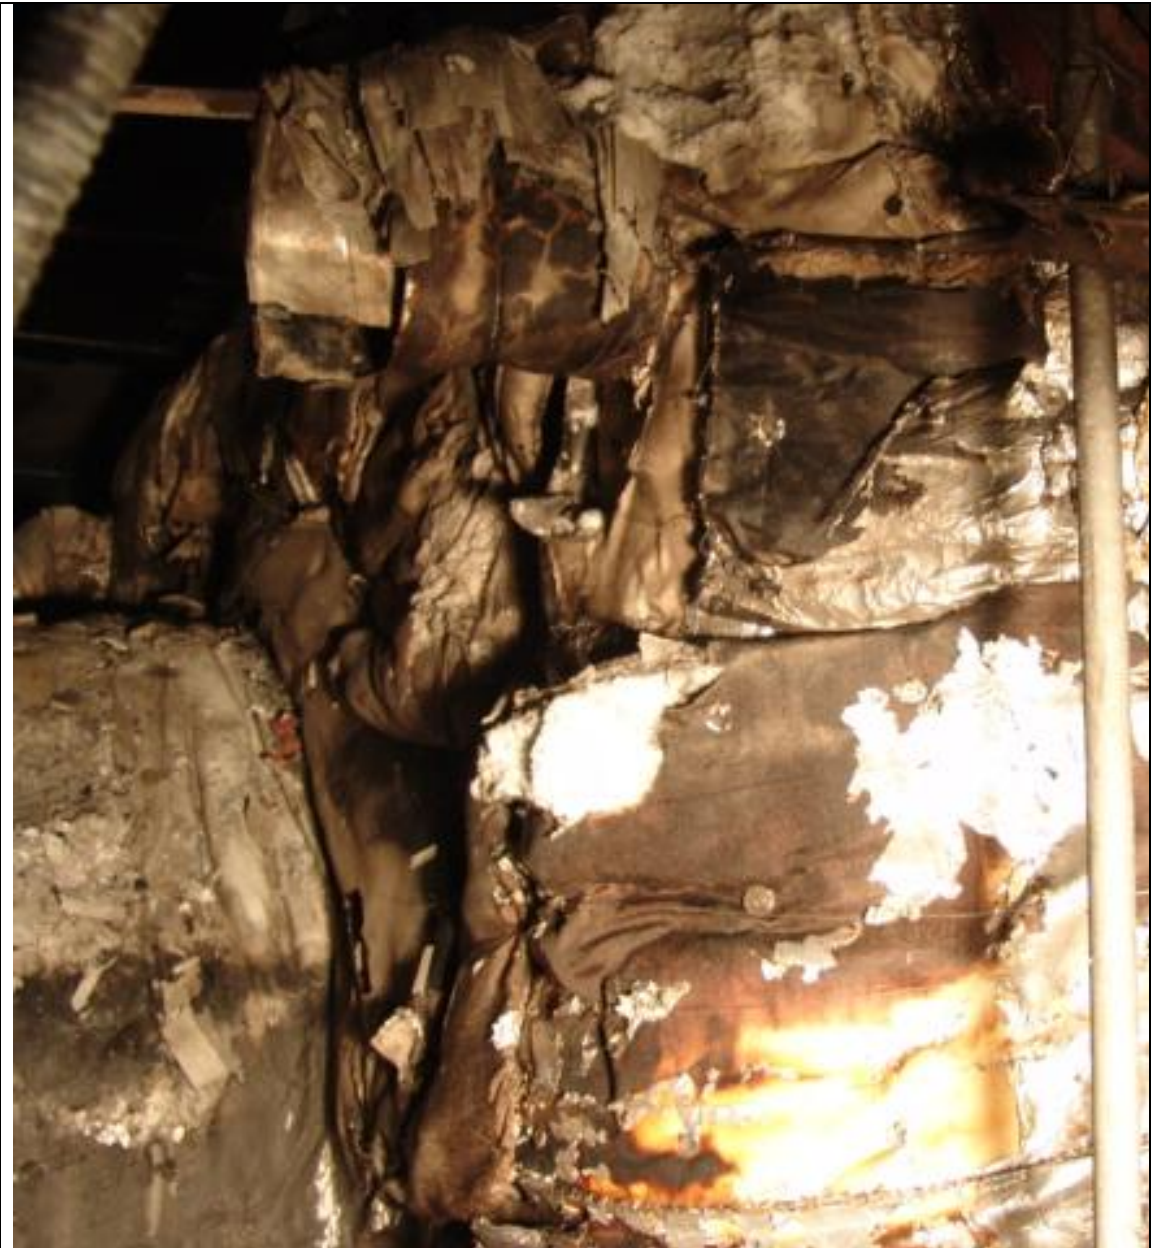
Pic # 8: Damage to Turbine Insulation- HP Side.

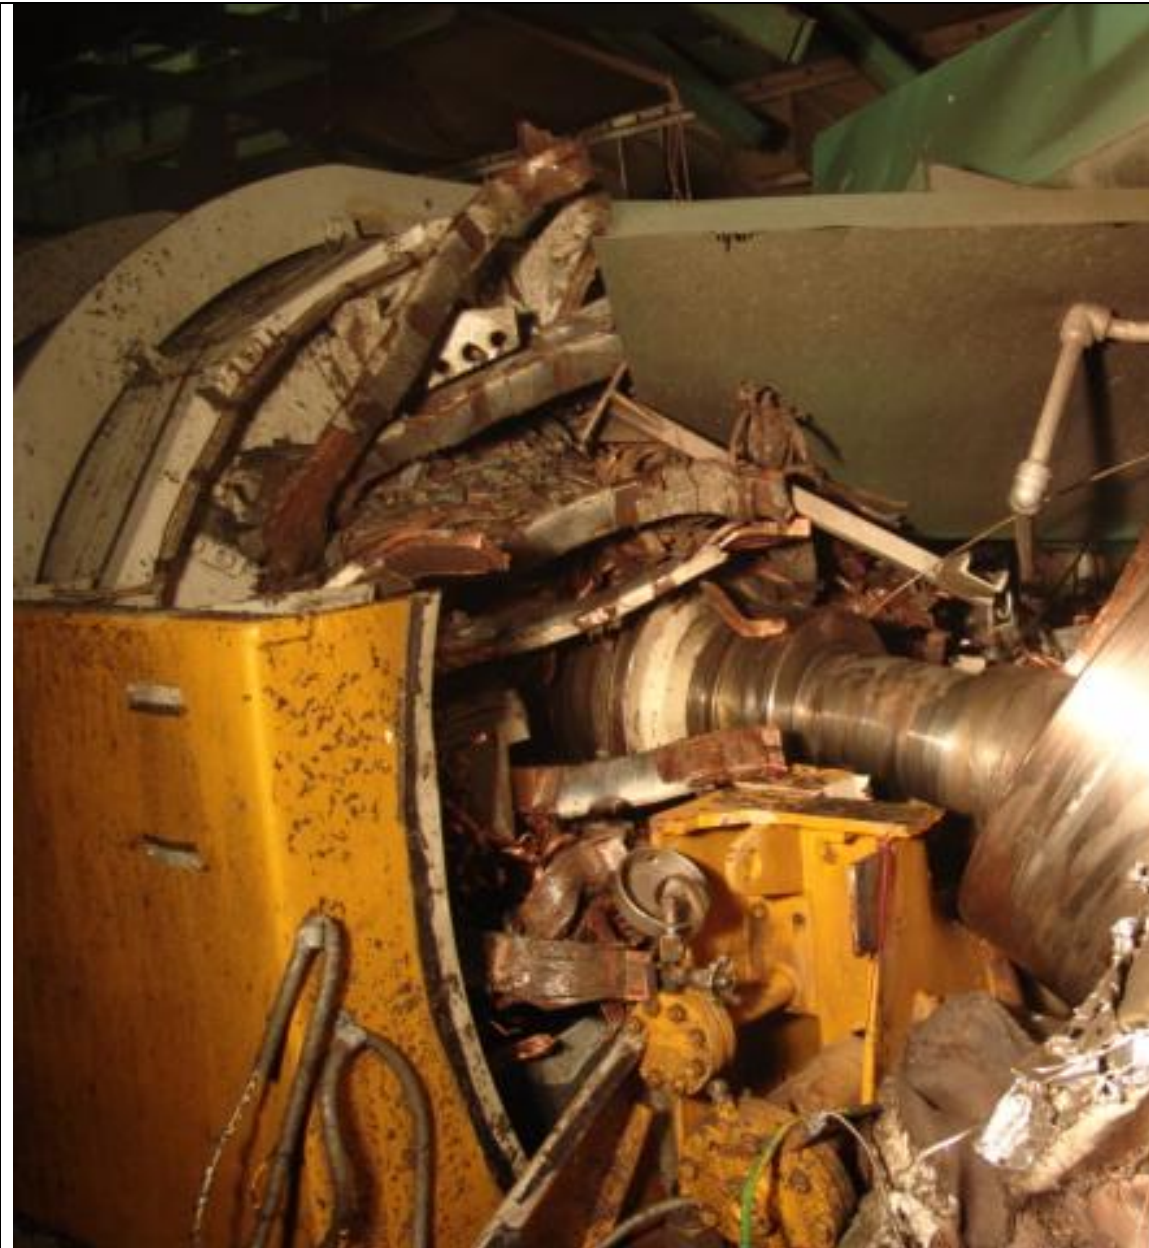
Pic# 9: Damage to Generator on Turbine Side-Retaining Ring Flown out towards Turbine Side.

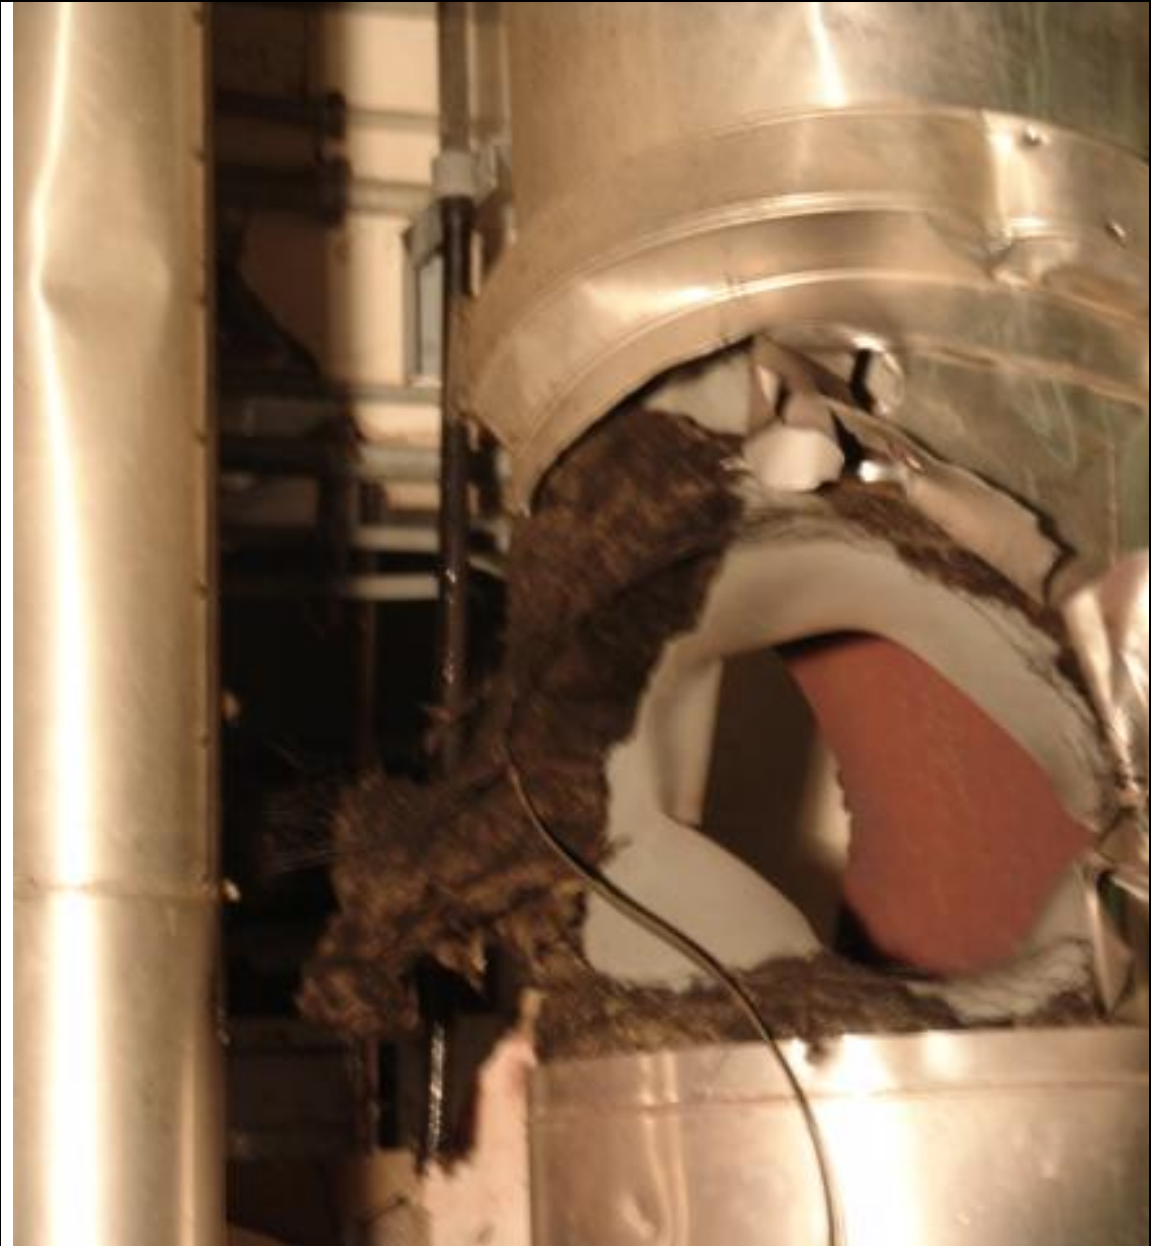
Pic# 10: Flying Piece Damaged LP Steam Line to Dearator.

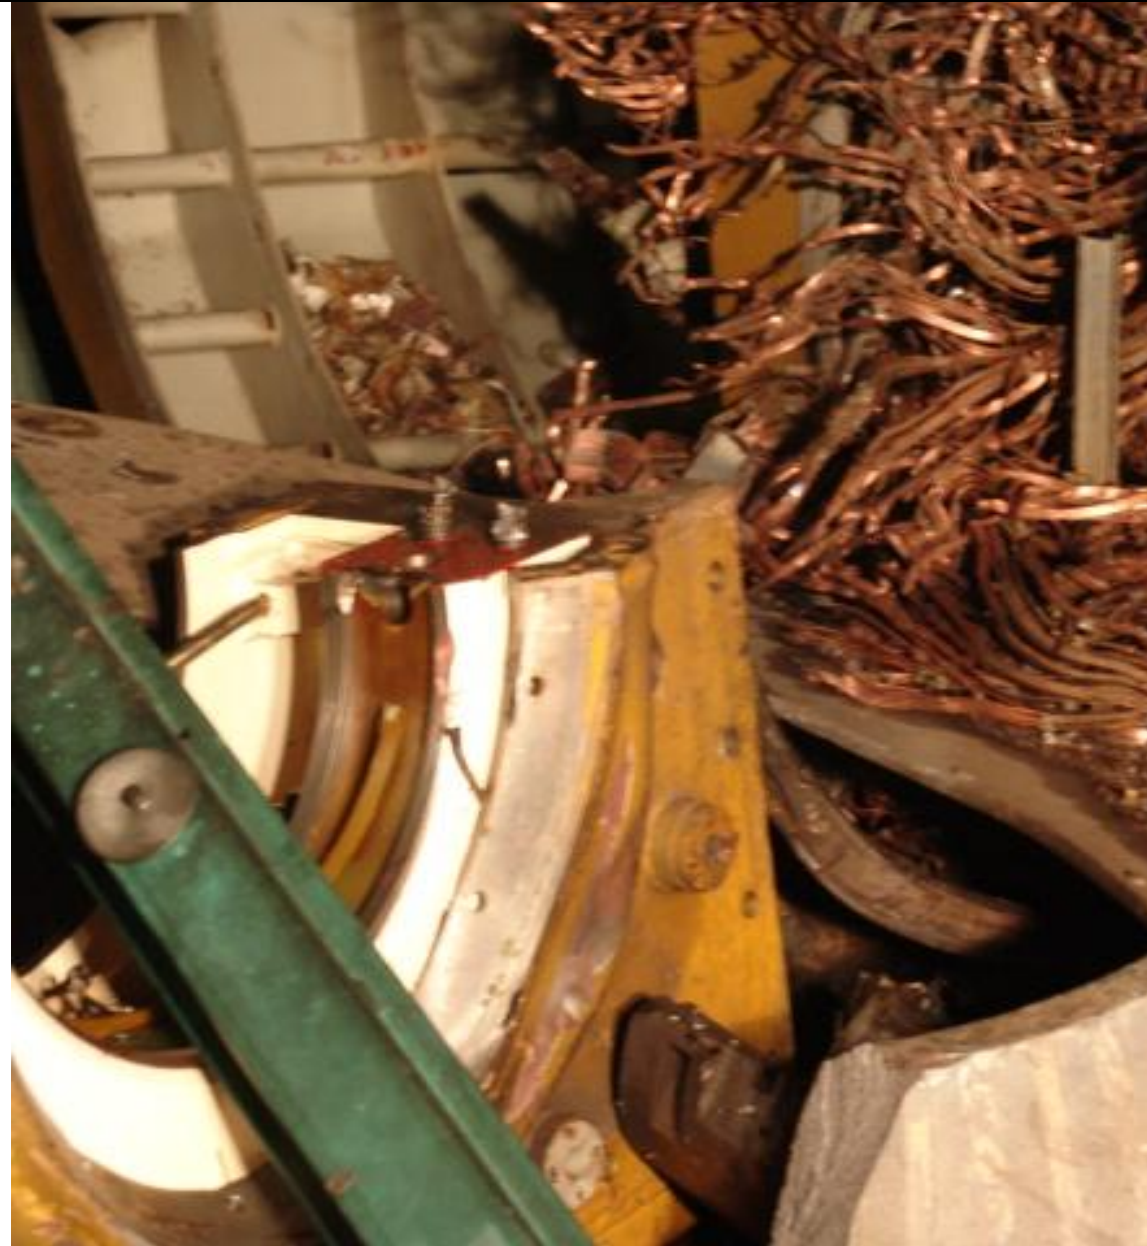
Pic#11: Damage to the Generator Stator, Rotor and Bearing Housing on Exciter Side.

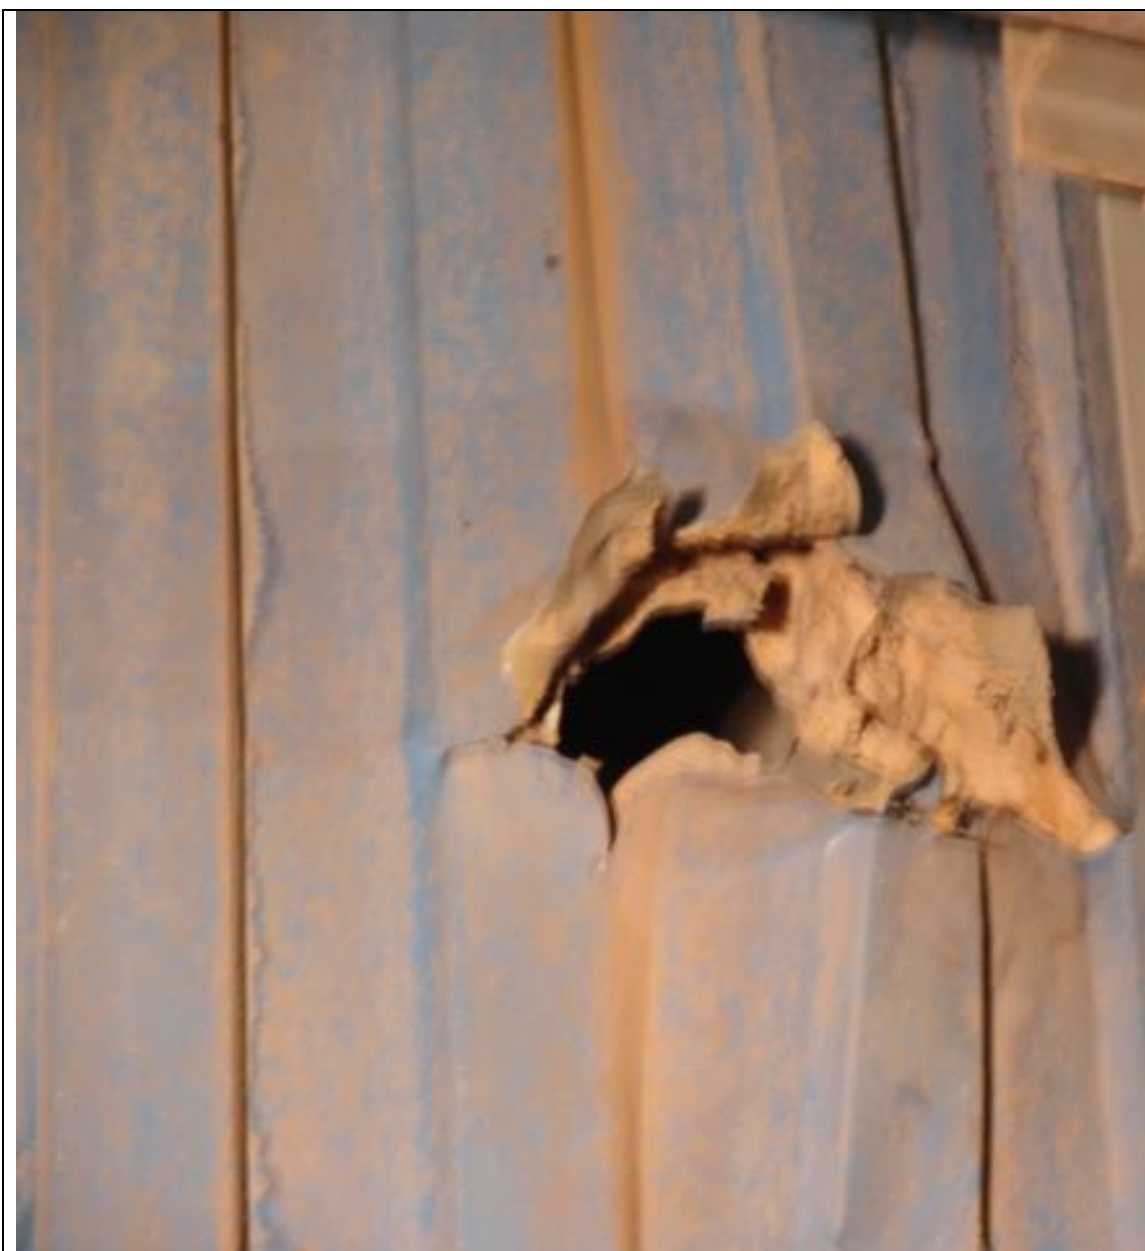
Pic# 12: Damage to Side Wall between Switchgear Room and Boiler

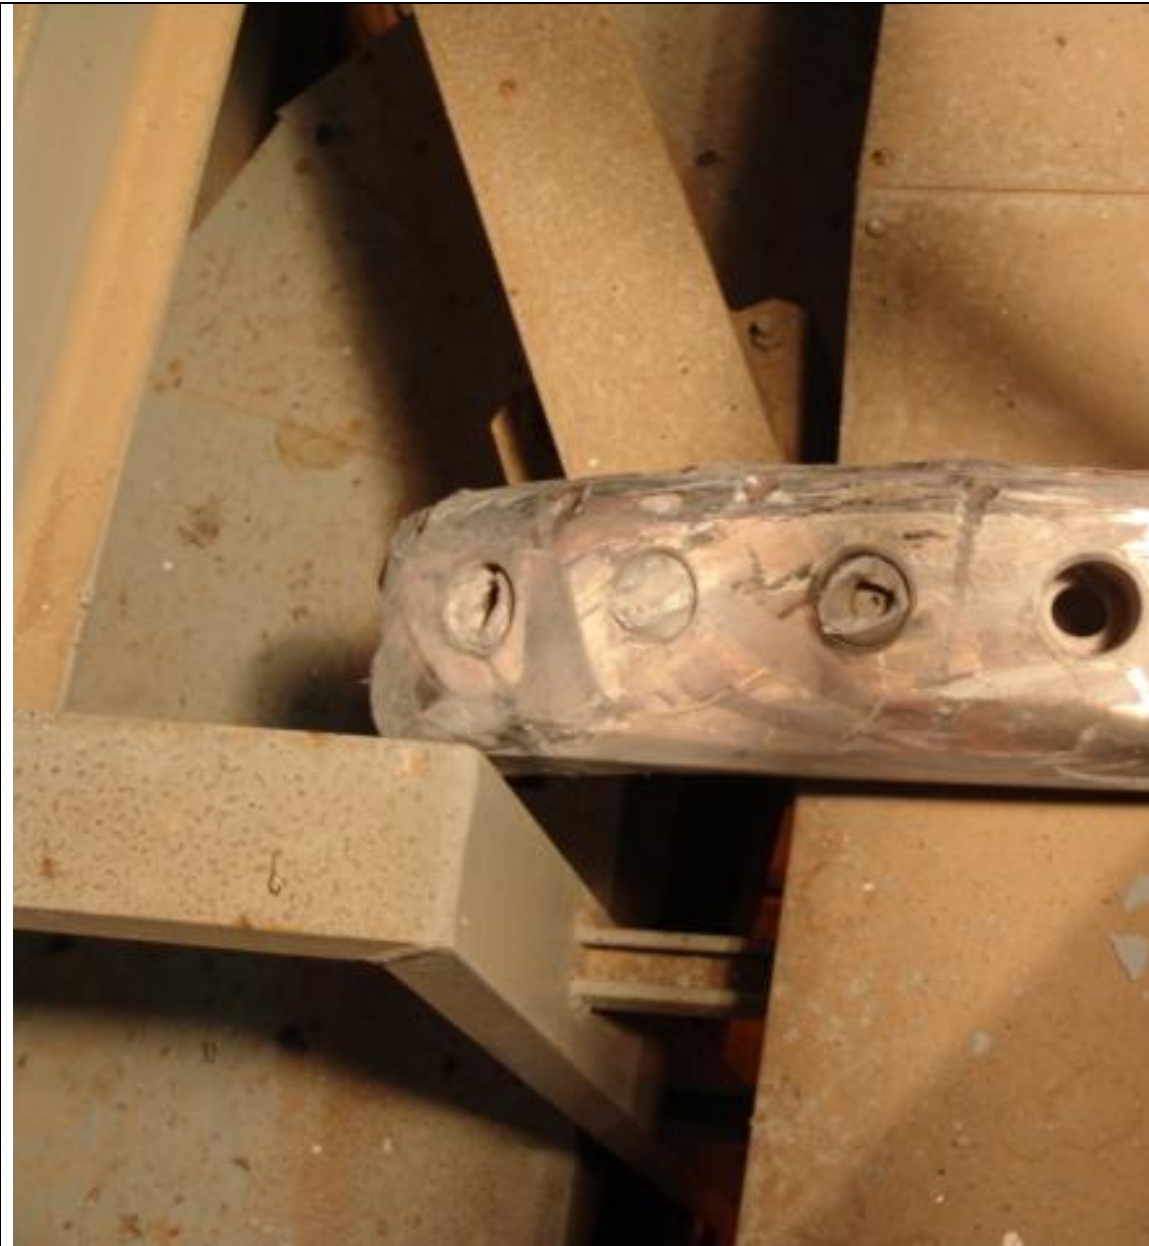
Pic#13: A Piece of Generator Flown to Boiler Area After Piercing the LP Steam Pipe, Switchgear room walls and one I- beam.

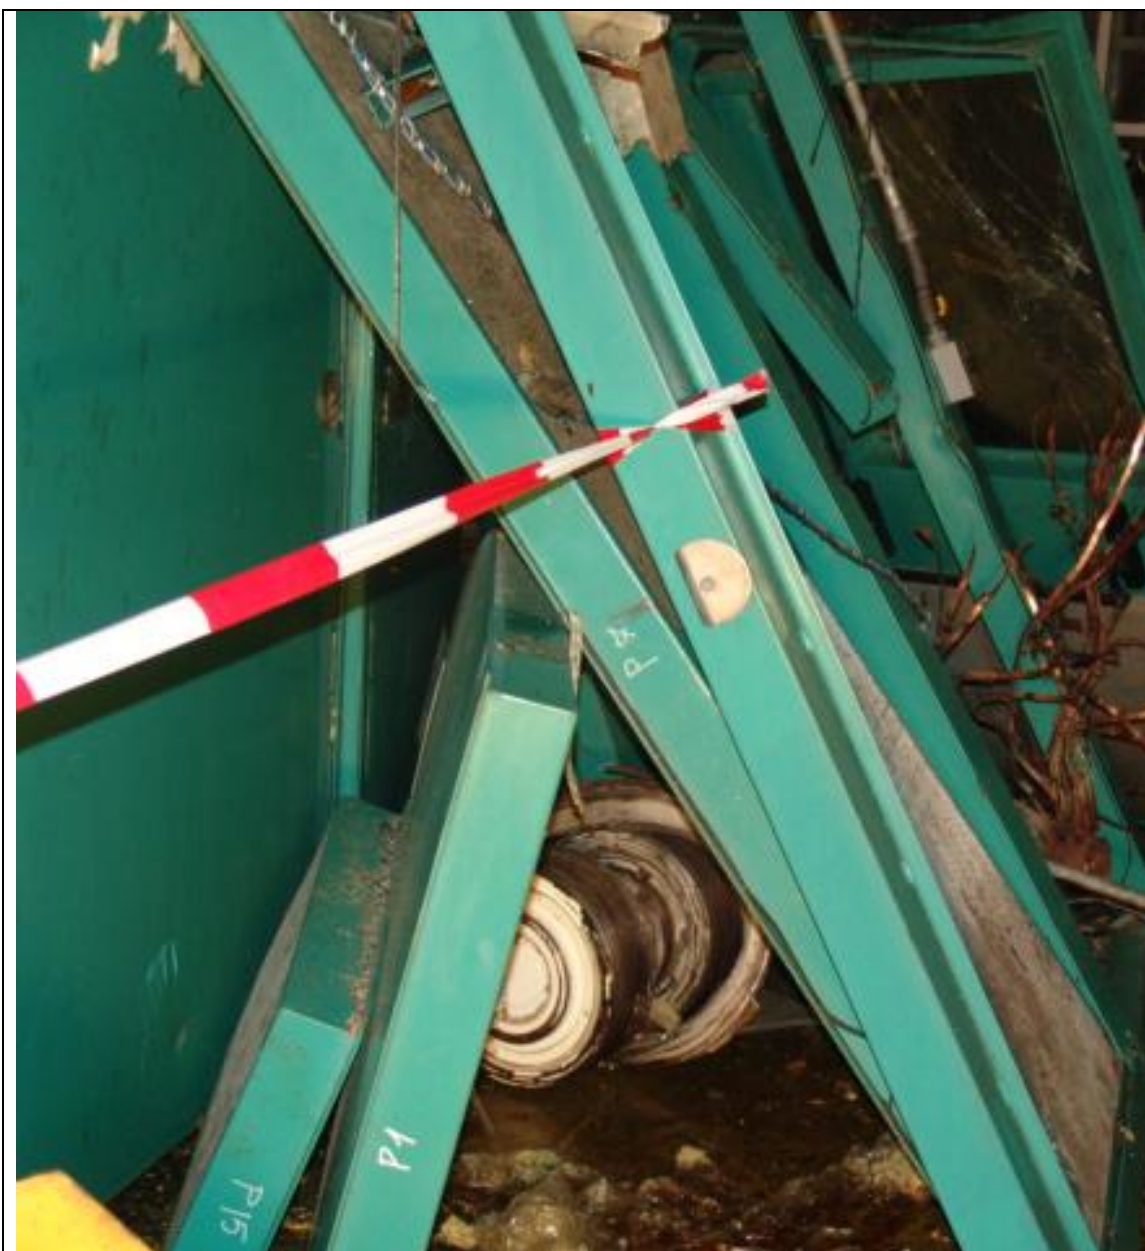
Pic#14: Sheared off Part of Generator Rotor Shaft of Exciter end.

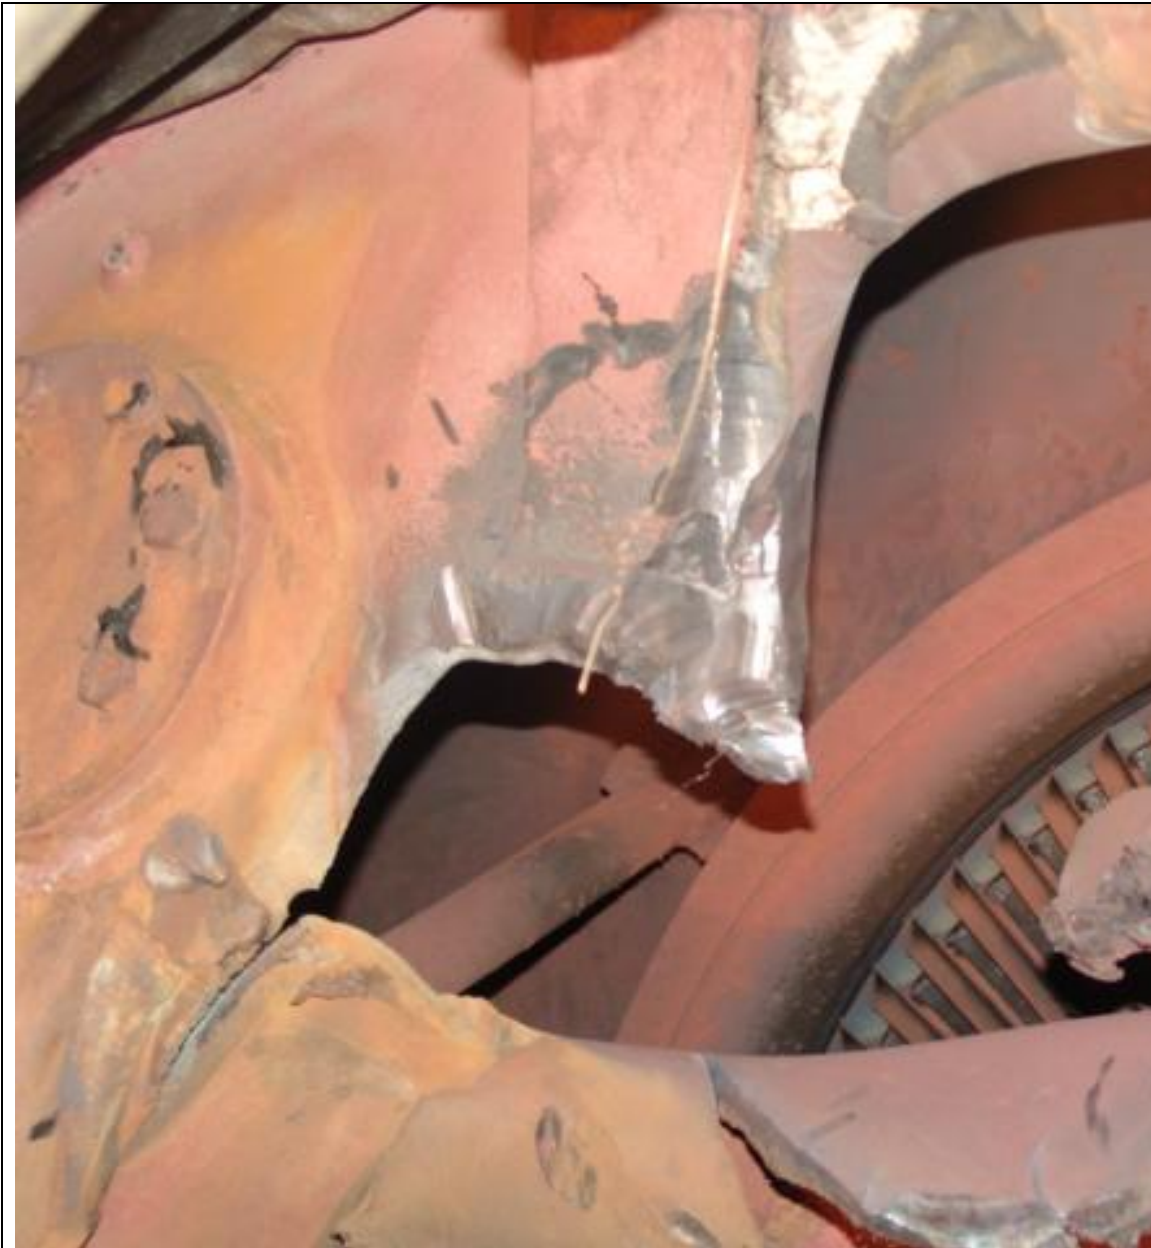
Pic# 15: Damage to Turbine LP Casing.

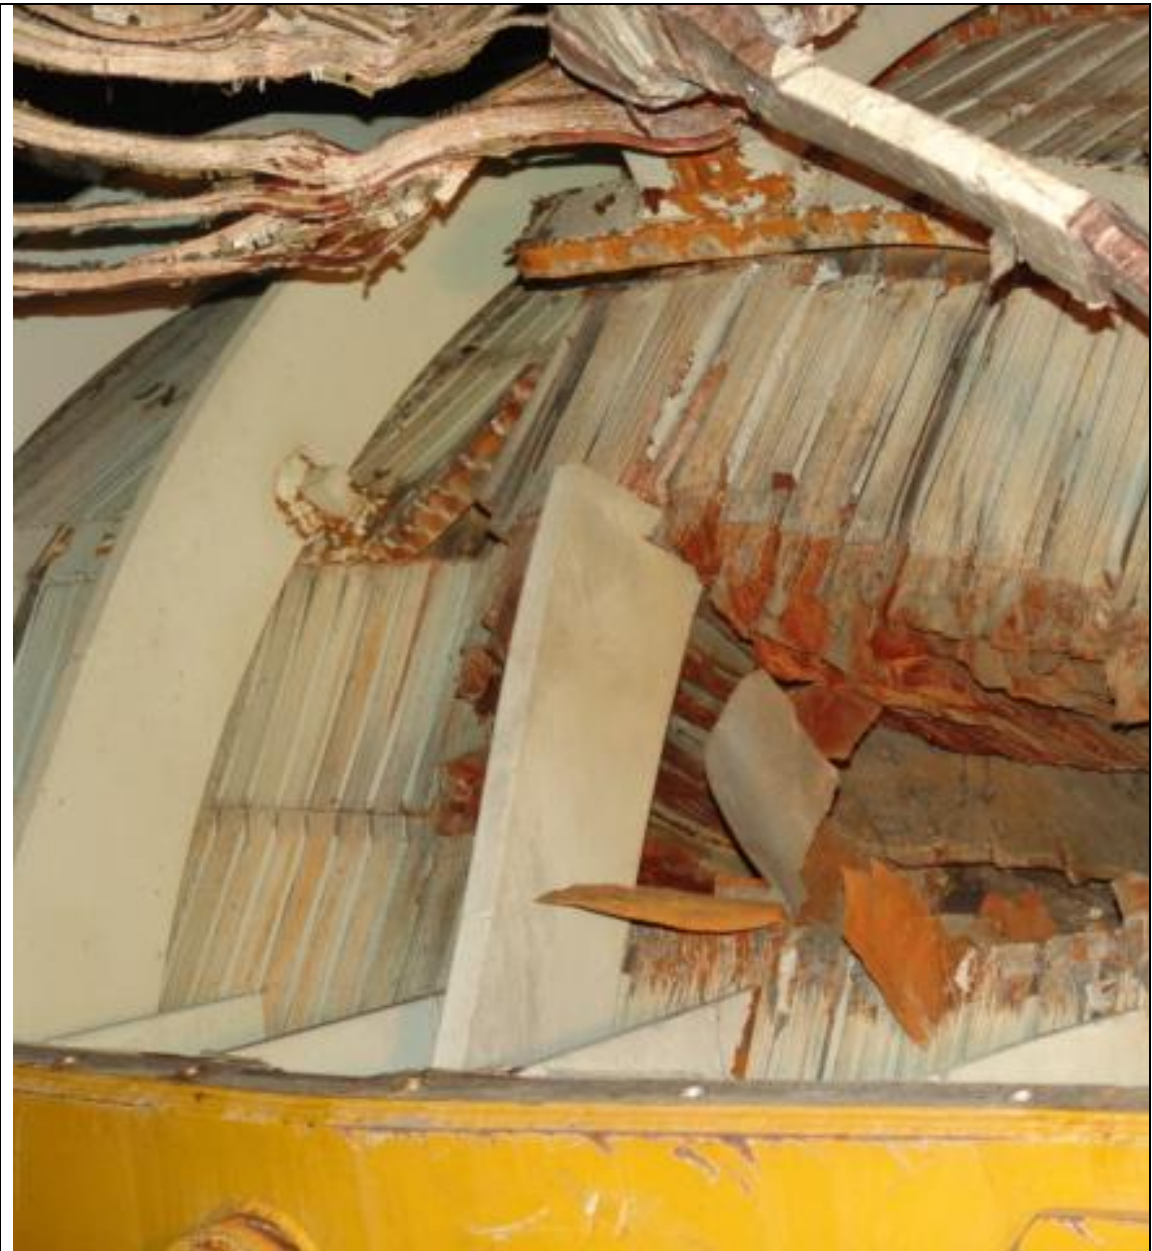
Pic# 16: Damage to Generator Stator Core.
