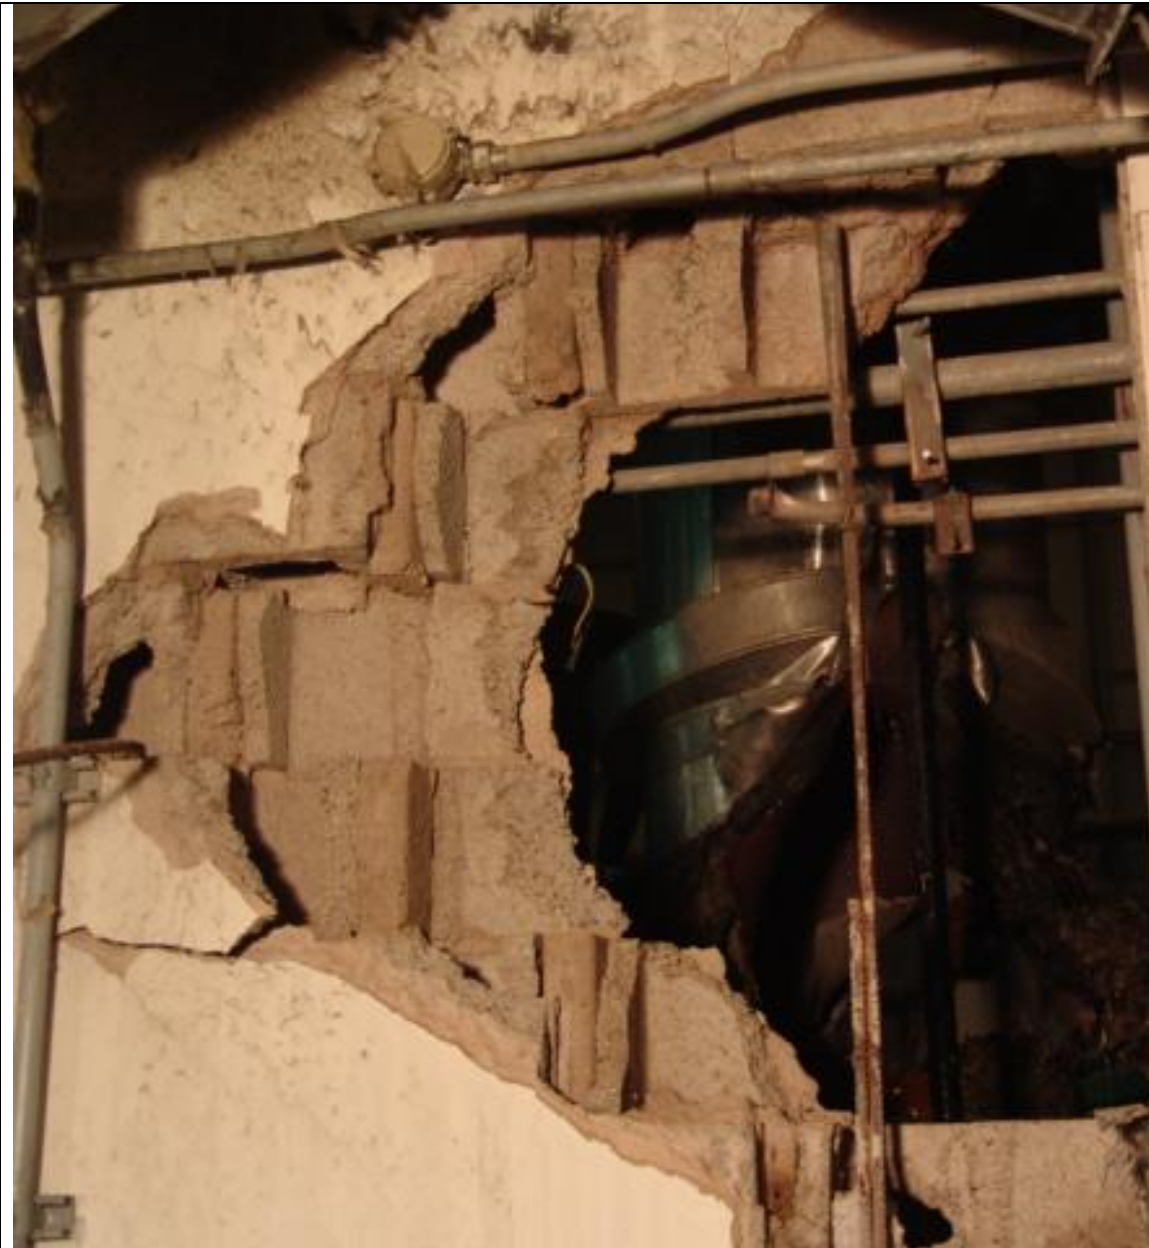
Pic# 17: Damage Occurred to Switchgear Room Wall –Viewed from Switchgear Room.

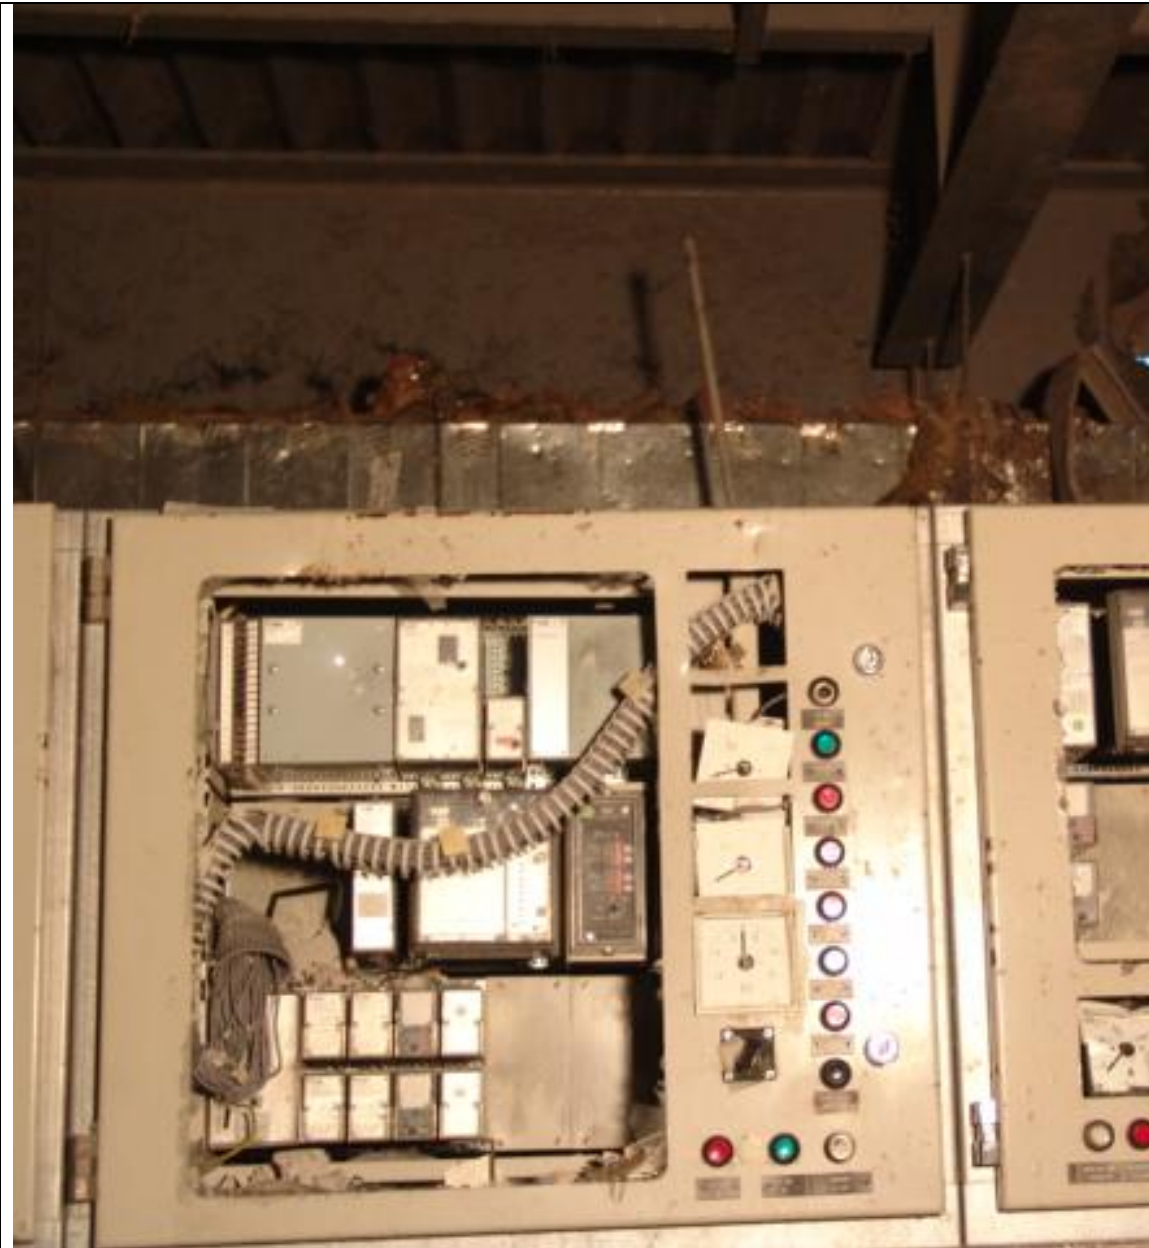
Pic# 18: Damage to Switchgears.

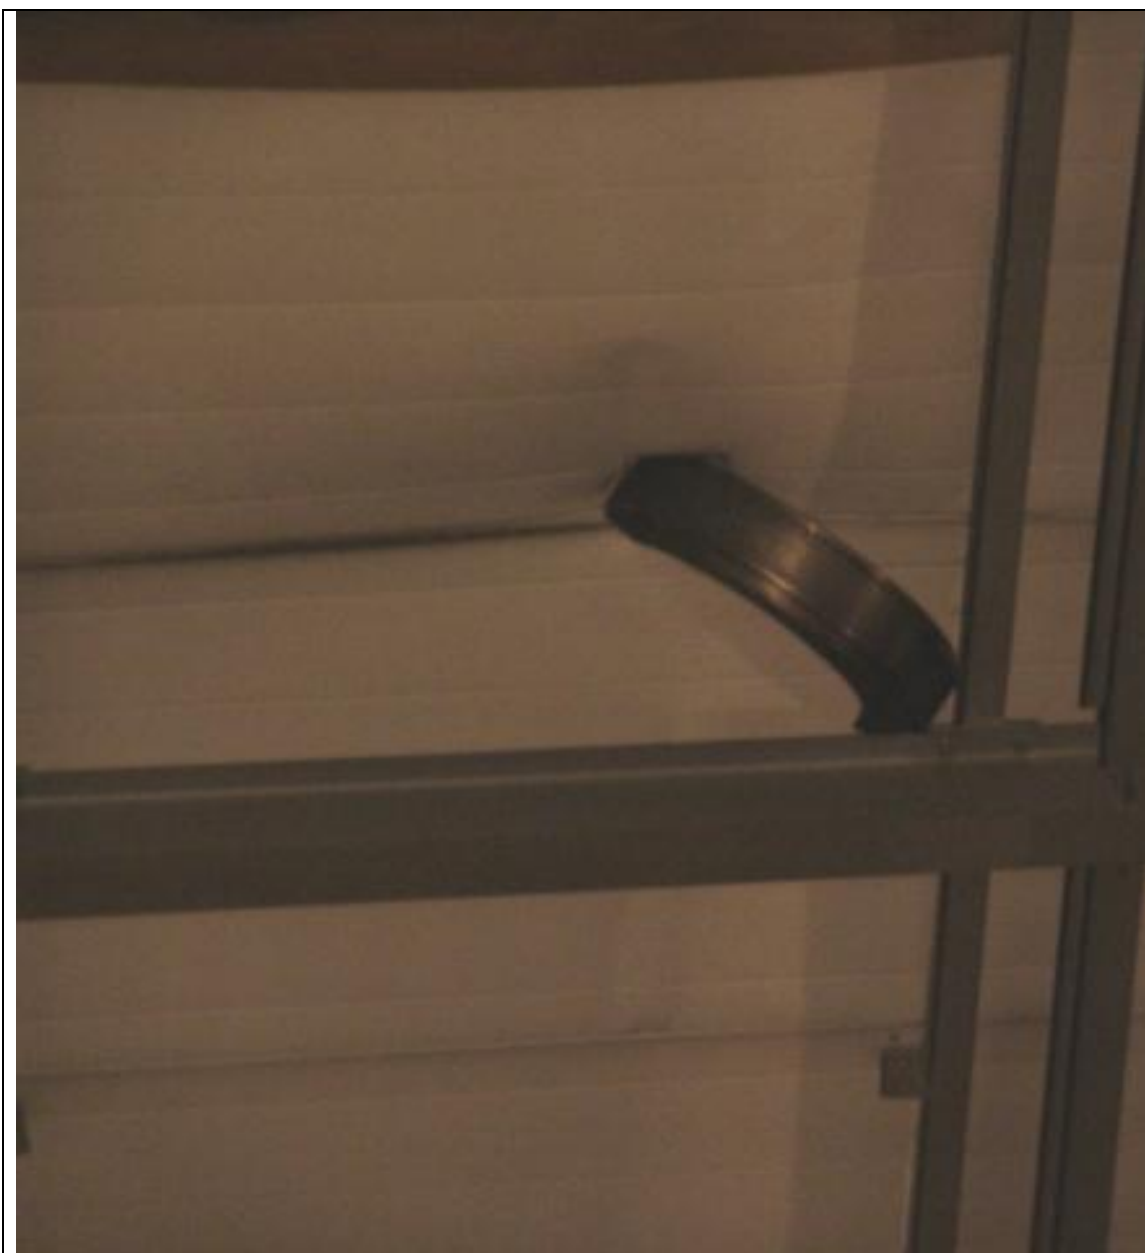
Pic# 19: A Metal Piece Flown and lying on Ceiling of the Turbine Hall.
