Intel[®] DBPXA250 and DBPXA210 Development Platform for Intel[®] Personal Internet Client Architecture

Specification Update

July 2002

Order Number: **278555-002**

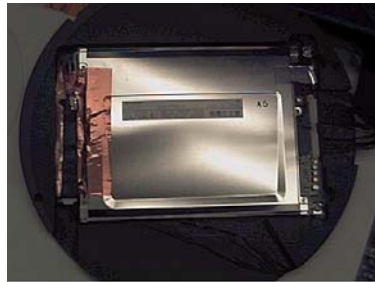
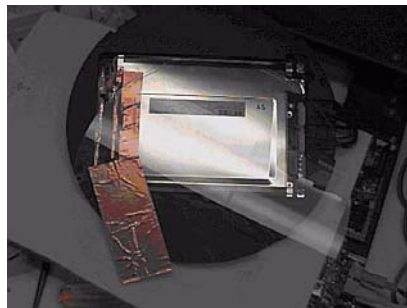
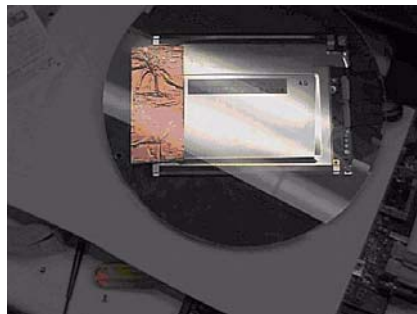
14. LCD Touch Screen Intermittently Fails

Problem: LCD screen is open to excessive noise disruption on the touch screen.

Implication: Excessive noise disruption reduces LCD screen display quality. The touch screen may not work correctly.

Workaround: Fix this problem by covering the back light inverter with copper foil shielding tape to decrease the electrical noise transferred to the LCD and Touch Screen.

1. Disassemble the BBPXA2xx development baseboard touch screen enclosure.
2. Remove the back light inverter.
3. Cut a piece of heat shrink tubing (1"x3") and place over the inverter.
4. Heat the tubing until it collapses on the inverter.
5. Cut a 2"x5" piece of copper tape and place on clear plastic disk covering the inverter. The adhesive side should face the plastic.
6. Cut a 2"x5" piece of copper tape and place on the black plastic disk under the inverter. The adhesive side should face the back of the LCD metal enclosure.
7. Reassemble the touch screen enclosure.

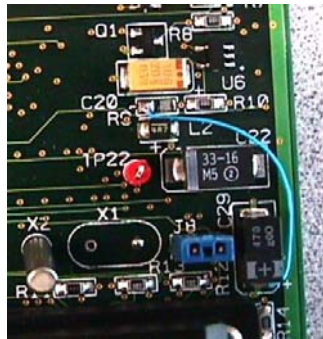
Figure 6. R9 Pad to C29

3. VCC_PLL And VCC_CORE Pin Voltage Must Be Equal

Problem: The Intel® PXA250 and PXA210 Application Processors Developer's Manual states VCC_PLL requires VCC_CORE voltage instead of a separate voltage supply.

Implication: The PXA250 processor may not work if VCC_PLL is not equal to VCC_CORE.

1. Remove R9.
2. Add a 30-AWG wire from the R9 pad (inductor L2 side) to the positive side of C29. This can be done on the top of the board.

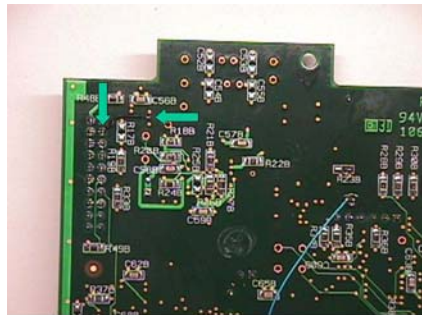
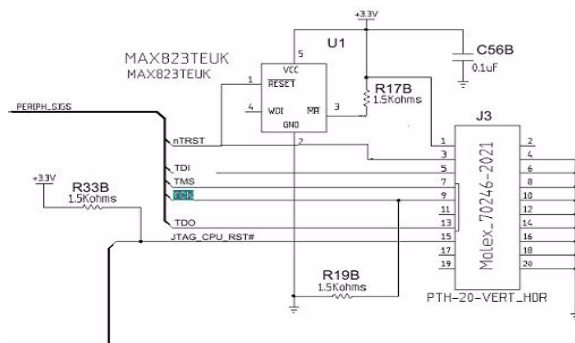
Figure 7. Wire From The J3-3 To The Via Of U1 Pin 1

7. For ARM® Multi-ICE® JTAG Use

Problem: JTAG connection fails when using ARM Multi-ICE tools.

Implication: No JTAG debugging facility is available with ARM Multi-ICE.

1. Cut the trace on the top of the processor card between U1 pin 3 and via to the right.
2. Add 30-AWG wire from the J3-3 to the via of U1 pin 1 on the bottom of the processor card.

3. Add a 30-AWG wire from J3-2 to +3.3 V.

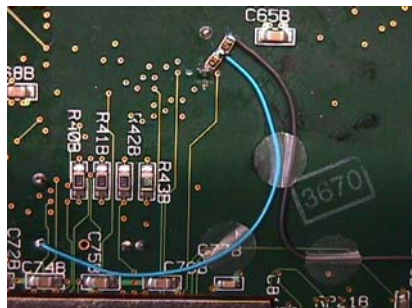
Figure 9. Voltage Divider

8. Excessive Oscillator Output Voltage to PEXTAL Pin

Problem: On systems using an oscillator to drive PEXTAL, the 3.3 V output from the oscillator is too high.

Implication: Possible damage to chip.

Note: These steps bring the oscillator voltage down to 1.1 V. The oscillator and core voltages need to be equal.

1. Attach one side of a 430-ohm resistor to the bottom (on the bottom of the processor card) of TP19 (ground).
2. Attach a 30-AWG wire from the remaining side of the 430-ohm to crystal X1 (The pin closest to the edge of the board).
3. Attach one side of a 620-ohm resistor to the junction of the wire and the 430-ohm resistor. The two resistors will “sandwich” the wire going to X1.
4. Attach another 30-AWG wire from the +3.3 V oscillator output (bottom of U7) to the open end of the 620-ohm resistor.

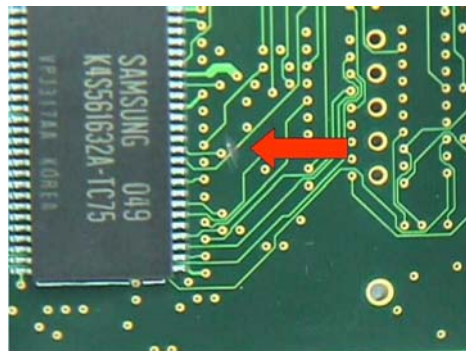
Figure 11. U10B Trace Cut Pin 38

10. Signal Integrity Problems On SDCLK

Problem: Signal integrity problems on SDCLK.

Implication: Unstable operation with 100-MHz SDCLK.

Use the following procedure to improve the SDCLK signal integrity.

1. Cut the trace exiting U10B, pin 38 on the bottom of the DCPXA250 processor card.
2. Update CPLD U4 with latest code. Refer to <http://developer.intel.com> for latest CPLD updates. This adjusts the voltage (VCC) from +1.2 V to +1.4 V.
