Firmware 2.06.3 issue list:

List of bugs/improvement requests

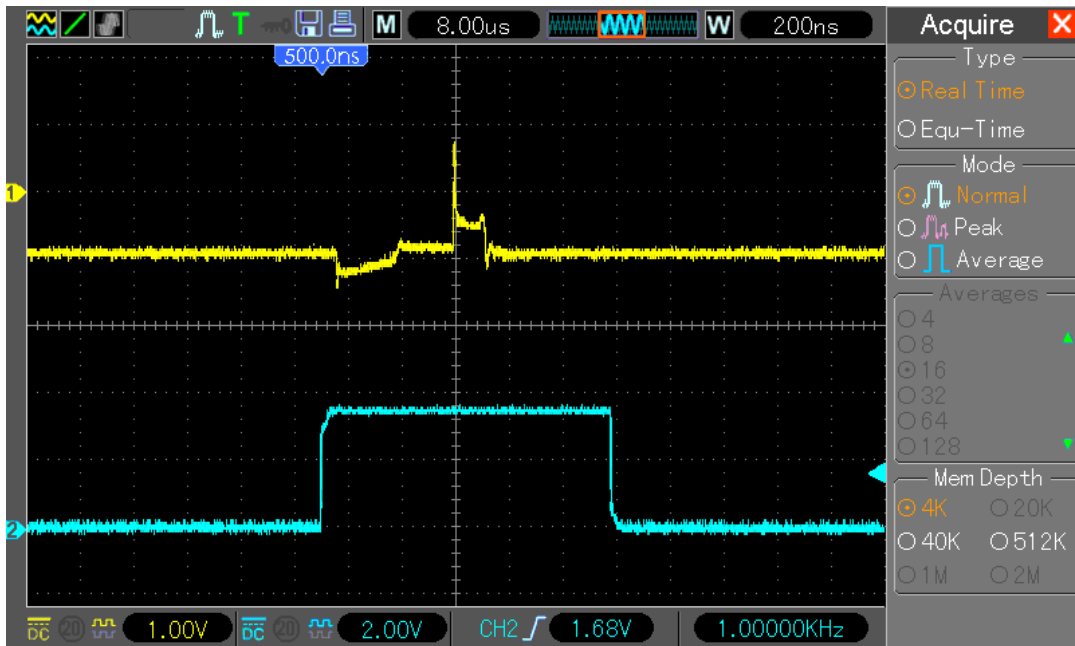
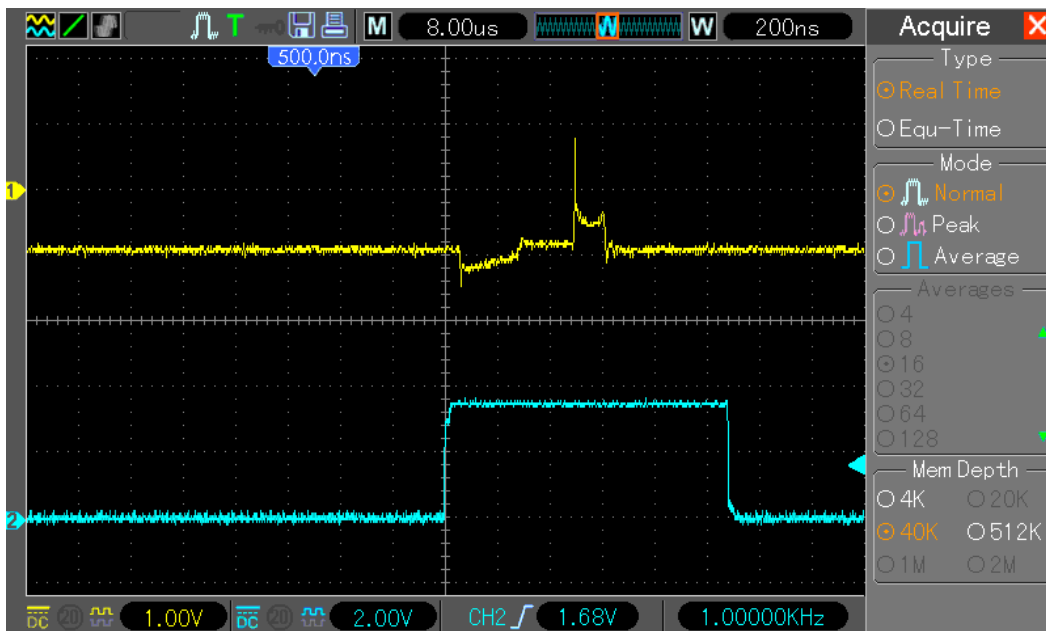
8. In single window, sample memory $\geq 40k$, both channels (ch1, ch2) enabled and time base from 400ns/div up to 2ns/div the position change (fine and coarse) control is not working. Only scale is moving, but not the waveform. See attached picture to understand issue:

with 4k memory when changing position waveform is moving

with 40k and above, when moving changing time base position waveform is NOT moving when in RUN mode (but works in STOP mode)

7. This is improvement proposal and not a bug
8. This is a very unfortunate bug; possible workaround is to use dual window mode or less memory depth (both with disadvantages)

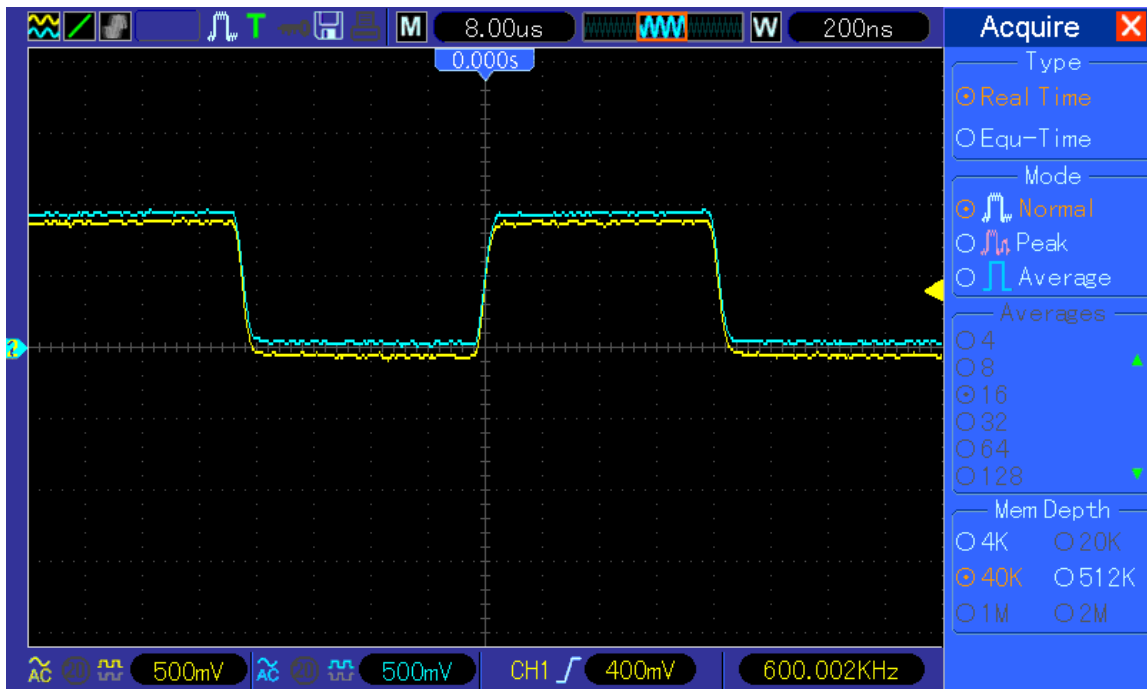
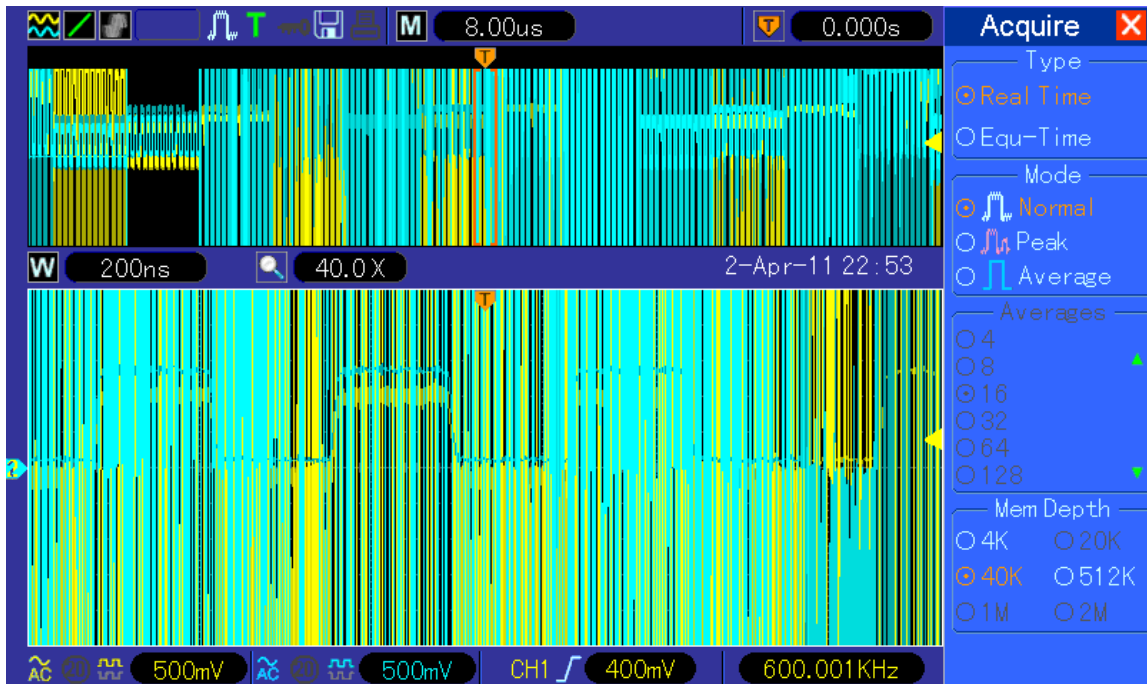
9. In single window mode, sample memory 40k, both channels (ch1, ch2) enabled – while switching to dual window mode artifacts on screen and DSO later crashing and not responding.

Artifacts disappear when changing timebase just after switch to dual window, so just an init error?

Set like on picture

and switch dual window mode to see artifacts like this:

9. Workaround is to change Timebase (just one step forward and back) right after dual window enabled. Note – the main window (top) need to be activated, the bug have something to do with main TB buffer initialization.

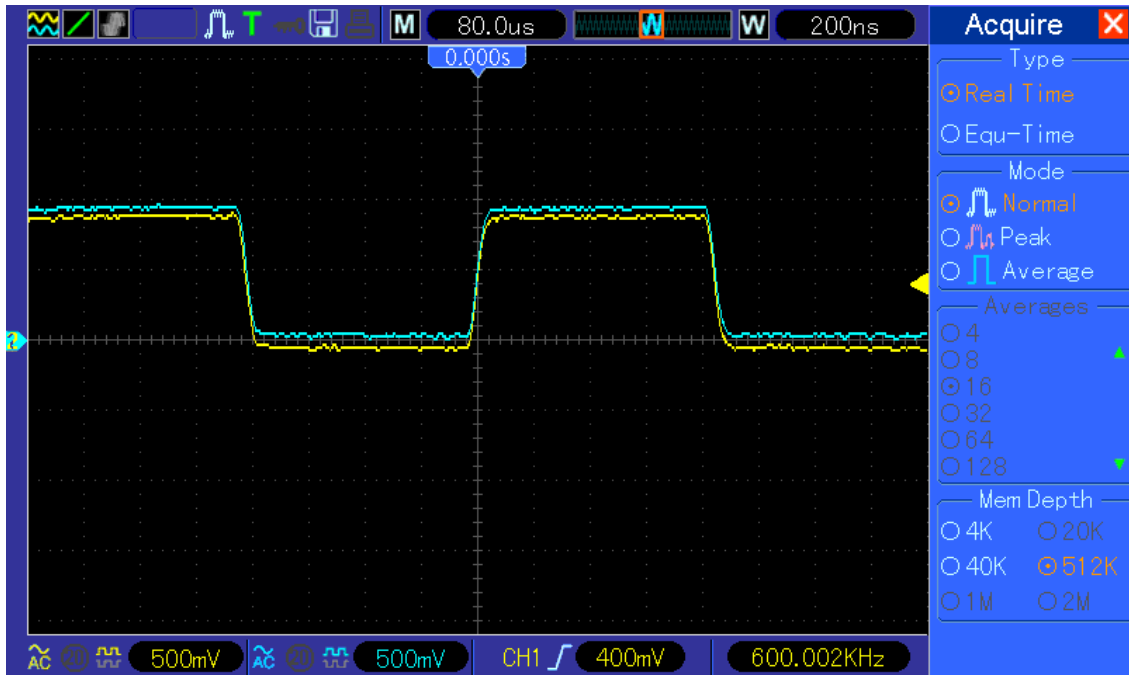
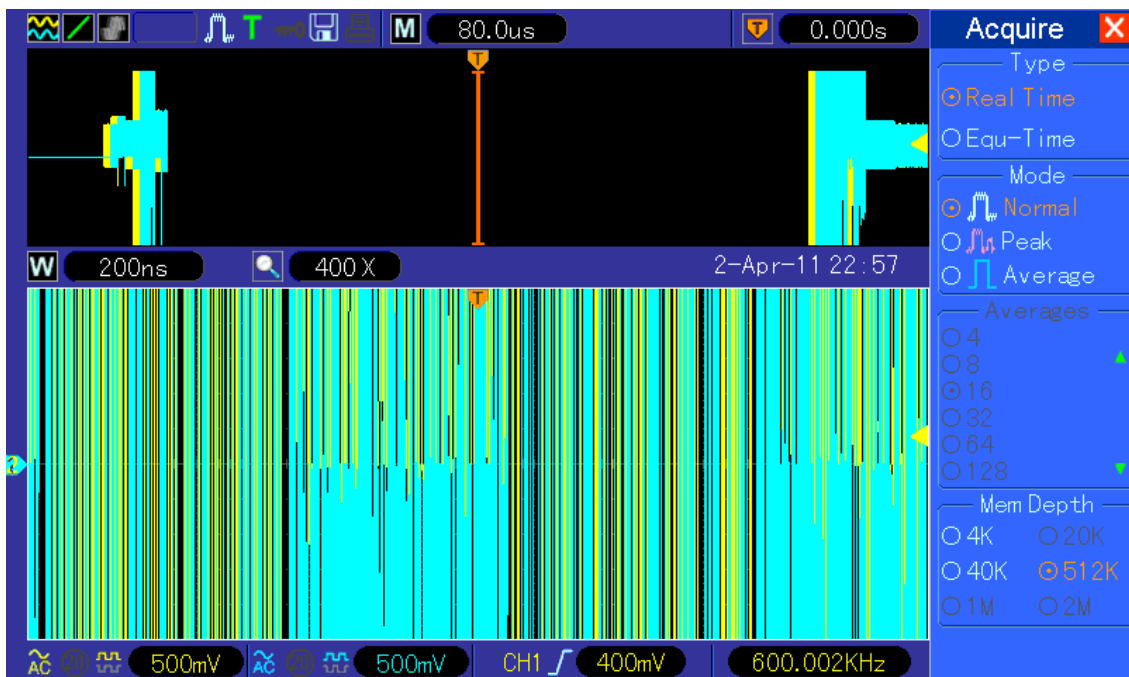
10. In single window mode, sample memory 512k, both channels (ch1, ch2) enabled – when switching to dual window mode artifacts on screen and DSO later crashing and not responding

Artifacts disappear when changing timebase just after switch to dual window, so just an init error?

Set DSO like on picture

and switch dual window mode to see artifacts like this:

10. Workaround is to change Timebase (just one step forward and back) right after dual window enabled. Note – the main window (top) need to be activated, the bug have something to do with main TB buffer initialization.

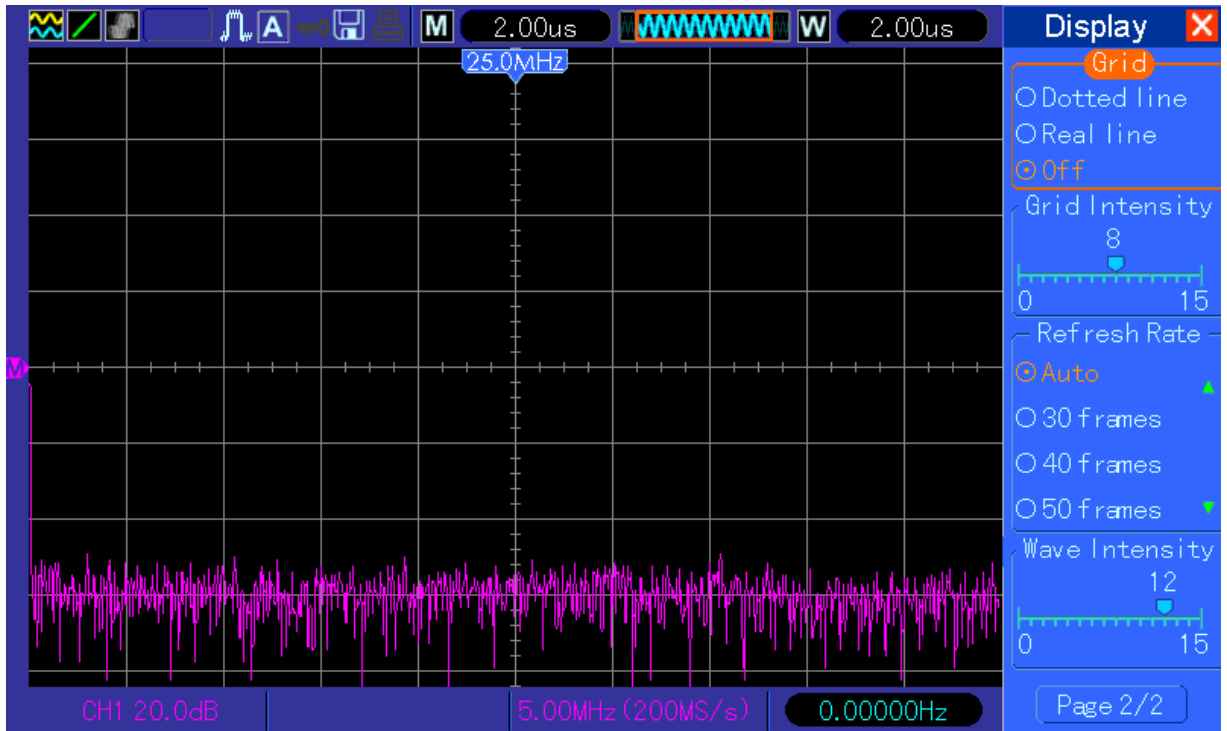
11. In FFT mode the Display -> Grid option is not changing the grid, it is always “real line” and not possible to change to “dotted line” or “off”.

11. This is improvement proposal and not a bug.
12. Use my firmware (2.06.3_120507.6), I removed that bug.
13. Use DC trigger coupling or “add offset” when you set trigger point.

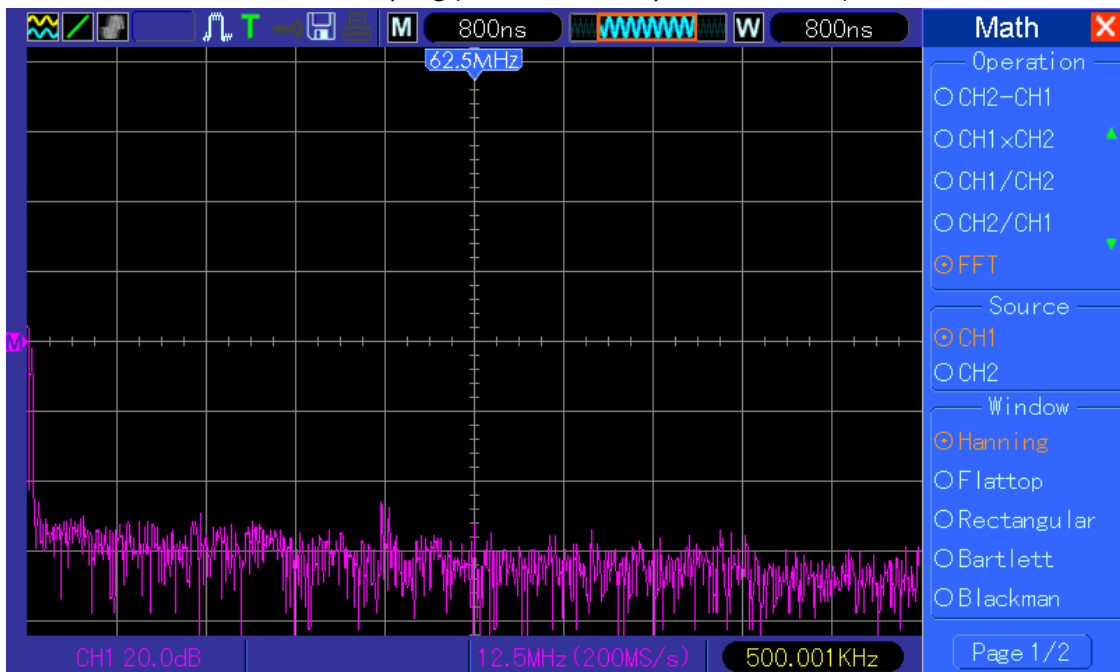
12. In FFT mode “Full span” is higher than Nyquist (sample rate / 2)

Example: 800ns/DIV, sample rate is 200MSs, full span 125MHz. Easy to fix by enabling from 800ns/DIV to 20ns/DIV 1GSs sampling (when 4k memory or FFT enabled)

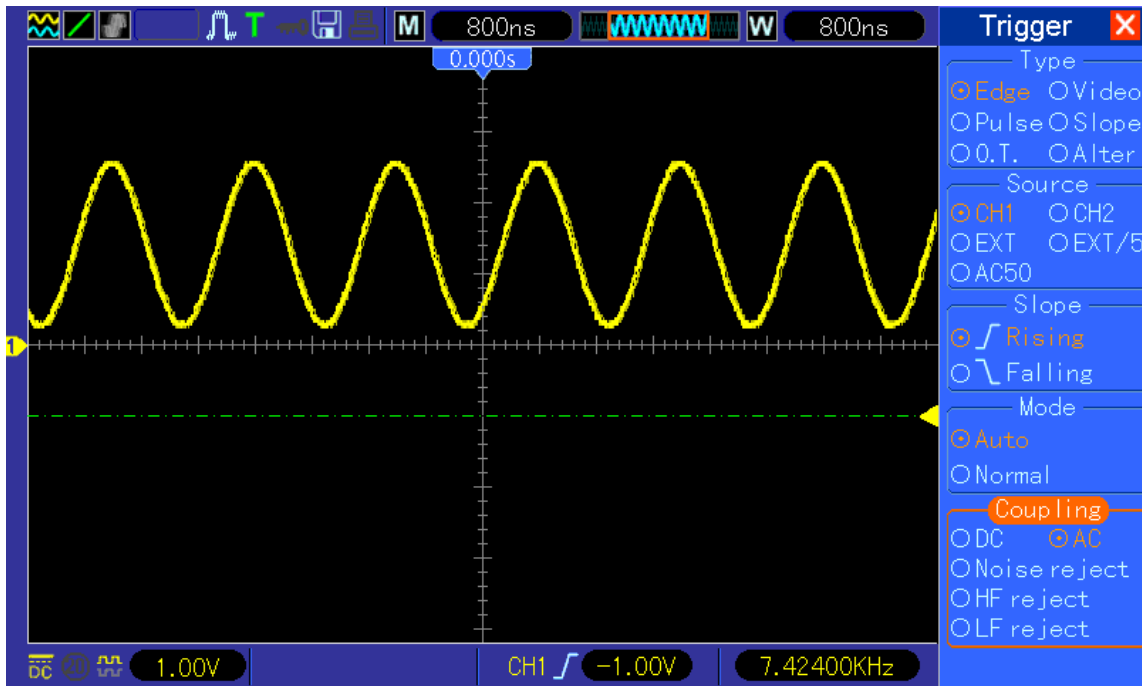
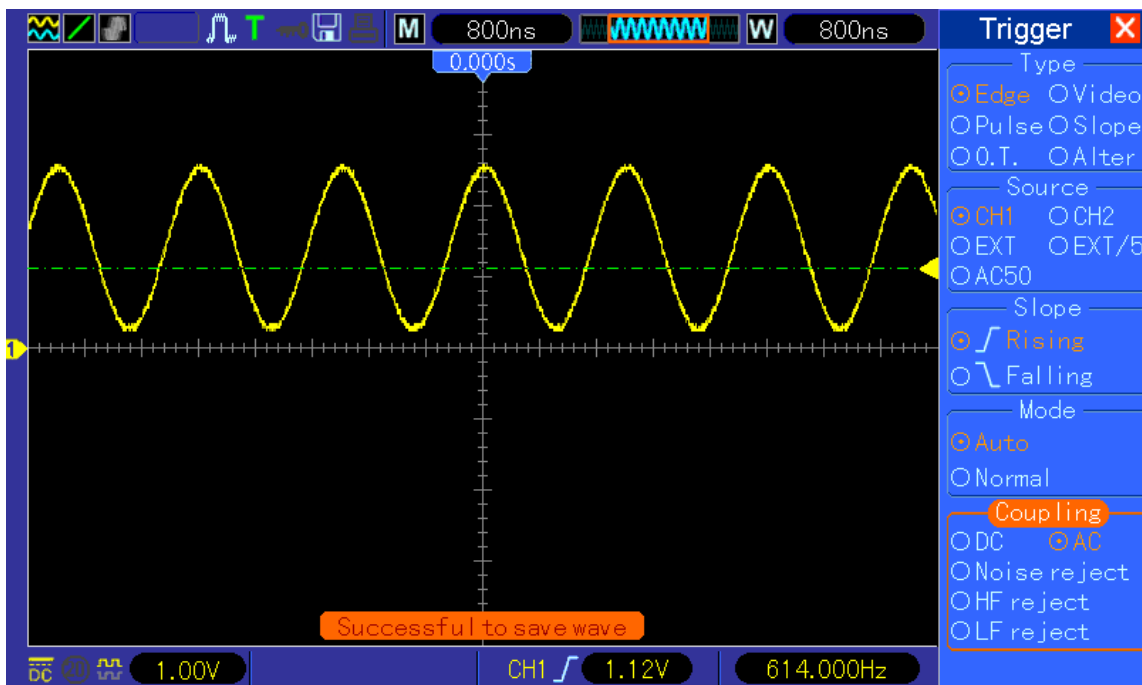
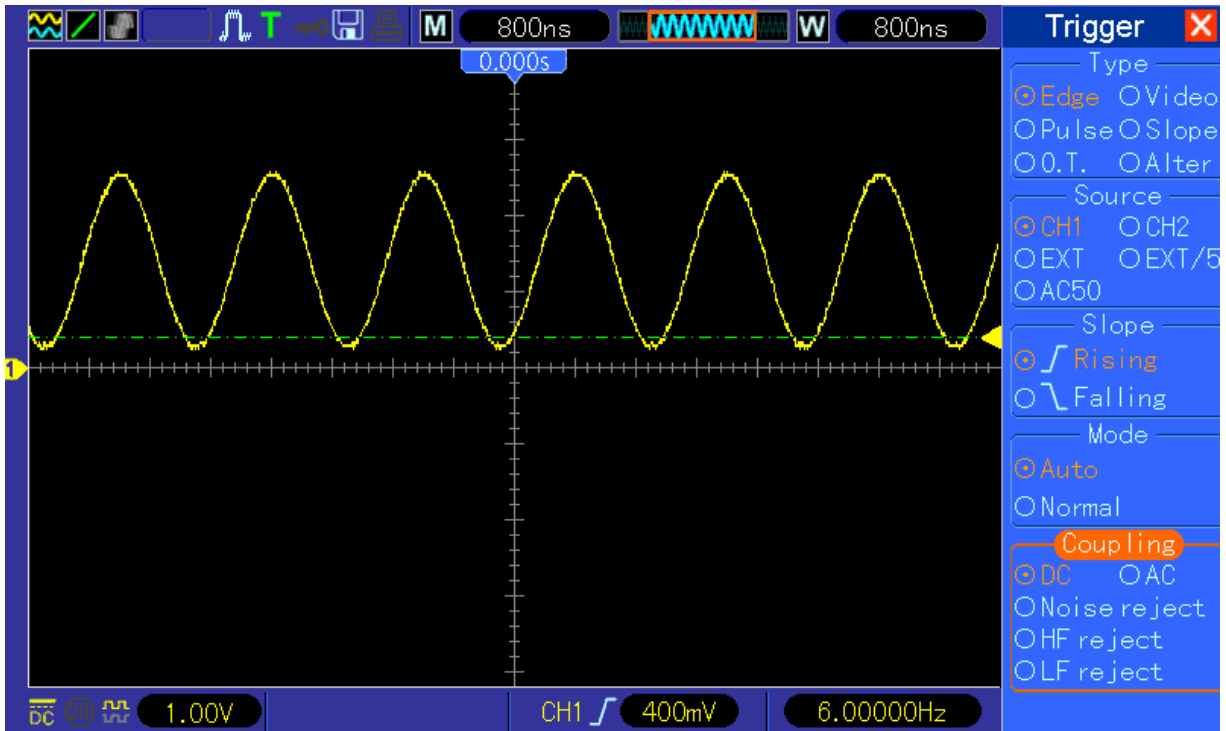
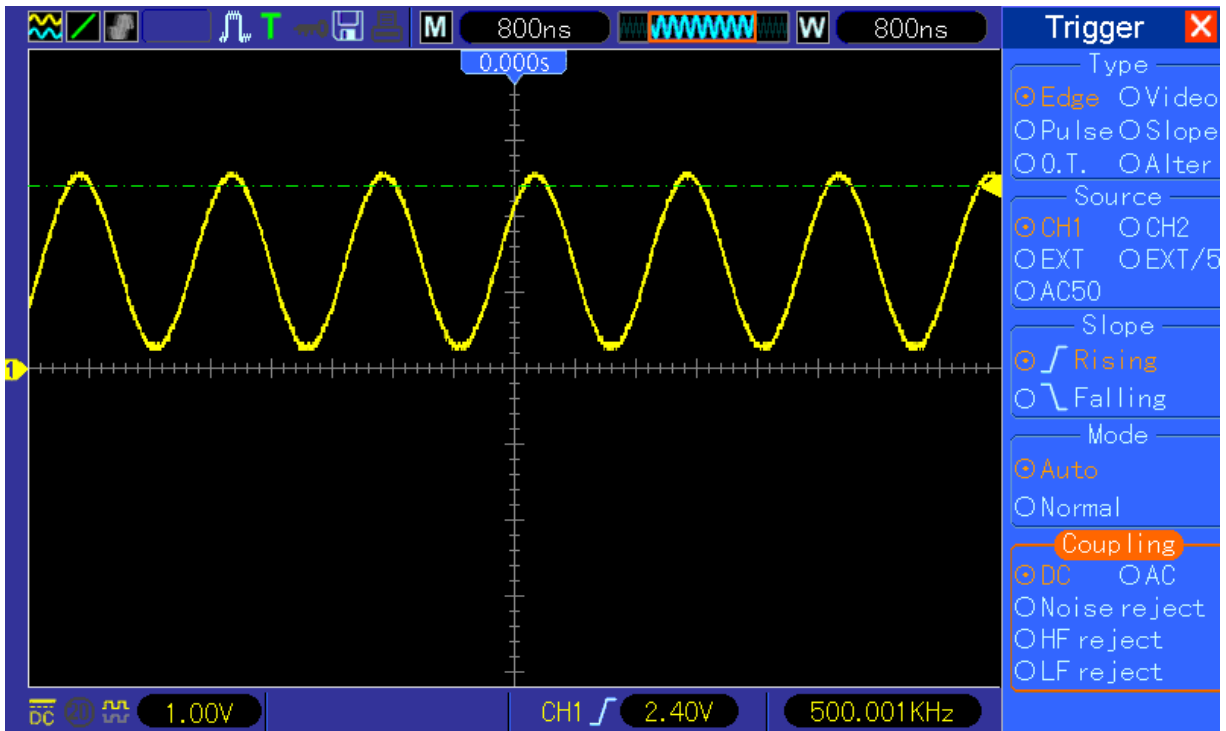
13. AC trigger indicator and line wrong. Set ch1, signal DC coupled, trigger AC coupled. The trigger lowest level below signal :

highest level only mid of signal

But both should look like when trigger coupled in DC mode:

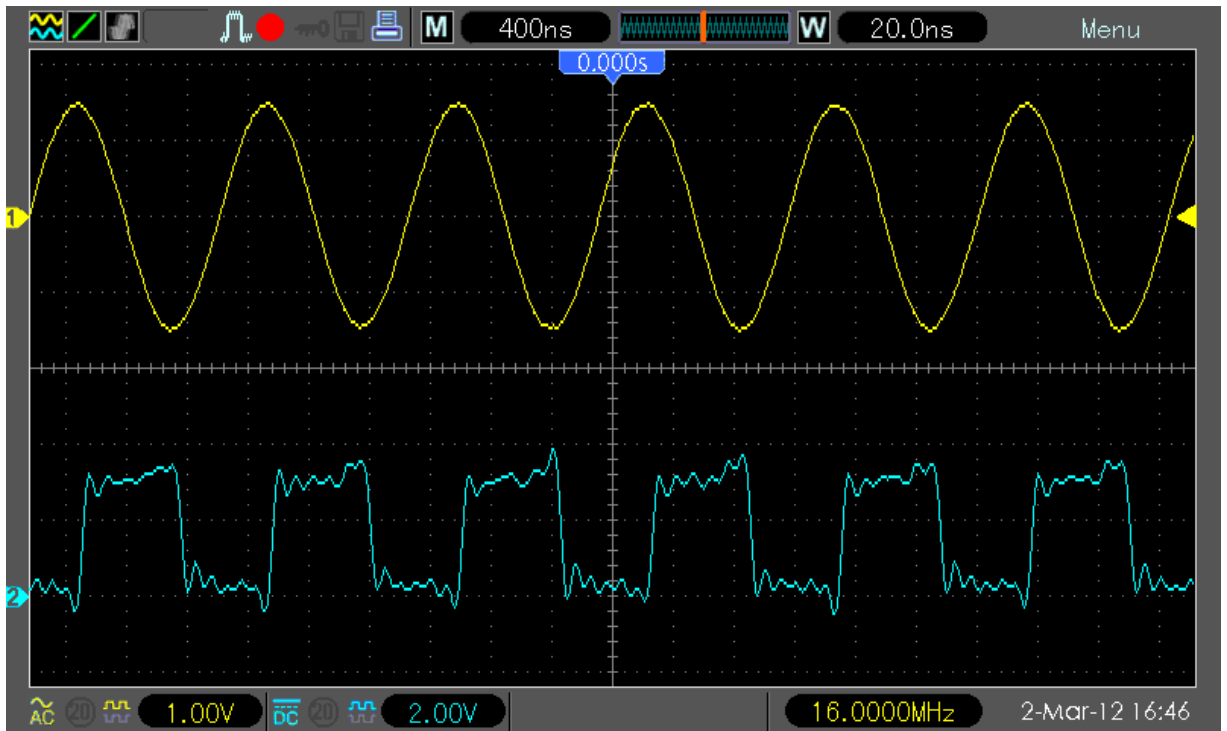
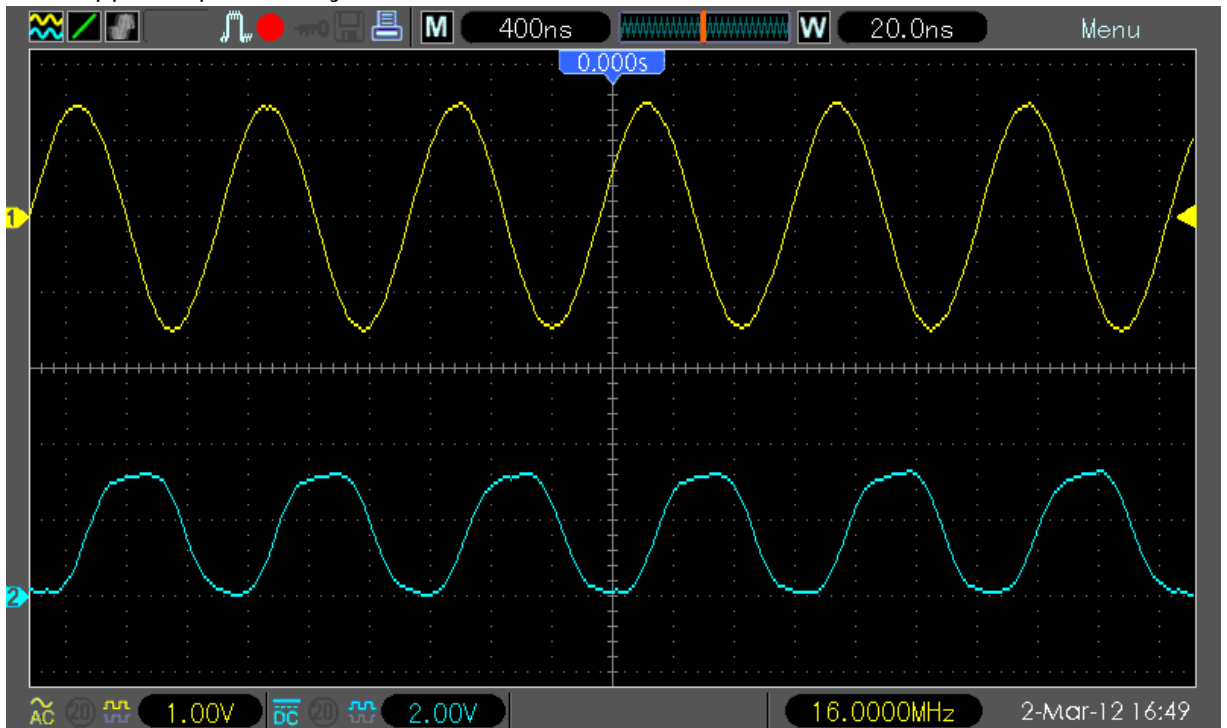
14. Dithering/interpolation filter of waveform too sharp. When enabling both channels (this also occurs in single channel mode and 1GSs, but test signal need to be higher to get same error) and applying for example 16MHz square wave the waveform is switching between proper square:

and crippled square every second:

14. For sure a stupid bug, but since you can see when the signal is “wobbling” you can quick change (when necessary) to single channel to observe the waveform with better resolution and without wobble.

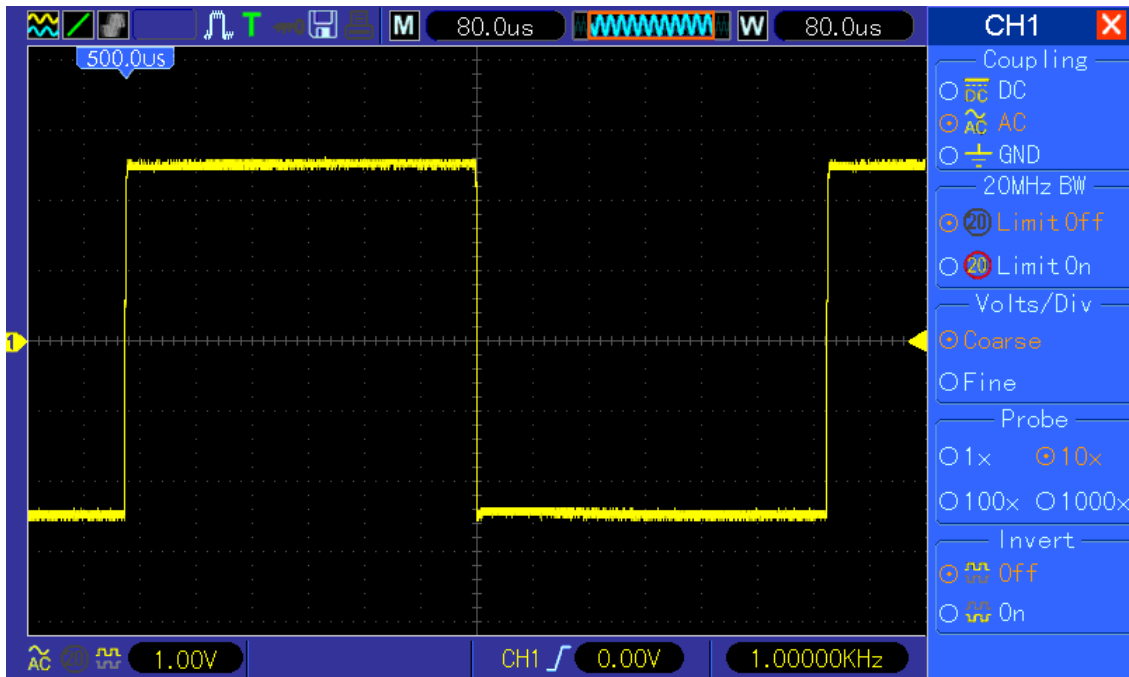
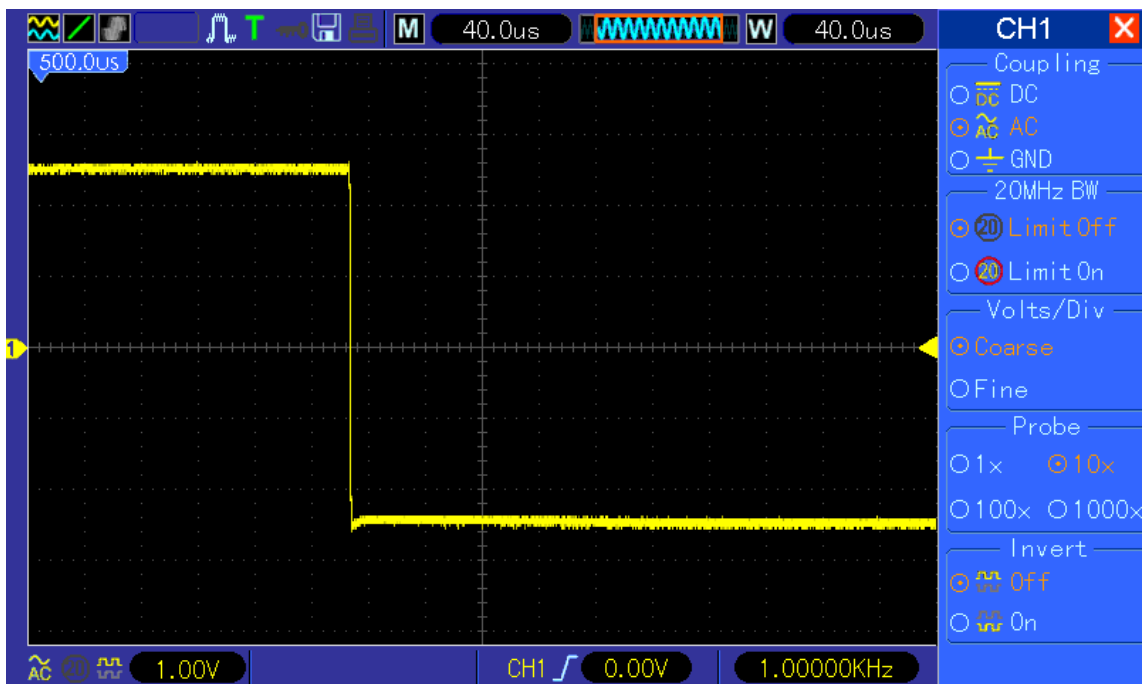
15. Display / Time base scaling strange behavior. When you apply e.g. 1kHz signal, set time base to 80us/DIV and move the waveform to 500us/DIV :

When you now change time base to 40uS/DIV the falling edge (which should be still in the middle of the screen) has been moved to 454uS position (but it should stay on 500uS). The same happens of course with 20uS/DIV.

15. Funny bug, but easy to omit since we know it.
16. This is already fixed, the /dsod (or /dso/app/dsod – this depends on fw/DSO model version) binary is working perfectly as watch dog monitoring potential profile issues.
