## Firmware 2.06.3 bug list:

## List of bugs/improvement requests

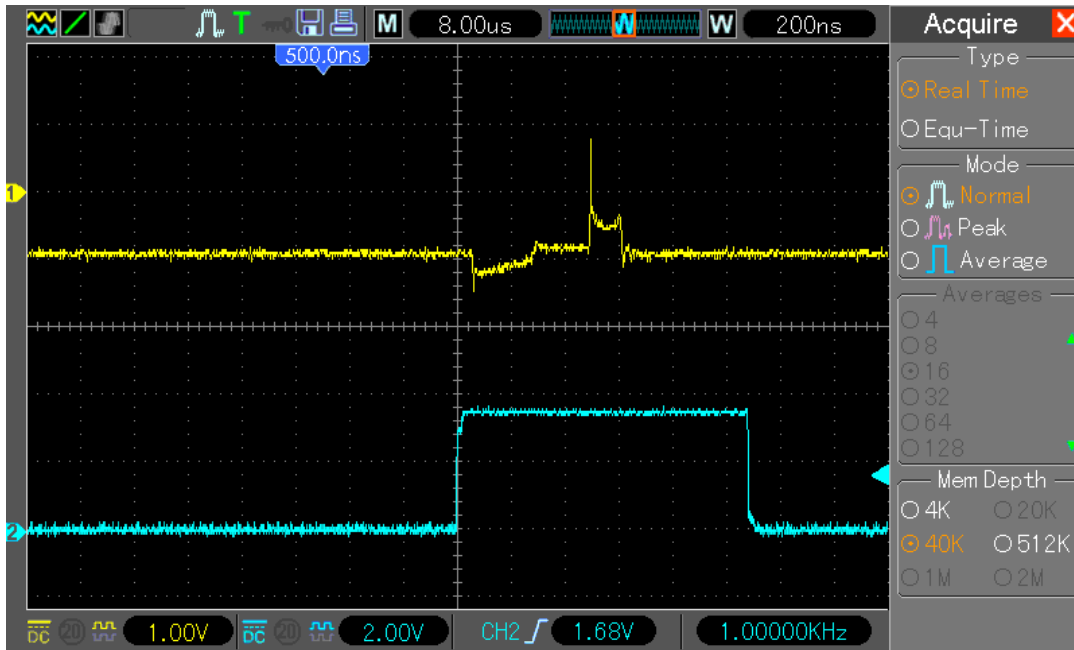
8. In single window, sample memory  $\geq 40k$ , both channels (ch1, ch2) enabled and time base from 400ns/div up to 2ns/div the position change (fine and coarse) control is not working. Only scale is moving, but not the waveform. See attached picture to understand issue:

with 4k memory when changing position waveform is moving

with 40k and above, when moving changing time base position waveform is NOT moving when in RUN mode (but works in STOP mode)

7. This is improvement proposal and not a bug. It has been removed from to-do as “not important”.
8. **This is a very unfortunate bug; possible workaround is to use dual window mode or less memory depth (both with disadvantages)**

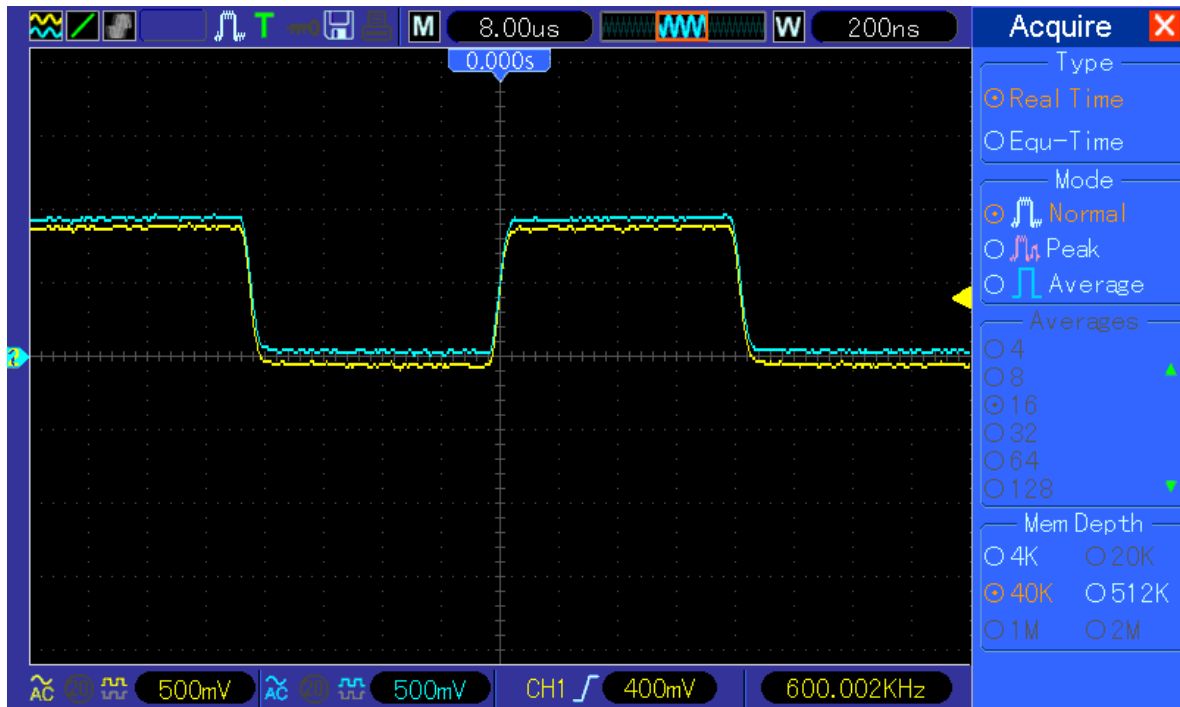
9. In single window mode, sample memory 40k, both channels (ch1, ch2) enabled – while switching to dual window mode artifacts on screen and DSO later crashing and not responding.

**Artifacts disappear when changing timebase just after switch to dual window, so just an init error?**

Set like on picture

and switch dual window mode to see artifacts like this:

9. ~~Workaround is to change Timebase (just one step forward and back) right after dual window enabled. Note – the main window (top) need to be activated, the bug have something to do with main TB buffer initialization.~~

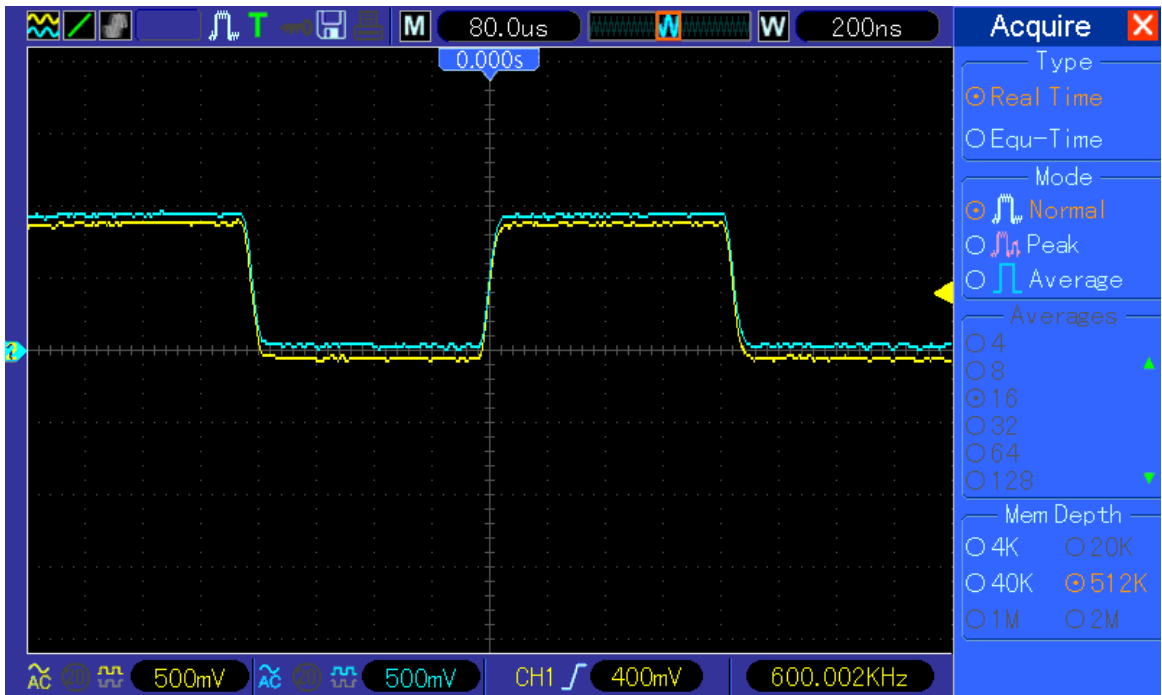
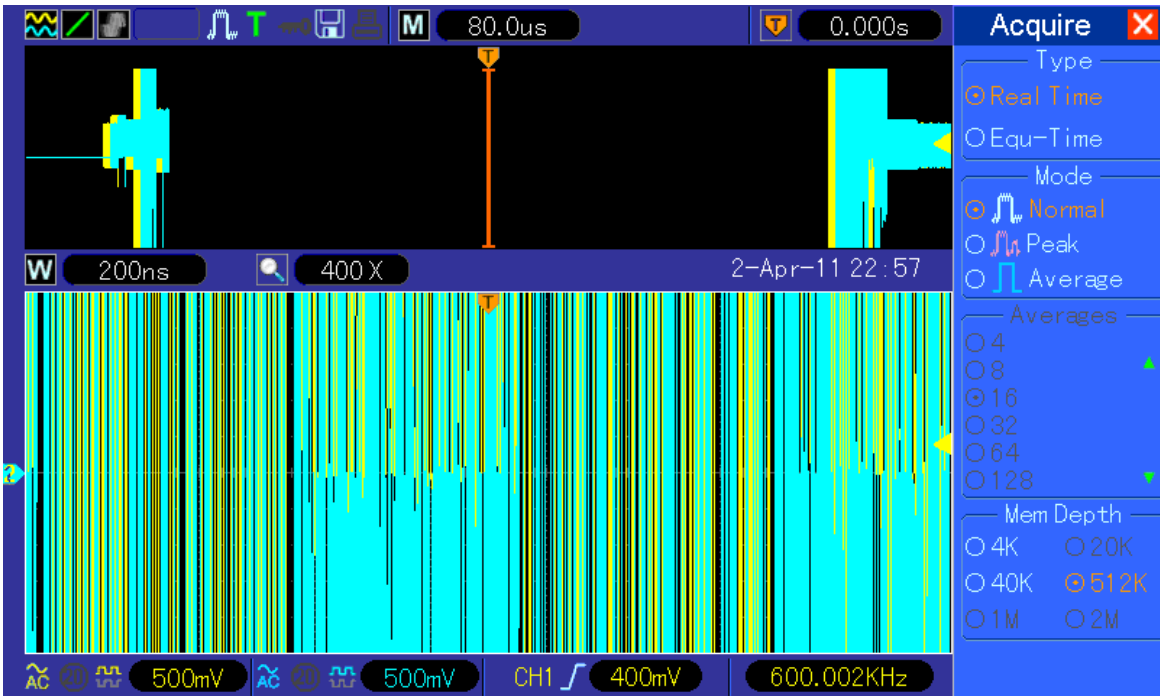
10. In single window mode, sample memory 512k, both channels (ch1, ch2) enabled – when switching to dual window mode artifacts on screen and DSO later crashing and not responding

**Artifacts disappear when changing timebase just after switch to dual window, so just an init error?**

Set DSO like on picture

and switch dual window mode to see artifacts like this:

10. Workaround is to change Timebase (just one step forward and back) right after dual window enabled. Note — the main window (top) need to be activated, the bug have something to do with main TB buffer initialization.
11. This is improvement proposal and not a bug.
12. Use my firmware (2.06.3\_120507.6), I removed that bug.
13. Use DC trigger coupling or “add offset” when you set trigger point. On some other good known DSOs (e.g. Tektronix TDS7xxx) there is exact the same DC-signal/AC-trigger “dependency” (bug) and nobody ever complained about.

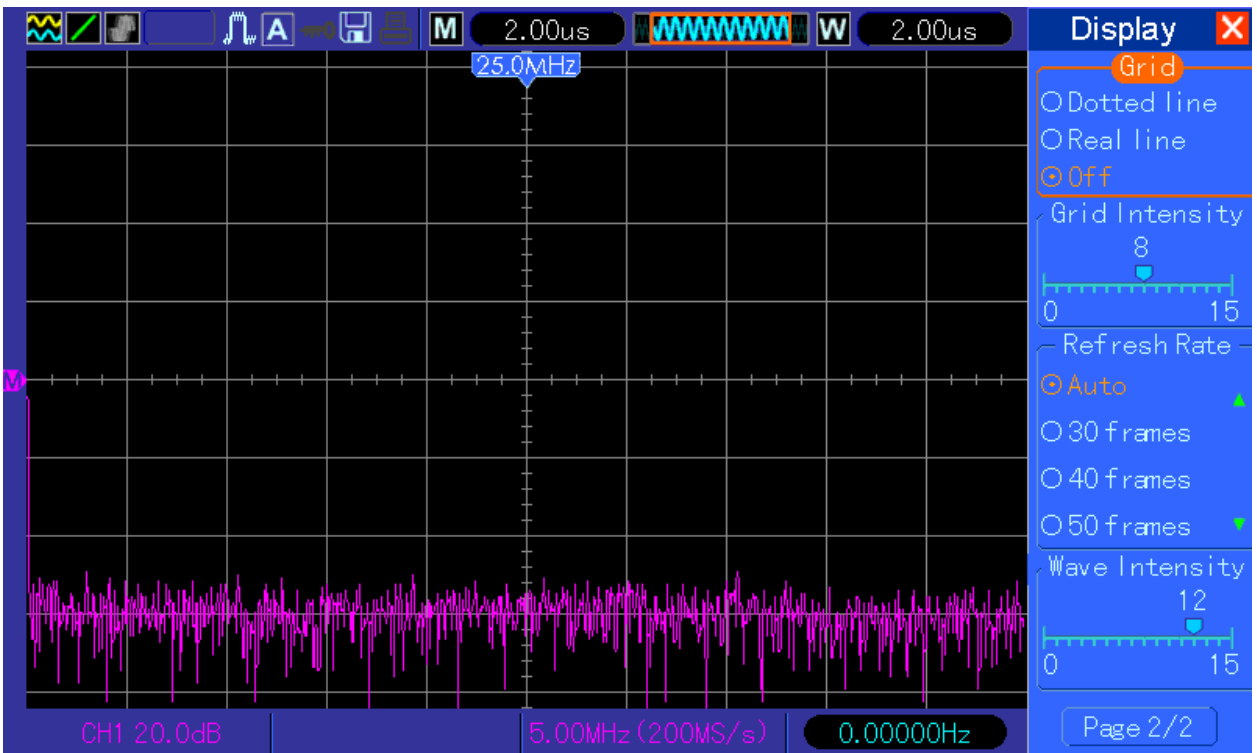
11. In FFT mode the Display -> Grid option is not changing the grid, it is always “real line” and not possible to change to “dotted line” or “off”.

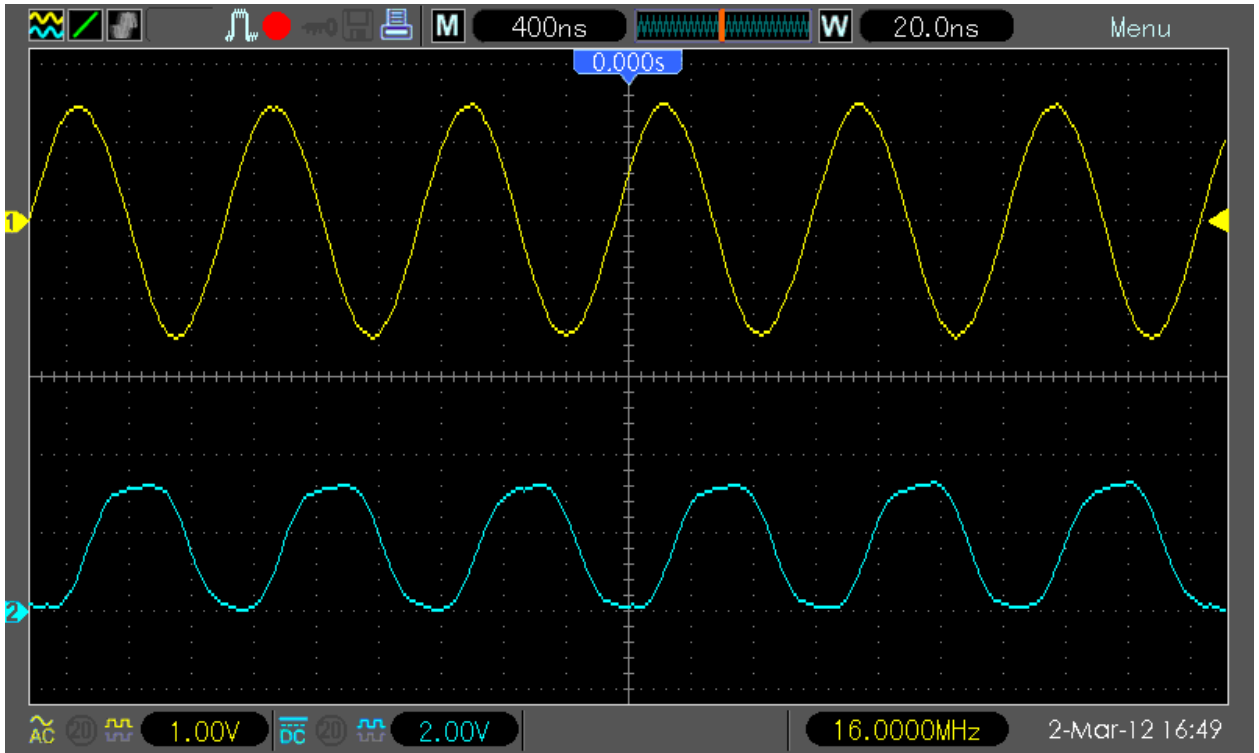
14. Dithering/interpolation filter of waveform too sharp. When enabling both channels (this also occurs in single channel mode and 1GSs, but test signal need to be higher to get same error) and applying for example 16MHz square wave the waveform is switching between proper square:

and crippled square every second:

14. For sure a stupid bug, but since you can see when the signal is “wobbling” you can quick change (when necessary) to single channel to observe the waveform with better resolution and without wobble.
15. Funny bug, but easy to omit since we know it (remember, with higher sample depth there is no issues)
16. This is already fixed, the /dsod (or /dso/app/dsod — this depends on fw/DSO model version) binary is working perfectly as watch dog monitoring potential profile issues.

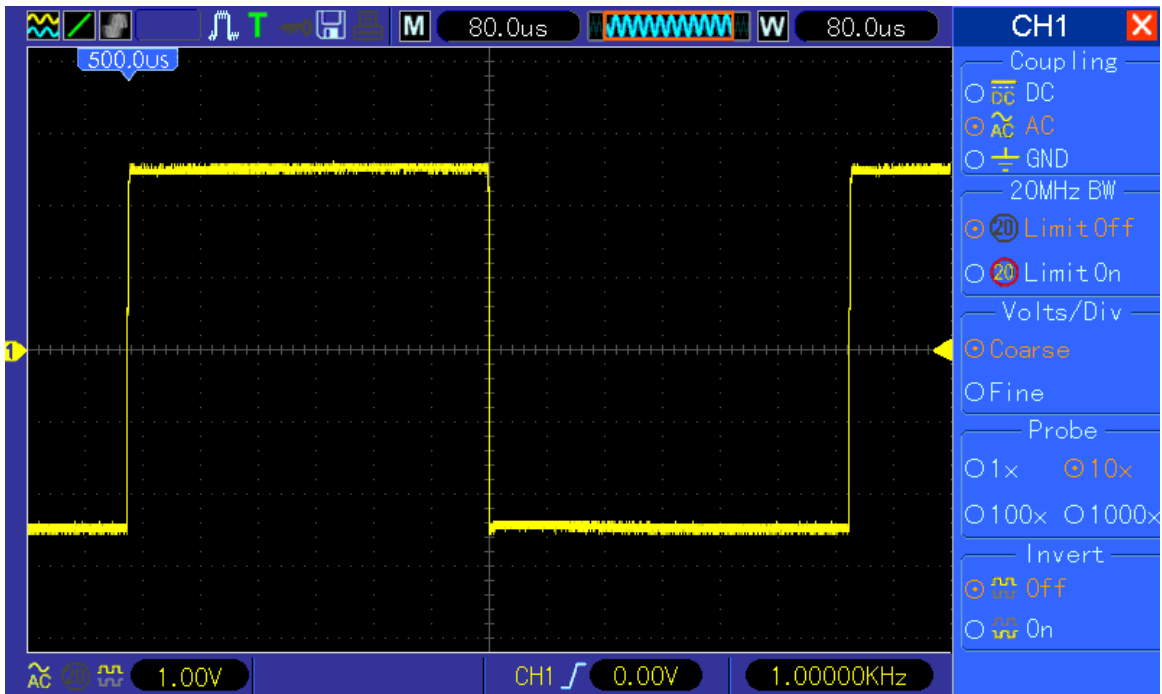
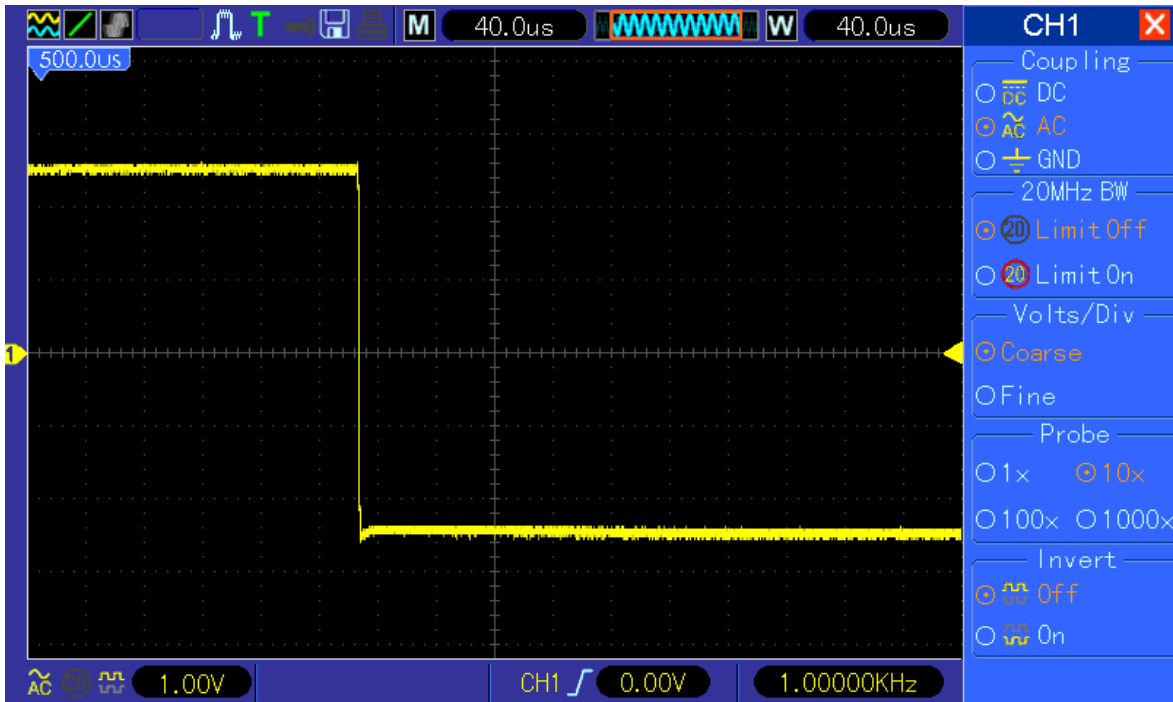
15. Display / Time base scaling strange behavior. When you apply e.g. 1kHz signal, set time base to 80us/DIV and move the waveform to 500us/DIV (bug only in 4/40k memory depth, 512k/1M/2M works fine):

When you now change time base to 40uS/DIV the falling edge (which should be still in the middle of the screen) has been moved to 454uS position (but it should stay on 500uS). The same happens of course with 20uS/DIV.

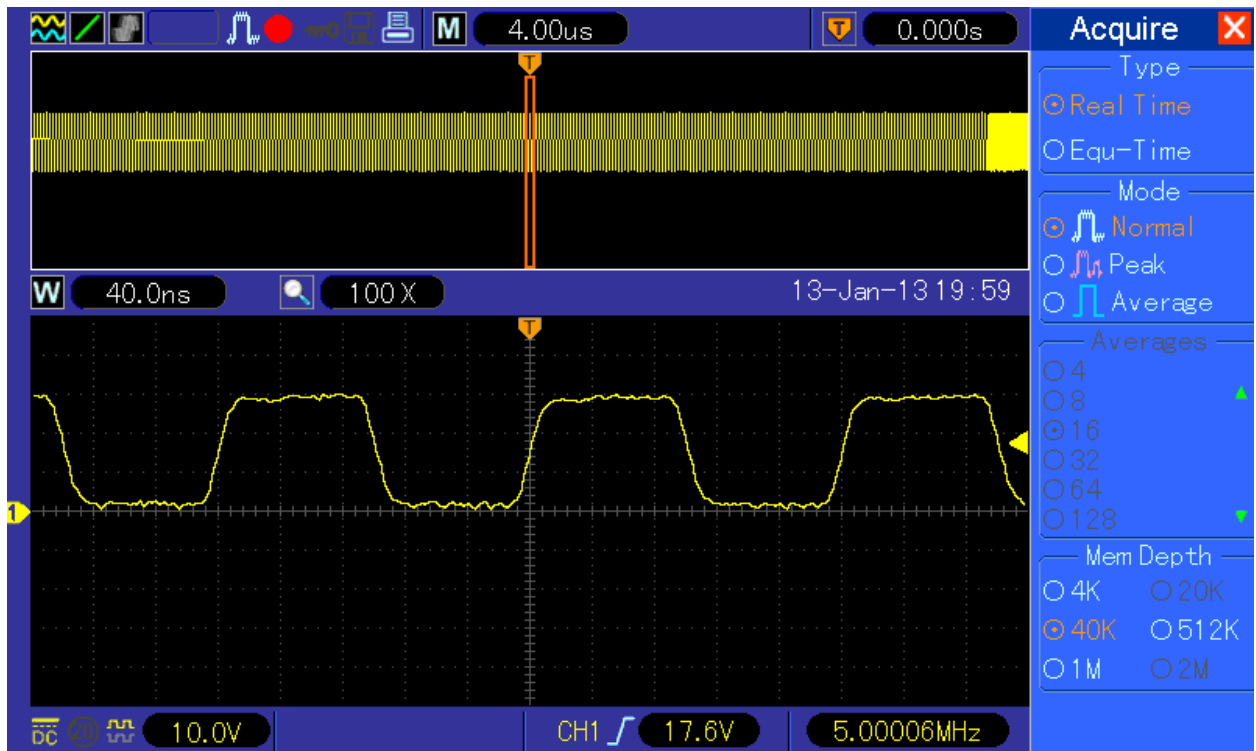
Example2 : 40k depth, 5MHz signal, 40ns/DIV WTB

now when we change with F7 to dual window the top window is showing wrong scaled waveform, the resulting bottom zoom window showing as well wrong :

when we turn now the Timebase knob one position "up" (4us/DIV is actually to max "up" position for MTB by 40k depth, but by turning the knob firmware is updating windows) the

waveform in top and bottom window is properly scaled:

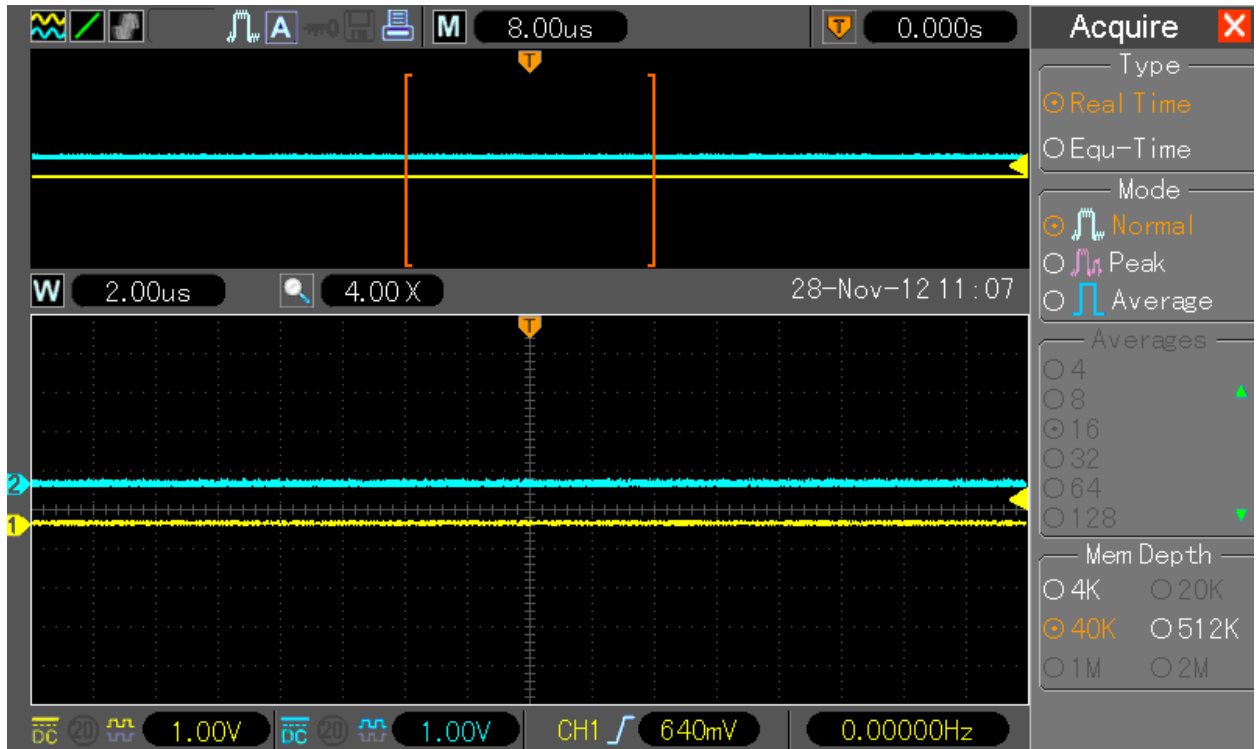
27. While switching from single into dual window mode the main timebase is changing with a wrong factor, e.g. from 200ns/DIV in single into 400ns/DIV in dual window mode. Similar issue in 40k/512k and 1M – in dual window the MTB is twice that high as before in single window mode. Due incorrect timebase the display buffer is showing artifacts on both right and left side of the waveform (end of buffer). Example: CH1 enabled, 40k memory, single window and windows timebase smaller than main timebase, here 400ns/DIV (Main TB is 4us/DIV for 40k)

Now when switching to dual window the Main TB is changing to wrong value (here from 4us/DIV to 8us/DIV – actually it will be always doubled in length) and artifacts from “end of buffer” right and left in top window are shown:

When the Acquisition would be stopped and restarted or Timebase changed one position forth

and back (while Main window is focused) the Main TB and displayed data will be fixed to proper length; no artifacts shown anymore:

With 2 channels enabled this bug **DOES NOT EXIST**, this is because the doubled Main TB value is exactly what it should be for dual channel view:

26. ~~Just ignore it for now; it is interim fw version — for testing only.~~ This is no in production firmware as well, very annoying bug.
27. Switch once focus from minor (bottom window) to major (top window) window by pushing timebase knob down, turn then timebase one position fort and back to get rid of waveform artifacts on left and right side of the waveform.

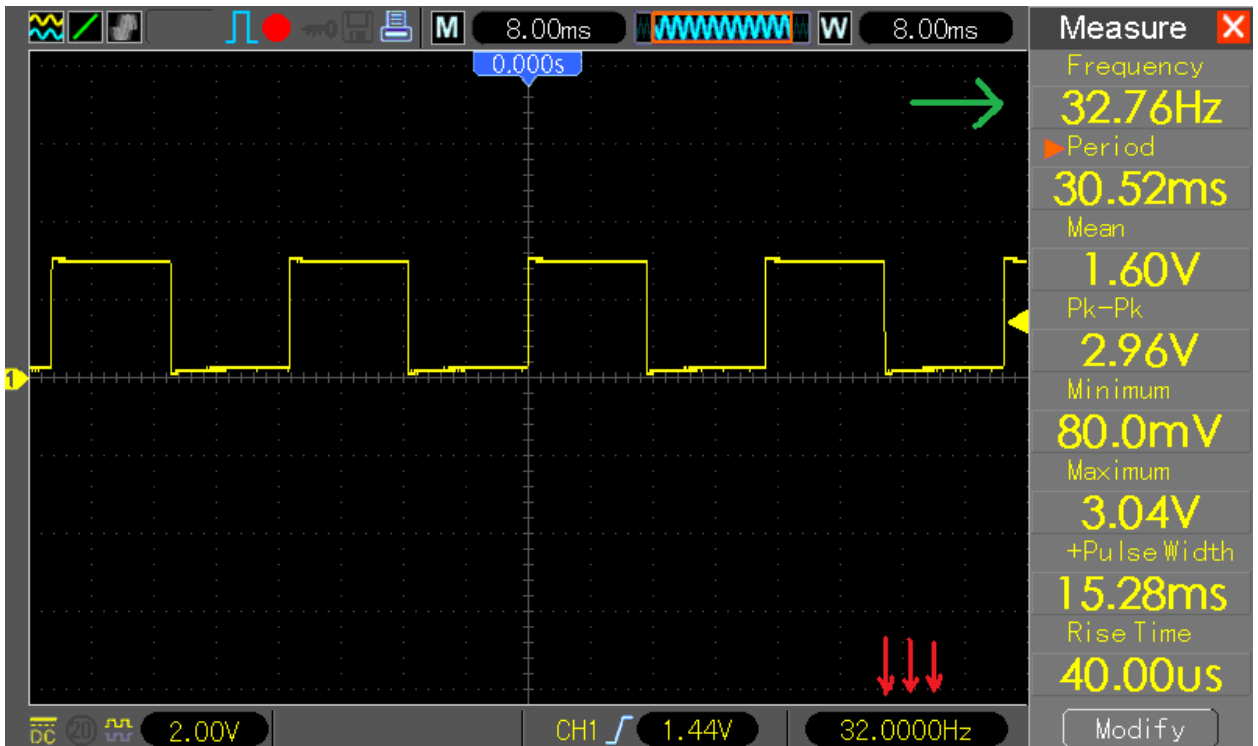
36. If possible change the Frequency Counter to display in mHz resolution when counter value between 1Hz and 99.999kHz (99999Hz). If not possible change displayed value to cut (trailing) zeros, when there is no mHz no need to see zeros instead (e.g 10Hz should be shows as 10Hz and not 10.0000Hz). This might be sometimes very confusing for the user, imagine e.g. frequency of 32.768Hz – the counter will show 32.000Hz (and Wave measure 32.76Hz).

36. Not a bug, but who need to see trailing zeros?
37. Turn Timebase knob one position forth and back.
38. This is funny bug, isn't?
39. Turn Timebase knob one position forth and back, in most cases the Sampling Rate within FFT will be then updated to proper value.
40. ~~Ensure that no more than 10 file on the Flash Drive.~~
41. ~~No fix for this~~

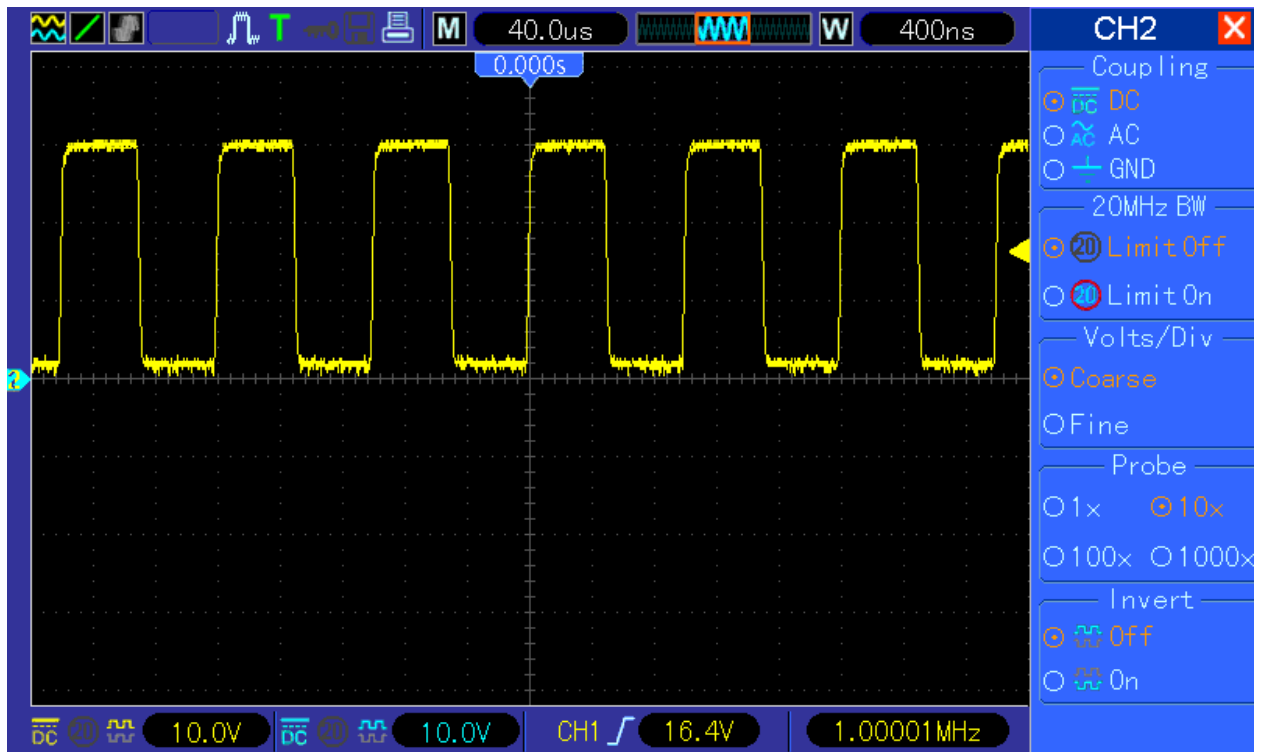
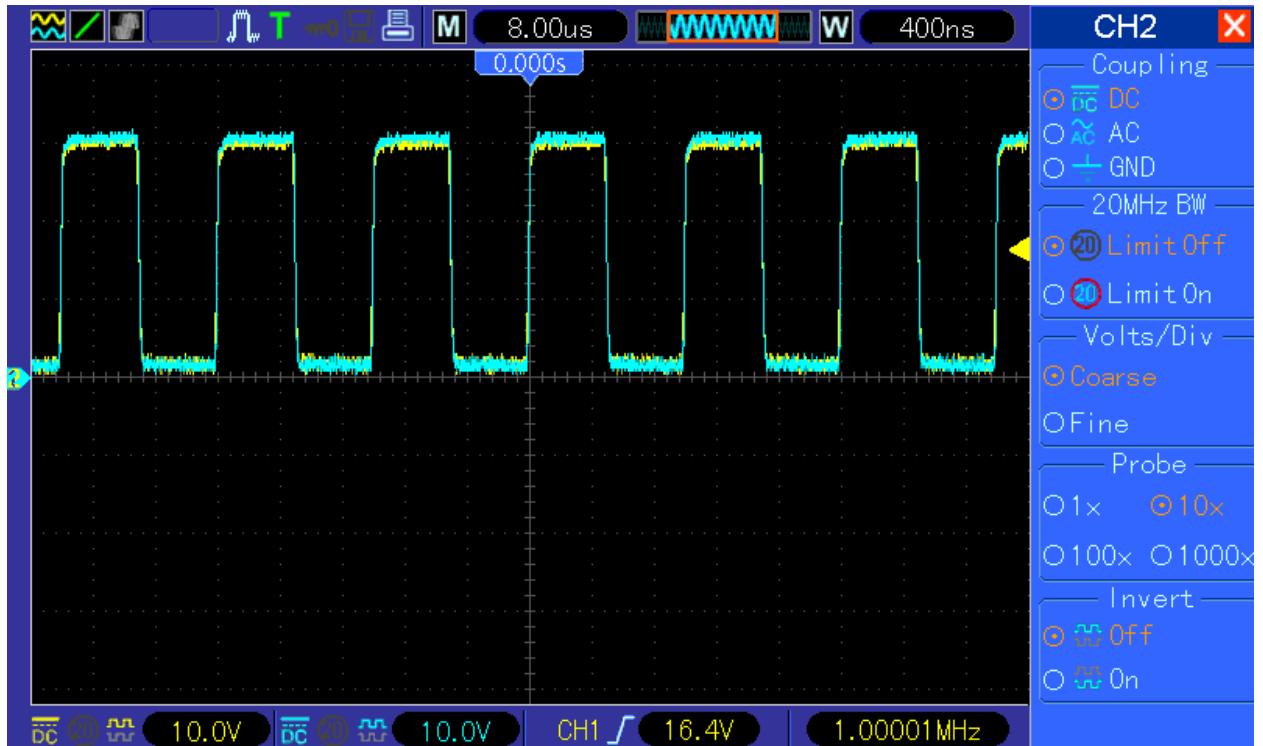
37. With Long Memory enabled (40k, 512k, 1M, 2M?) when the WTB is 400ns/DIV (and lower, up to 2ns/DIV) when enabling second channel the indicator in status line will be already displayed but the waveform is missing. Additionally the CH2 LED is off :

But after changing Timebase (or wave position) one position forth and back the second channel waveform will get displayed and LED gets on :

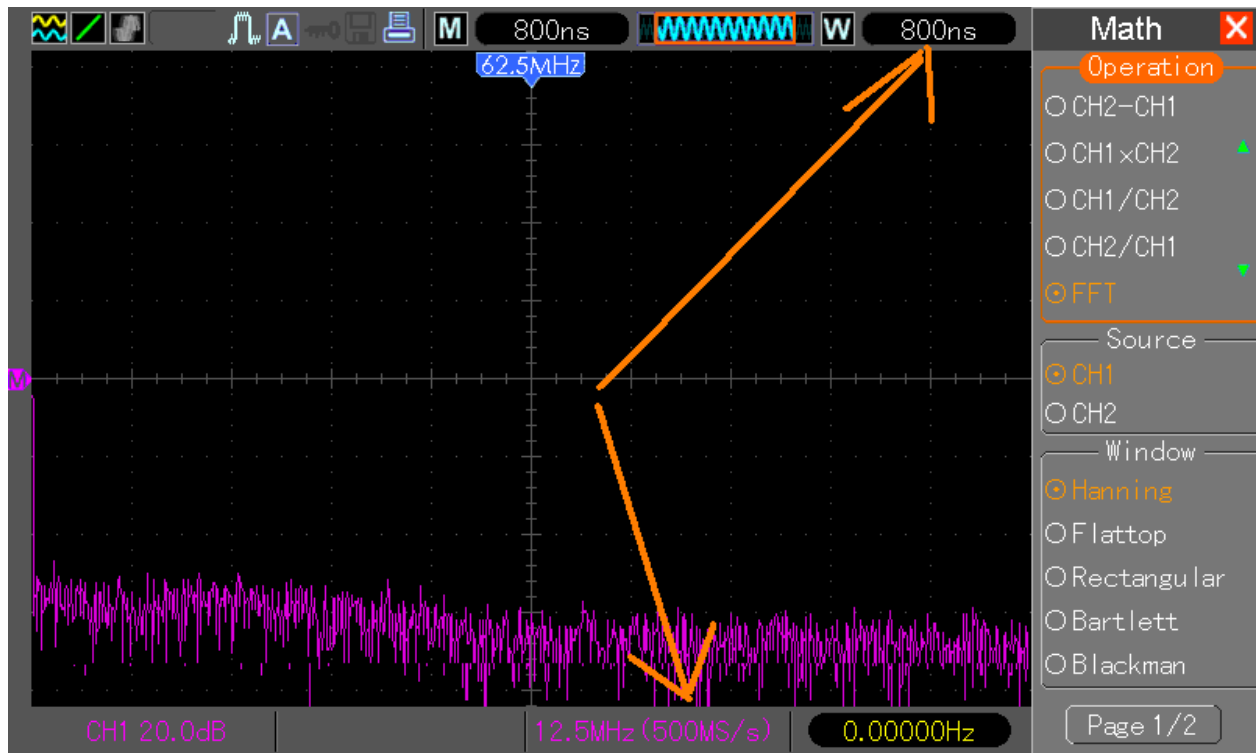
39. Within FFT the information in status bar is not always showing the proper sampling rate, sometimes even jumping from proper to bad value. As the FFT cursor is taking in count the sampling rate, the measure value might be not correct. Example random values in 800ns/DIV FFT , here 100MS/s

then 250MS/s (but still 800ns/DIV)

and here 500MS/s (but still 800ns/DIV)

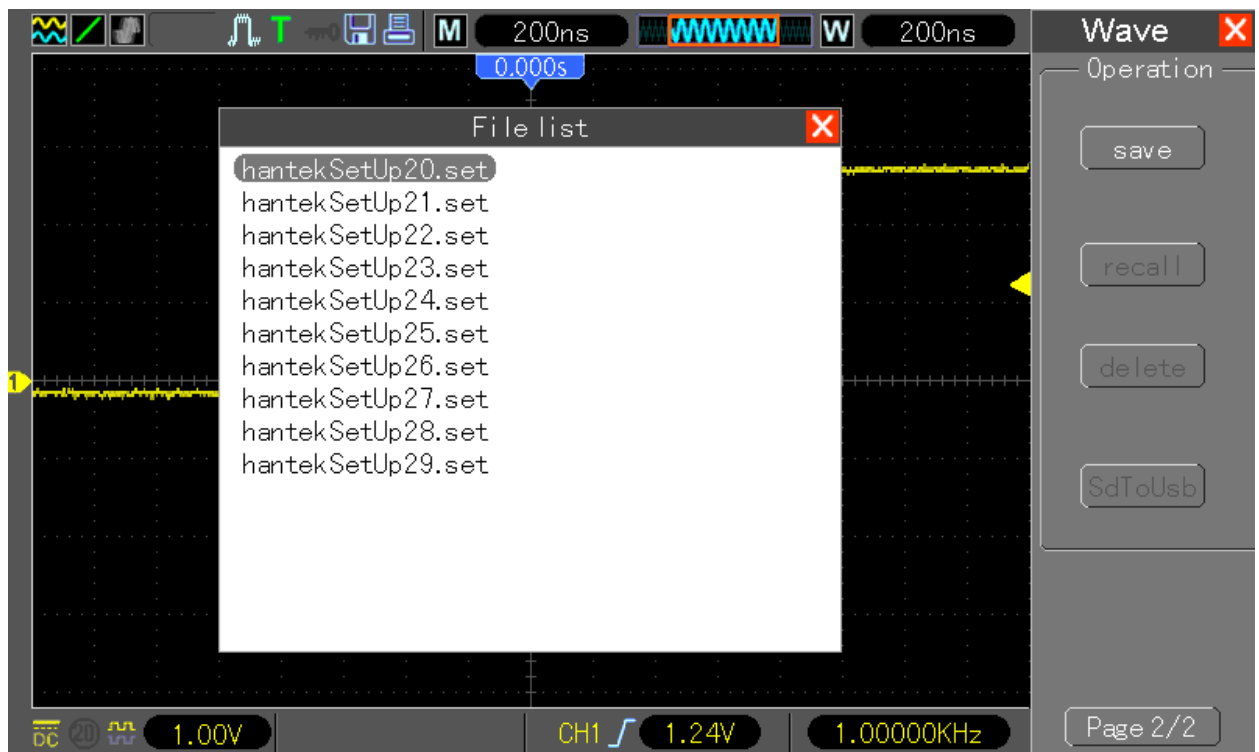
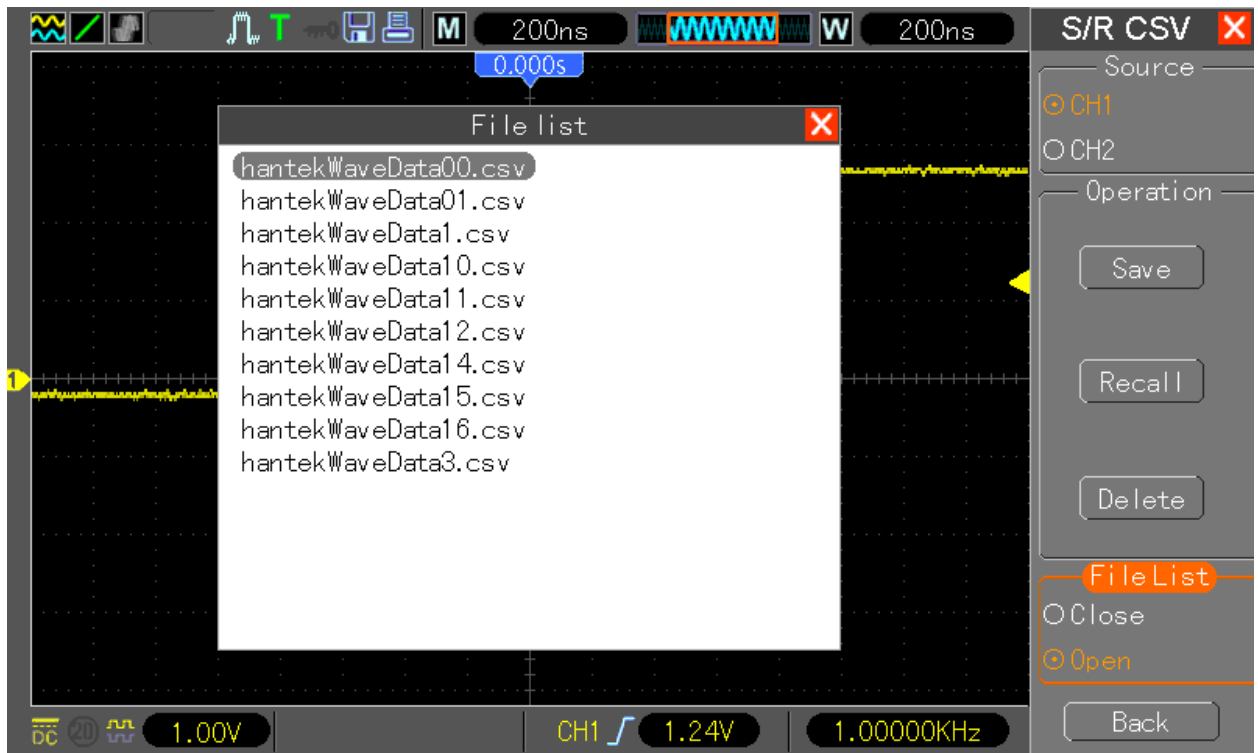
40. Flash Drive directory listing (in CSV Save/Recall and DSO Setup Save/Recall menus) is showing maximum 10 files. Additionally no option to scroll over the directory to choose other than one of the listed 10 files

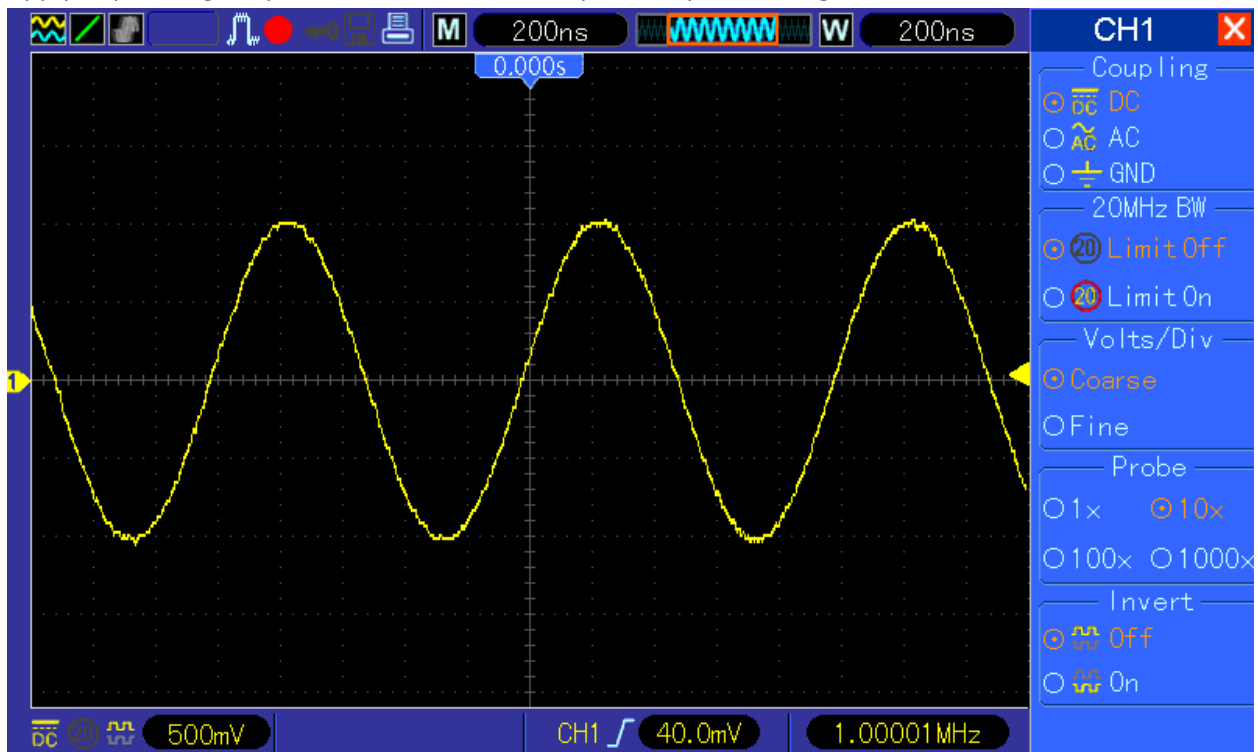
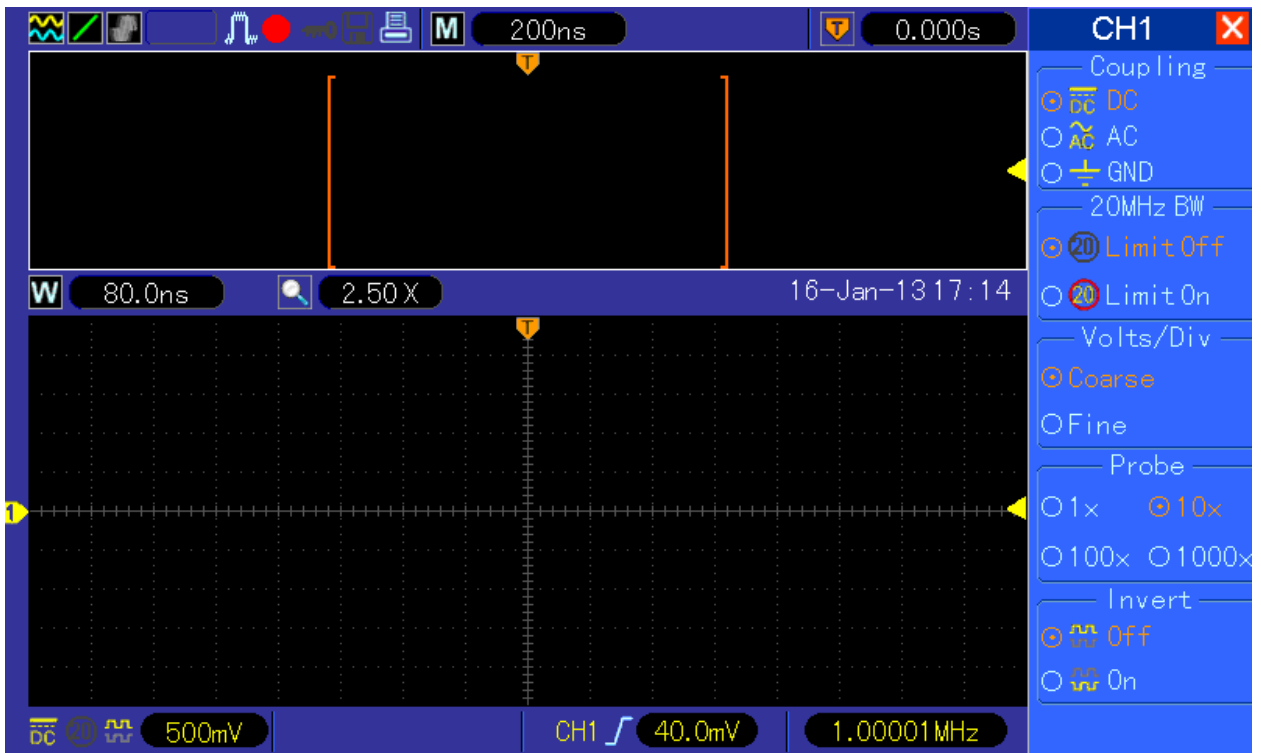
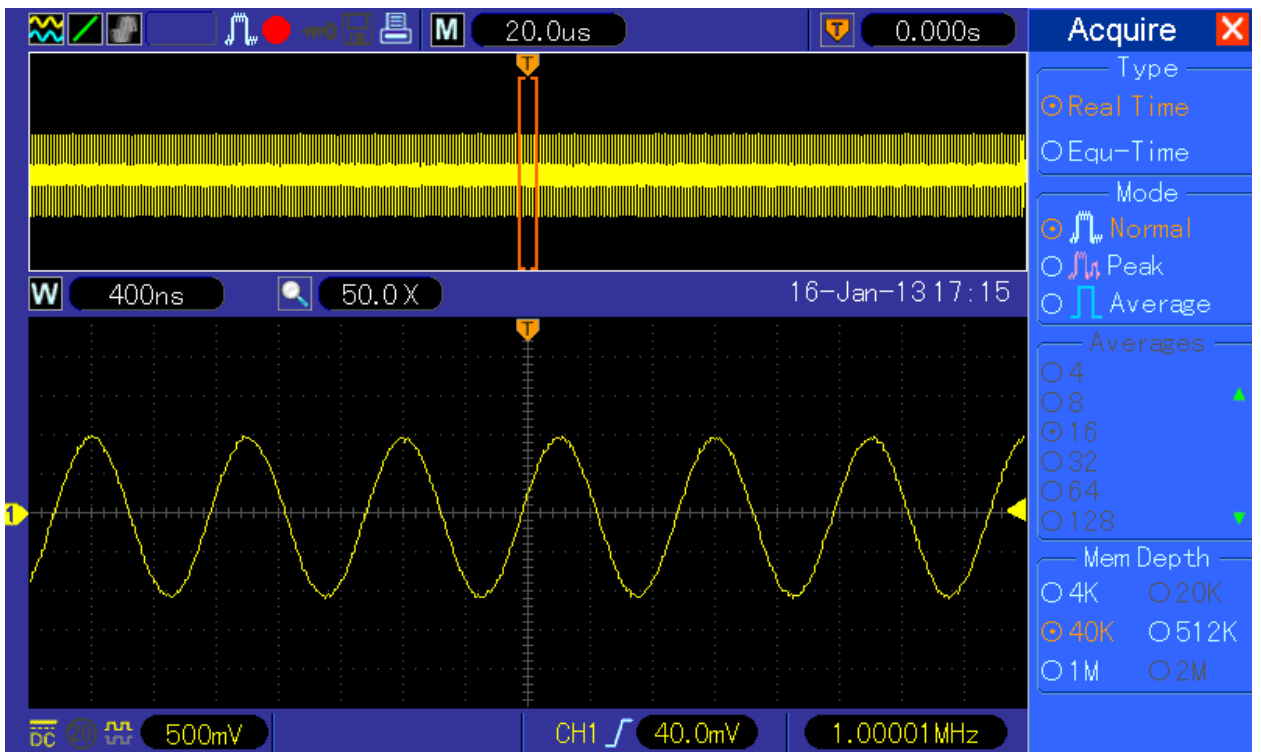
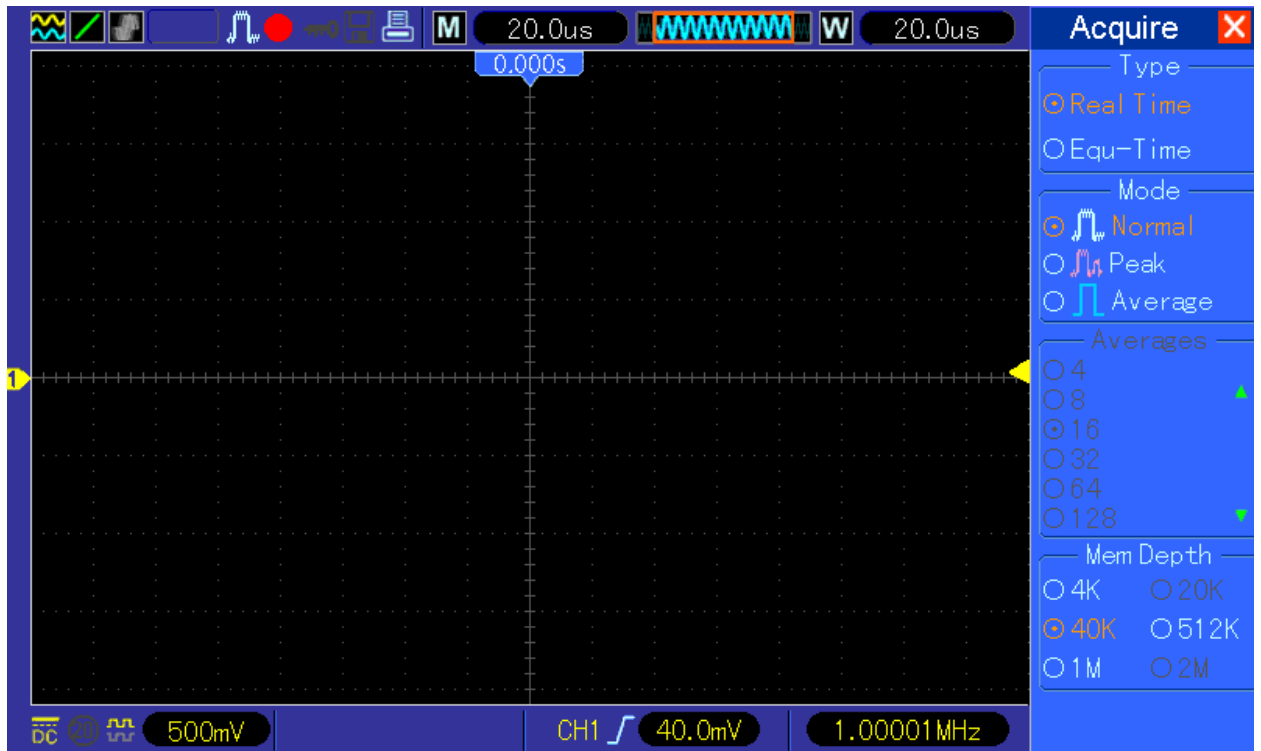
41. **This bug was already there in 2011, then it has been fixed. Now it's again there.**  
**This is one of the DSO basic functions; this bug is really annoying and need to be fixed FIRST.**

Apply any test signal, push "STOP" button to stop the Acquisition, e.g.:

now change to Dual Window by pushing F7, the Waveform disappeared from the Screen!!!:

This bug is not dependent on Memory Depth nor Timebase position, here another one example.

This time apply any test signal while in Dual Window and push "STOP", the Screen is e.g. like :

now push F7 to go back to Single Window mode – the Waveform disappeared from Screen :
