Screenshot vom PCB (TopOverlay)

Assembly Variant Manager:

hier zum Testen und Aufzeigen des Problems alle Bauteile als ‚Not Fitted‘ markiert.

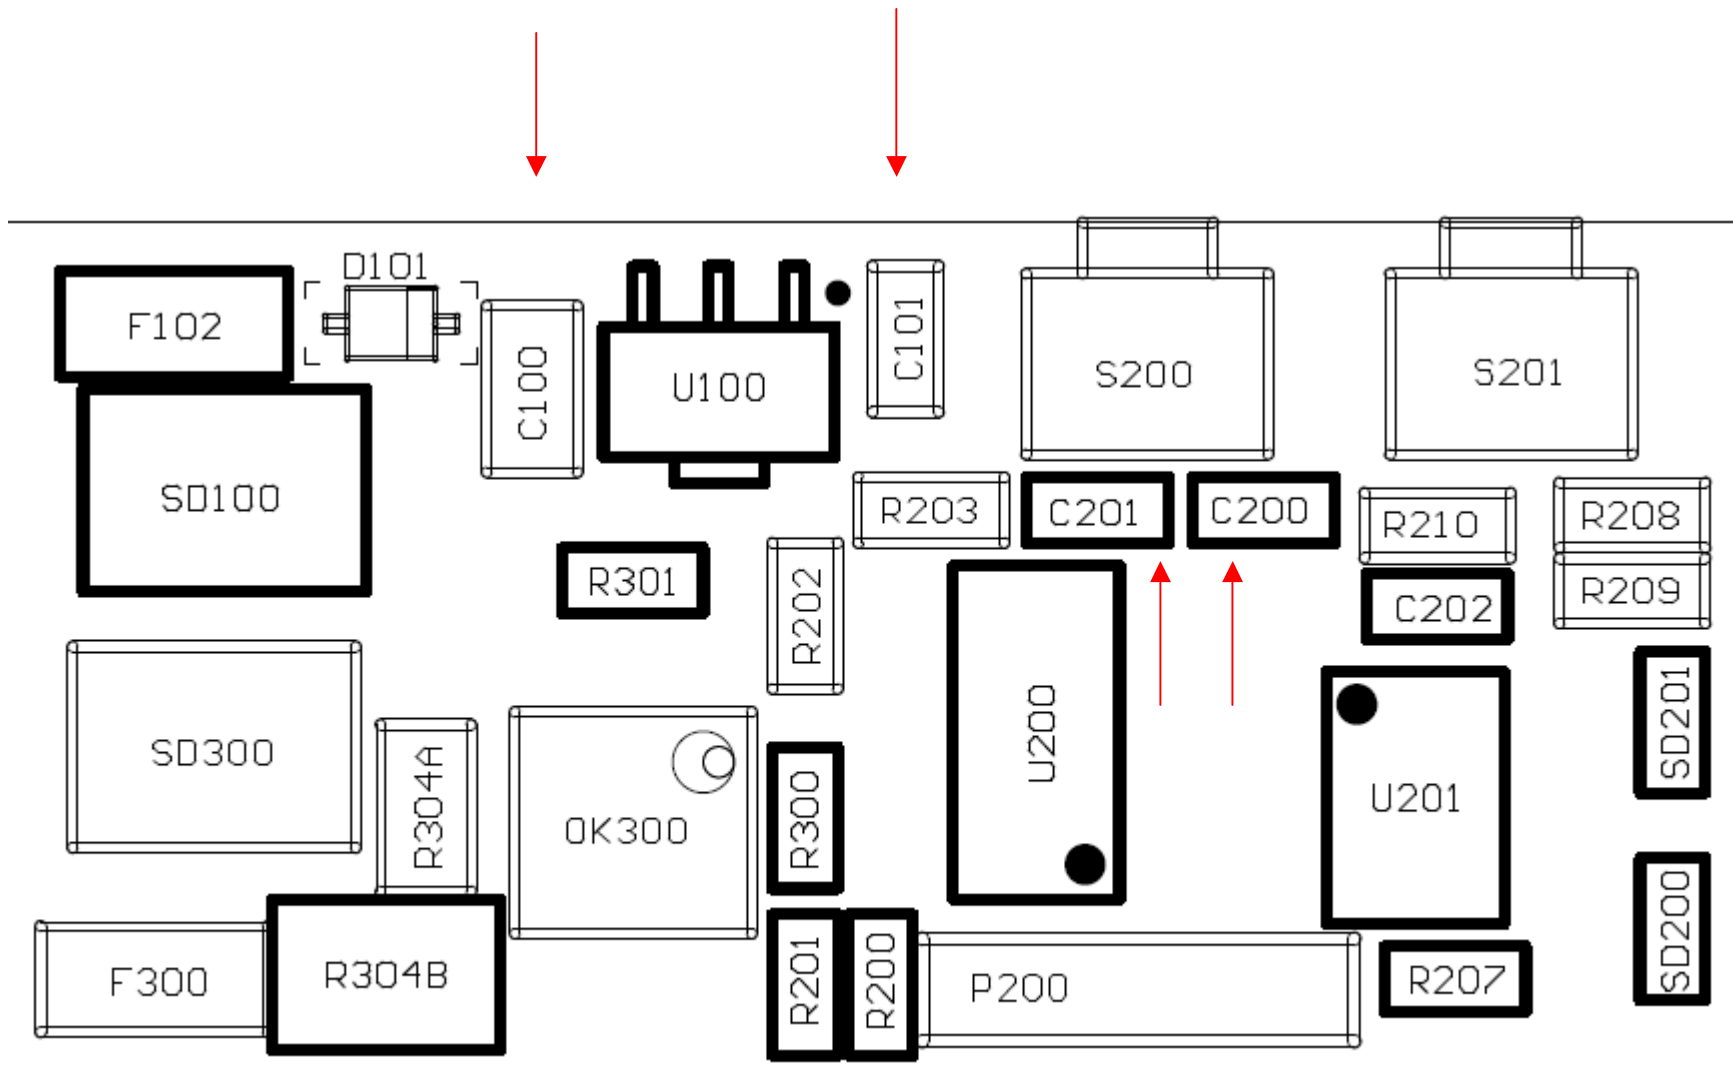
Im pdf-Bestückungsplan, generiert mit obenstehender Job-Ausgabe, sind zwei davon vorhanden und zwei nicht. Die roten Pfeile habe ich nachträglich eingefügt, nicht der Output-Job.

Betrachten wir als Beispiel diese vier Bauteile: alle sind als ‚Not Fitted‘ markiert.
