Tin Whiskers Growing Inside ~45 Year Old AF114 Germanium Transistors

Parts Analysis by: Chris Greenwell/QSS Group, Inc.

NASA Electronic Parts and
Packaging (NEPP) Program

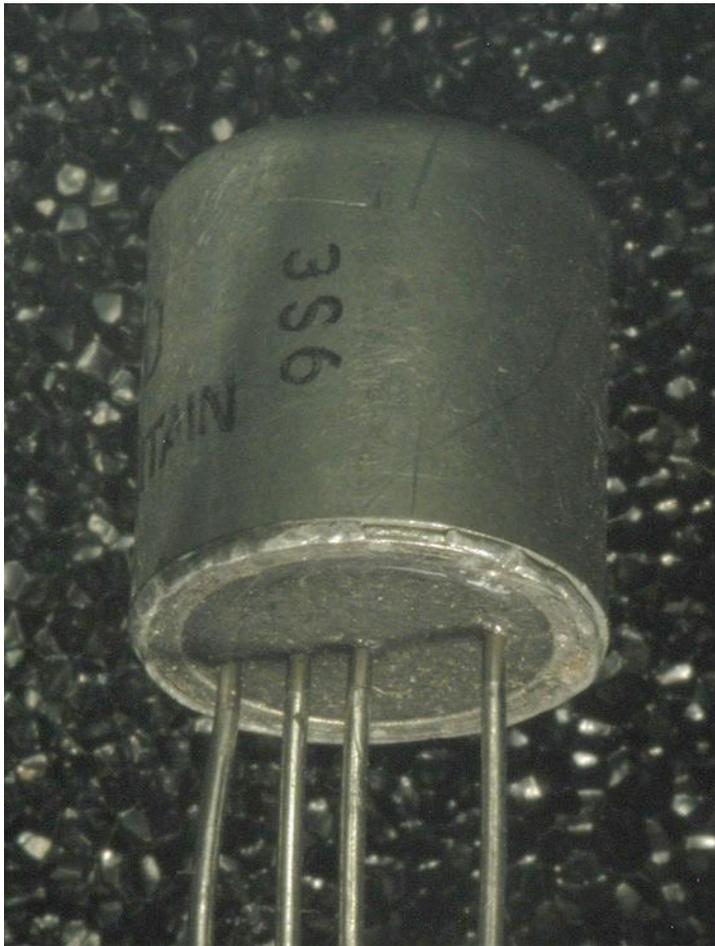
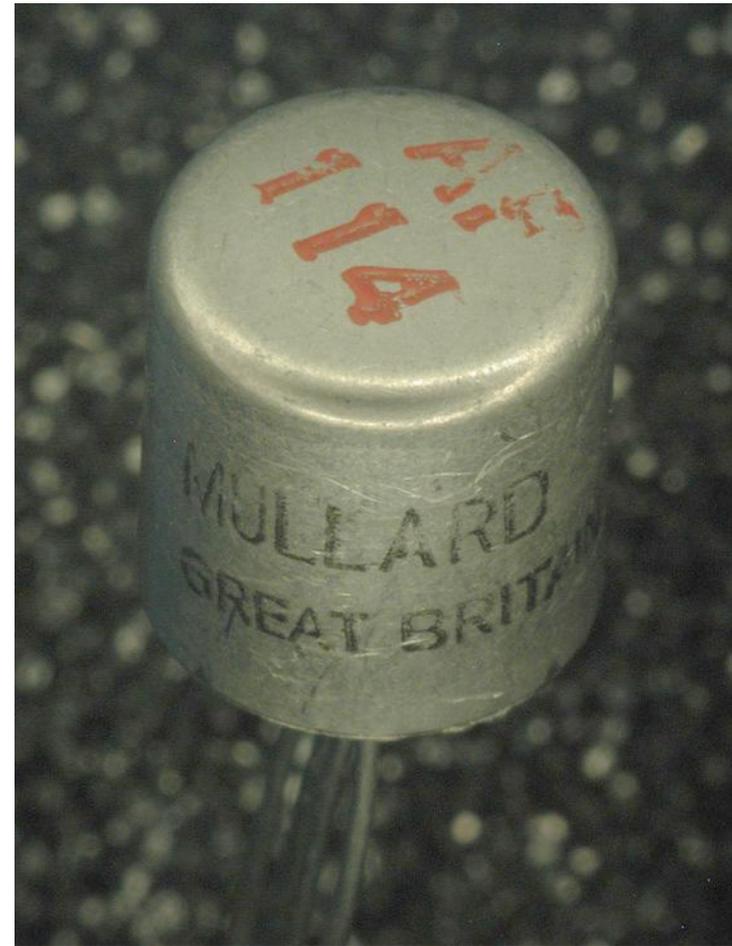
External Photographs – AF114

No Lot Date Code Information Marked on Devices
Based on Input from Source Assume parts made circa 1960

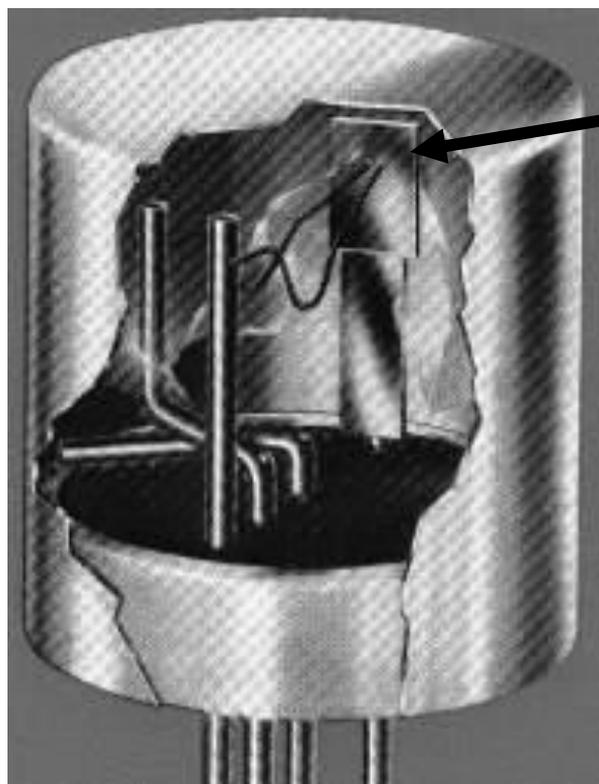
Internal Diagram & X-Ray of AF114

Note that Pin 3 is connected to the case,
but is not connected to the transistor (pins 1, 2 and 4)

Pin 1 = Emitter, 2 = Base, 3 = Case, 4 = Collector

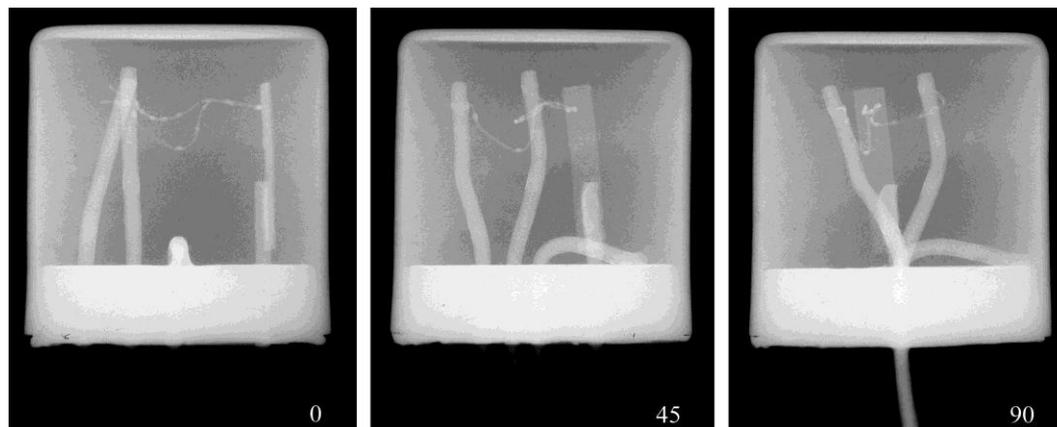
NASA GSFC X-Ray of AF114 Device Received
(3-Views at 0°, 45°, 90°)

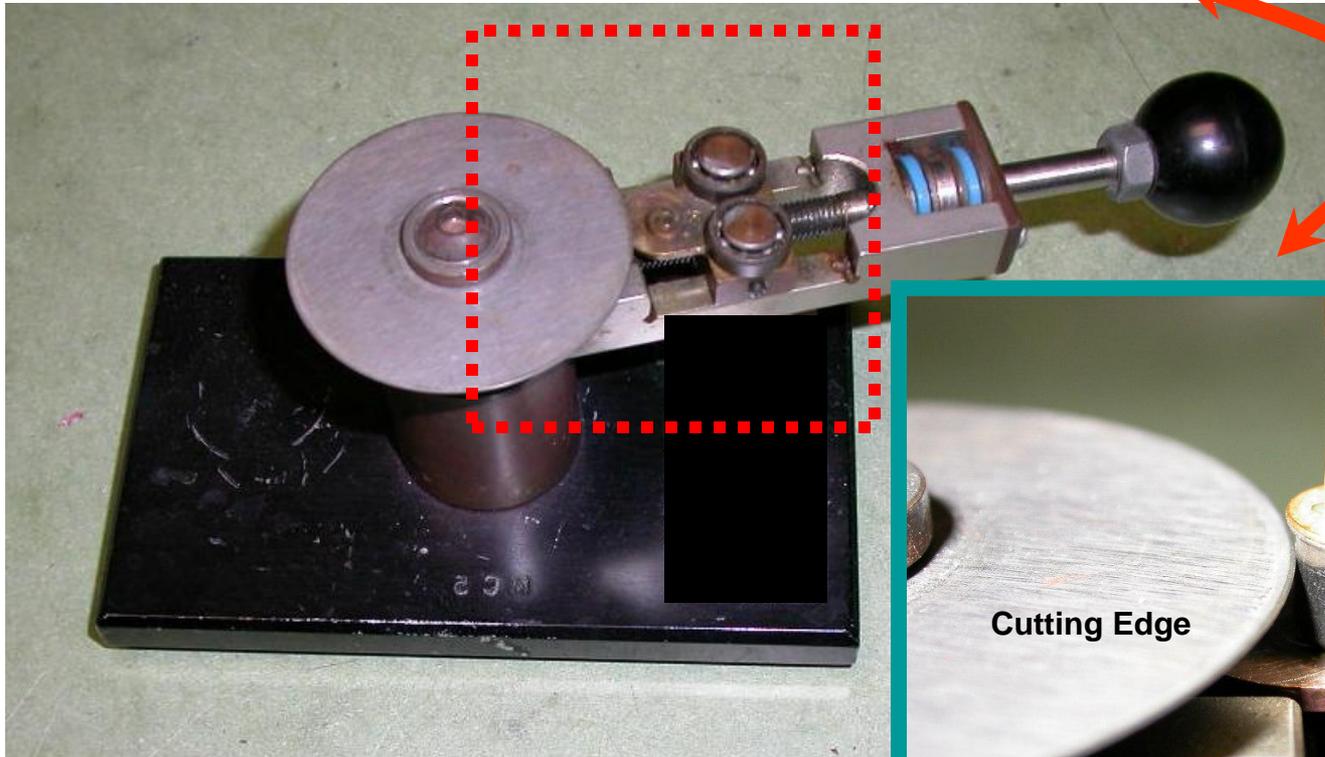
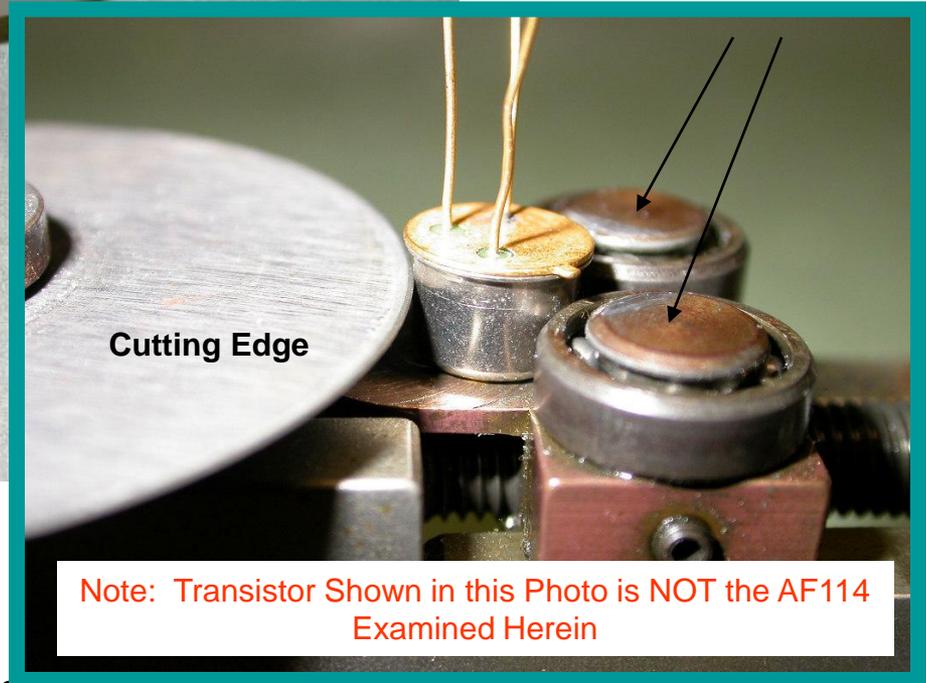
“Can Opener”

Photos to Illustrate type of Tool Used to Open the Transistor Package

Pivoting this Handle Rotates the Device Package Against the Cutting Edge

Roller Bearings

Note: Transistor Shown in this Photo is NOT the AF114 Examined Herein

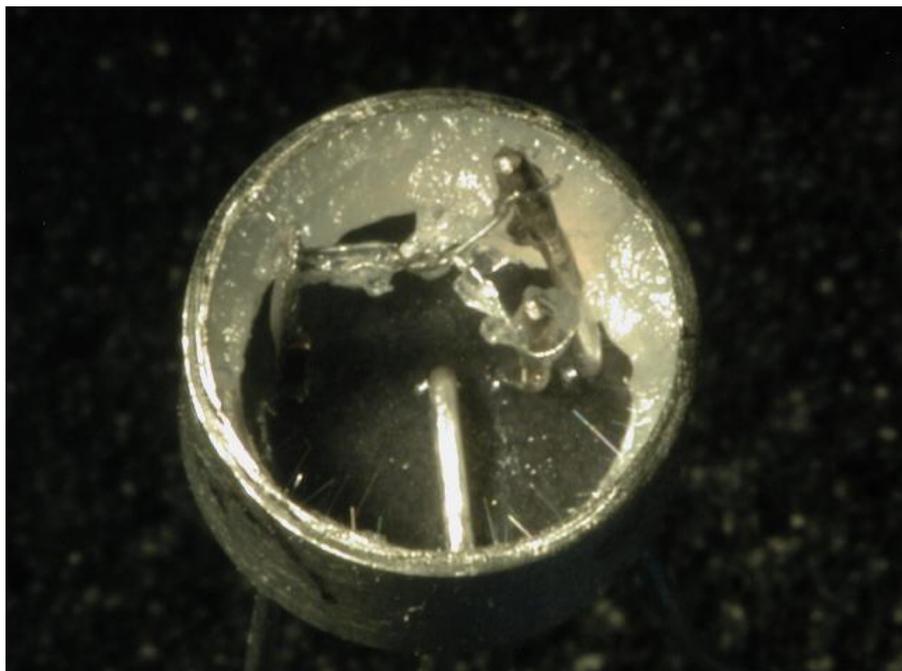
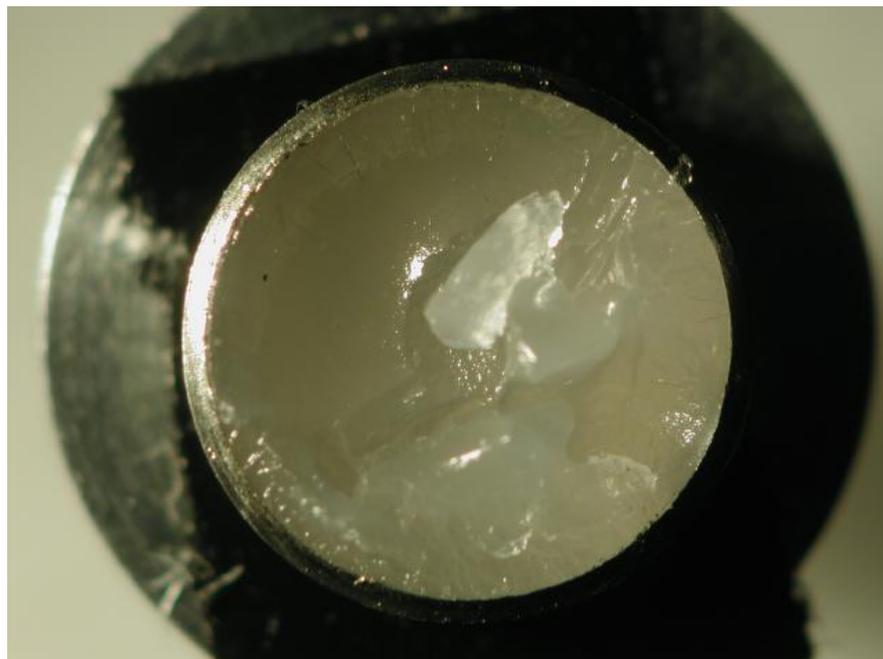
Internal Optical Microscopy of AF114 after Opening TO Package

Inside of Transistor with Top Removed
Whiskers are already evident

Top of Case contains
Jelly-Like Substance
(Somewhat lower viscosity than petroleum jelly,
Suspected to be some type of Silicone)

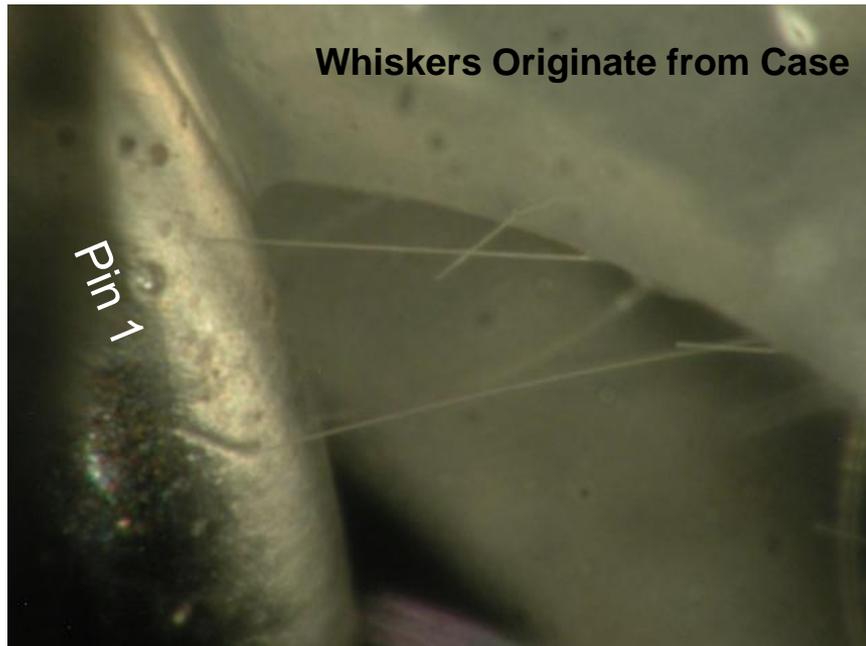
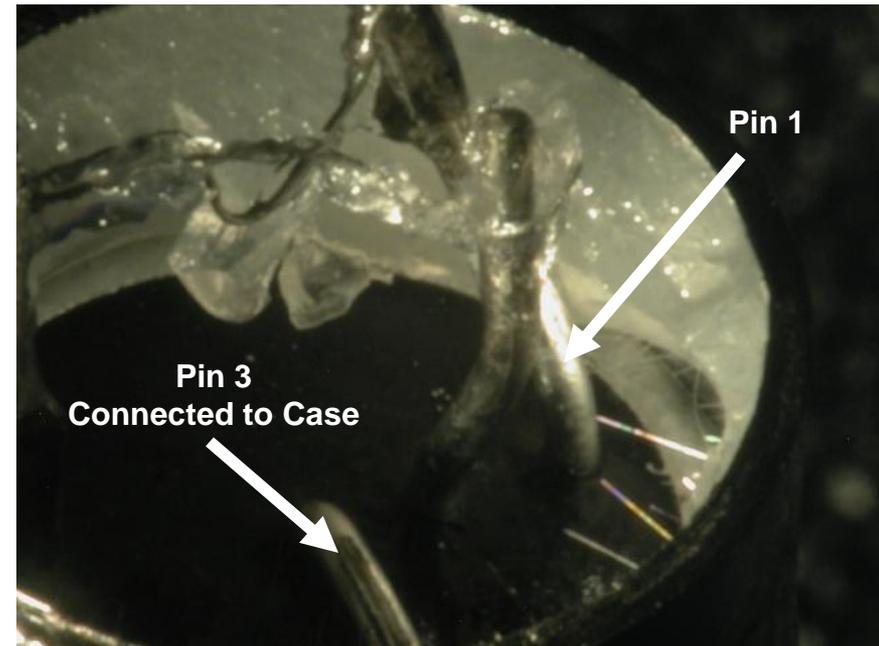
Internal Optical Microscopy

Whiskers Shorting from Case to Pin 1

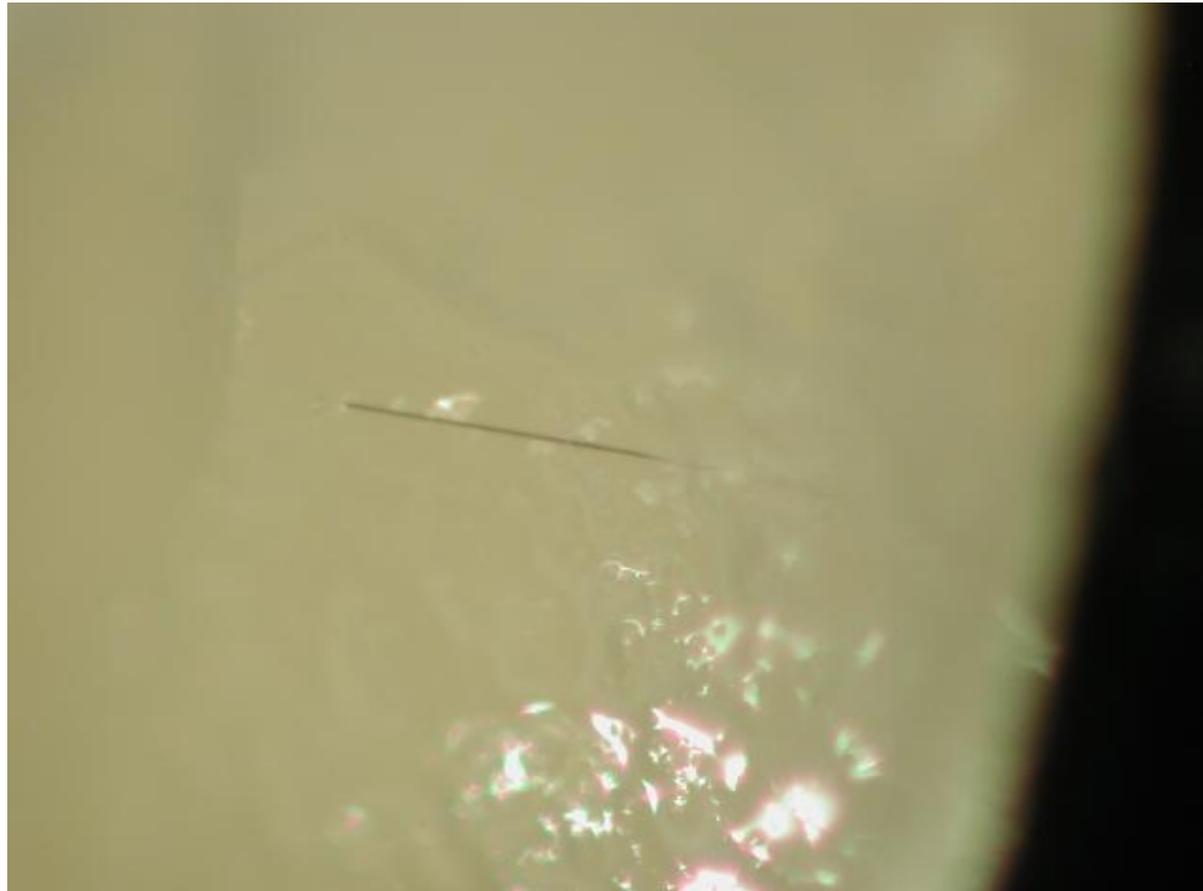
Internal Optical Microscopy

*Whiskers Grow Readily Within and Through the
Jelly-Like Substance.*

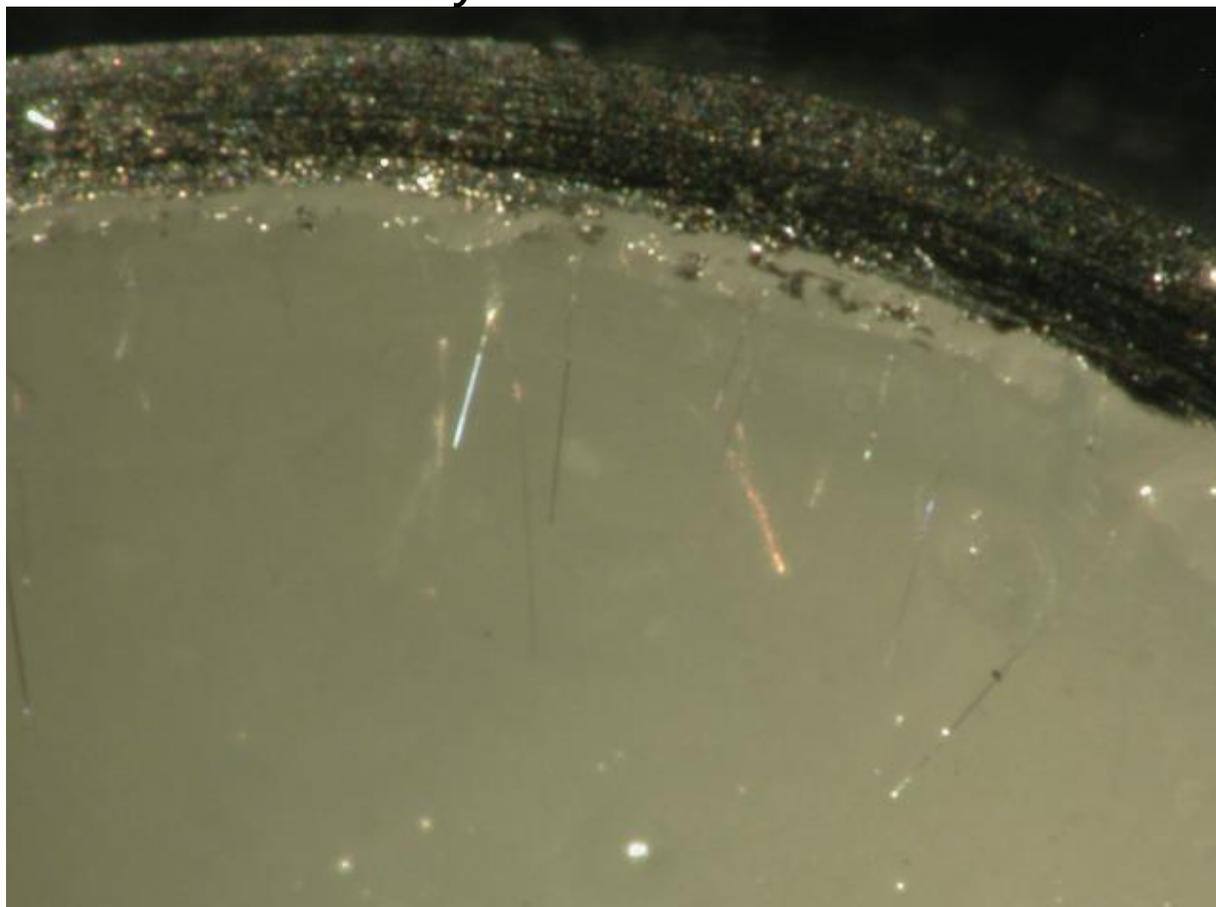
Internal Optical Microscopy

*Whiskers Grow Readily Within and Through the
Jelly-Like Substance.*

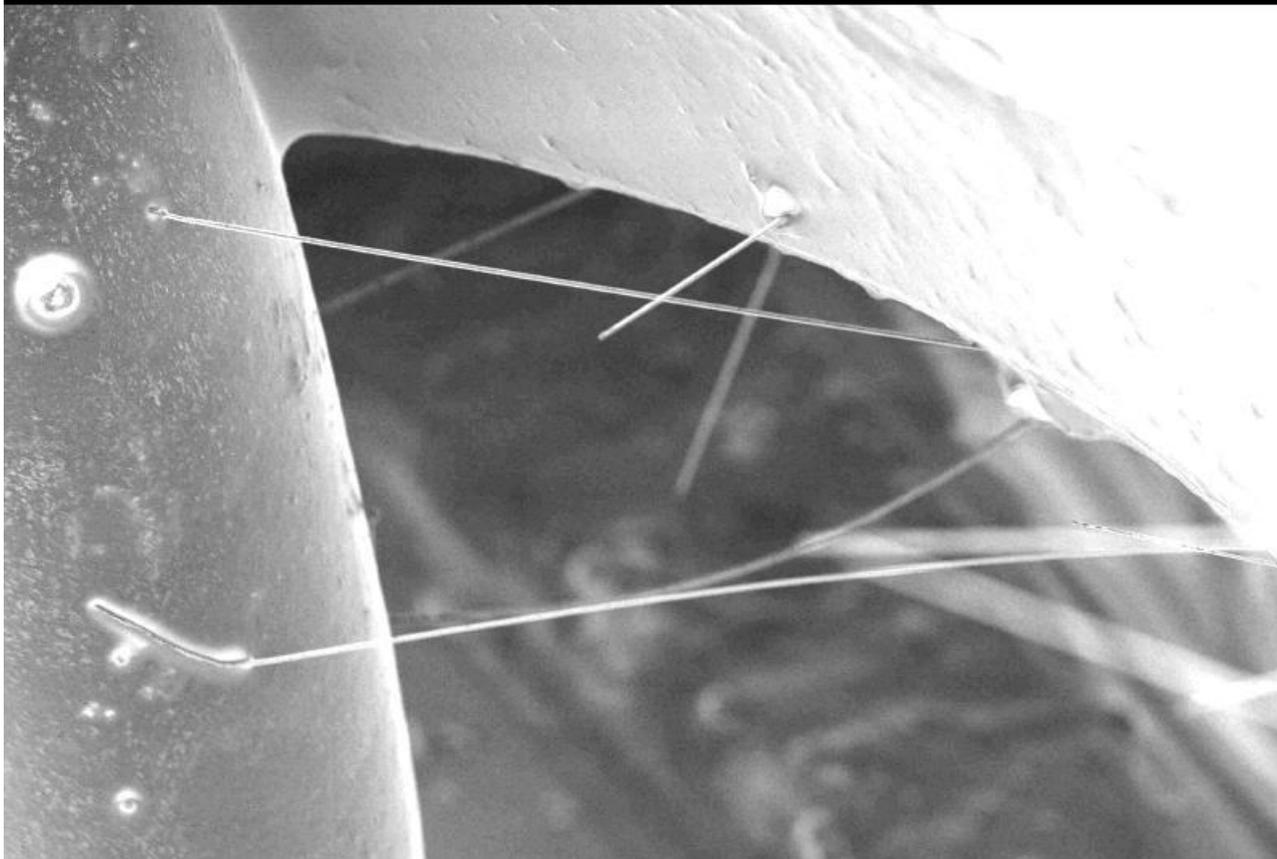
Whiskers Shorting Case to Pin 1

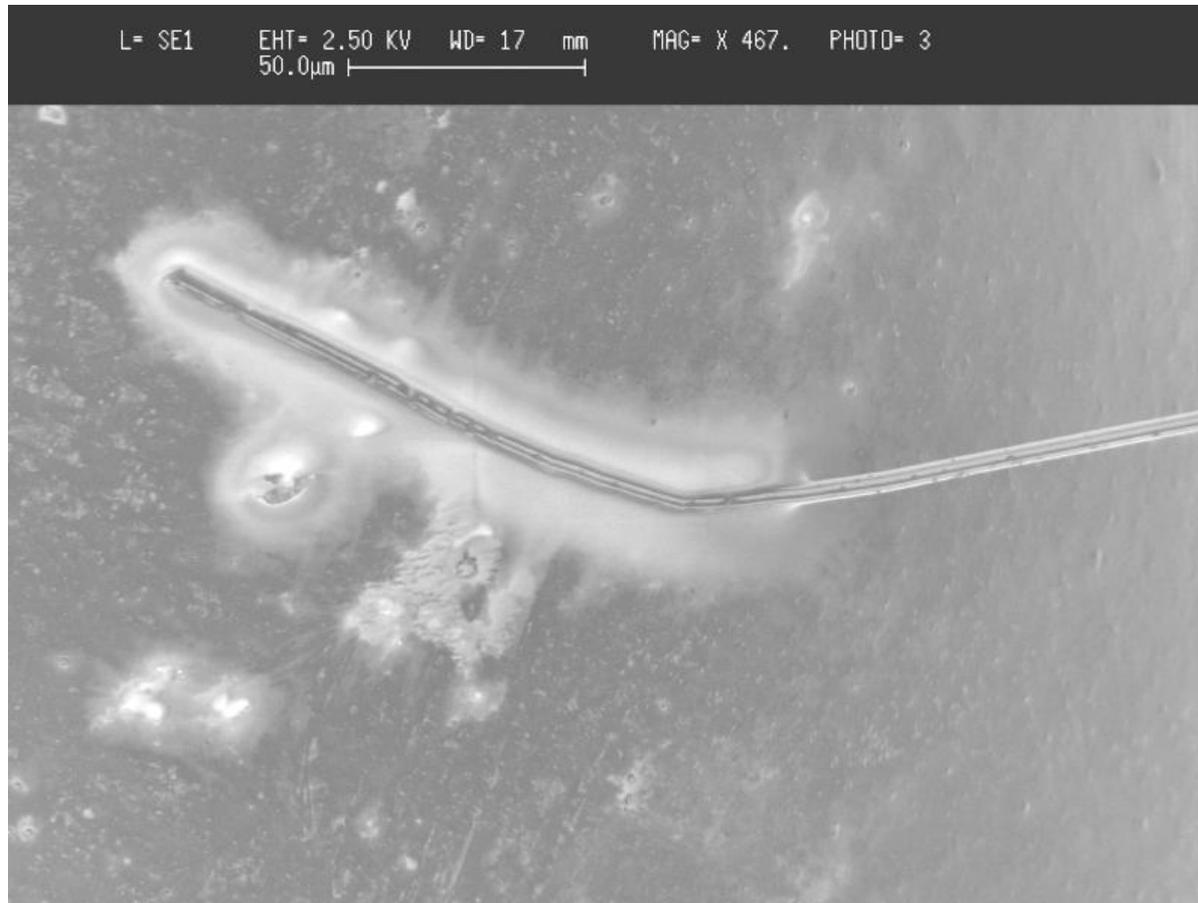
Whisker Shorting to Pin 1

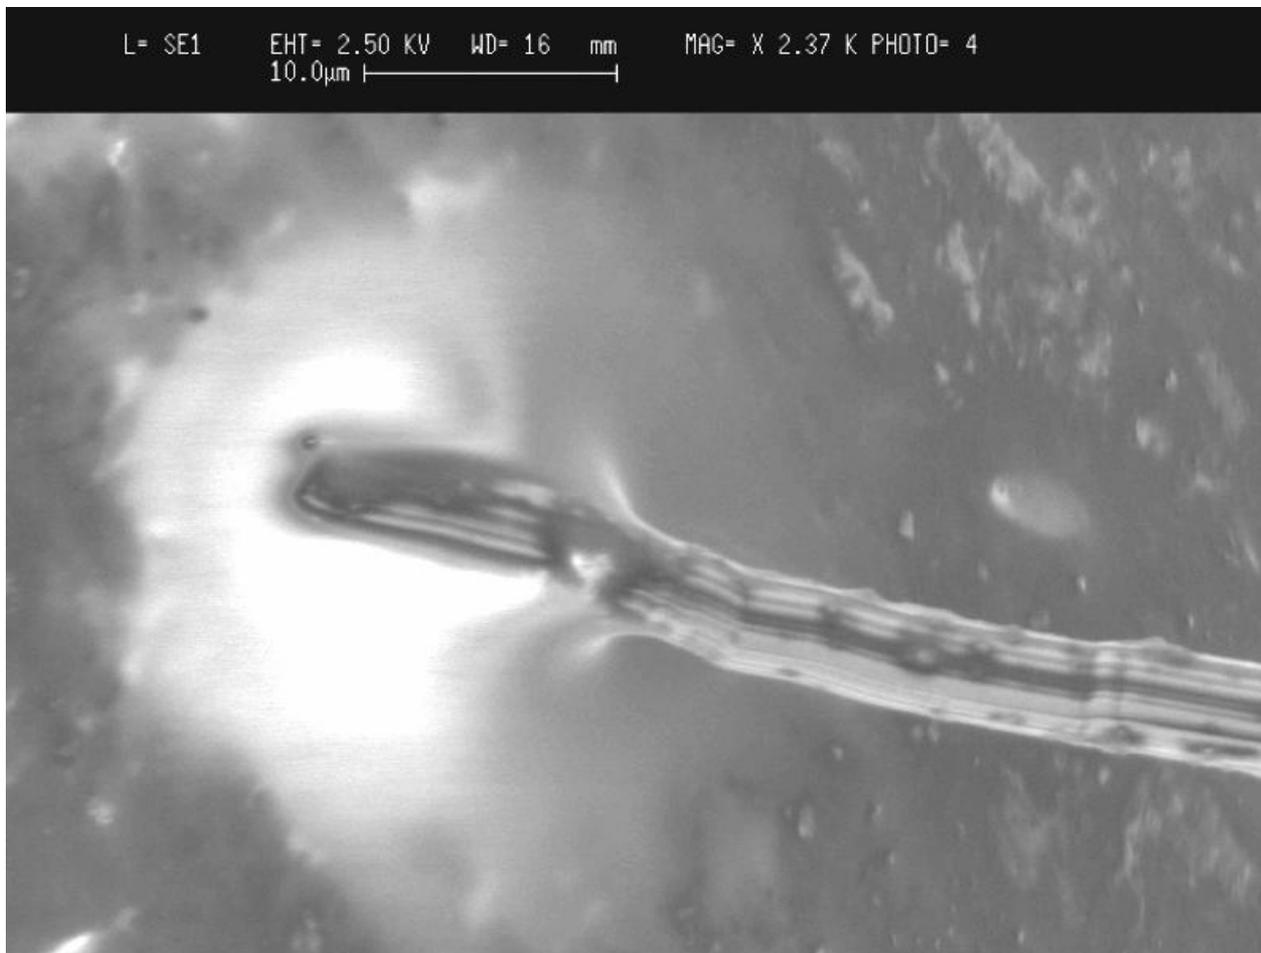
Whisker Shorting to Pin 1

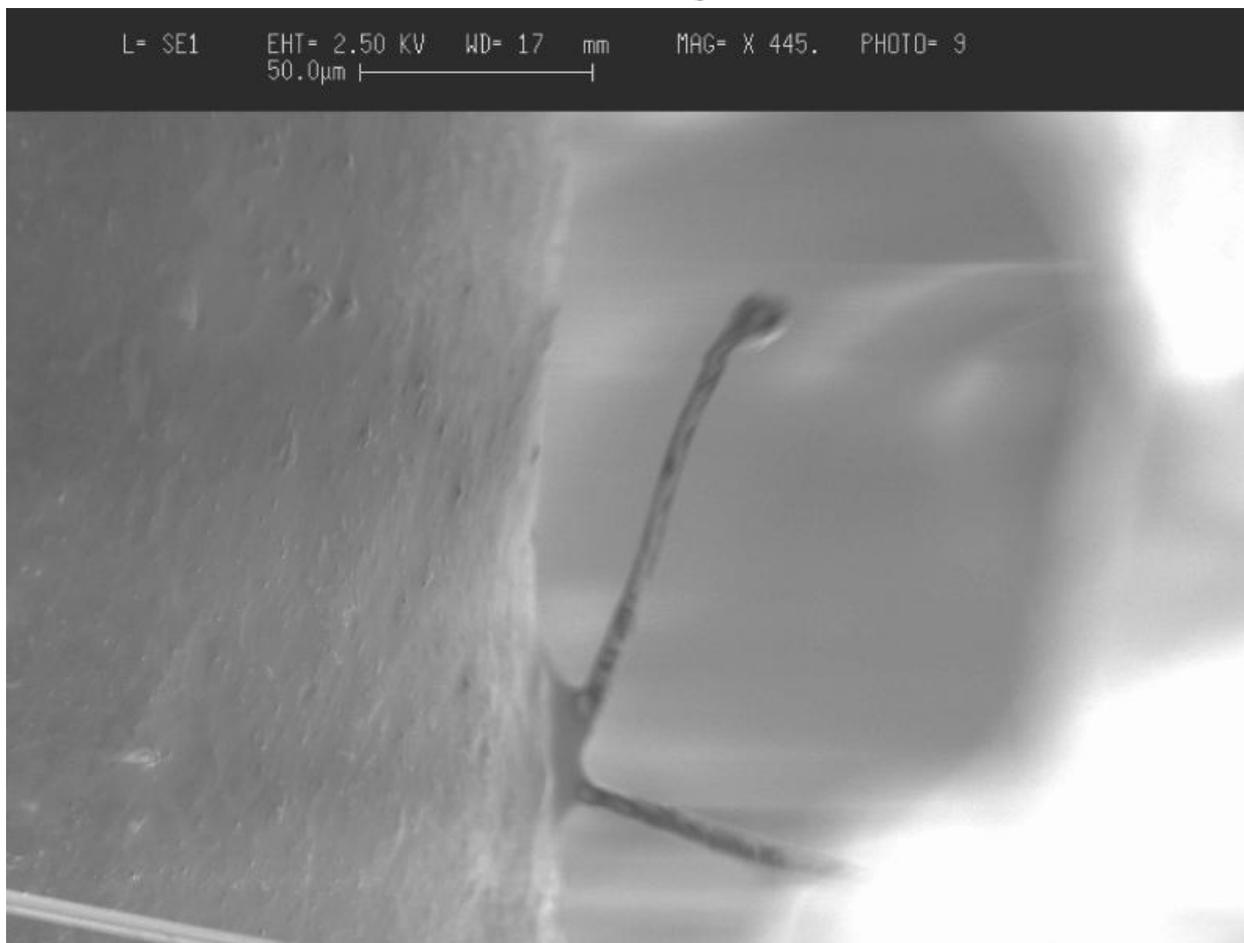
Whisker Shorting to Pin 1

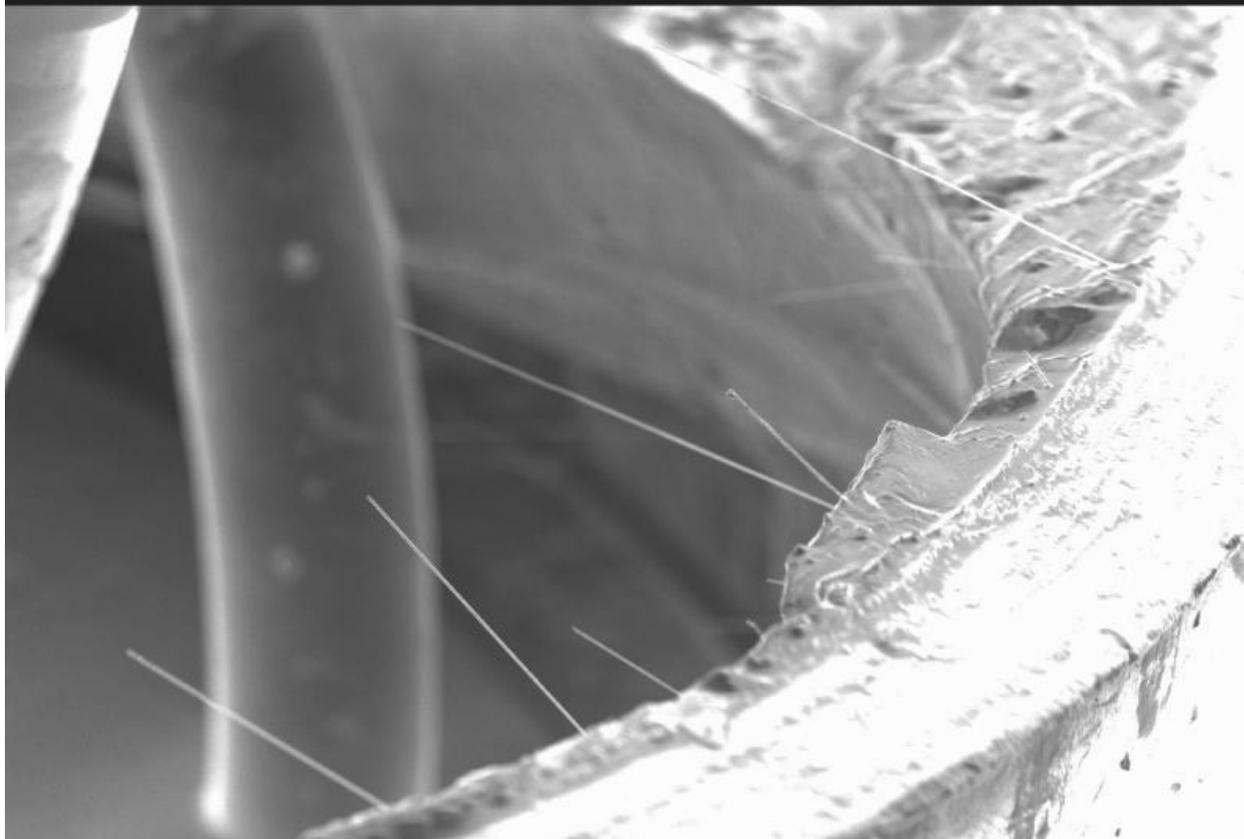
Whiskers Growing from Case Wall

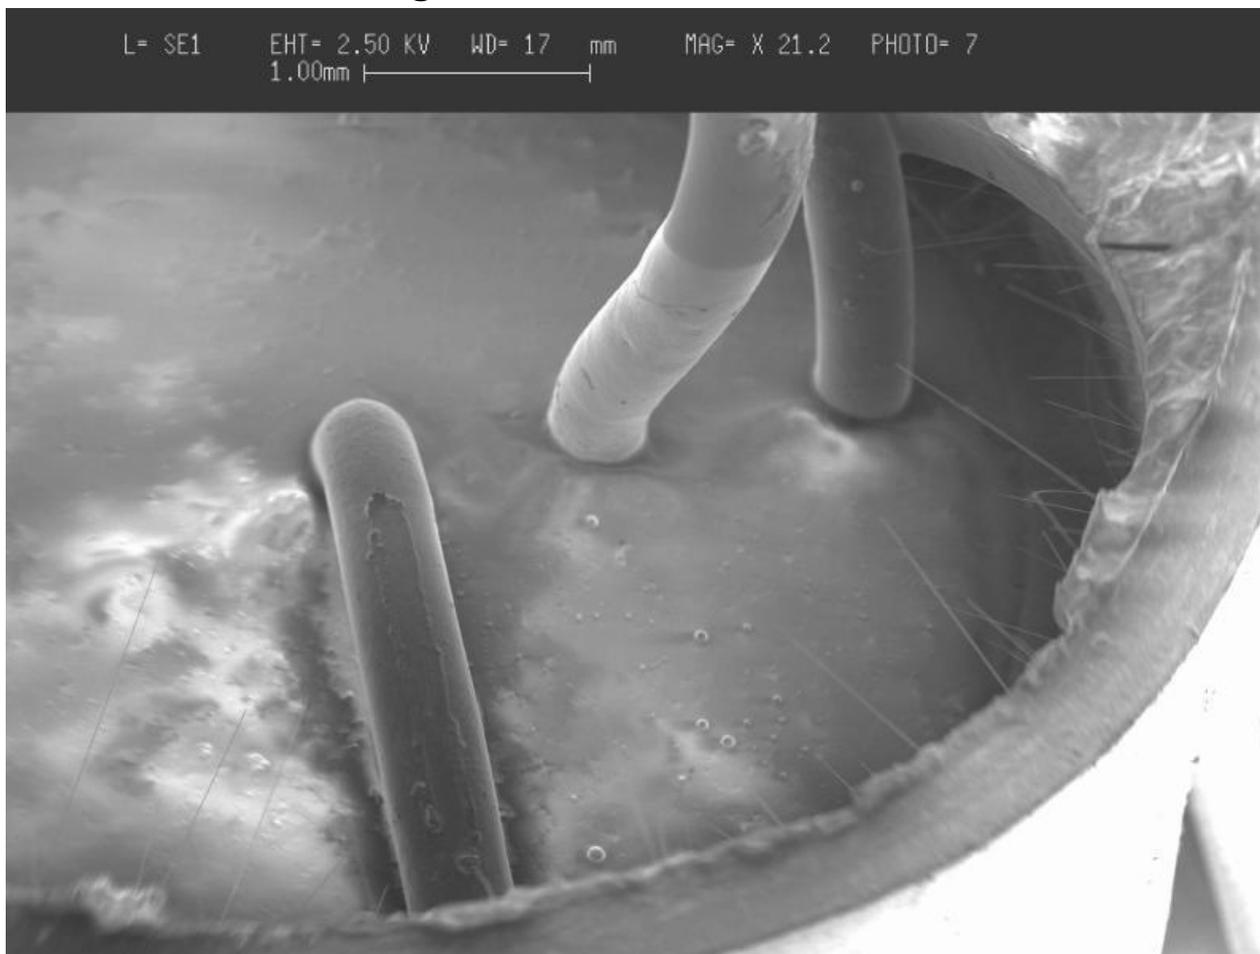
Whiskers Growing from Case Wall Towards Internal Pins

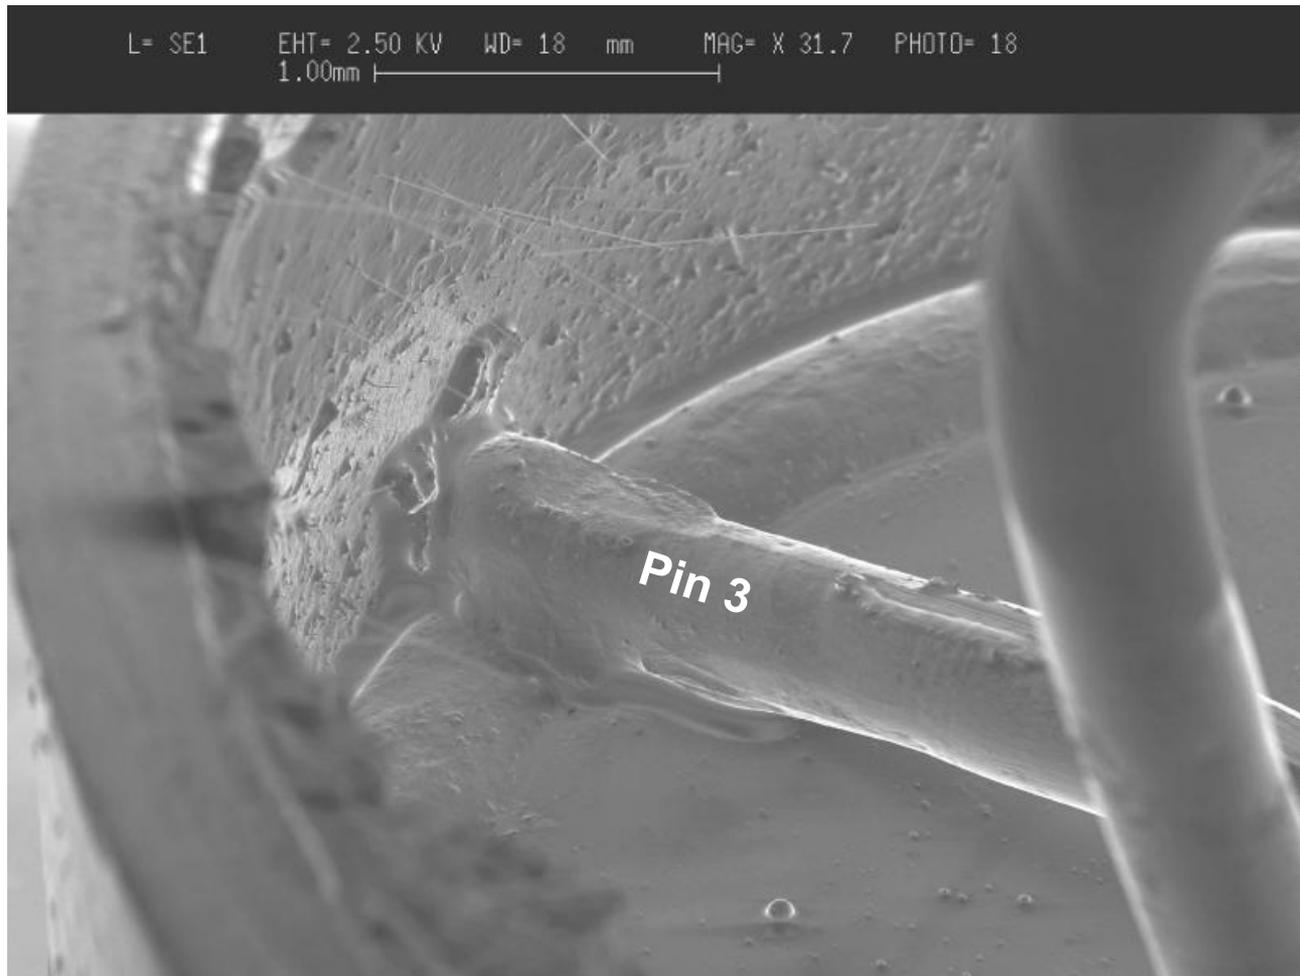
Pin 3 Connected Internally to Case

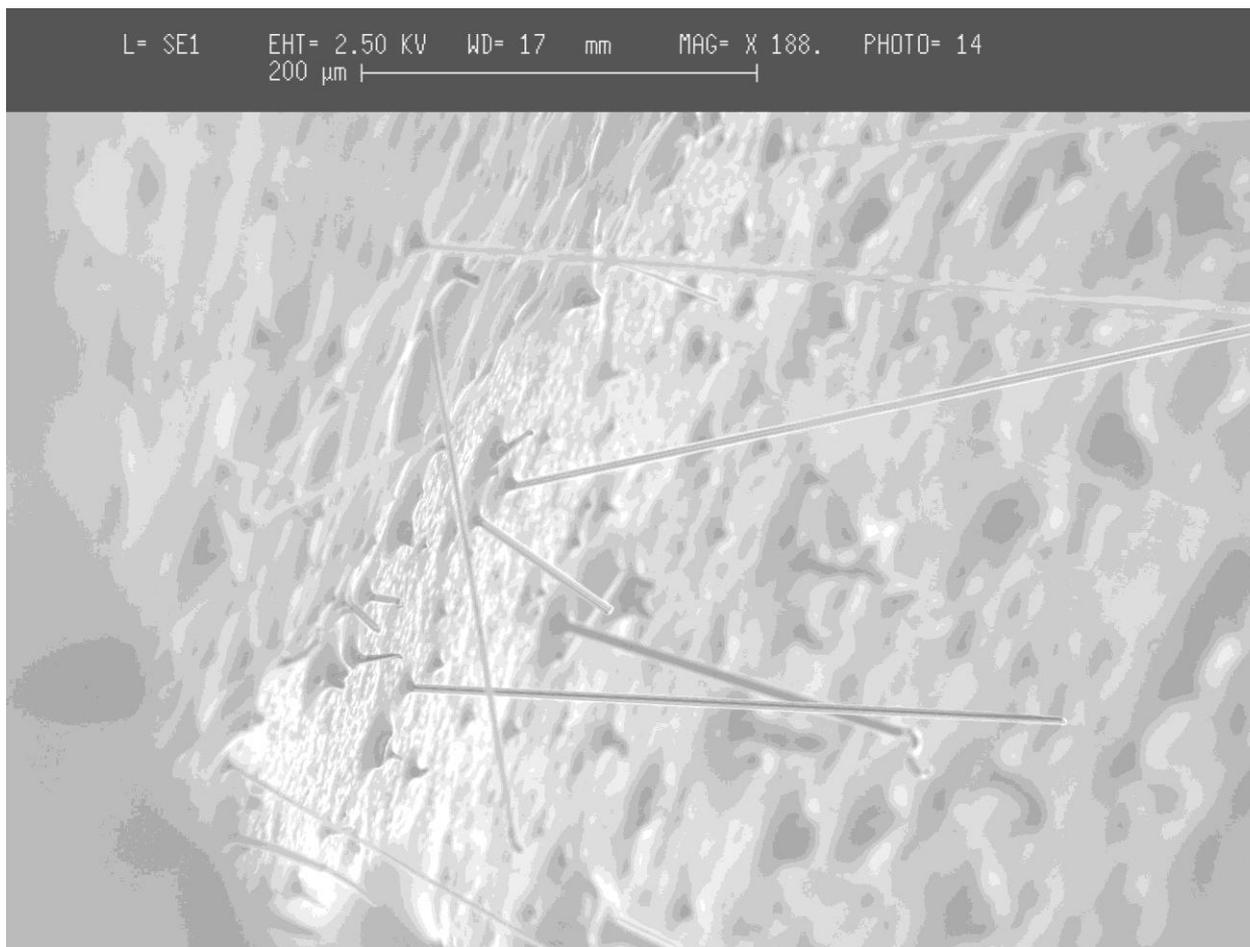
Filament Type Whiskers + Nodules

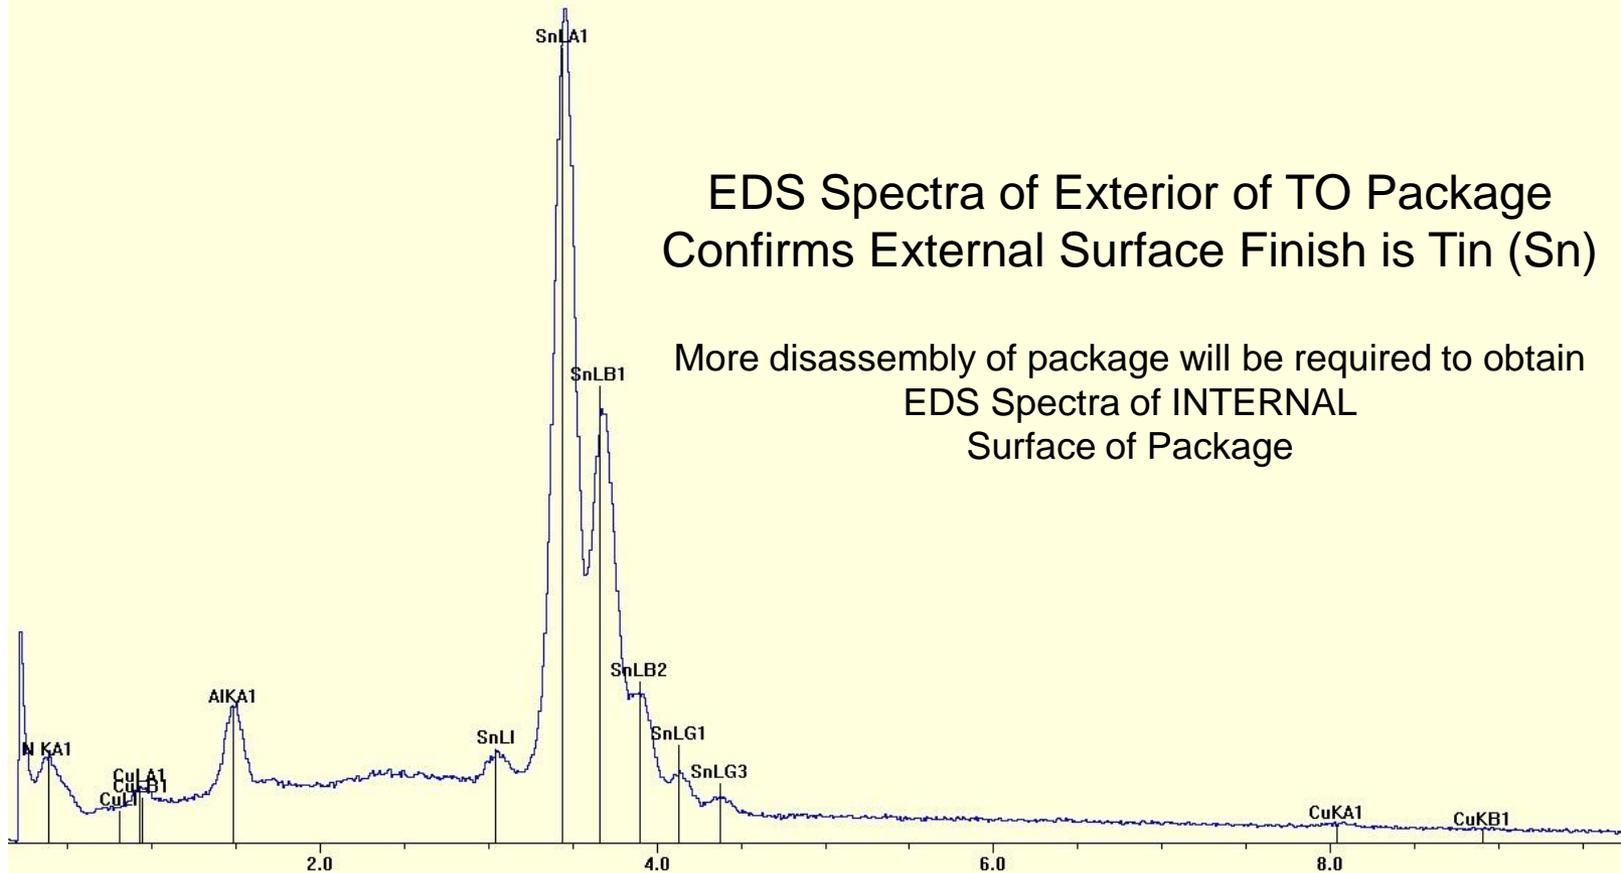
Q50529 outside can surface 15kV.pgt

EDS Spectra of Exterior of TO Package
Confirms External Surface Finish is Tin (Sn)

More disassembly of package will be required to obtain
EDS Spectra of INTERNAL
Surface of Package
