Firmware 2.06.3 bug list:

List of bugs/improvement requests

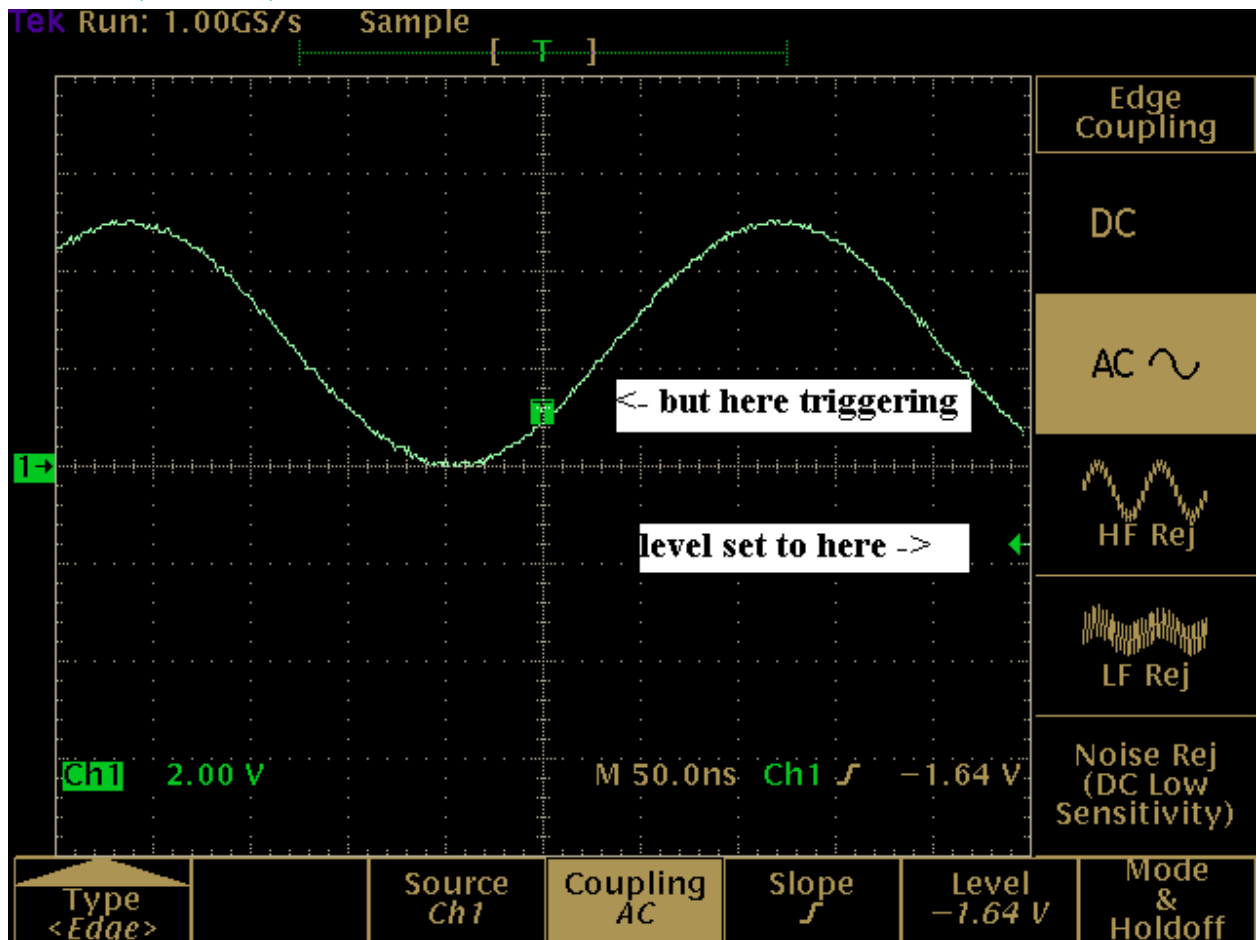
10. Workaround is to change Timebase (just one step forward and back) right after dual window enabled. Note — the main window (top) need to be activated, the bug have something to do with main TB buffer initialization.
11. This is improvement proposal and not a bug.
12. Use my firmware (2.06.3_120507.6), I removed that bug.
13. Use DC trigger coupling or “add offset” when you set trigger point. On some other good known DSOs (e.g. Tektronix TDS7xxx) there is exact the same DC-signal/AC-trigger “dependency” (bug) and nobody ever complained about.
