## Firmware 2.06.3 bug list:

## List of bugs/improvement requests

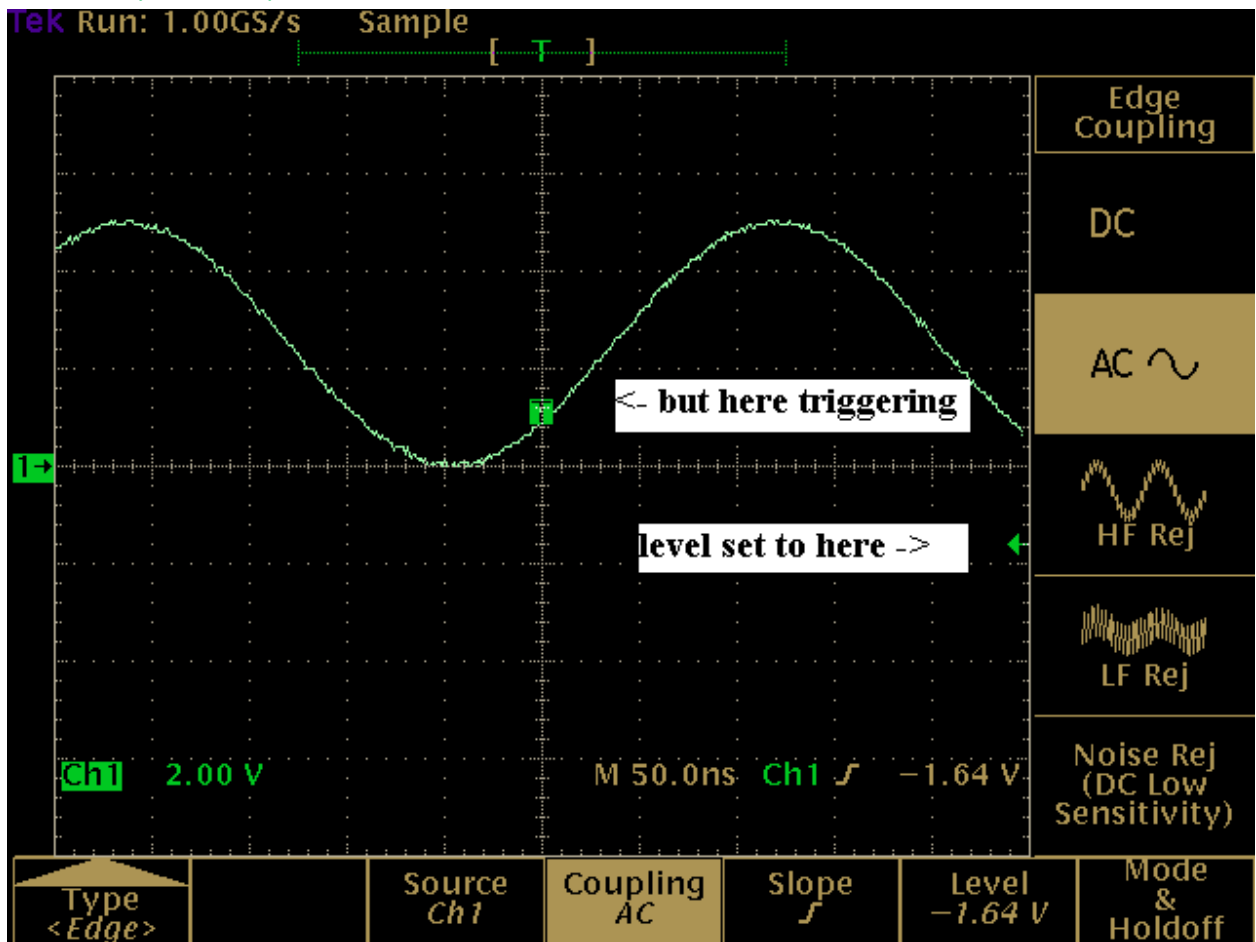
10. Workaround is to change Timebase (just one step forward and back) right after dual window enabled. Note — the main window (top) need to be activated, the bug have something to do with main TB buffer initialization.
11. This is improvement proposal and not a bug.
12. Use my firmware (2.06.3\_120507.6), I removed that bug.
13. Use DC trigger coupling or “add offset” when you set trigger point. On some other good known DSOs (e.g. Tektronix TDS7xxx) there is exact the same DC-signal/AC-trigger “dependency” (bug) and nobody ever complained about.
