## Firmware 2.06.3 bug list:

## List of bugs/improvement requests

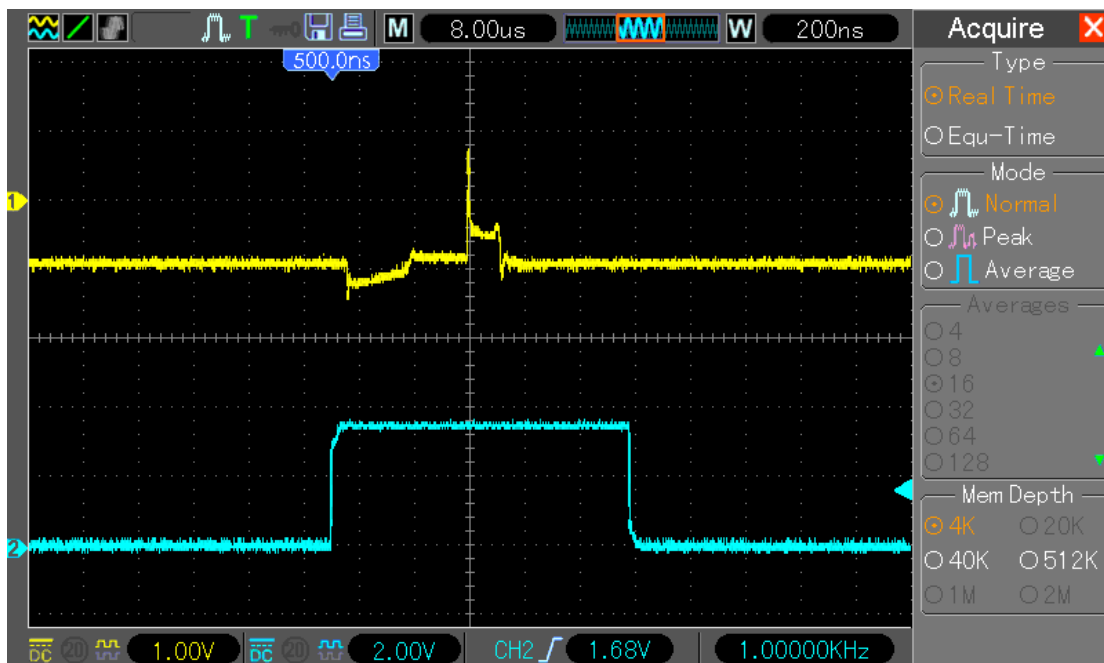
- In single window, sample memory  $\geq 40k$ , both channels (ch1, ch2) enabled and time base from 400ns/div up to 2ns/div the position change (fine and coarse) control is not working. Only scale is moving, but not the waveform. See attached picture to understand issue:

with 4k memory when changing position waveform is moving

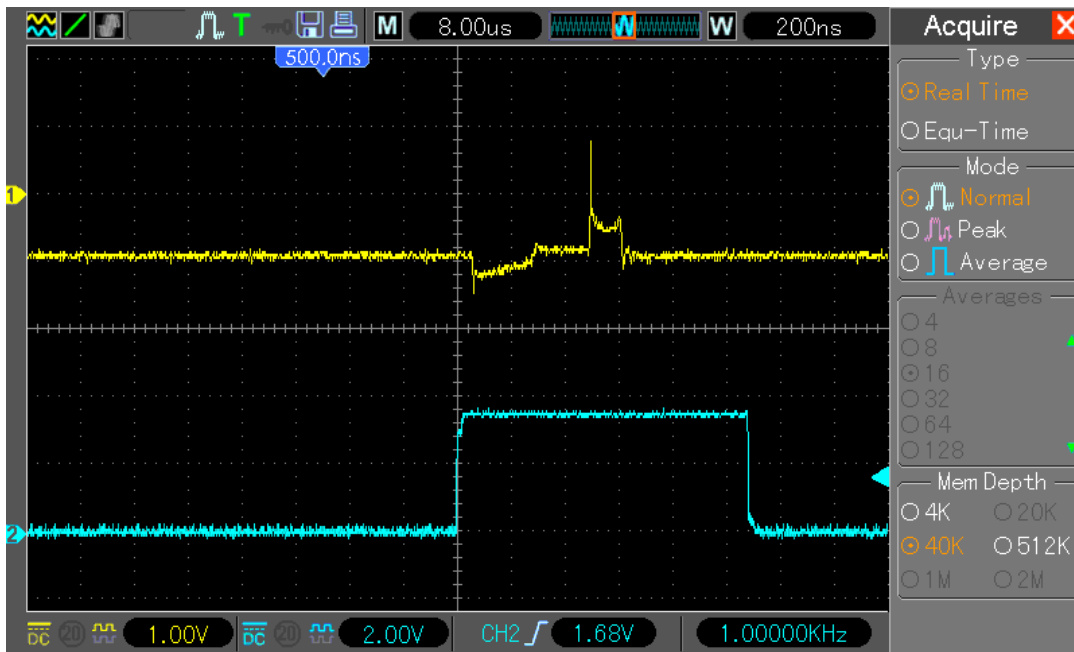
with 40k and above, when moving changing time base position waveform is NOT moving when in RUN mode (but works in STOP mode)

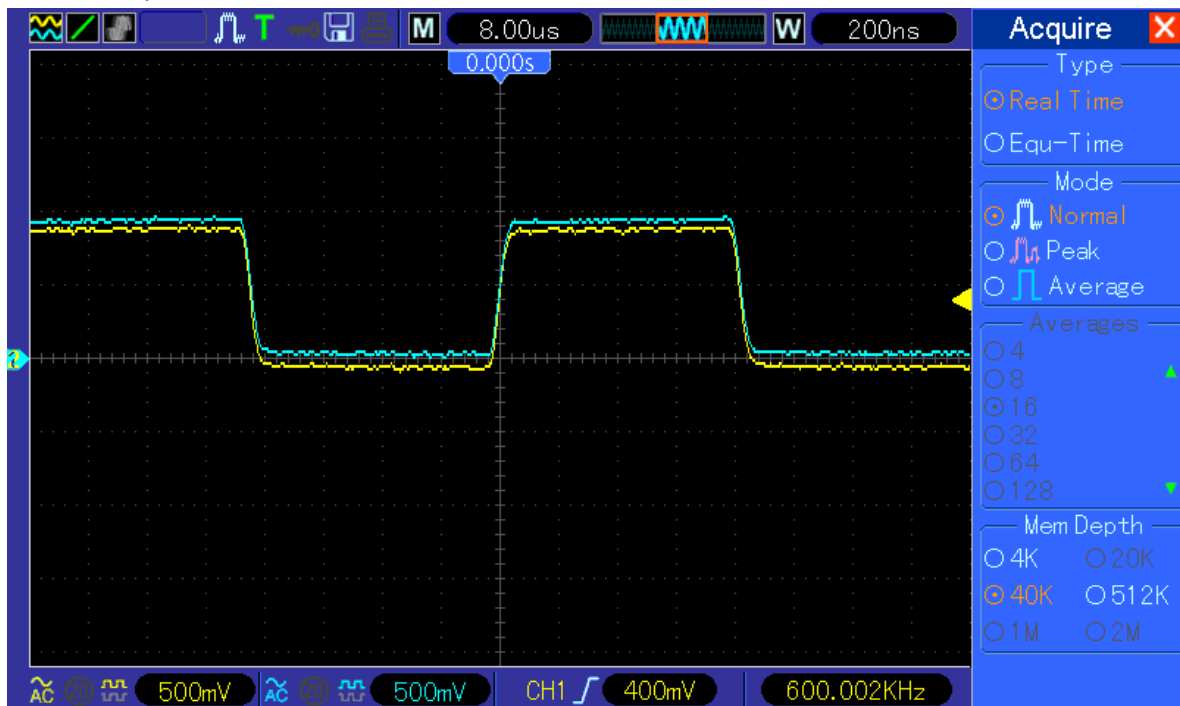
- In single window mode, sample memory 40k, both channels (ch1, ch2) enabled – while switching to dual window mode artifacts on screen and DSO later crashing and not responding.

**Artifacts disappear when changing timebase just after switch to dual window, so just an init error?**

and switch dual window mode to see artifacts like this:

10. ~~Workaround is to change Timebase (just one step forward and back) right after dual window enabled. Note – the main window (top) need to be activated, the bug have something to do with main TB buffer initialization.~~

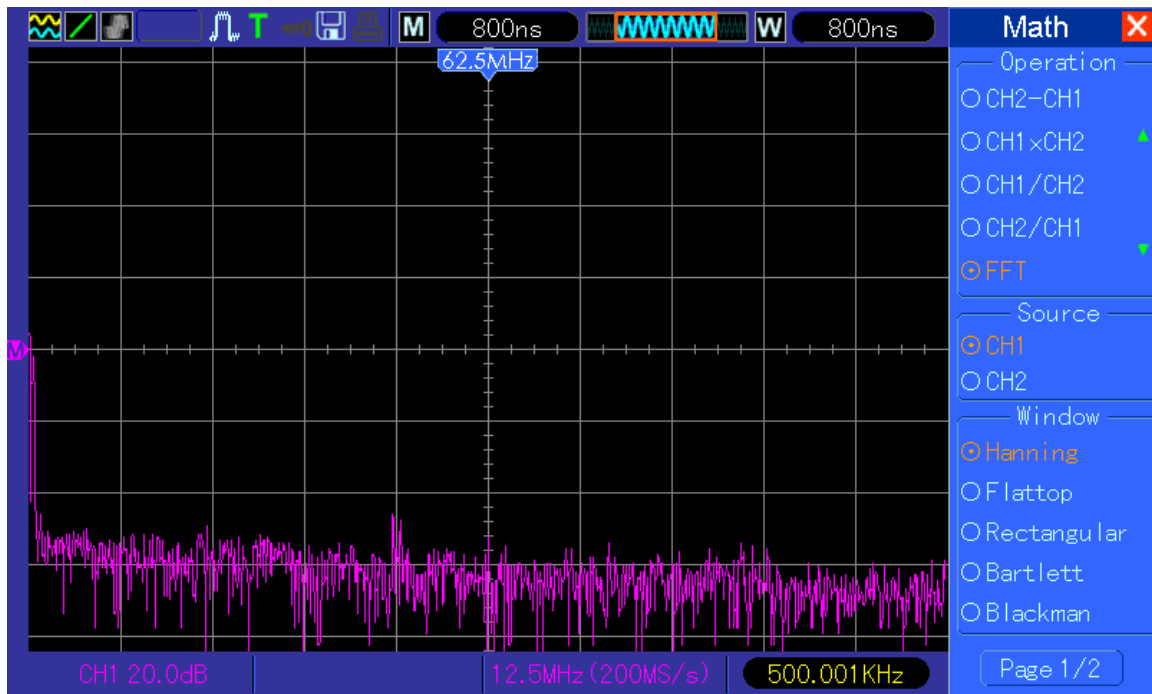
12. In FFT mode “Full span” is higher than Nyquist (sample rate / 2 )  
Example: 800ns/DIV, sample rate is 200MSs, full span 125MHz. Easy to fix by enabling from

800ns/DIV to 20ns/DIV 1GSs sampling (when 4k memory or FFT enabled)

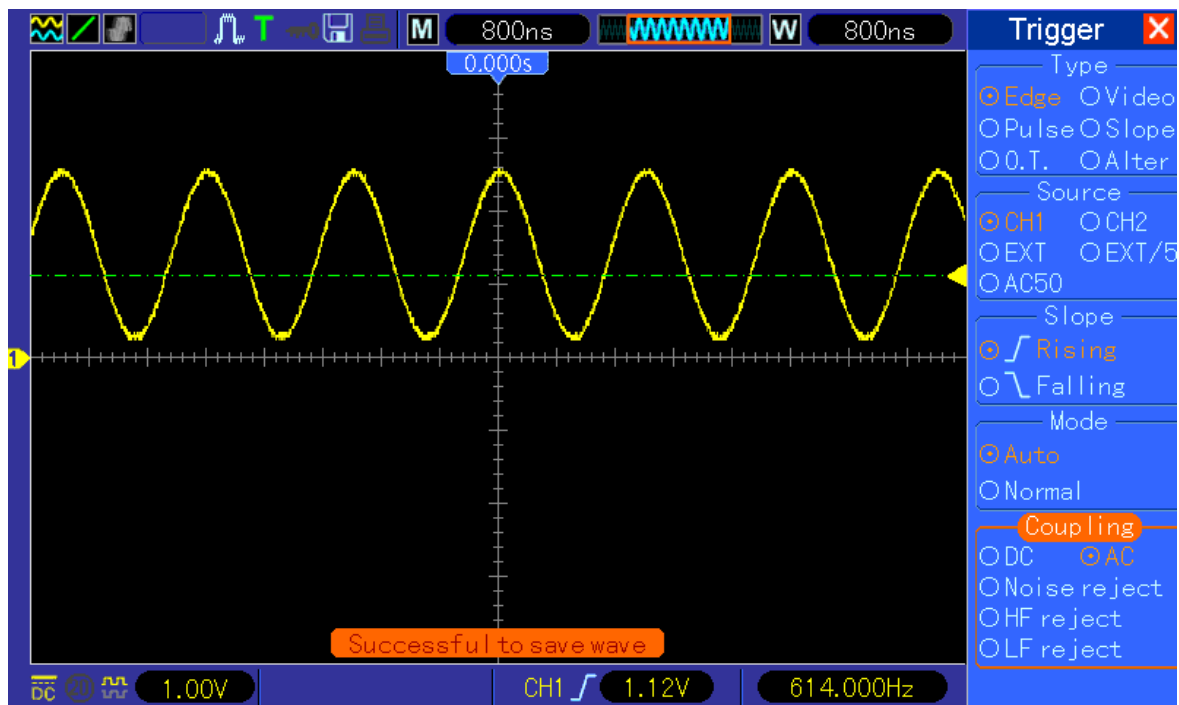
13. AC trigger indicator and line wrong. Set ch1, signal DC coupled, trigger AC coupled. The trigger lowest level below signal :

highest level only mid of signal

11. ~~This is improvement proposal and not a bug.~~
12. ~~Use my firmware (2.06.3\_120507.6), I removed that bug.~~
13. Use DC trigger coupling or “add offset” when you set trigger point. On some other good known DSOs (e.g. Tektronix TDS7xxx) there is exact the same DC-signal/AC-trigger “dependency” (bug) and nobody ever complained about.

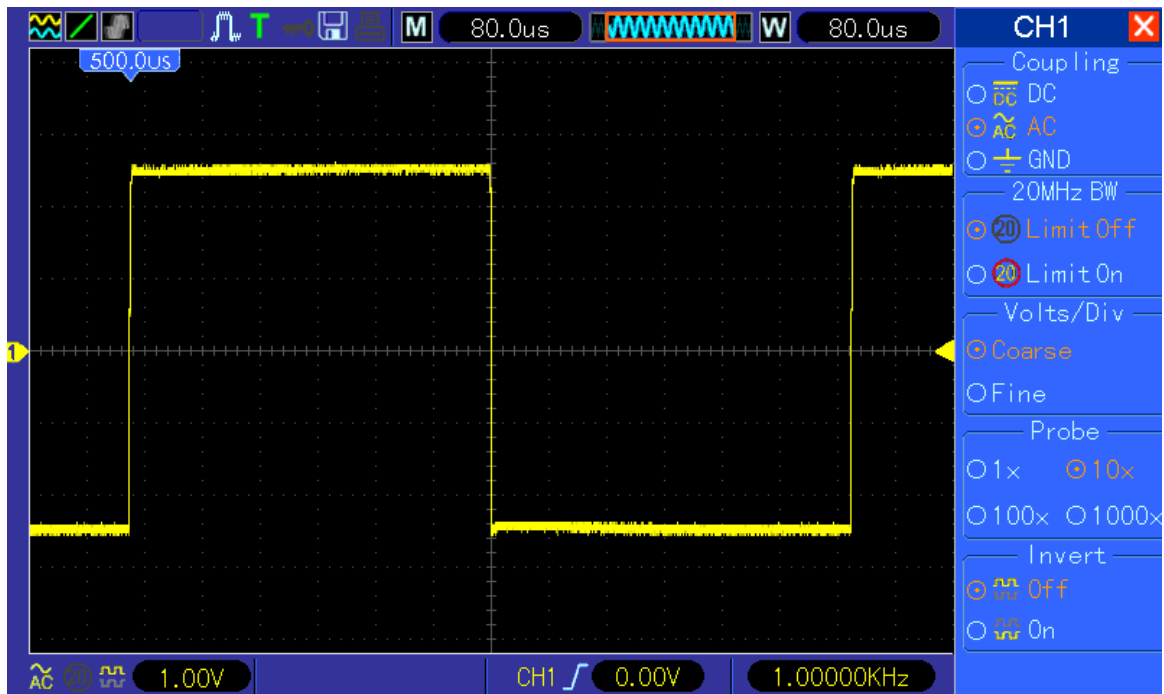
15. Display / Time base scaling strange behavior. When you apply e.g. 1kHz signal, set time base to 80us/DIV and move the waveform to 500us/DIV:

When you now change time base to 40uS/DIV the falling edge (which should be still in the middle of the screen) has been moved to 454uS position (but it should stay on 500uS). The same happens of course with 20uS/DIV.

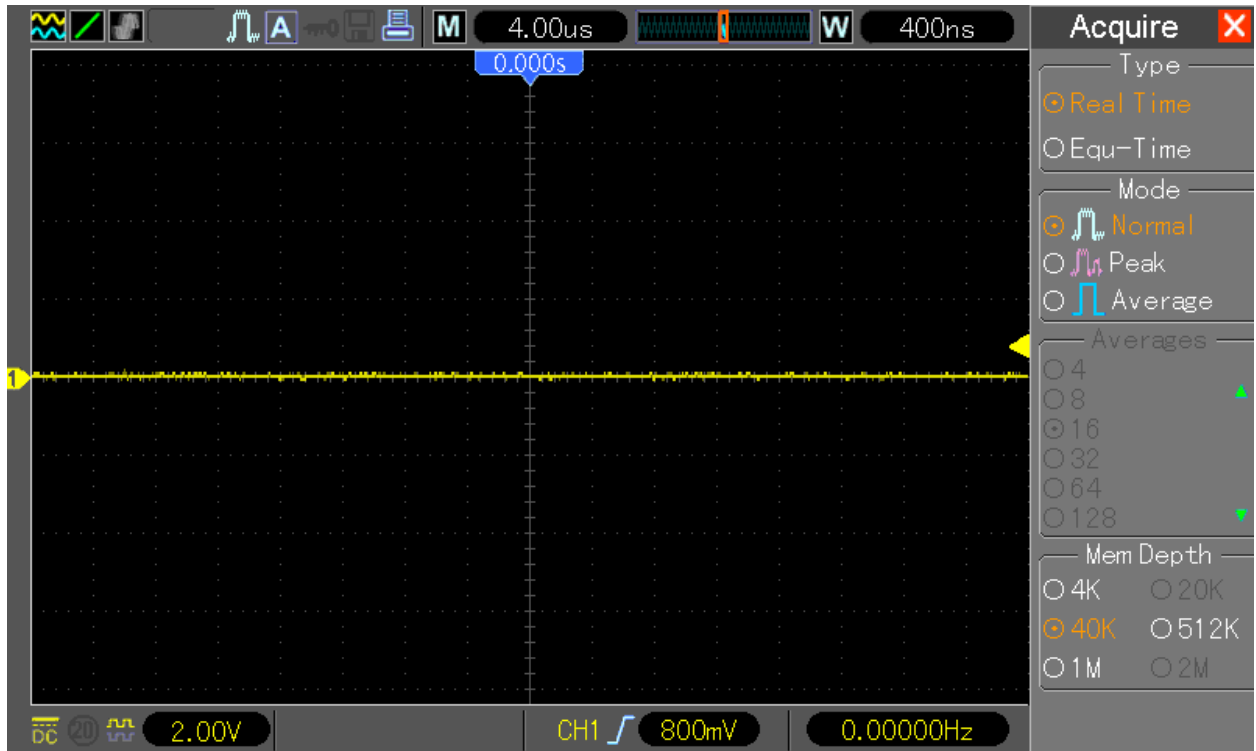
27. While switching from single into dual window mode the main timebase is changing with a wrong factor, e.g. from 200ns/DIV in single into 400ns/DIV in dual window mode. Similar issue in 40k/512k and 1M – in dual window the MTB is twice that high as before in single window mode. Due incorrect timebase the display buffer is showing artifacts on both right and left side of the waveform (end of buffer). Example: CH1 enabled, 40k memory, single window and windows timebase smaller than main timebase, here 400ns/DIV (Main TB is 4us/DIV for 40k)

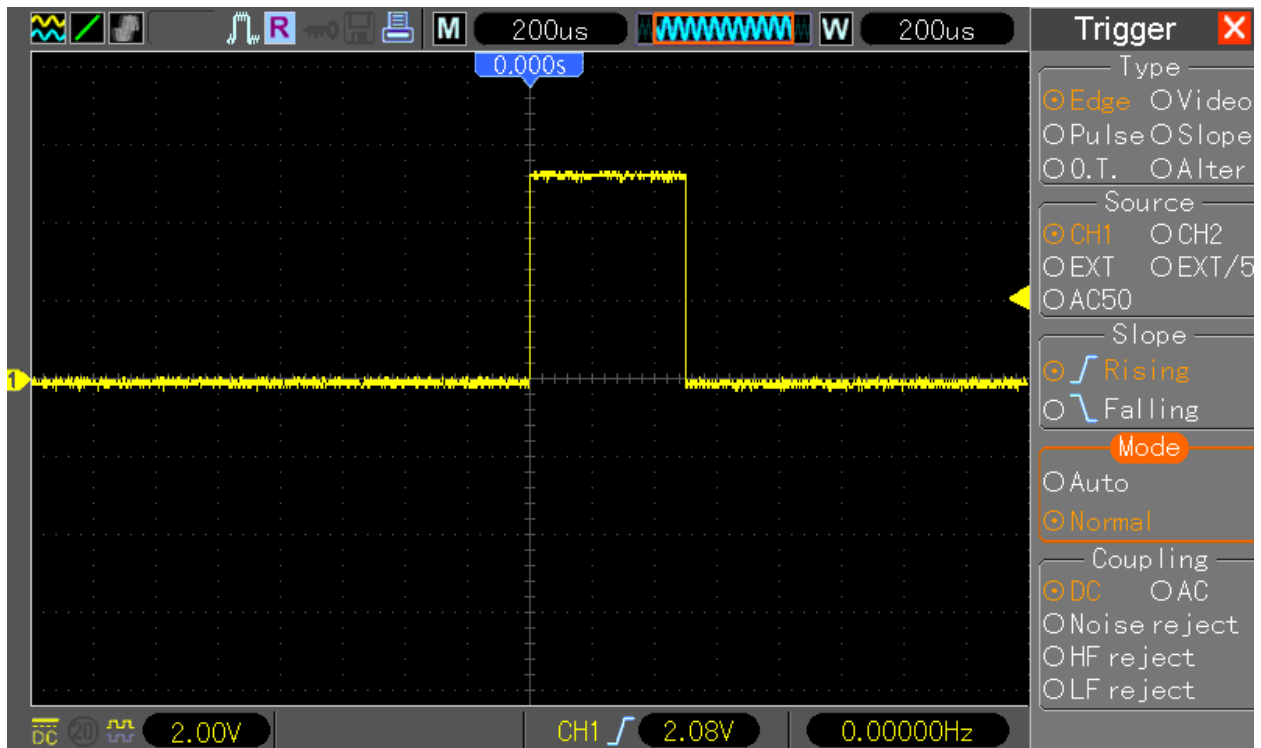
1ch, 4k memory depth, Trigger “Normal”, Signal generator to 500us pulse repeating for example every 5 seconds.

After first trigger event the waveform will appear as following on screen:

Now when you turn the Horizontal position knob to left or right to change the position, the blue trigger indicator is changing as expected, but the already captured waveform is not moving (which is a bug, it make sense to be able to move already captured waveform while waiting for next trigger event. )

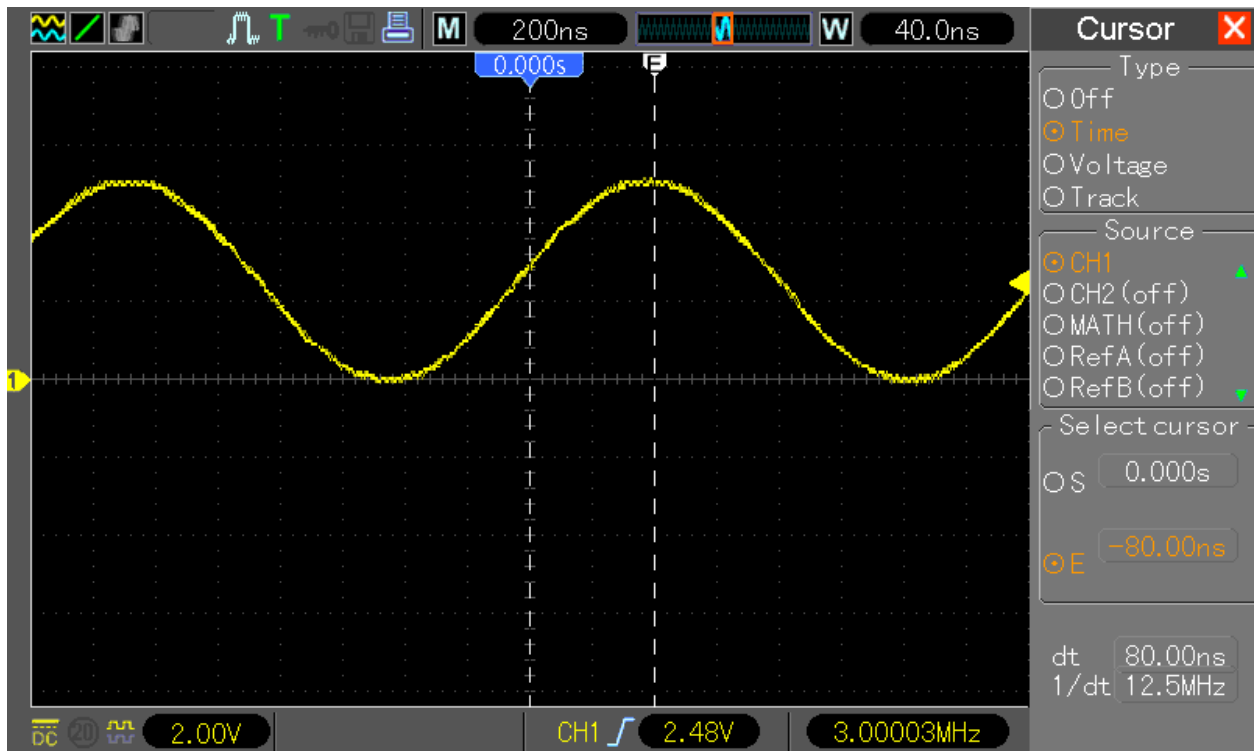
and enabling Menu again with F0. The E cursor value is now having proper value (-80ns):

This was working properly the last time in firmware 110923.1

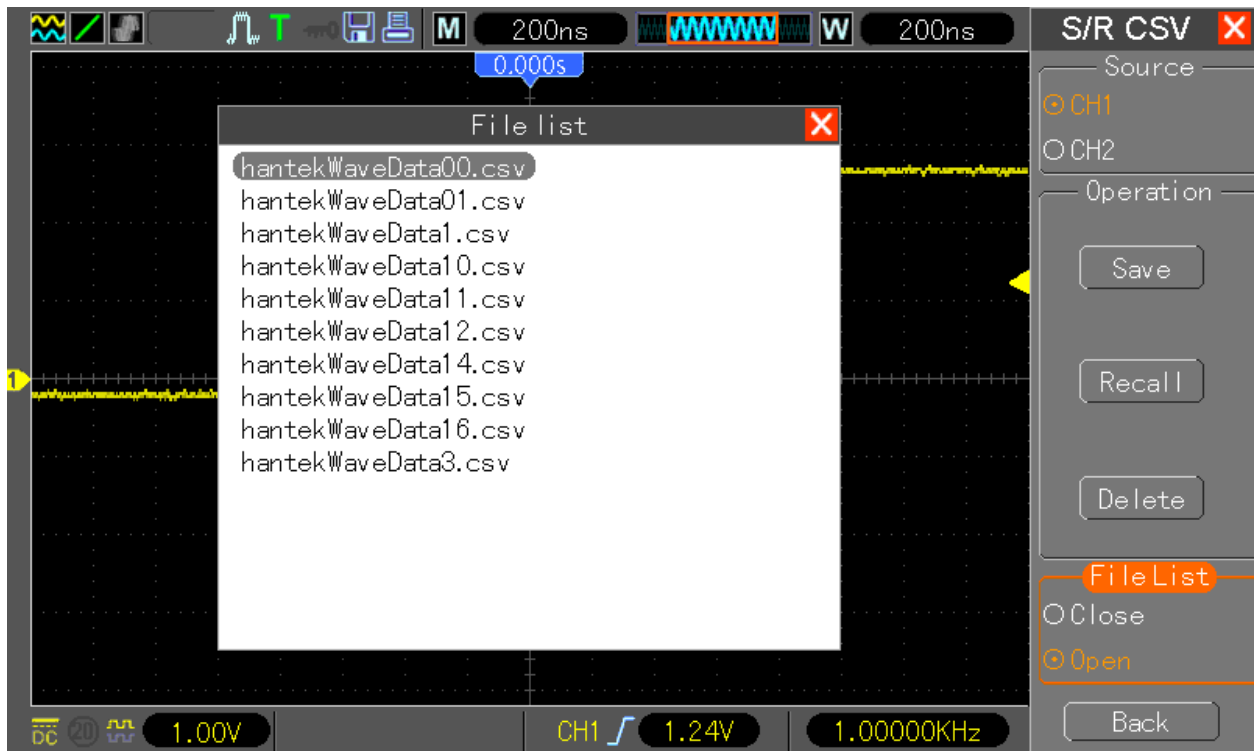
40. Flash Drive directory listing (in CSV Save/Recall and DSO Setup Save/Recall menus) is showing maximum 10 files. Additionally no option to scroll over the directory to choose other than one of the listed 10 files

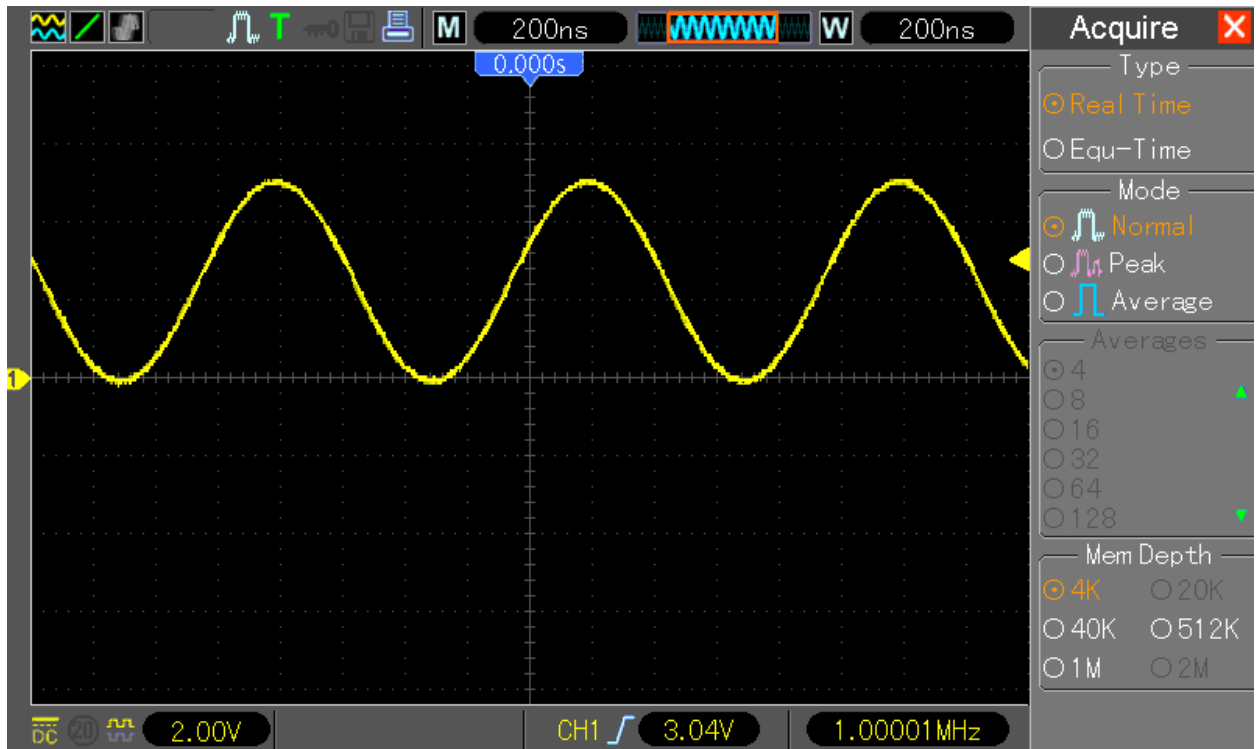
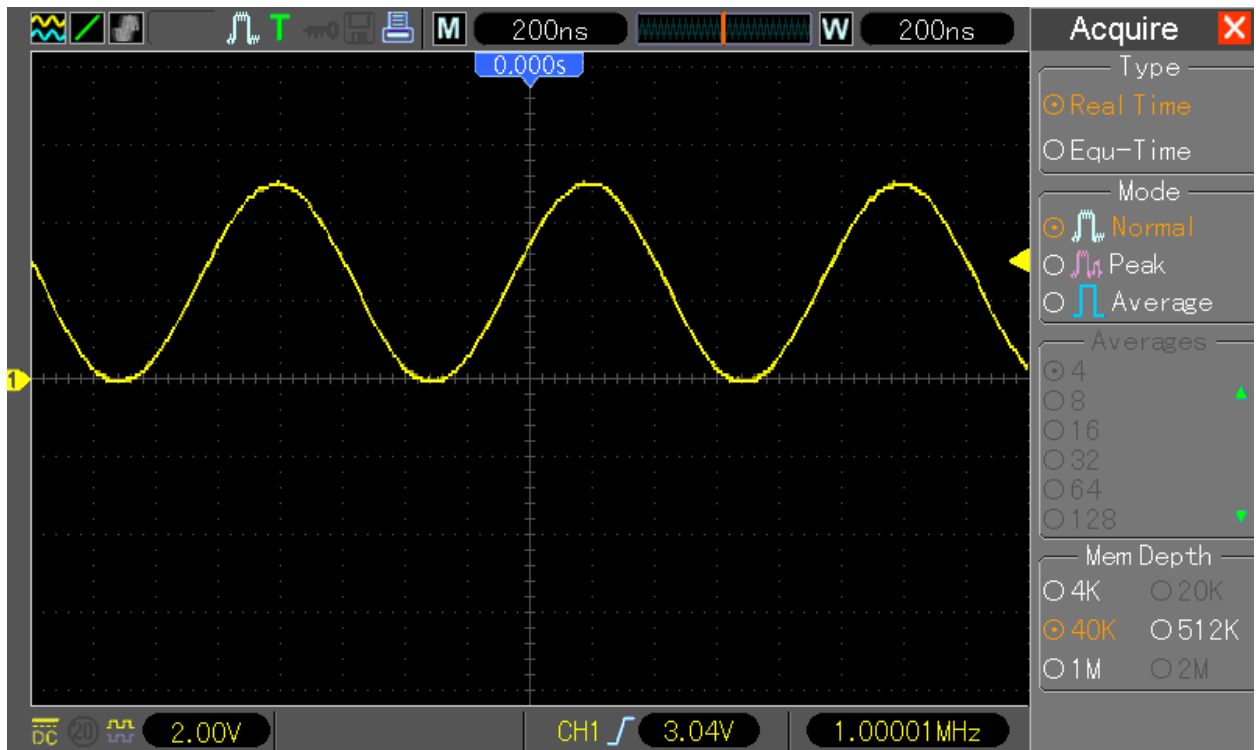
48. When changing memory depth, the MTB is not changing automatically together. Set following on DSO, 4k, 1ch, 200ns/DIV MTB:

change now memory depth to 40k, the MTB is still displaying 200ns/DIV

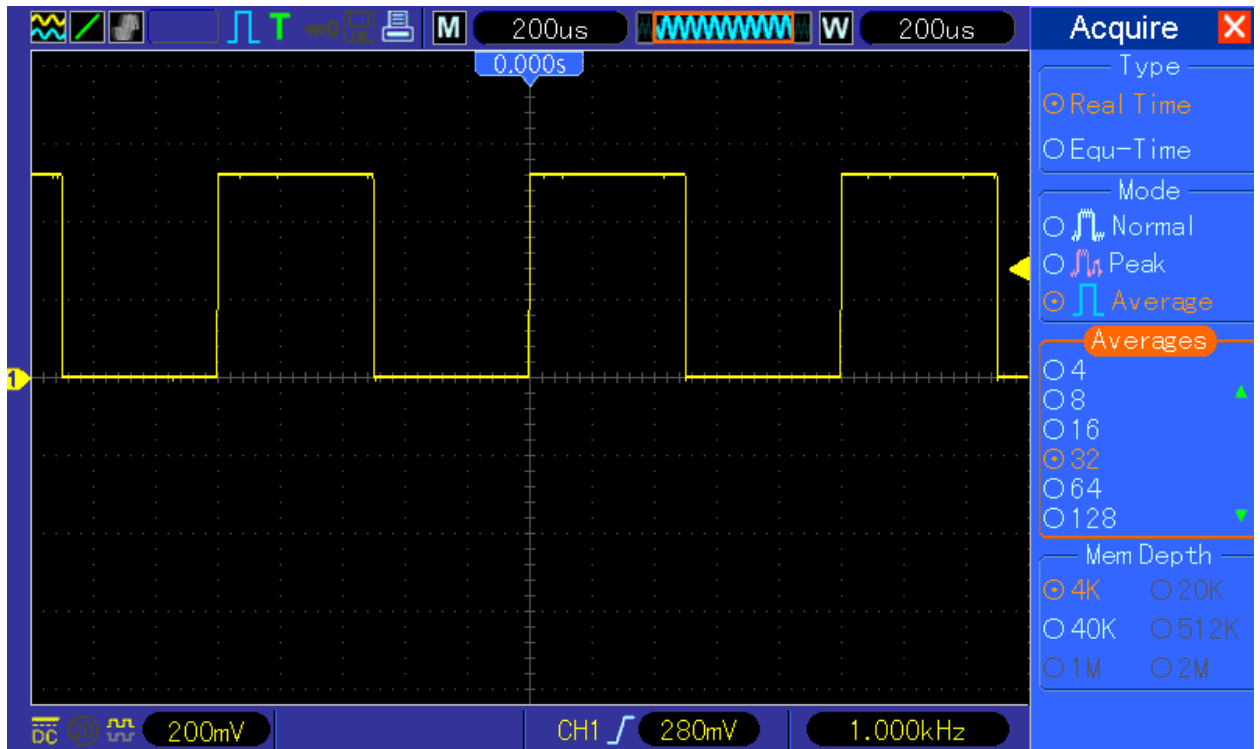
53. When number of Averages is higher than 16, and changing from 4k memory depth:
