## Firmware 2.06.3 bug list:

## List of bugs/improvement requests

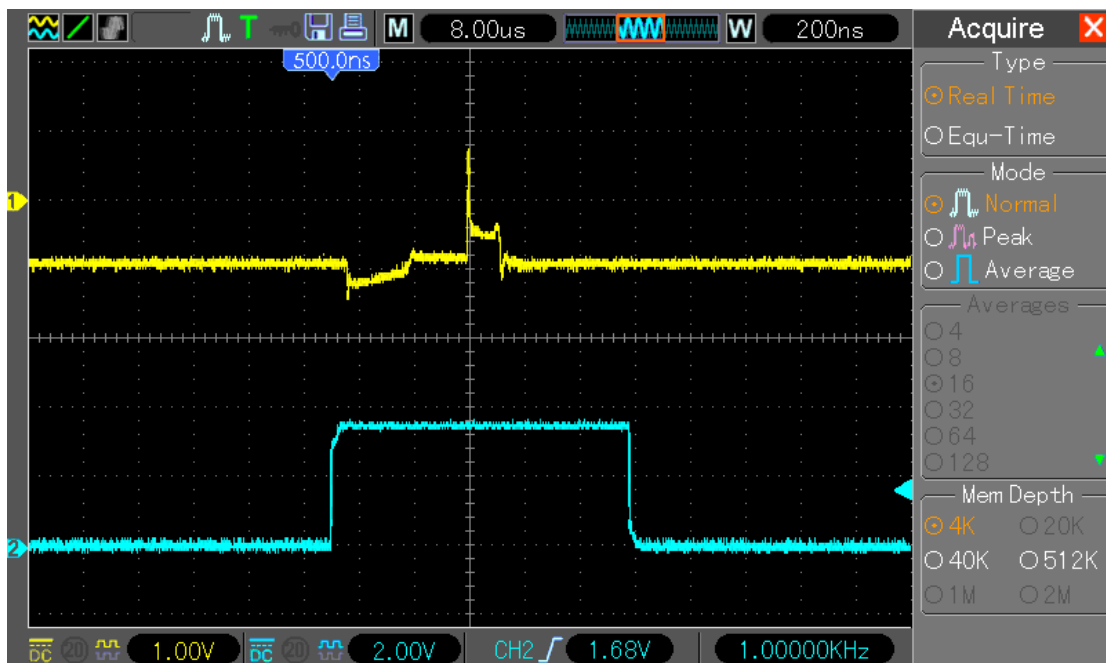
8. In single window, sample memory  $\geq 40k$ , both channels (ch1, ch2) enabled and time base from 400ns/div up to 2ns/div the position change (fine and coarse) control is not working. Only scale is moving, but not the waveform. See attached picture to understand issue:

with 4k memory when changing position waveform is moving

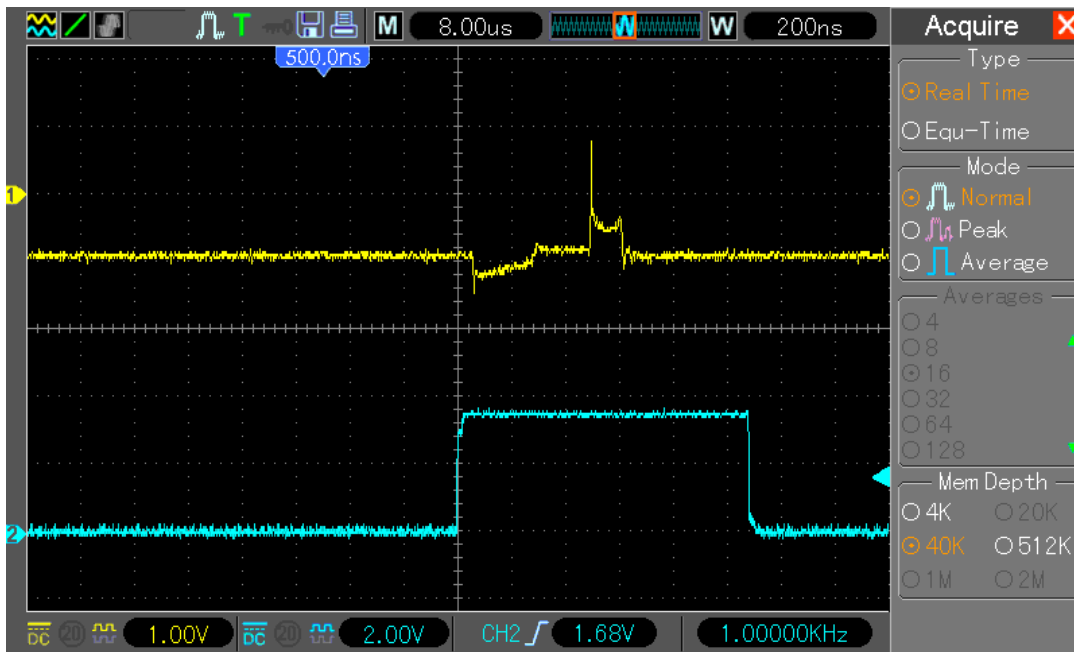
with 40k and above, when moving changing time base position waveform is NOT moving when in RUN mode (but works in STOP mode)

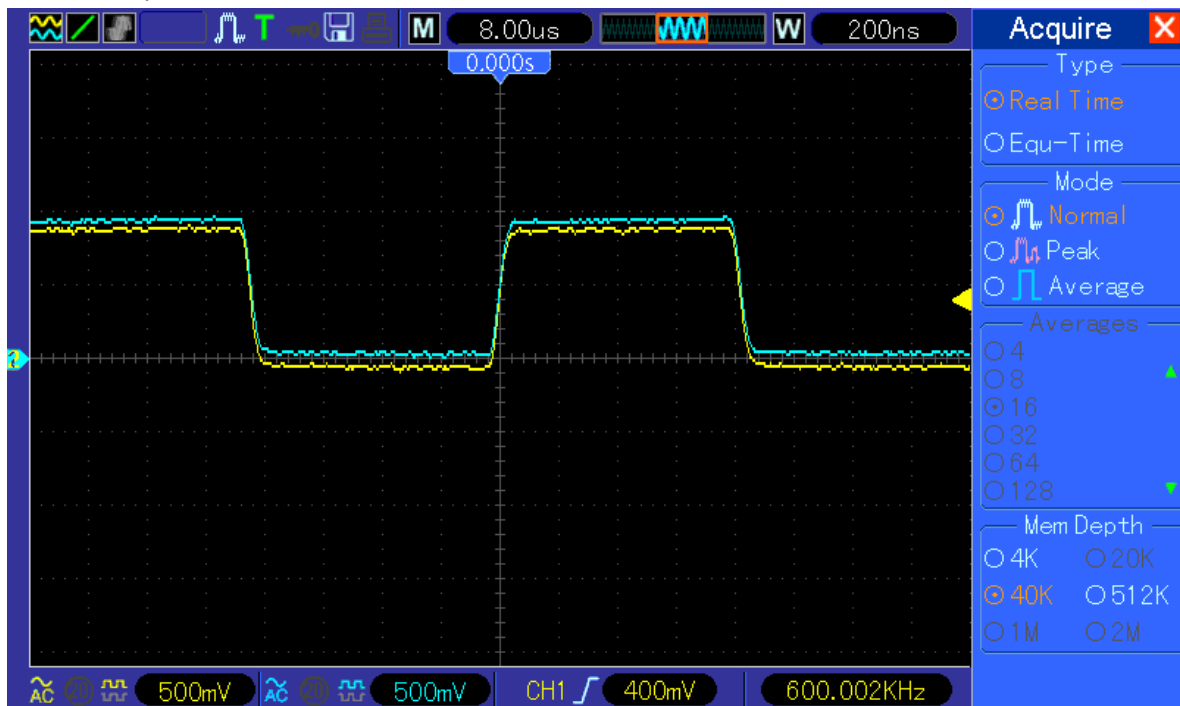
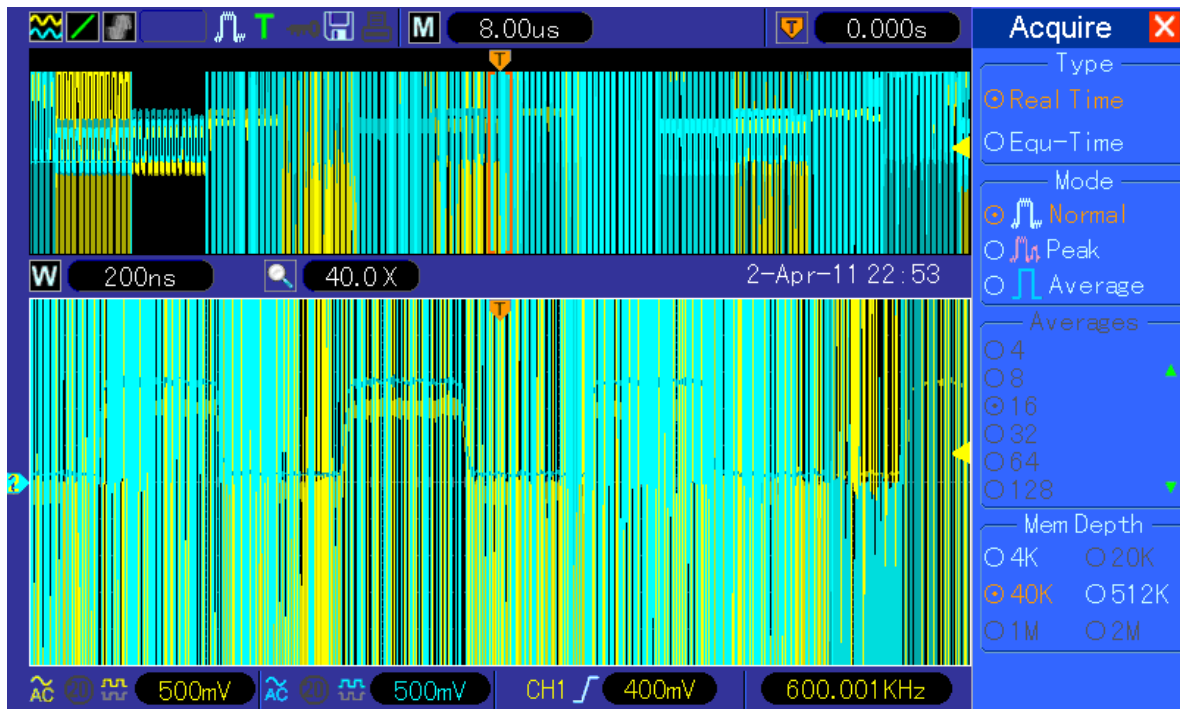
- In single window mode, sample memory 40k, both channels (ch1, ch2) enabled – while switching to dual window mode artifacts on screen and DSO later crashing and not responding.

**Artifacts disappear when changing timebase just after switch to dual window, so just an init error?**

and switch dual window mode to see artifacts like this:

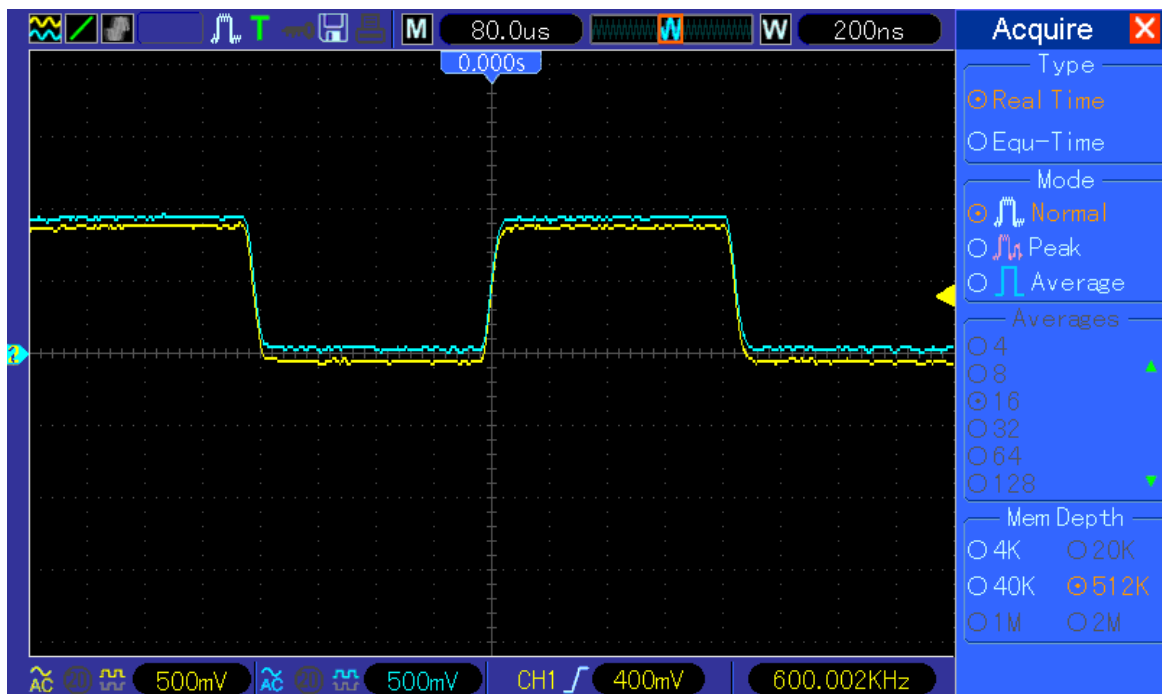
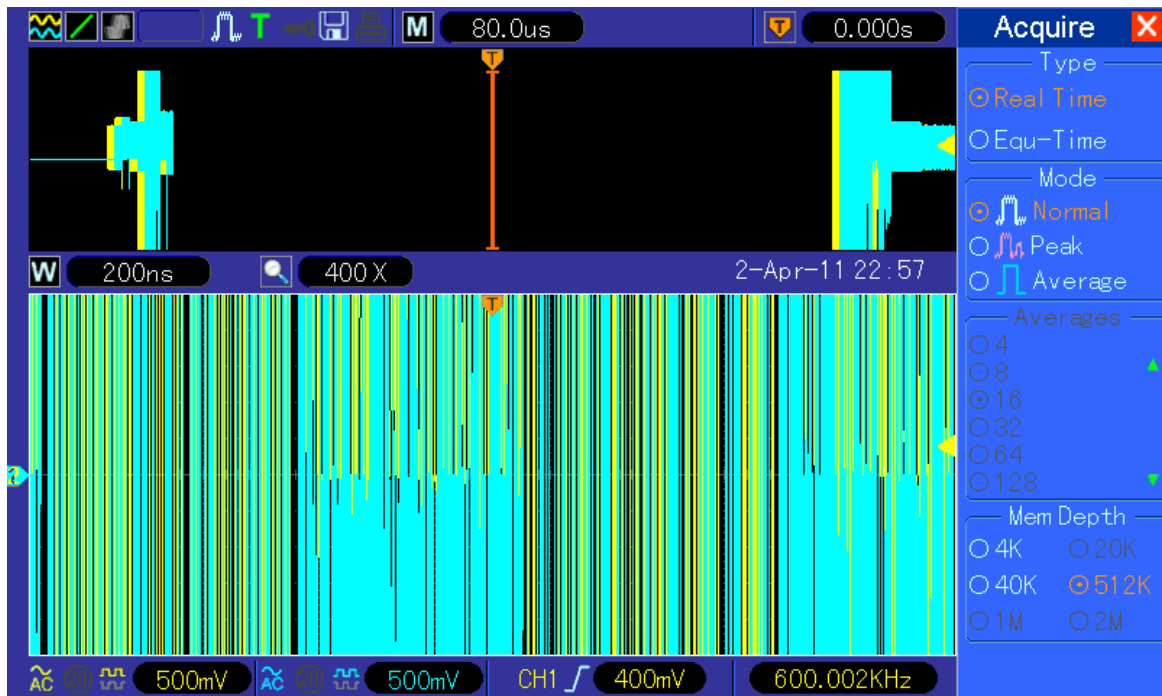
10. In single window mode, sample memory 512k, both channels (ch1, ch2) enabled – when switching to dual window mode artifacts on screen and DSO later crashing and not responding

**Artifacts disappear when changing timebase just after switch to dual window, so just an init error?**

and switch dual window mode to see artifacts like this:

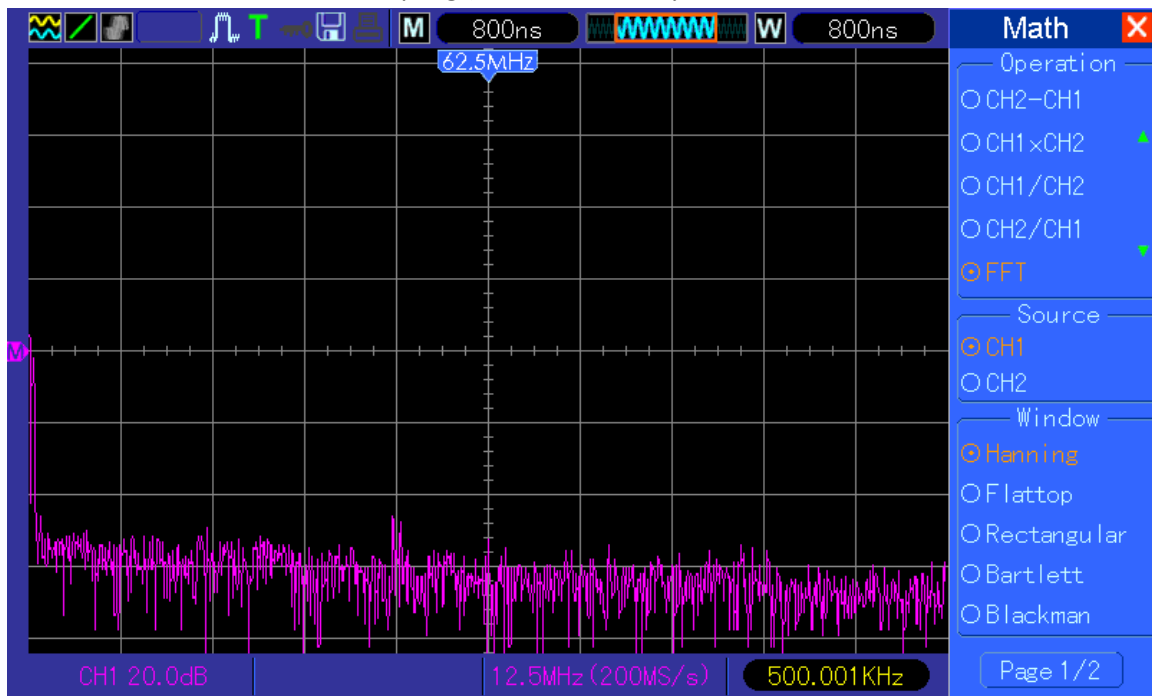
12. In FFT mode “Full span” is higher than Nyquist (sample rate / 2 )  
 Example: 800ns/DIV, sample rate is 200MSs, full span 125MHz. Easy to fix by enabling from

800ns/DIV to 20ns/DIV 1GSs sampling (when 4k memory or FFT enabled)

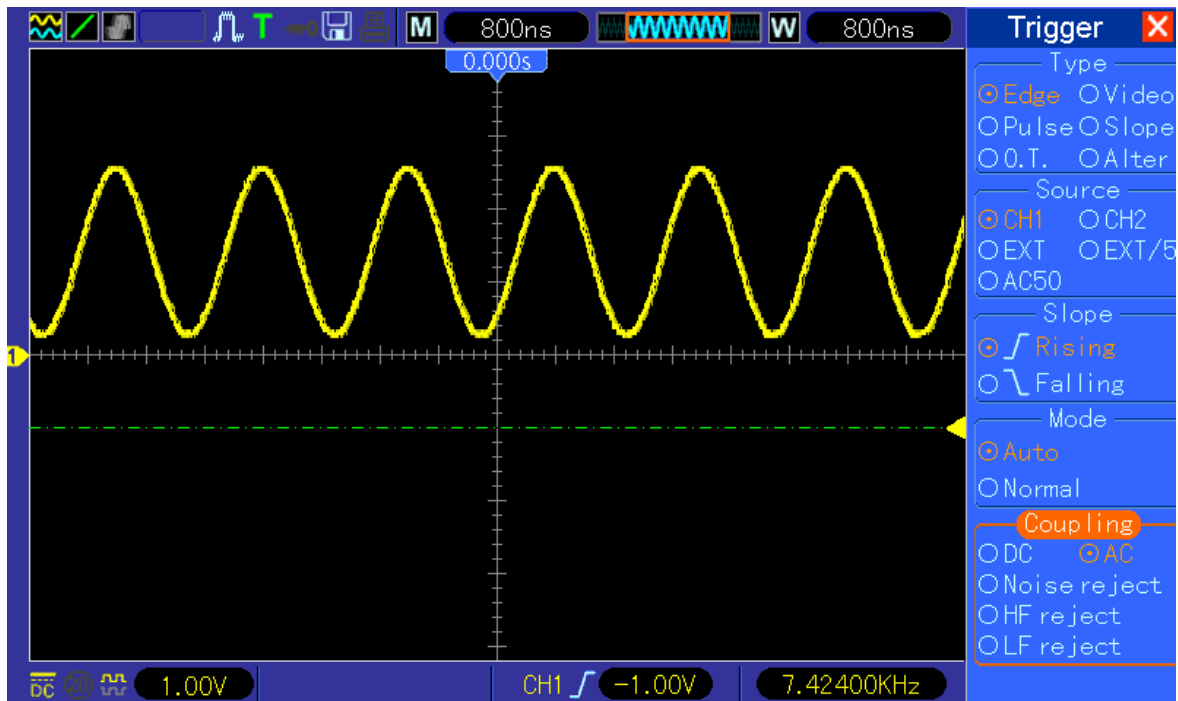
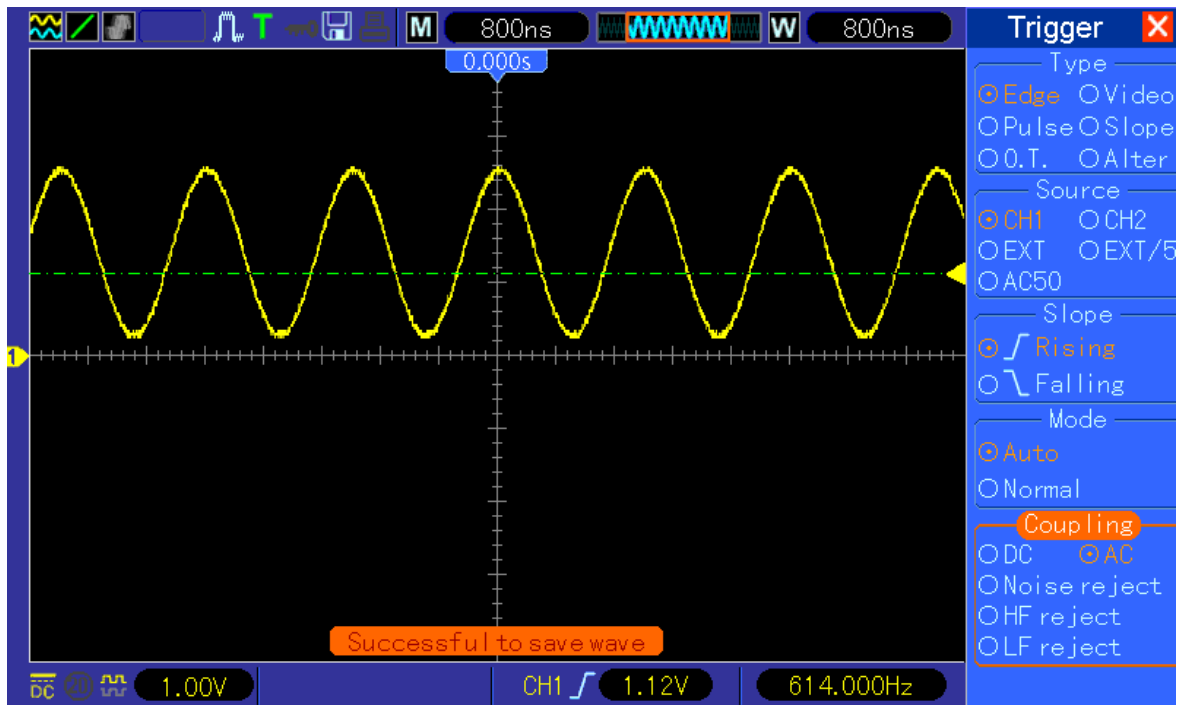
13. AC trigger indicator and line wrong. Set ch1, signal DC coupled, trigger AC coupled. The trigger lowest level below signal :

highest level only mid of signal

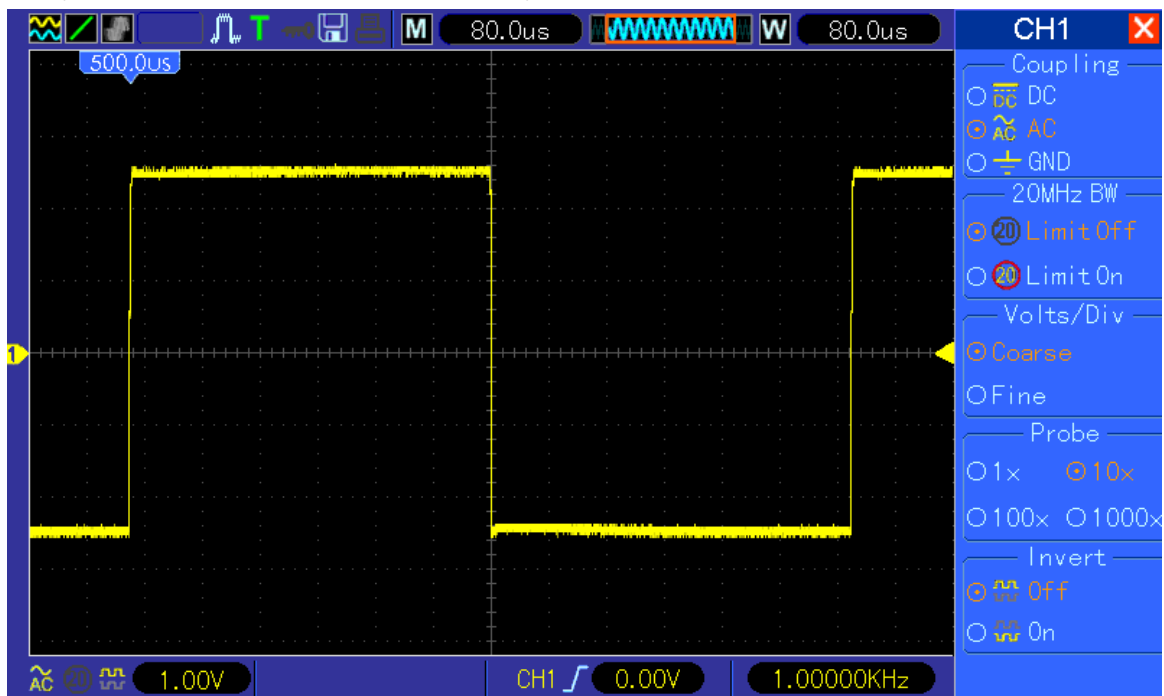
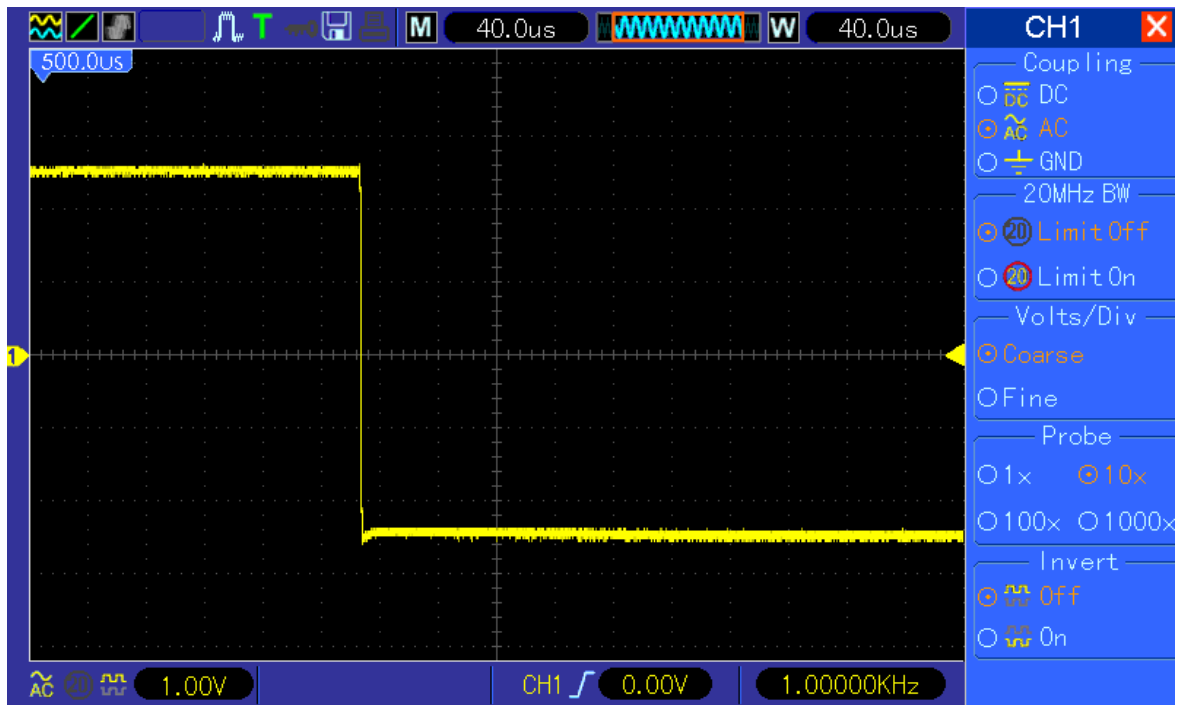
- Display / Time base scaling strange behavior. When you apply e.g. 1kHz signal, set time base to 80us/DIV and move the waveform to 500us/DIV:

When you now change time base to 40uS/DIV the falling edge (which should be still in the middle of the screen) has been moved to 454uS position (but it should stay on 500uS). The same happens of course with 20uS/DIV.

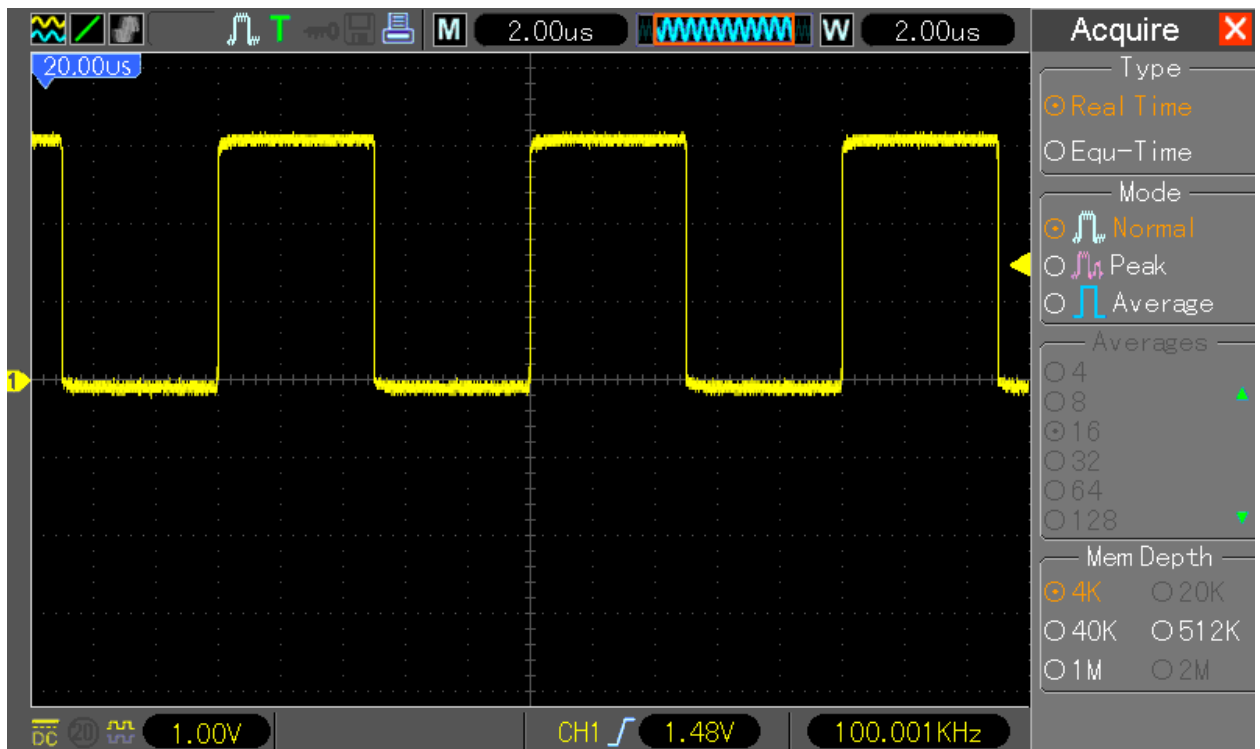
Another example , waveform moved to trigger delayed by 20us:

when zoomed it is not ok, it is off by 1.8us already!

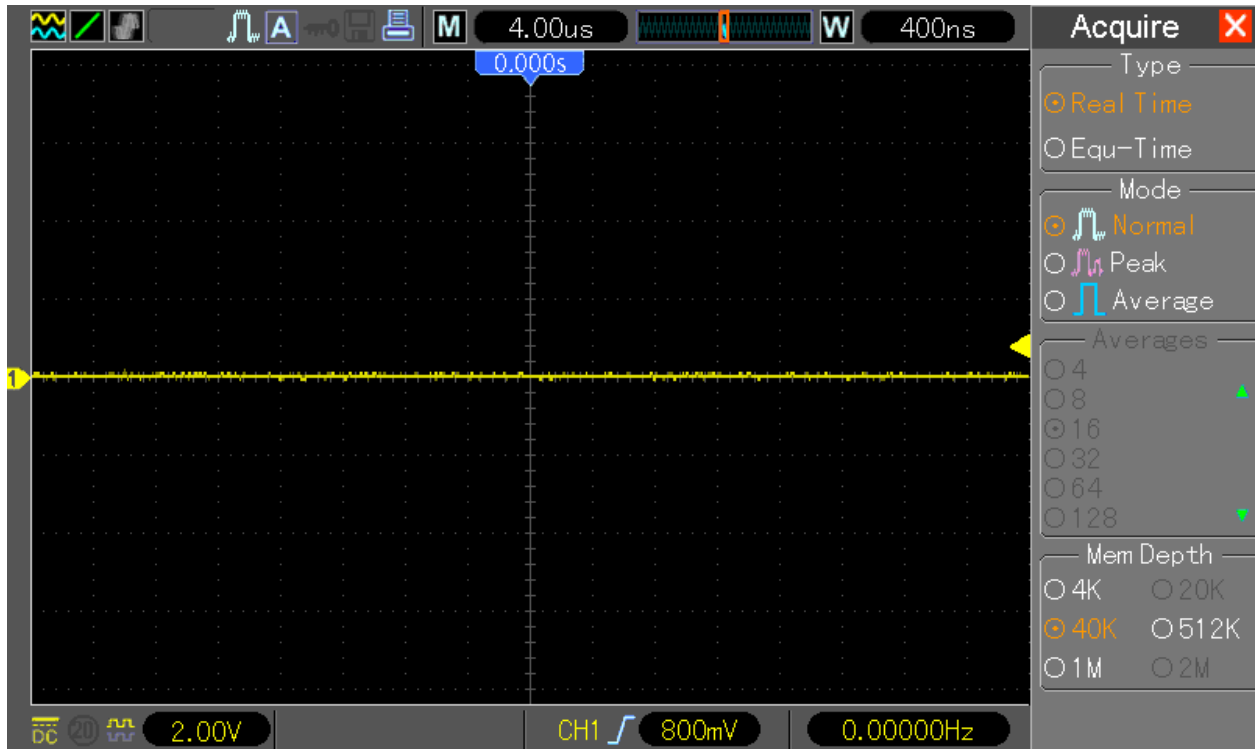
27. While switching from single into dual window mode the main timebase is changing with a wrong factor, e.g. from 200ns/DIV in single into 400ns/DIV in dual window mode. Similar issue in 40k/512k and 1M – in dual window the MTB is twice that high as before in single window mode. Due incorrect timebase the display buffer is showing artifacts on both right and left side of the waveform (end of buffer). Example: CH1 enabled, 40k memory, single window and windows timebase smaller than main timebase, here 400ns/DIV (Main TB is 4us/DIV for 40k)

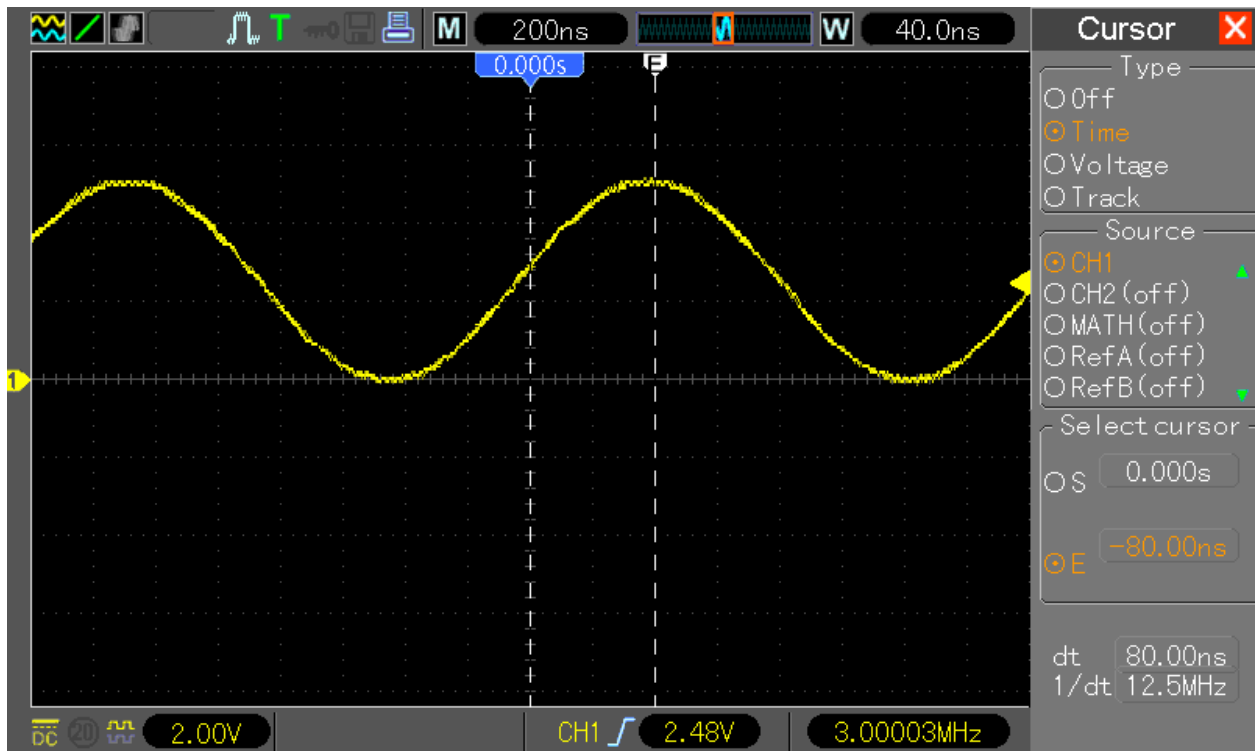
and enabling Menu again with F0. The E cursor value is now having proper value (-80ns):

This was working properly the last time in firmware 110923.1

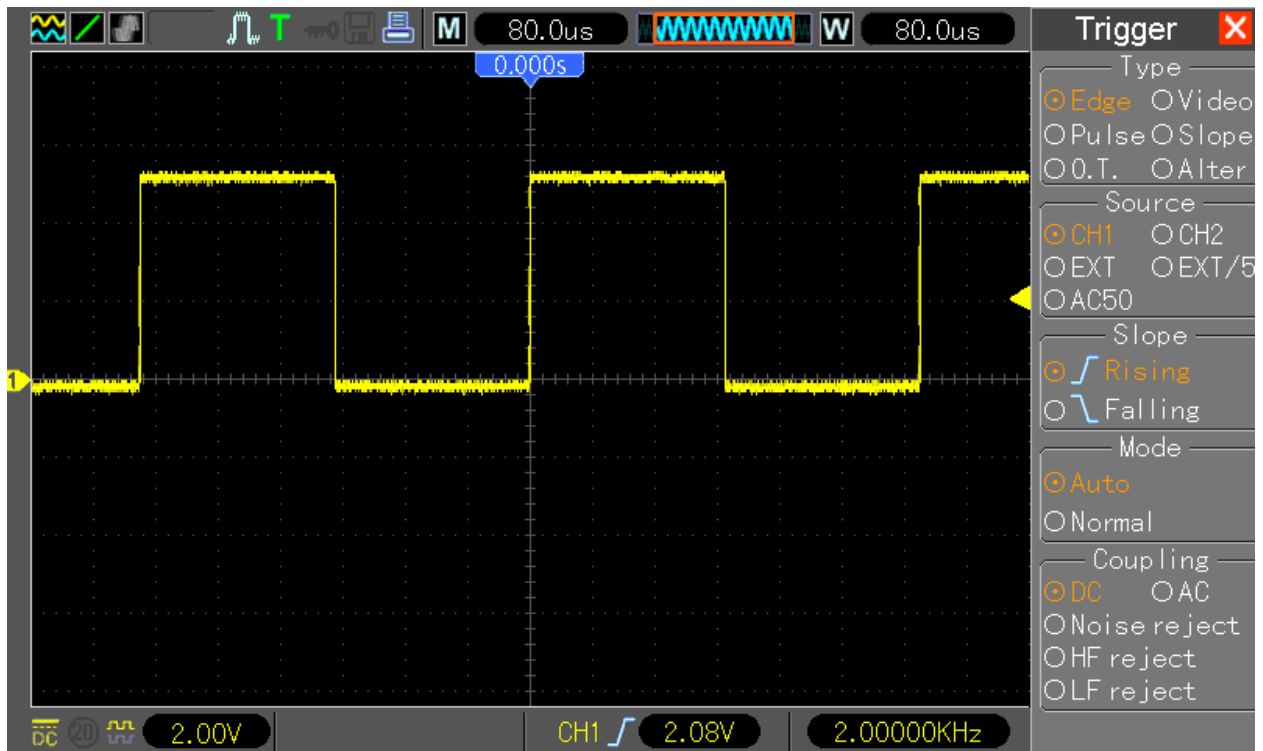
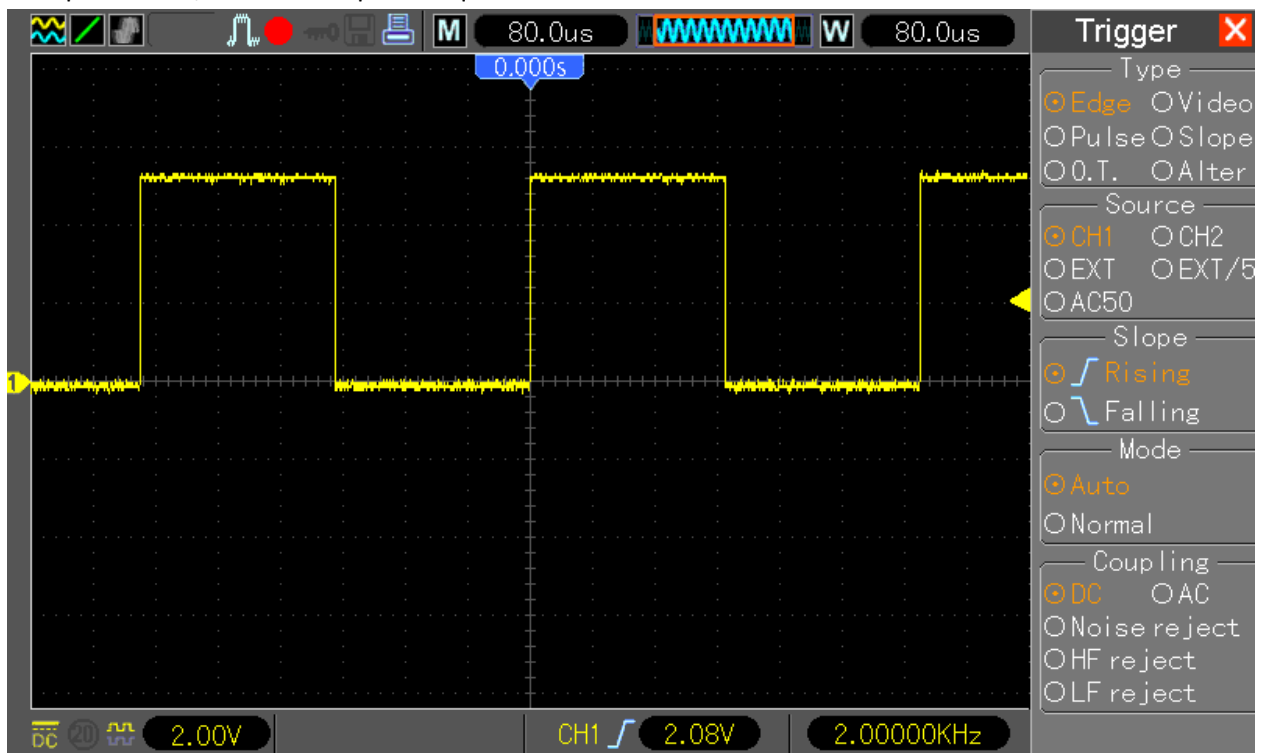
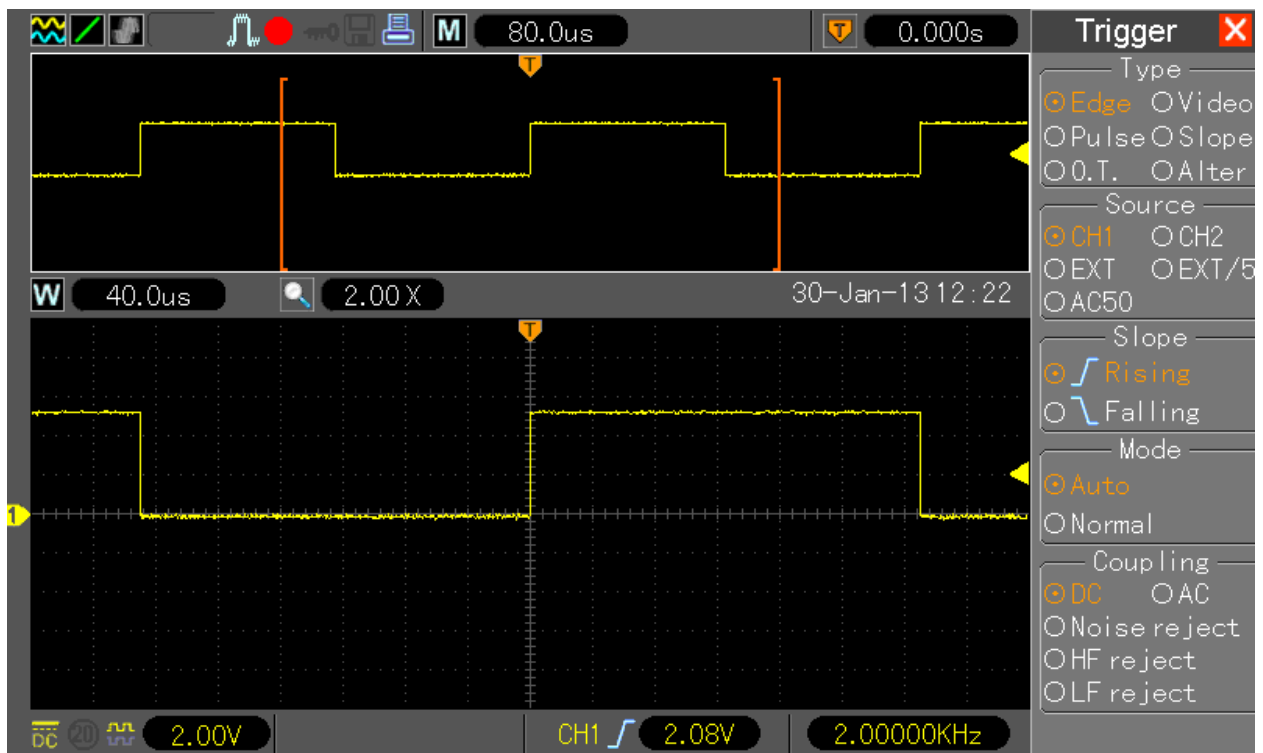
1ch, 4k memory depth, signal generator to 2kHz square, timebase to 80ns/DIV.

The DSO should display 2.5 periods of the waveform:

now push "RUN/STOP" to stop the acquisition:

and push F7 to switch into dual window, the waveform seems to be, top window displaying properly 2.5 periods:

but try now to move horizontal position: wave not moving:

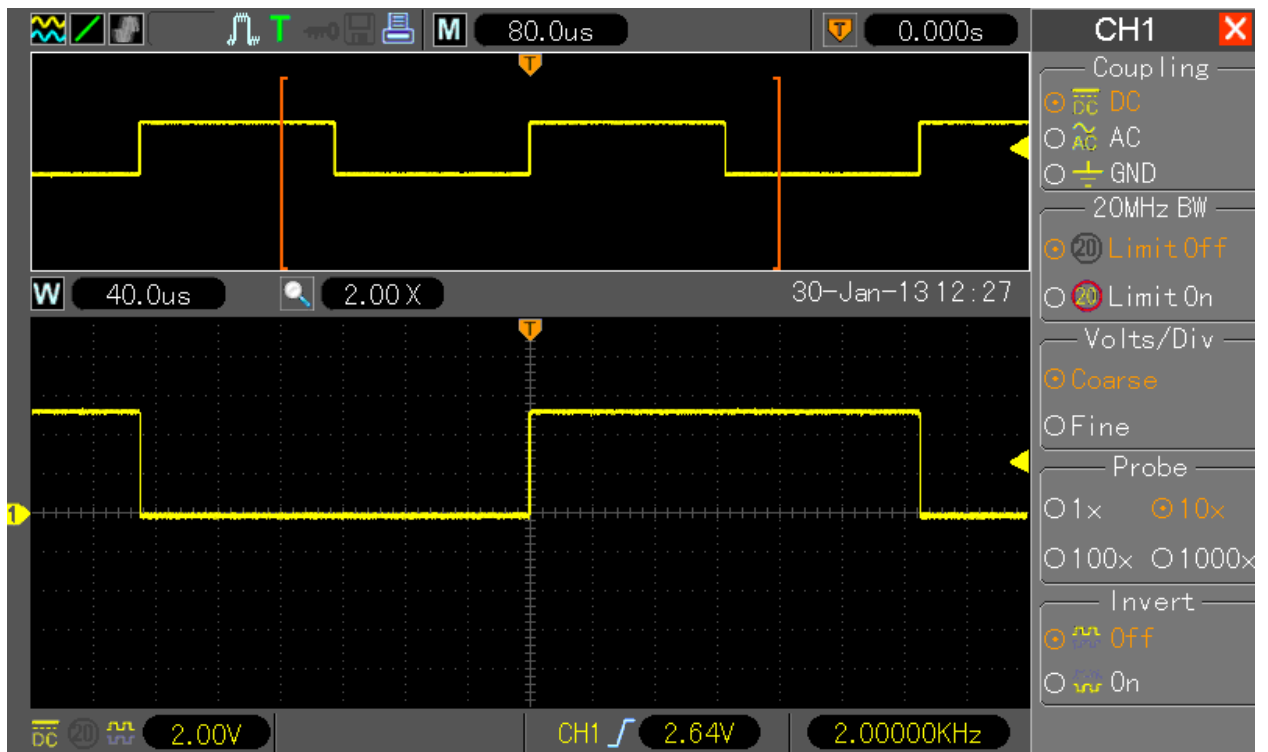
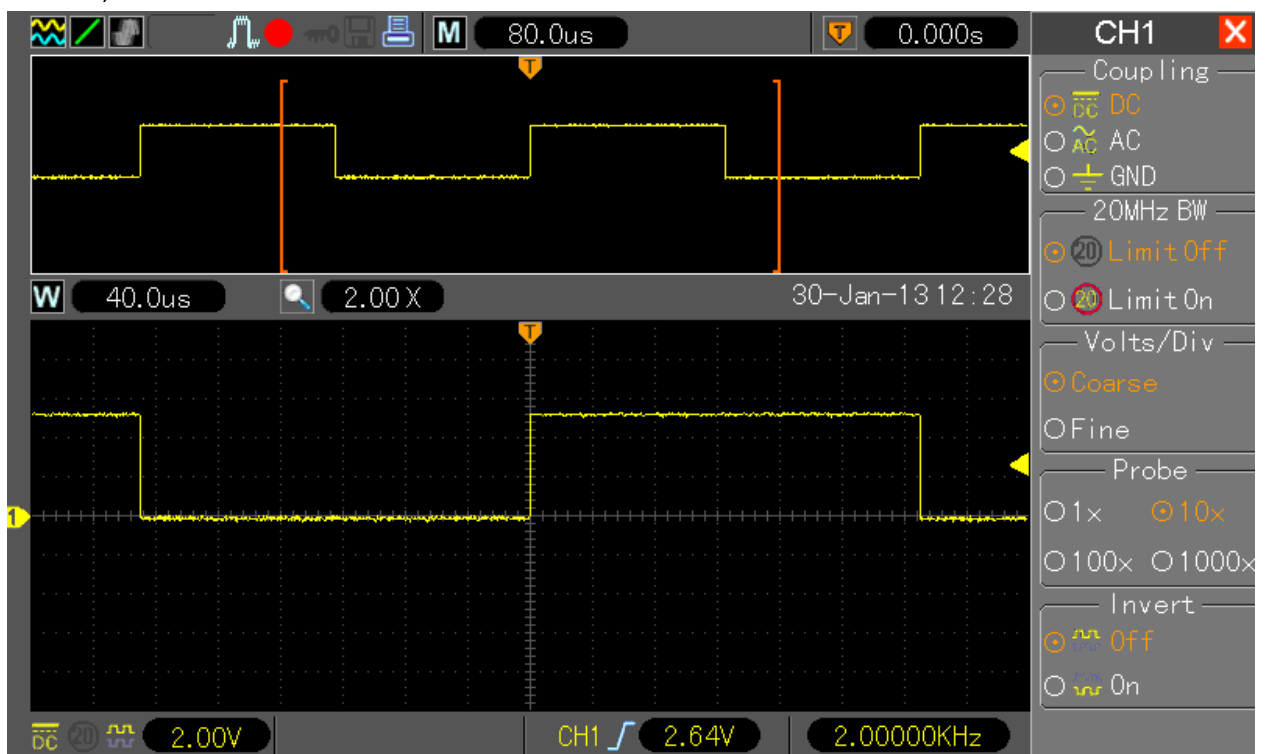
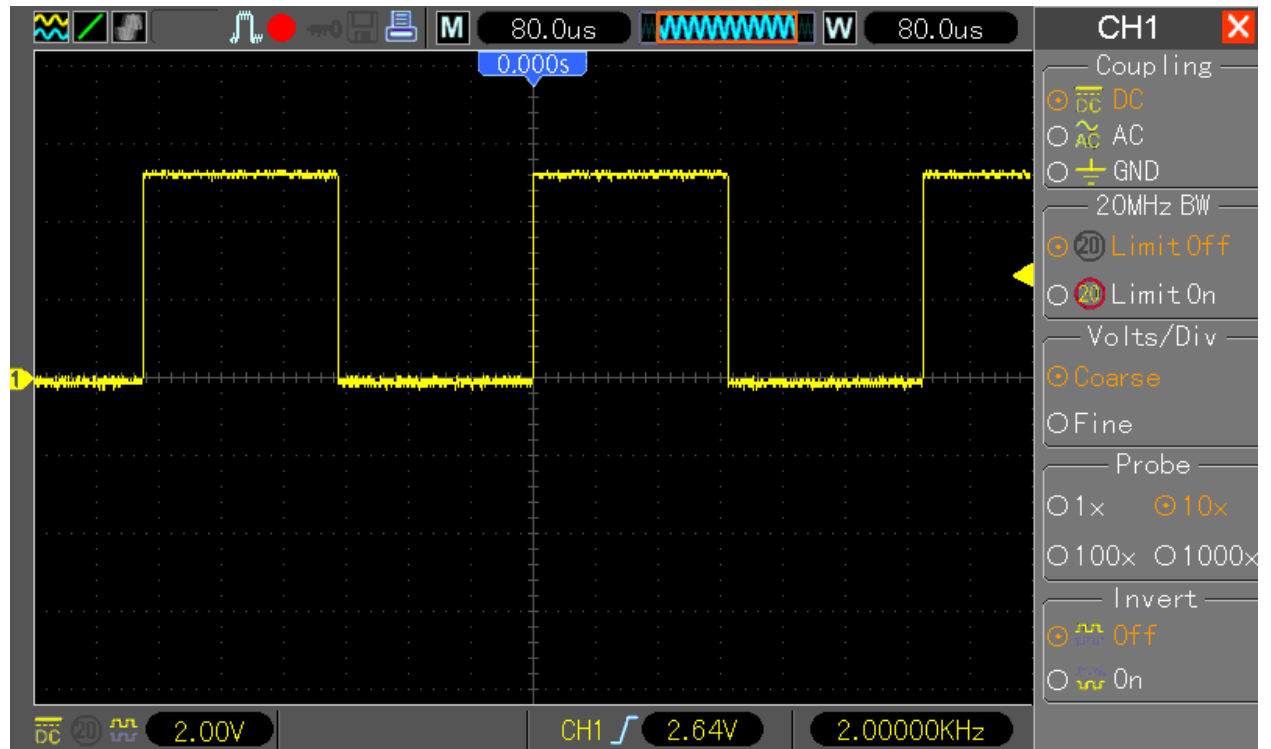
Set DSO to 1ch, 4k memory depth, signal generator to 2kHz square, timebase to 80ns/DIV, dual window mode enabled:

now push "RUN/STOP" button to stop acquisition, the waveform is still ok, can be moved or zoomed, etc:

push now F7 to switch to single window mode, the waveform seems to look ok:

but when you try to move it, or turn timebase nothing changing (see my picture, 8ms/DIV but DSO still showing 2.5 periods):

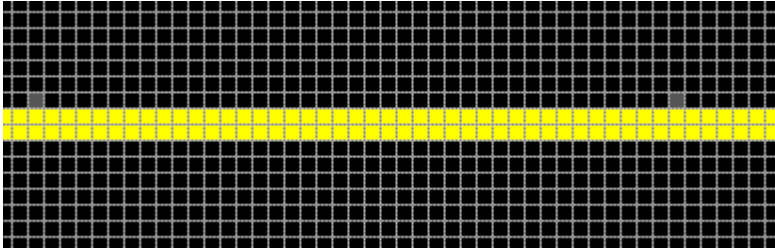
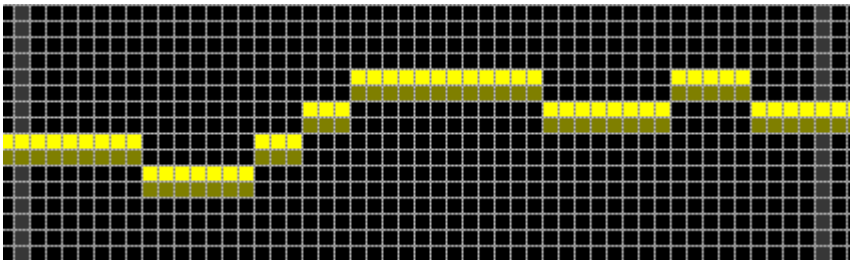
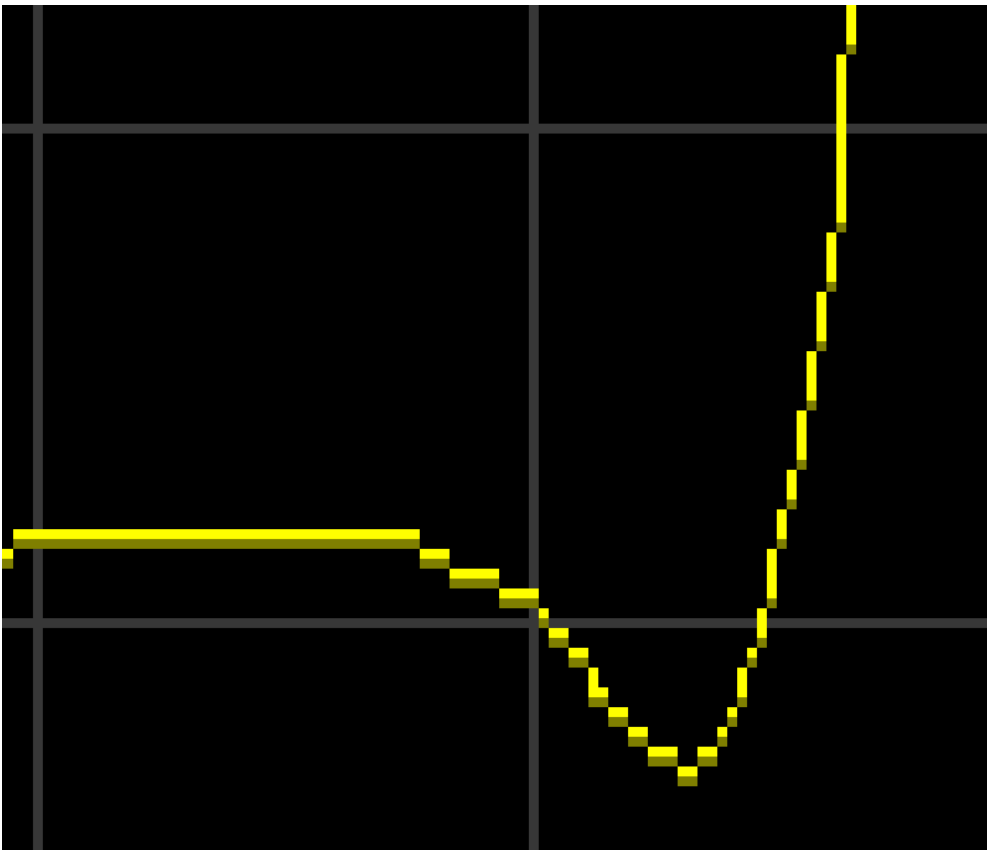
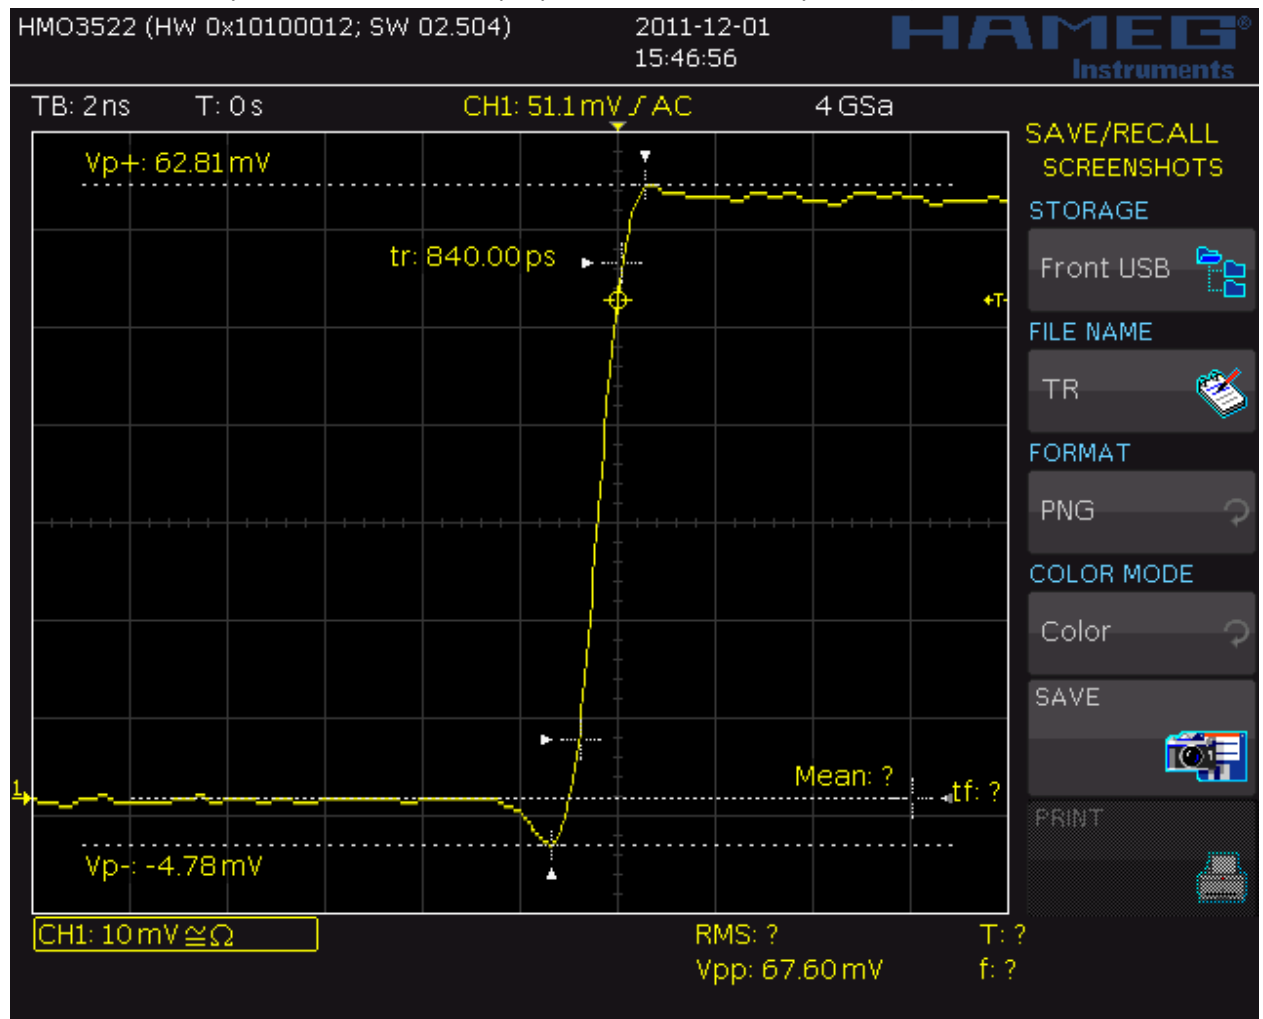
45. **Request** – add shading for pixels on screen. To optimize the view shading for pixels could be added (maybe even as separate Menu, to enable/disable shading)

Currently a line on displays is made from 2 pixels, they have same color:

However this could be improved by changing the **FIRST bottom pixels with shaded color**, like:

and the **pixels above with normal color** like:

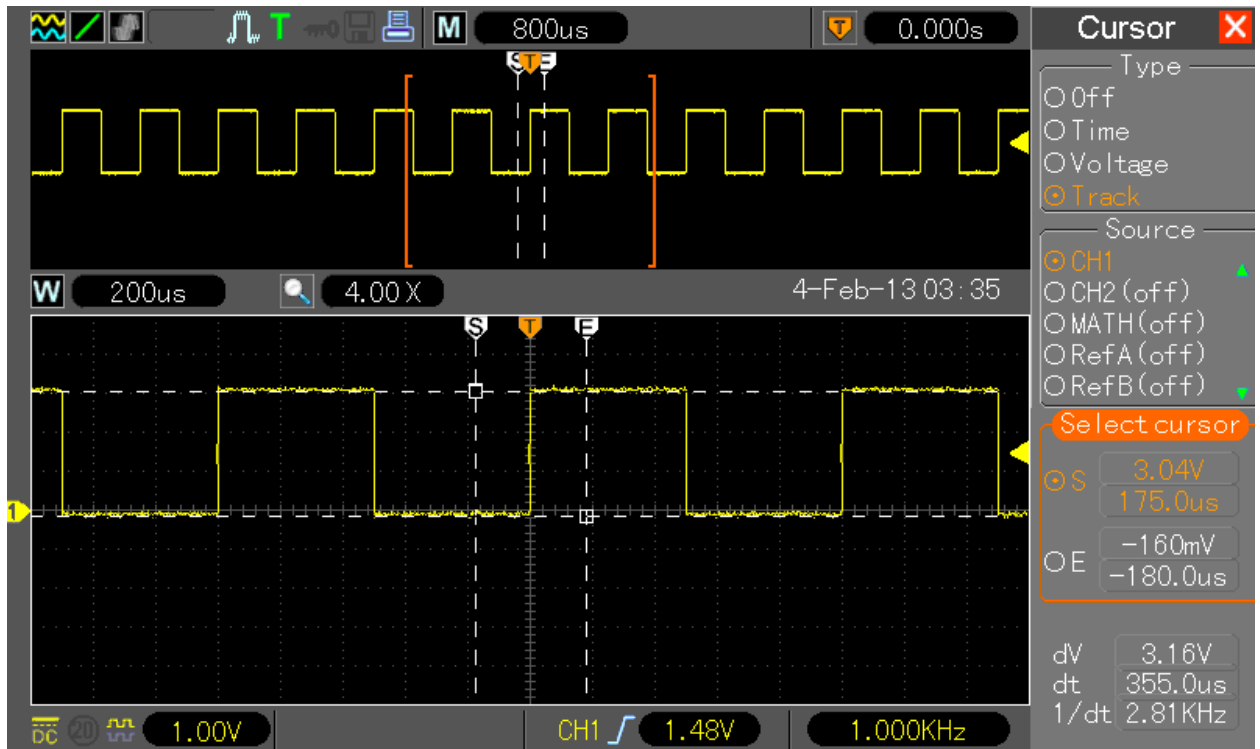
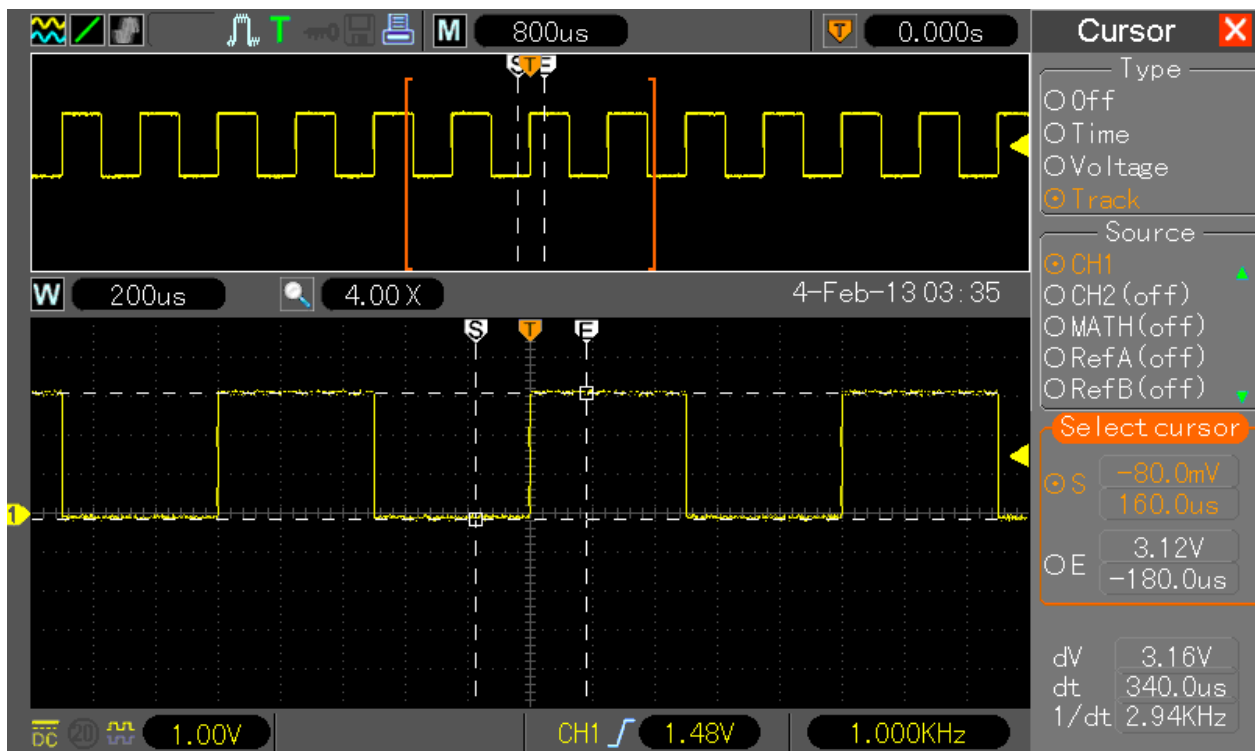
47. Tracking cursor not working when Zoom (W) window focused

When Main Windows selected (M) the tracking cursor however works good:
