## Firmware 2.06.3 bug list:

## List of bugs/improvement requests

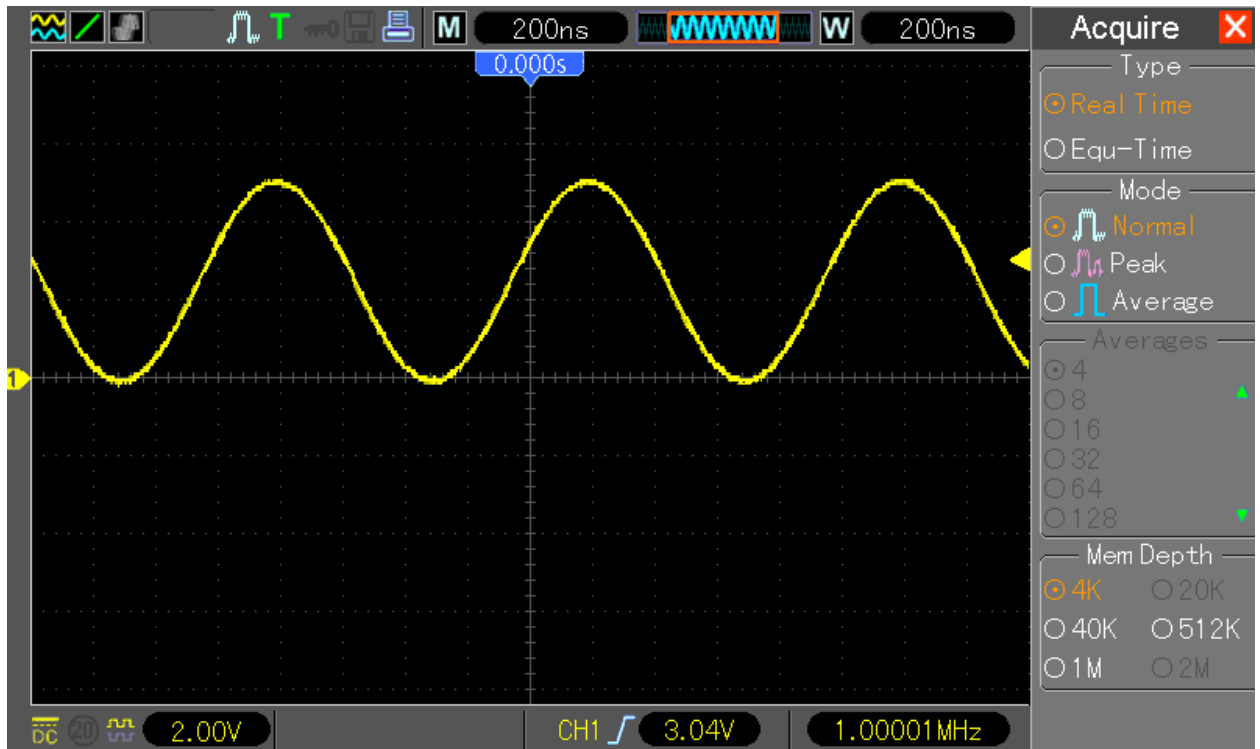
48. When changing memory depth, the MTB is not changing automatically together. Set following on DSO, 4k, 1ch, 200ns/DIV MTB:

change now memory depth to 40k, the MTB is still displaying 200ns/DIV

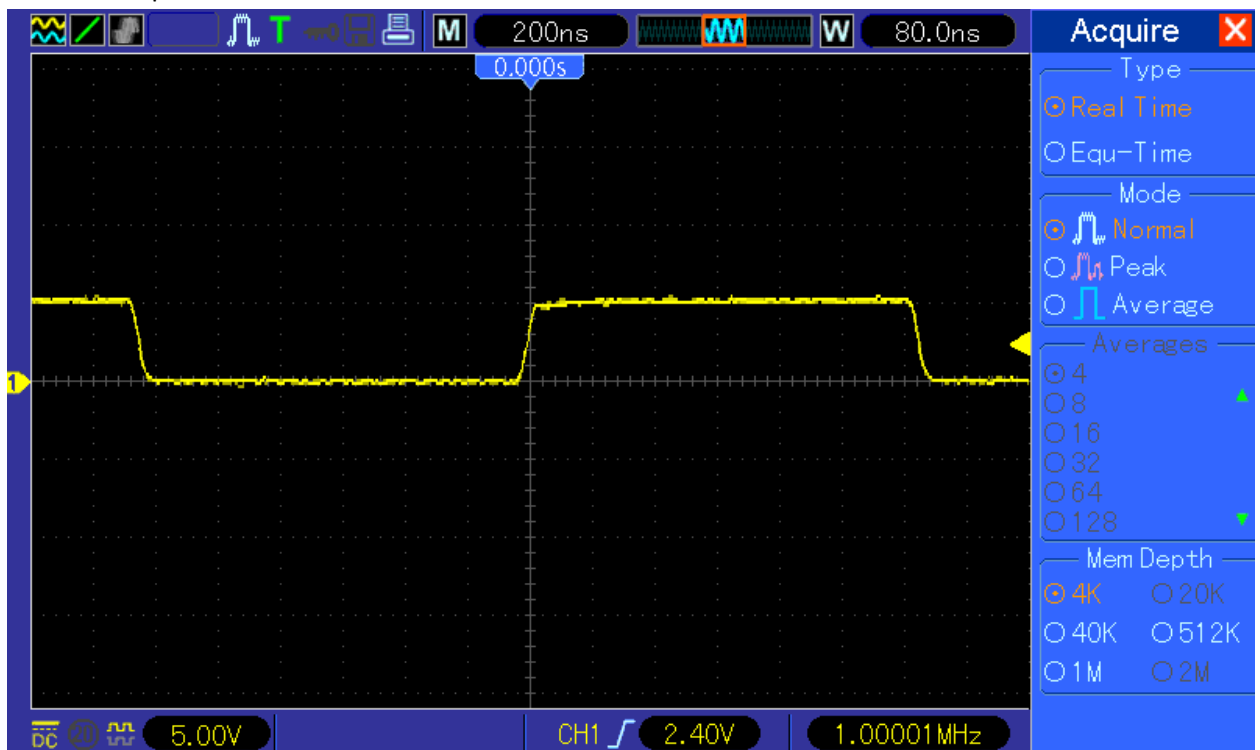
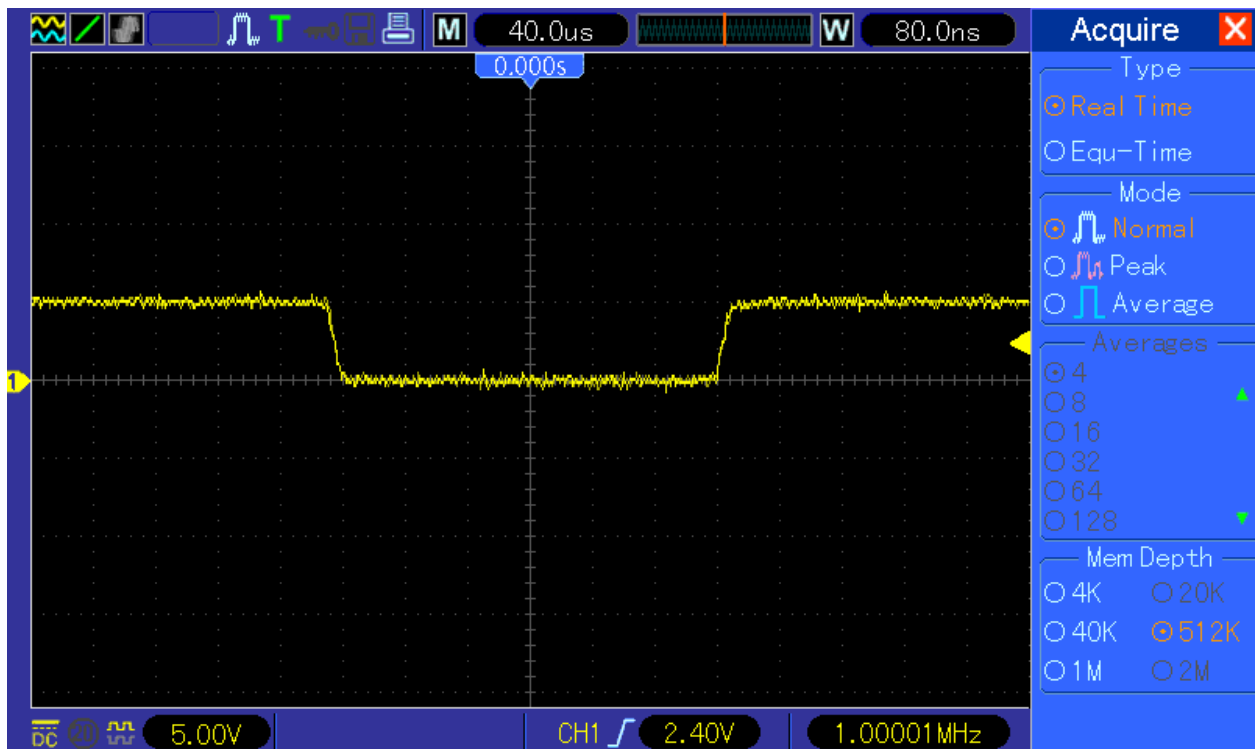
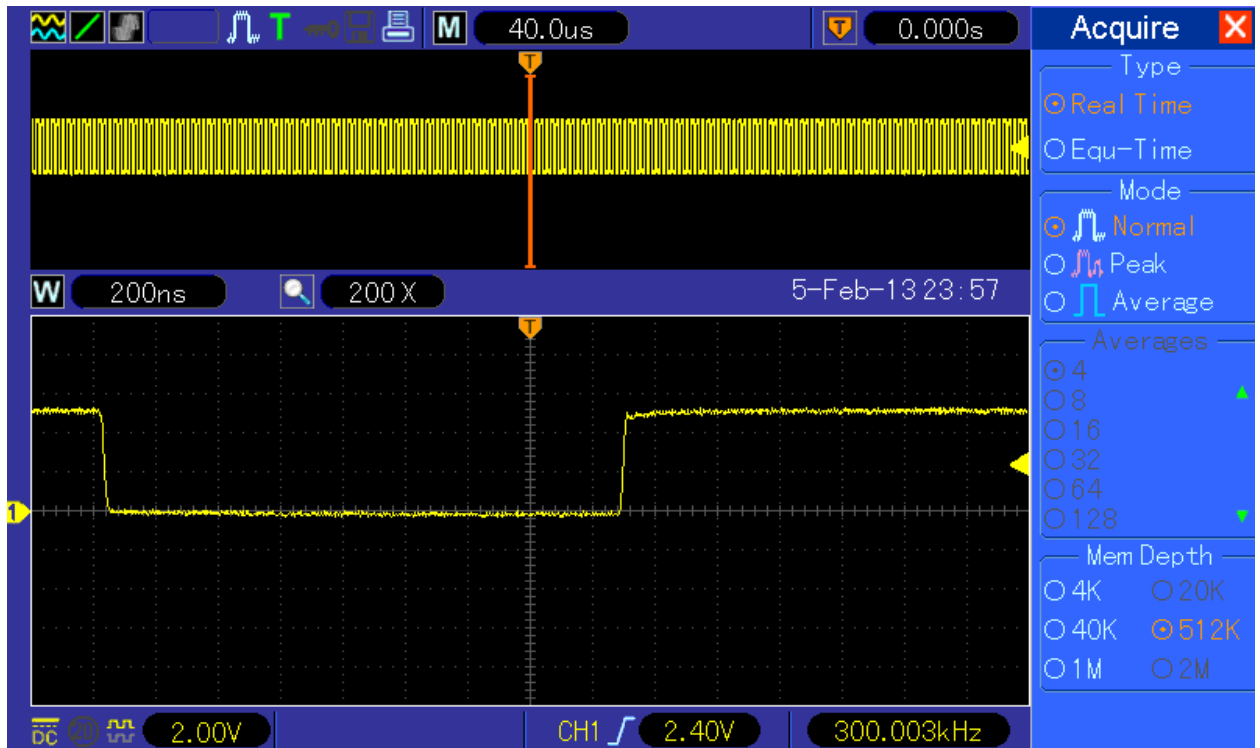
51. Trigger position broken in 40k, 512k and 1M memory depth mode.

Set DSO to 4k, 80ns/DIV, ch1 enabled, apply 1MHz square, the trigger is in the middle of the screen as expected:

Switch now to 40k, trigger is moved, zeroing of trigger position, selfcalibartion and even factory calibration is not helping. Tested with 83E9 and 83EB FPGA designs:

same problem in 512k:

in dual window same problem in 40k/512k and 1M memory depth:

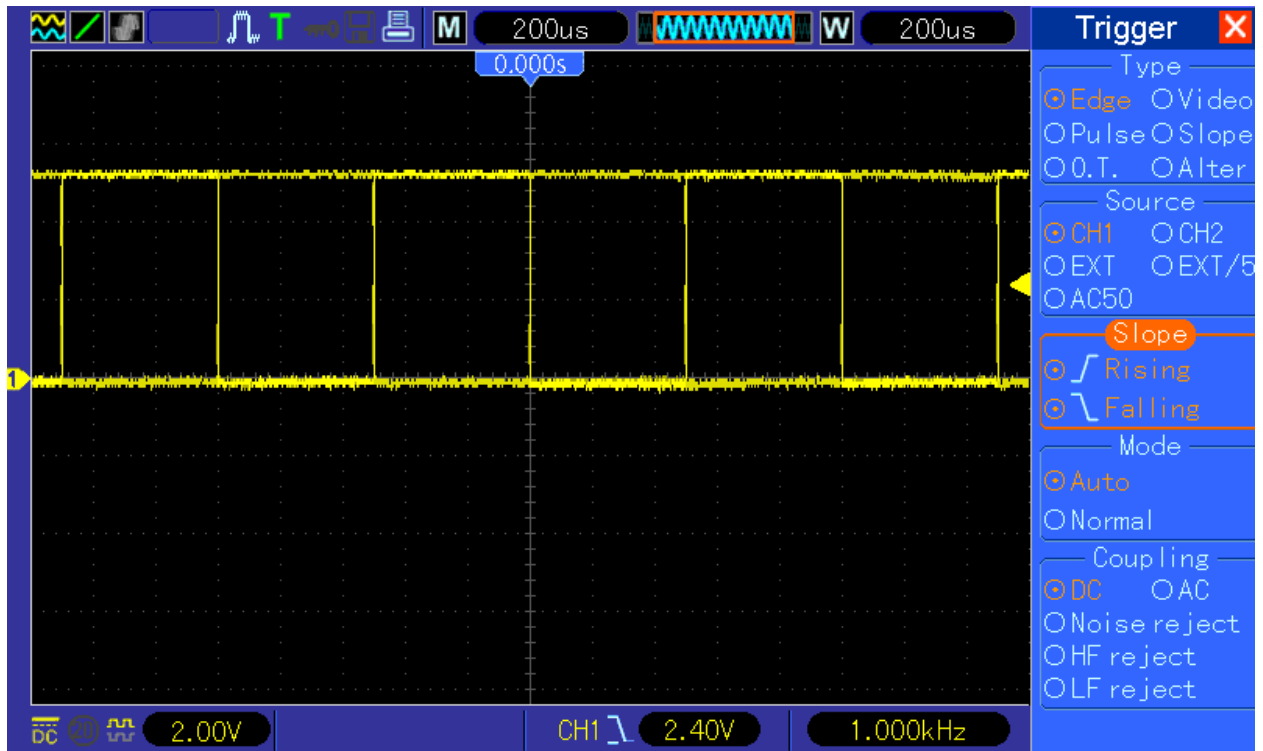
52. After enabling the Dual Slope in Edge trigger:

and changing to Alternate Trigger mode, the Dual Slope seems to be still on:

but I assume should be off? (I'm not sure about the intention here).

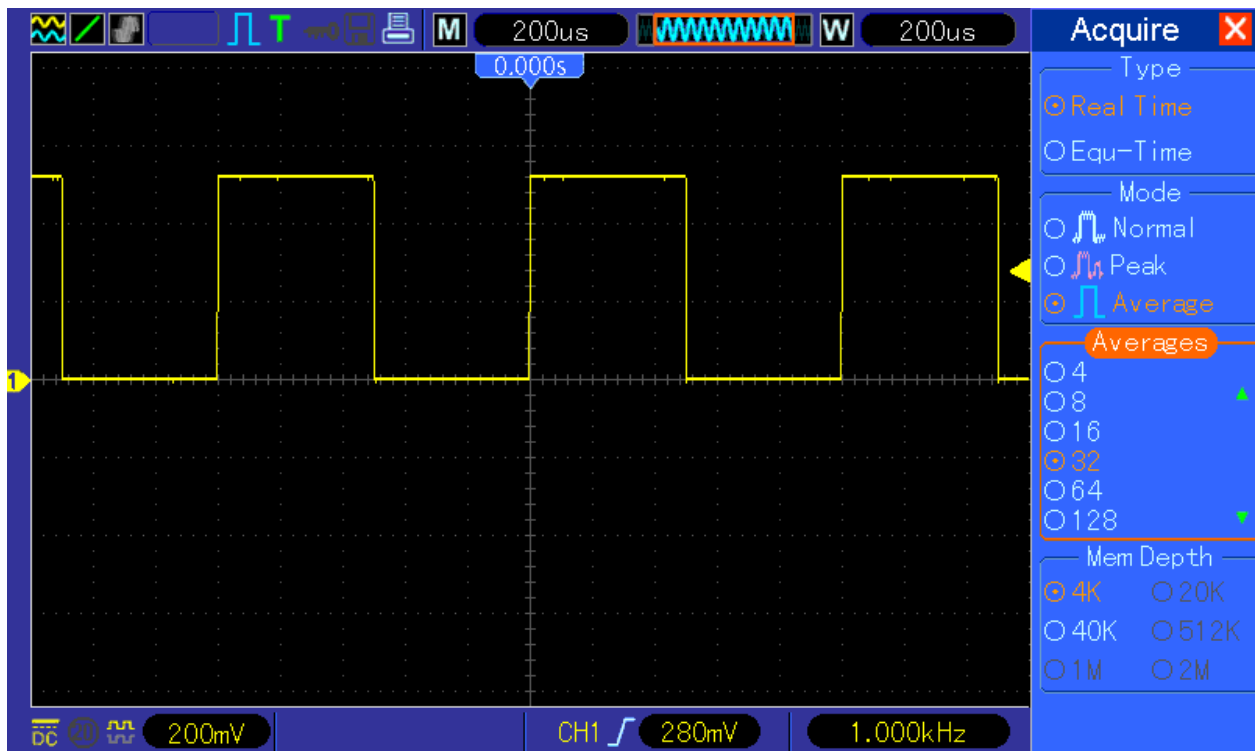
53. When number of Averages is higher than 16, and changing from 4k memory depth:

to 40k memory depth, the number of averages is showing nothing:
