Intel[®] DBPXA250 and DBPXA210 Development Platform for Intel[®] Personal Internet Client Architecture

Specification Update

July 2002

Order Number: **278555-002**

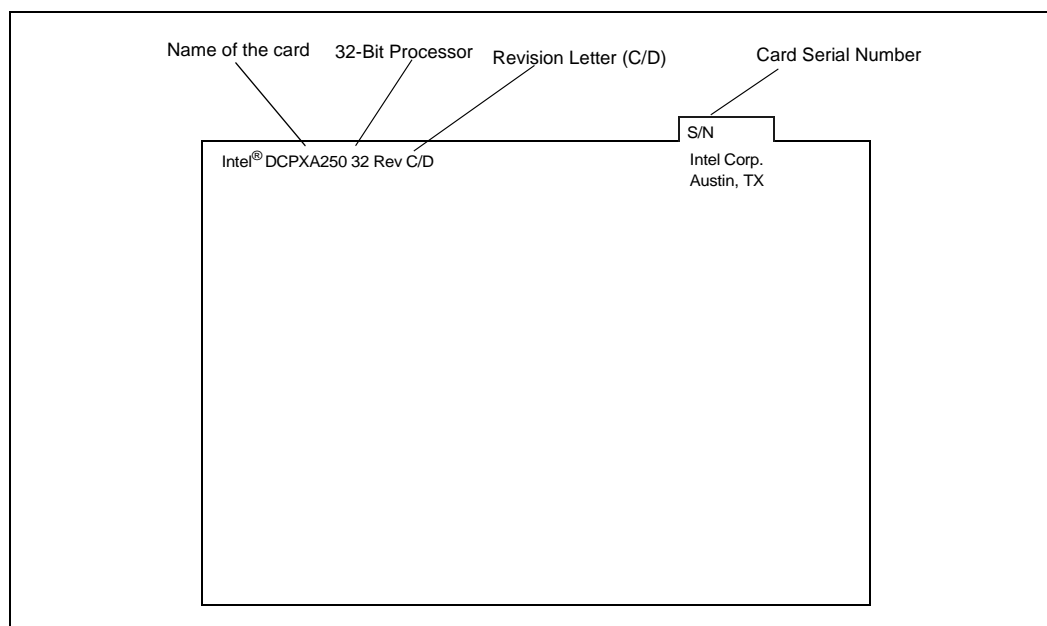
Figure 1. Intel® DCPXA250 Processor Card Markings

Figure 1 and Figure 2 show the markings for the DCPXA250 and DCPXA210 processor cards.
